FACTUAL SITE INVESTIGATION REPORT

Land at Branch Hill

Jon Sheaff & Associates

PROJECT REFERENCE: 20.1011

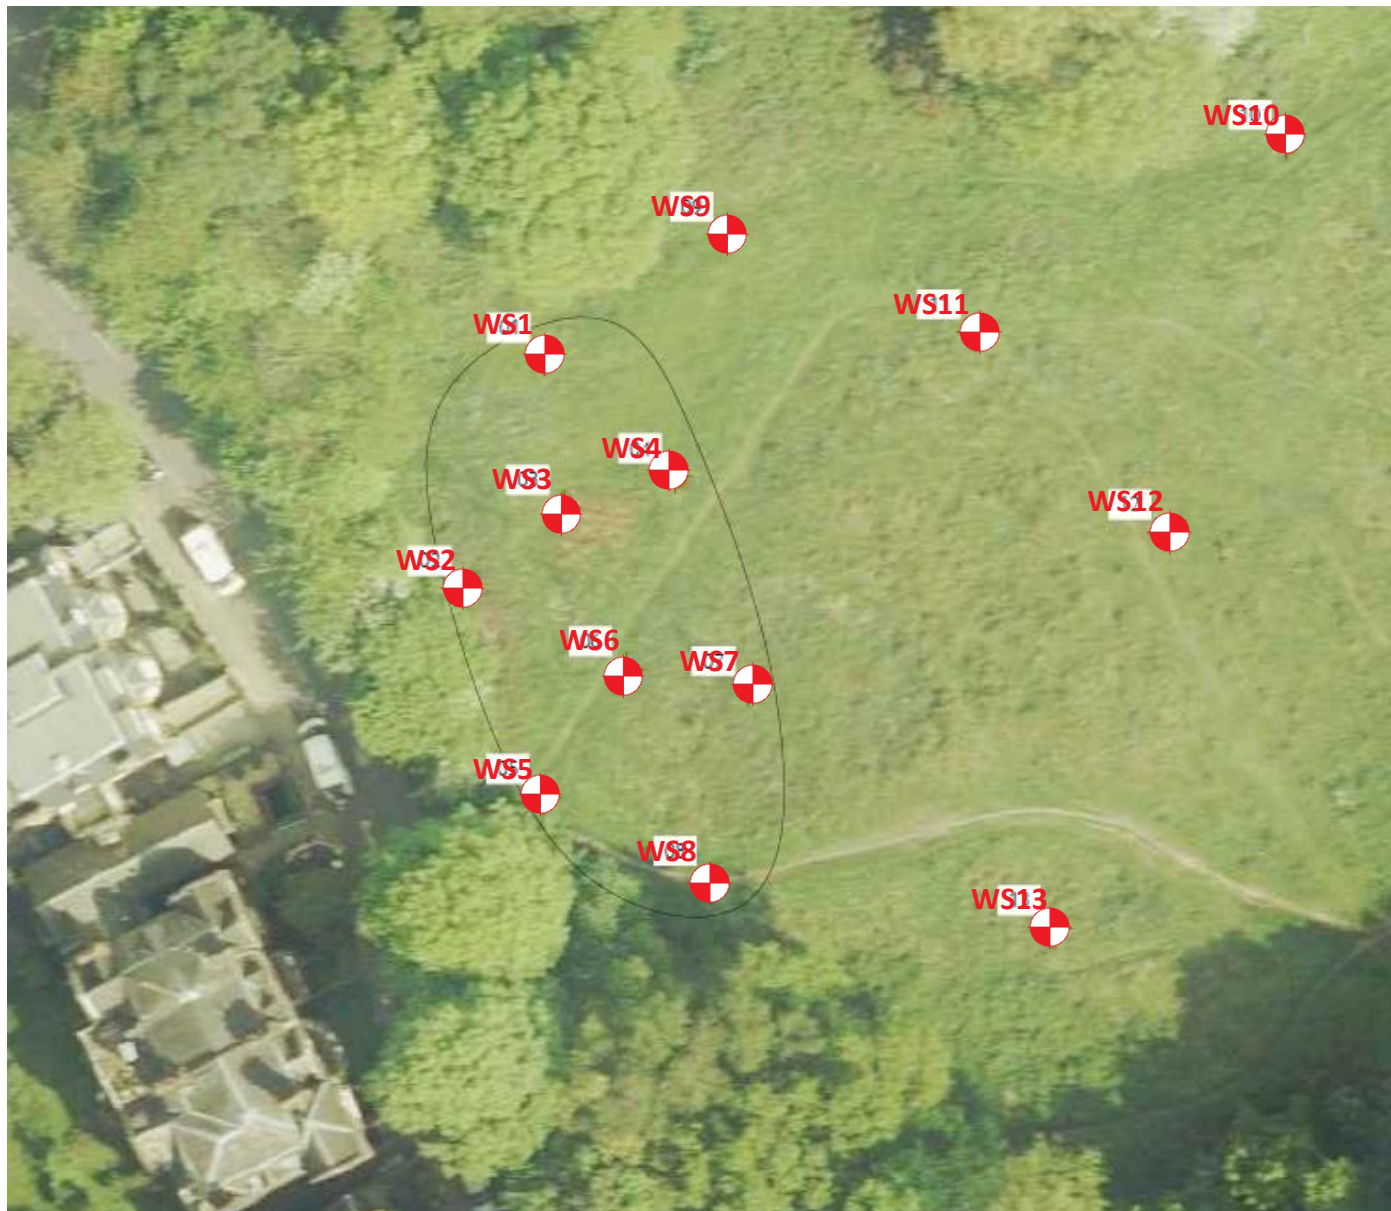
Site Investigation Plan

The following intrusive works as located in **Figure 2** were carried out over one day on the 25th June 2020, supervised by an Engineering Geologist from CE:

The final exploratory positions are provided in **Figure 2** with photographs of the site investigation can be found in **Appendix A**.

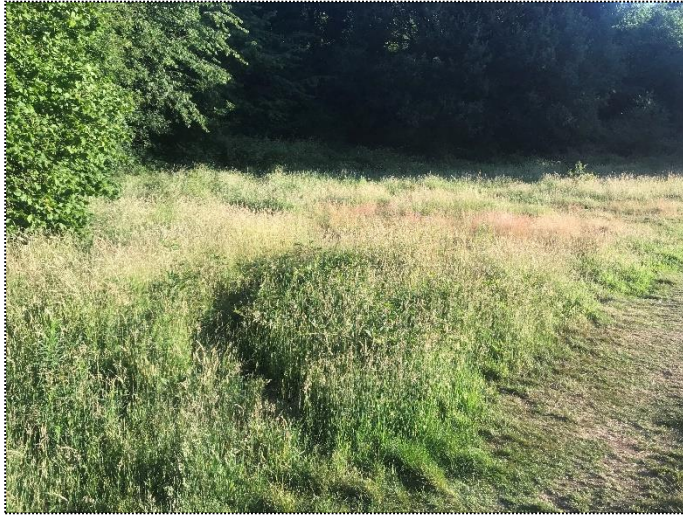
1.

- 1) Area of Former Pond
- 2) Overview of Site
- 3) Window Sampling Rig at BH4
- 4) Hand Held Window Sampling at BH11
