Tree Impact Plan  
showing surveyed  
trees, against the  
planning proposals

Project Name and Address  
**1 LYNTHURST ROAD,  
LONDON, NW3 5PX**

Project No <b>20126</b>	Sheet 1 of 1
Date <b>2021-09-27 14:46:02</b>	
Scale 1 to 200 at A3

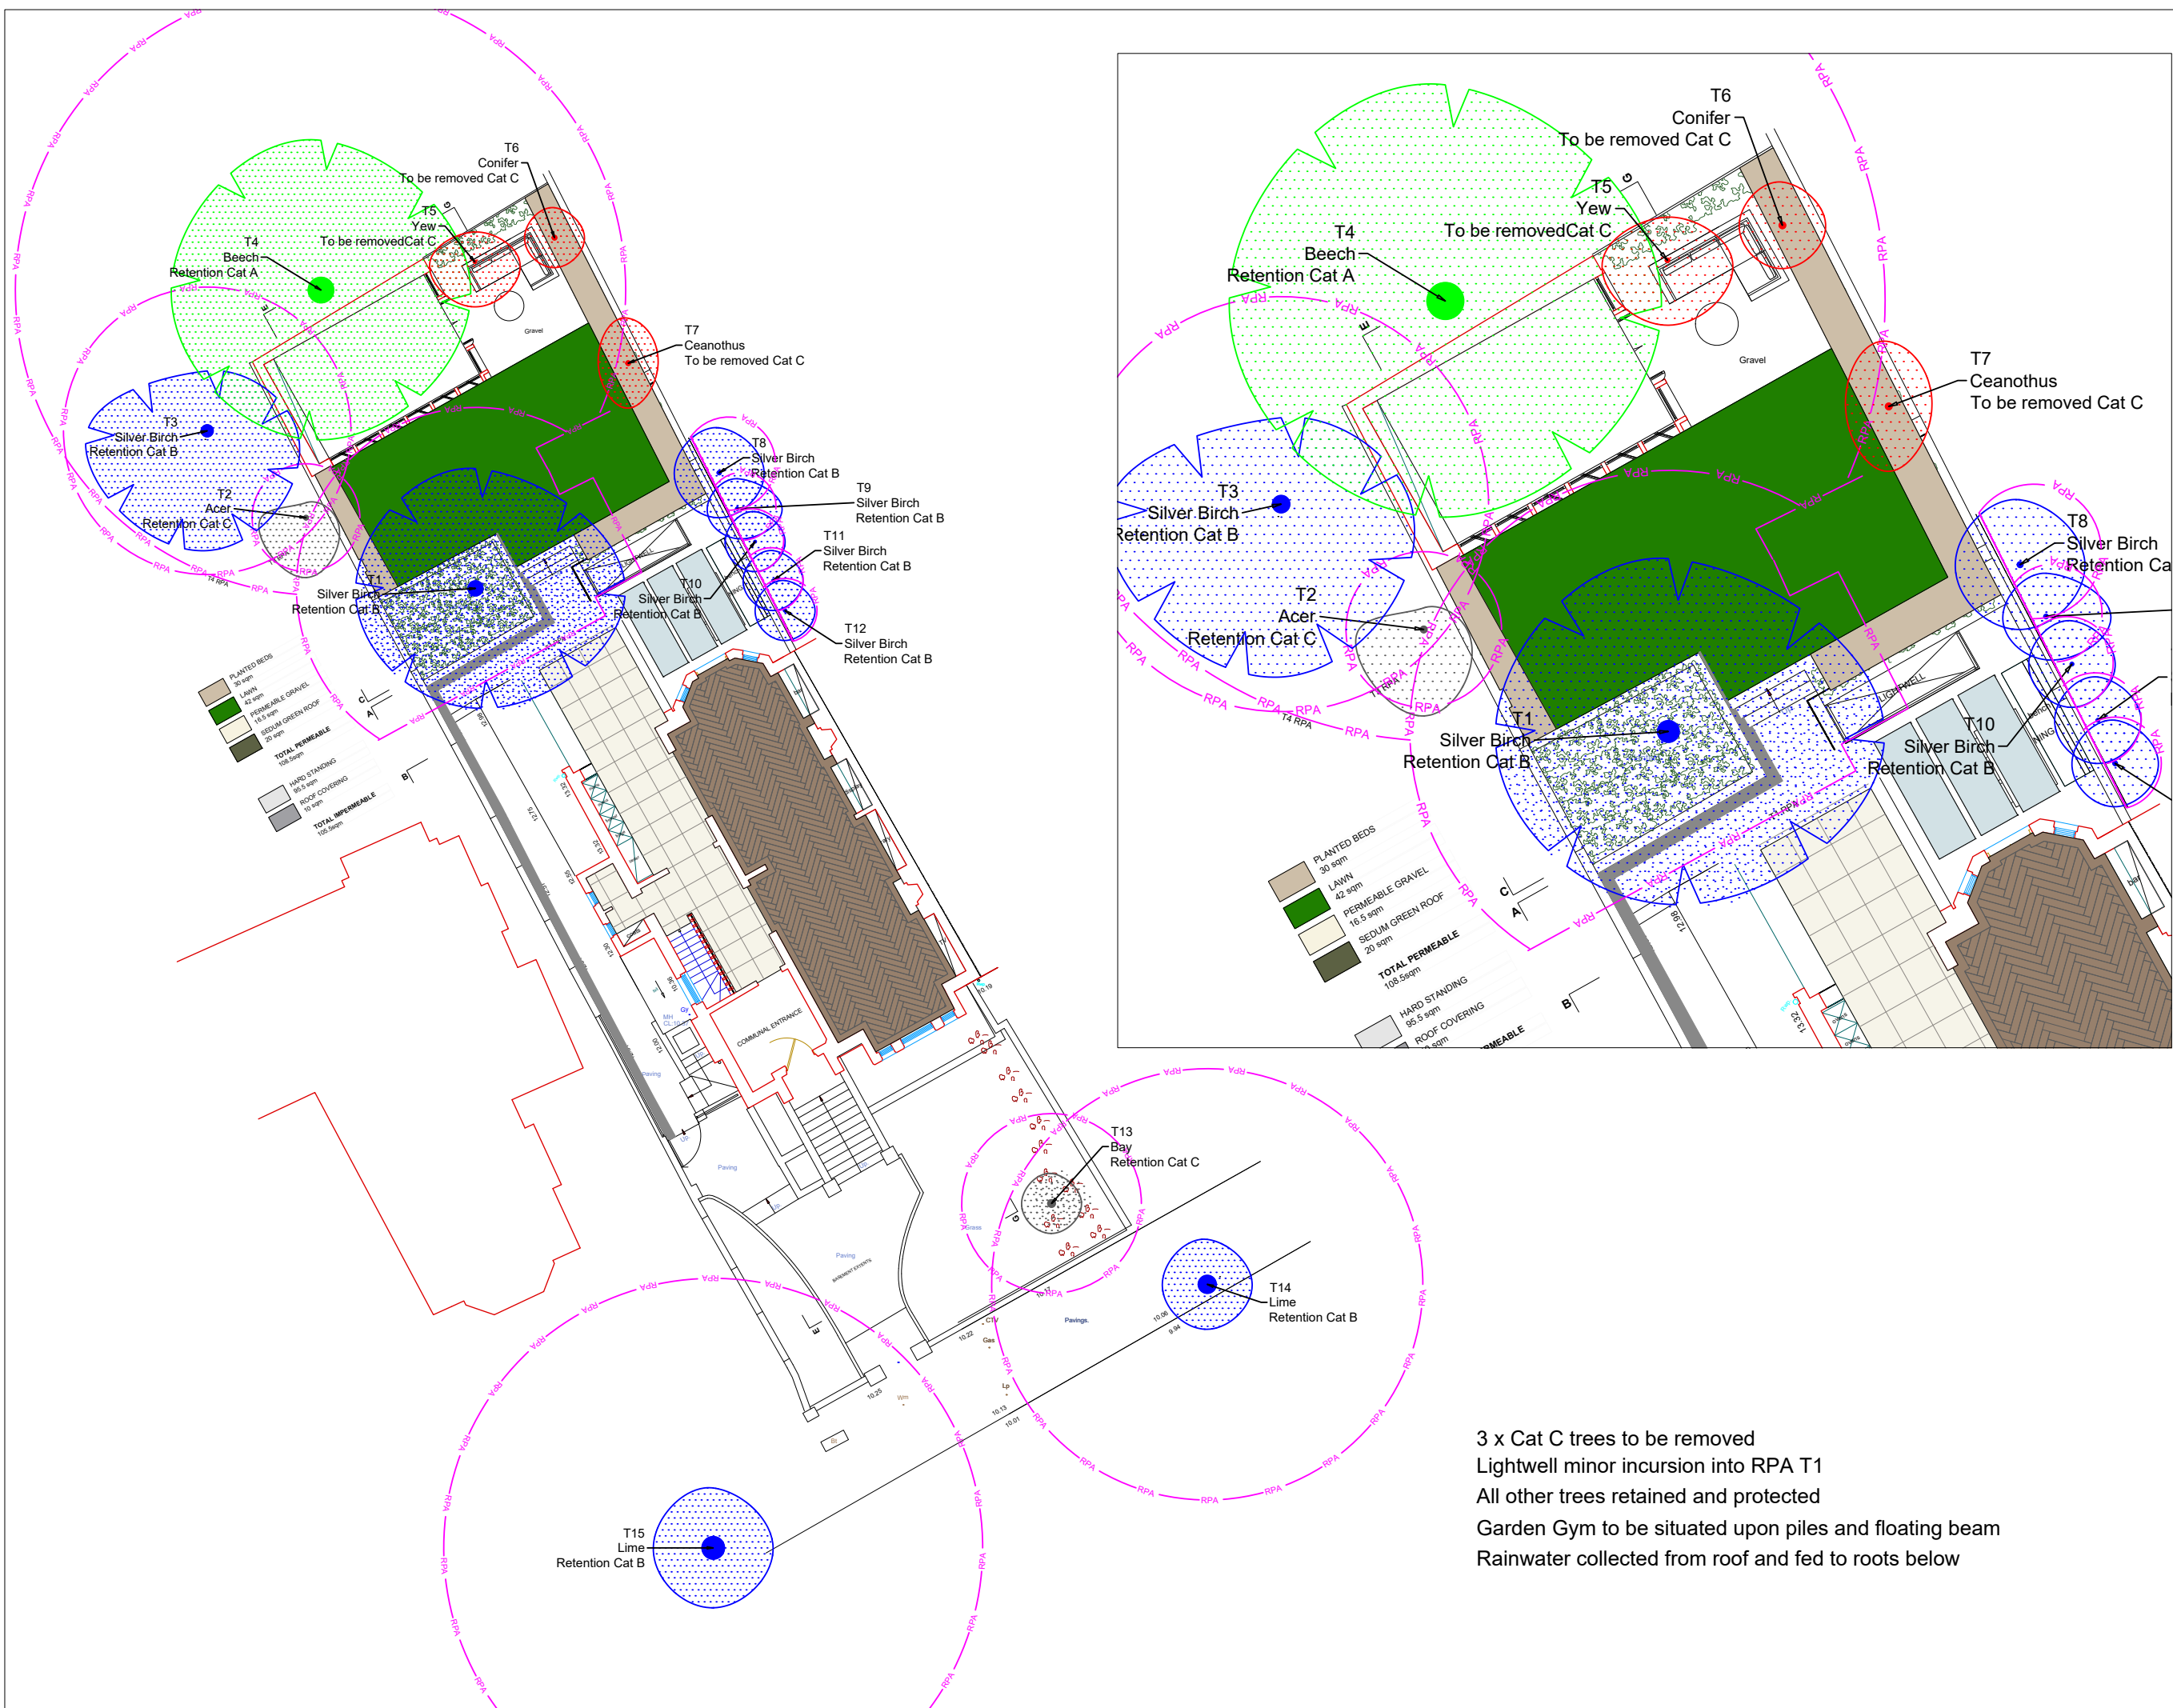
3 x Cat C trees to be removed  
Lightwell minor incursion into RPA T1  
All other trees retained and protected  
Garden Gym to be situated upon piles and floating beam  
Rainwater collected from roof and fed to roots below
