## Phase 1 Desk Study

22 Tanza Road, Hampstead, London NW3 2UB

Report Reference: GWPR4200/DS V1.01/May 2021			Status: Final
Issue	Prepared By	Checked By	Verified By
v.1.01

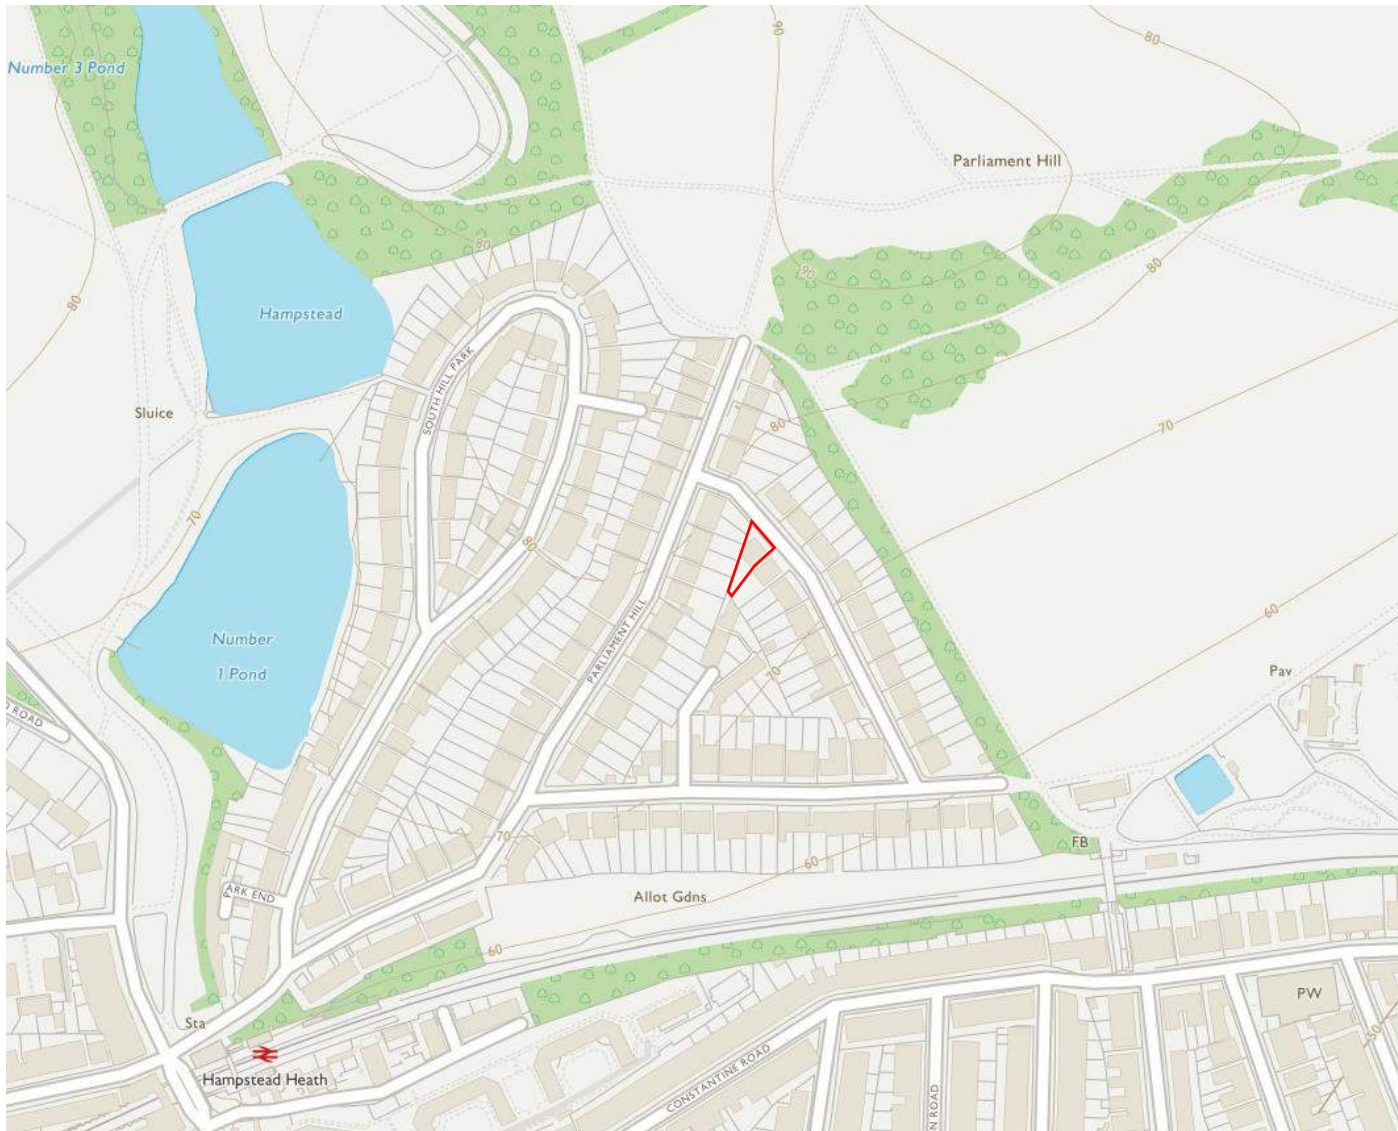
Figure 1: Site Location Plan

Approximate Site Development Area

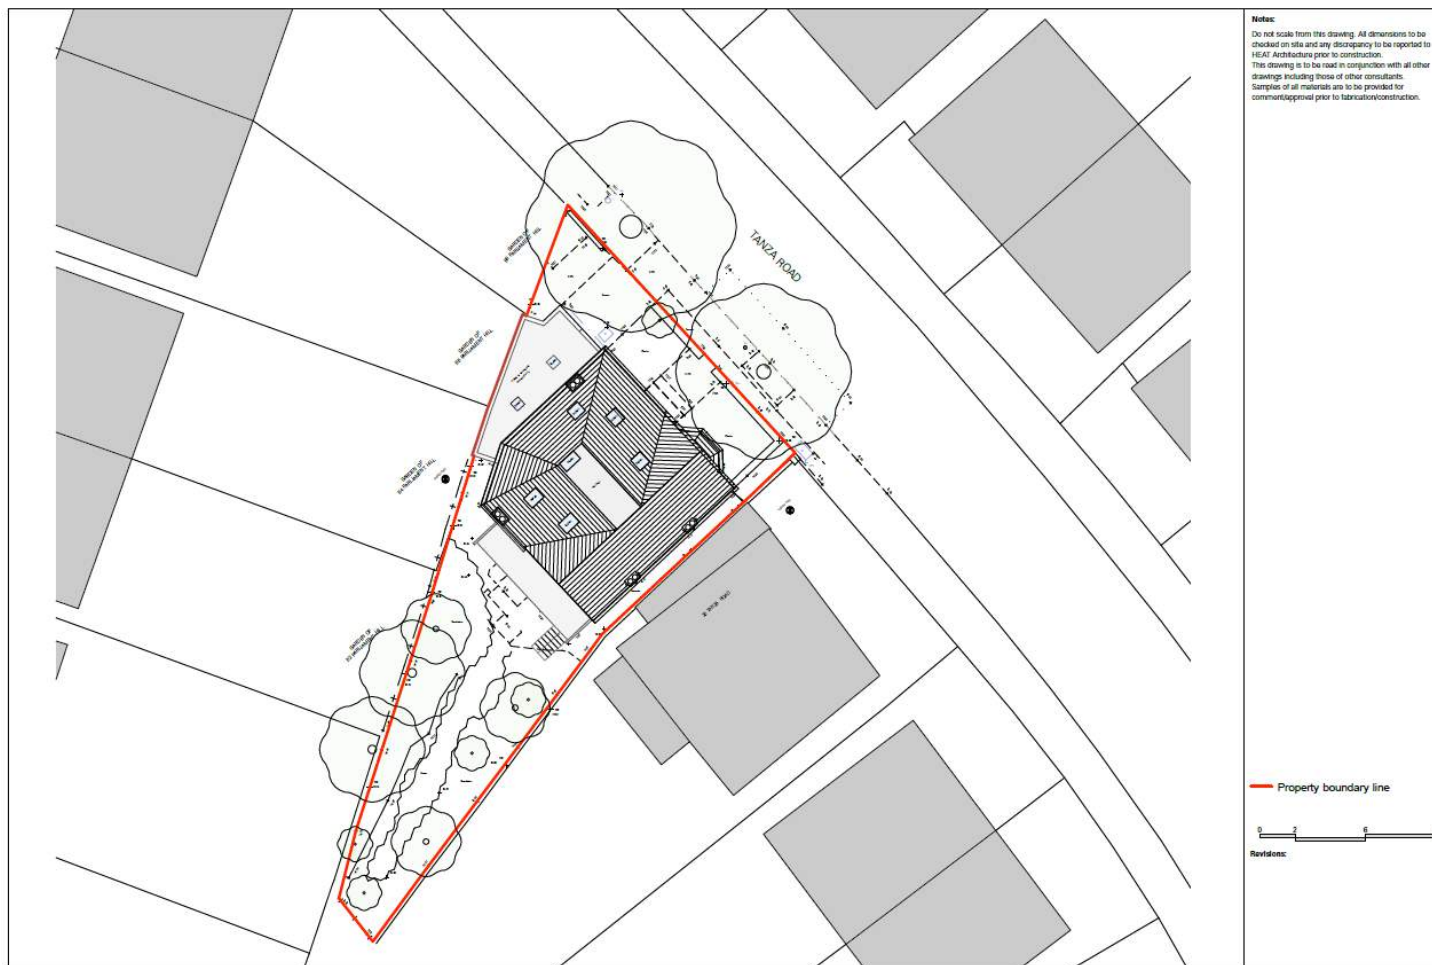
Figure 2: Site Development Area

Approximate Site Development Area

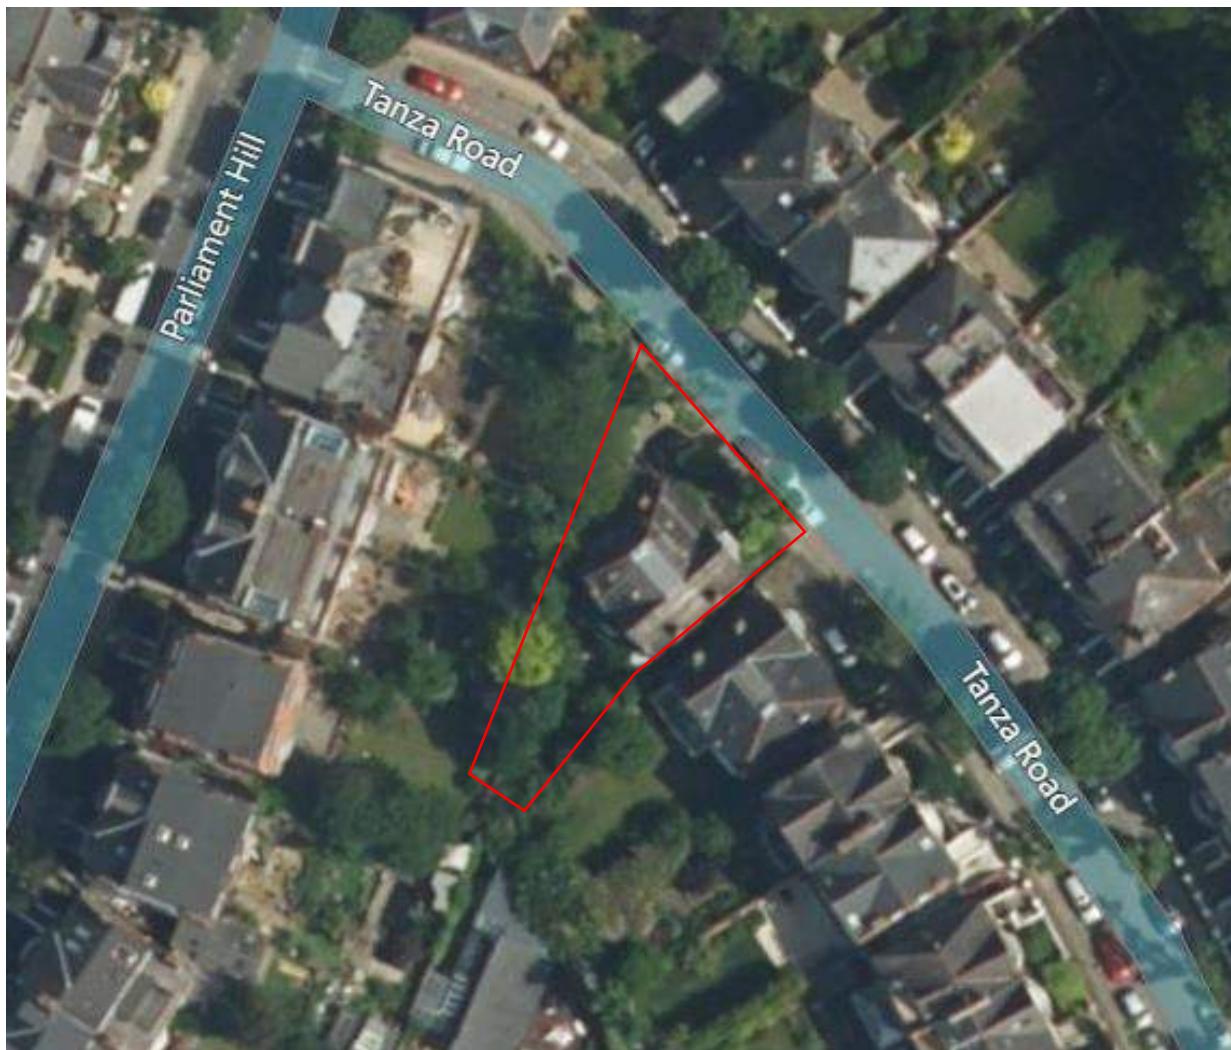
Approximate Site  
Development Area

The site comprised a ~390m<sup>2</sup> triangular-shaped plot of land, with a north-east to south-west orientation, along the south-western side of Tanza Road, ~35m south-east of the Junction with Parliament Hill. The site was located in the Hampstead, a primarily residential town within the north London Borough of Camden. The national grid reference for the centre of the site was approximately TQ 27541 85932. A site location plan is given within Figure 1. A plan showing the site area is given within Figure 2.

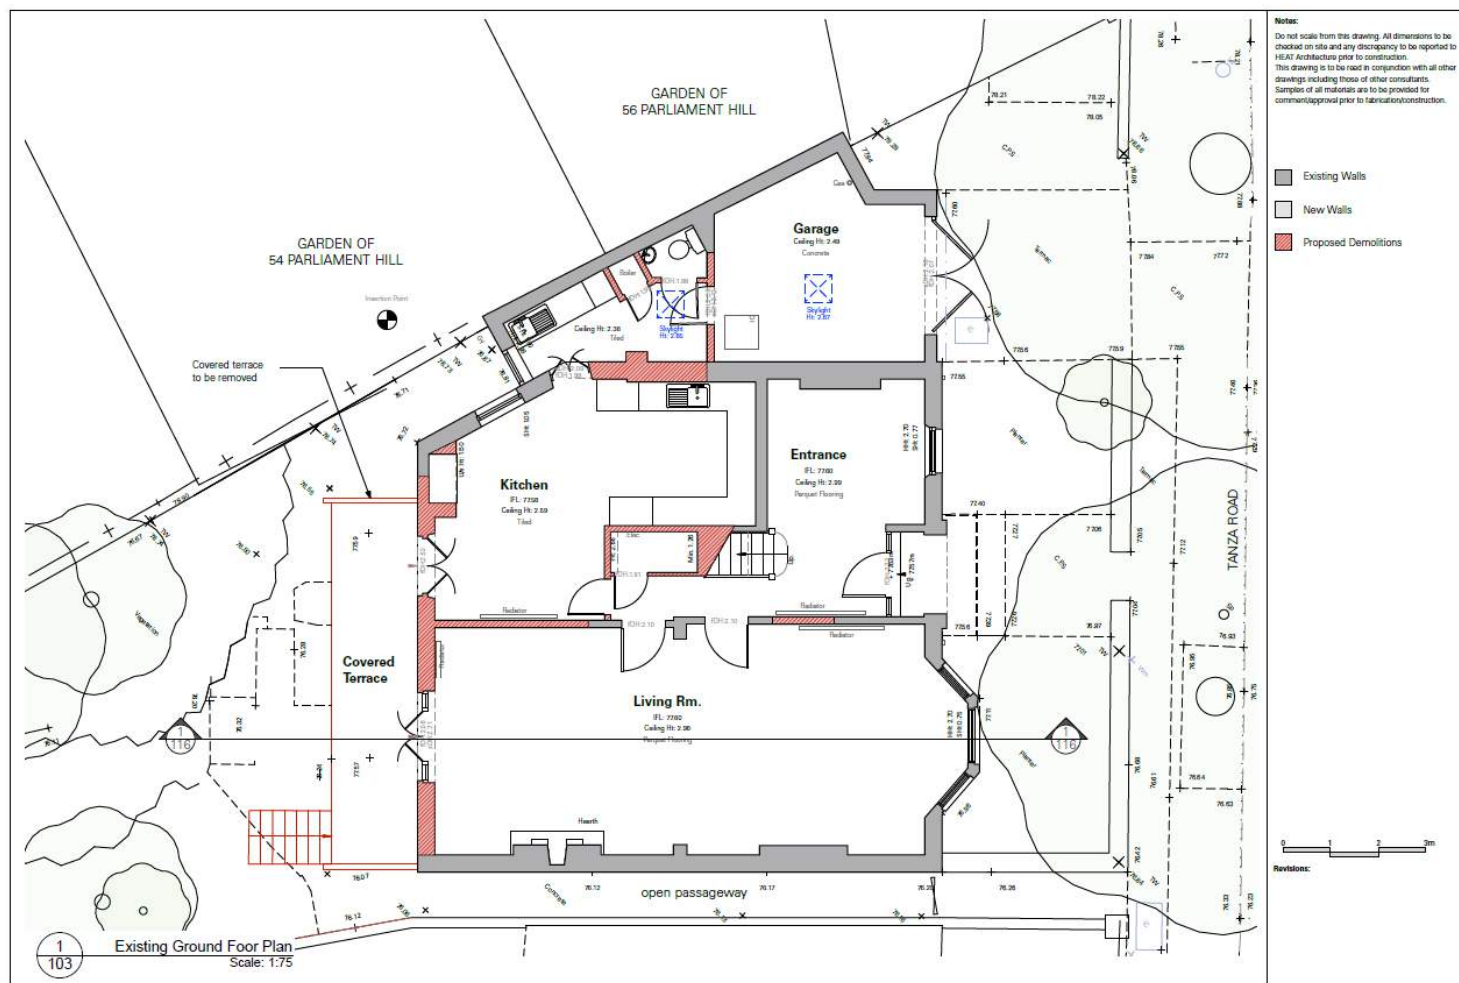
Figure 5: Existing Development Ground Floor Plan View

Existing Ground Floor

A Site Walkover was undertaken on the 27th April 2021 by a Ground and Water Limited representative. A description of the site, as noted during the Site Walkover, is tabulated below. An aerial view of the site, showing an approximate site boundary, is given within Figure 3. An existing plan view of the undercroft level and ground floor level have been provided within Figure 4 and 5 respectively, with an existing section view provided within Figure 6.

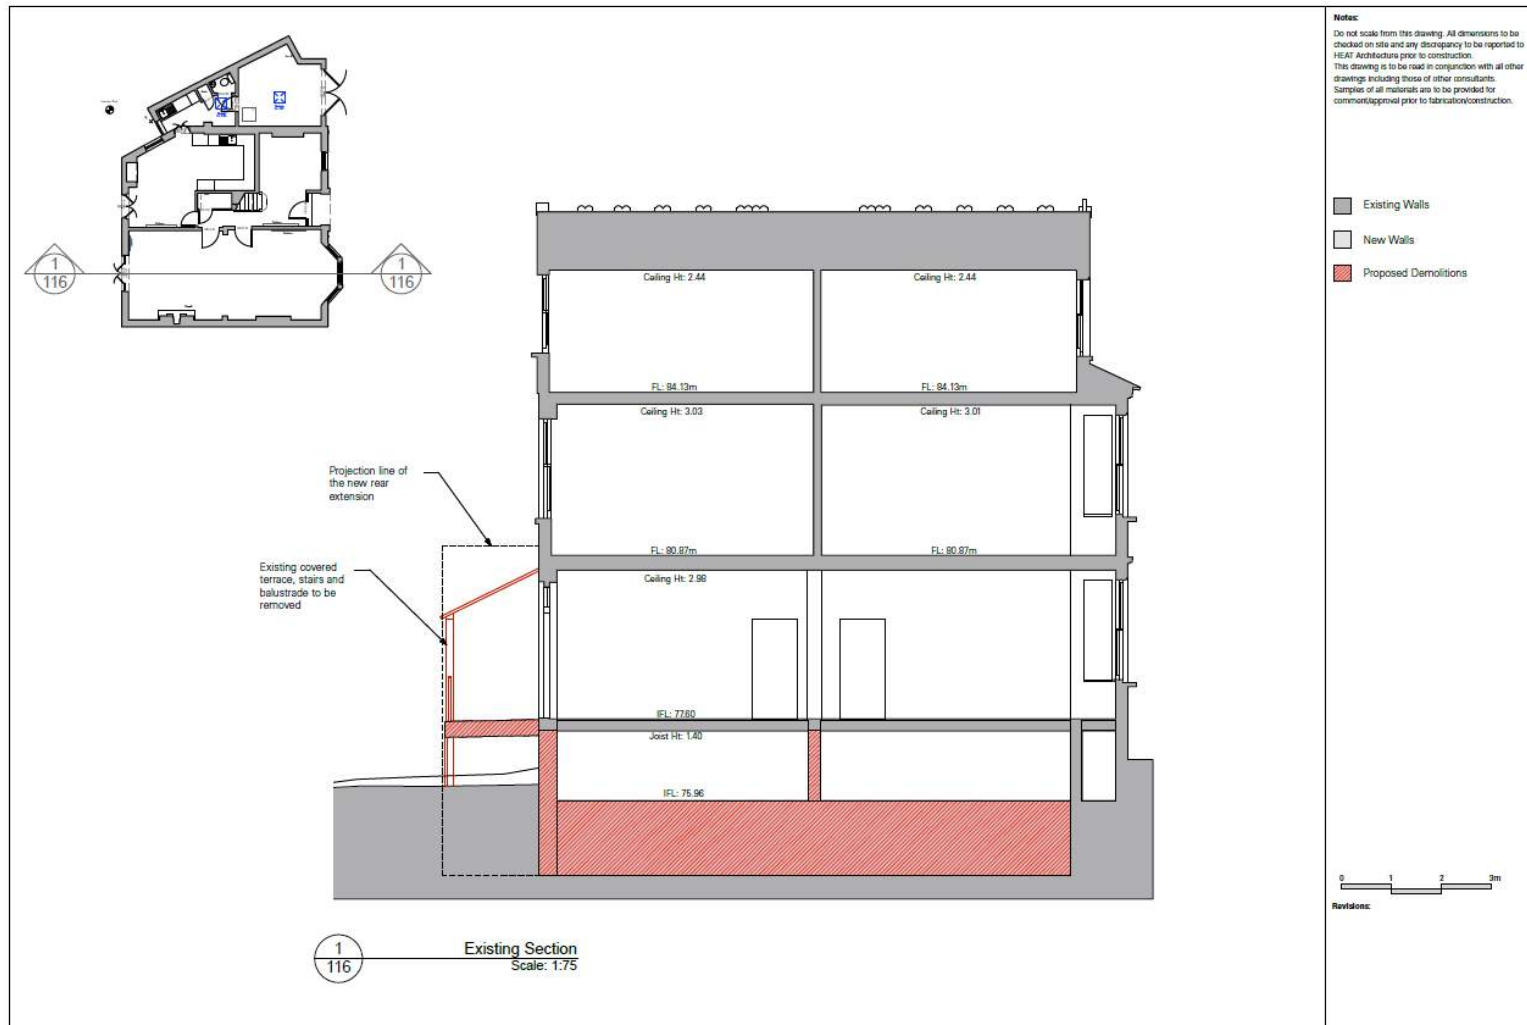
Figure 6: Existing Development Section View

Existing Section

The site was situated on a south-facing slope. It was however noted to be less than 7° steep. The existing basement floor level was 75.96m AOD, with the ground floor level 77.60m AOD. The front garden level was 78.20m AOD at the northern extreme, lowering to 76.26m AOD at the eastern extreme. The rear garden level was roughly between 76.00 – 76.60m AOD.

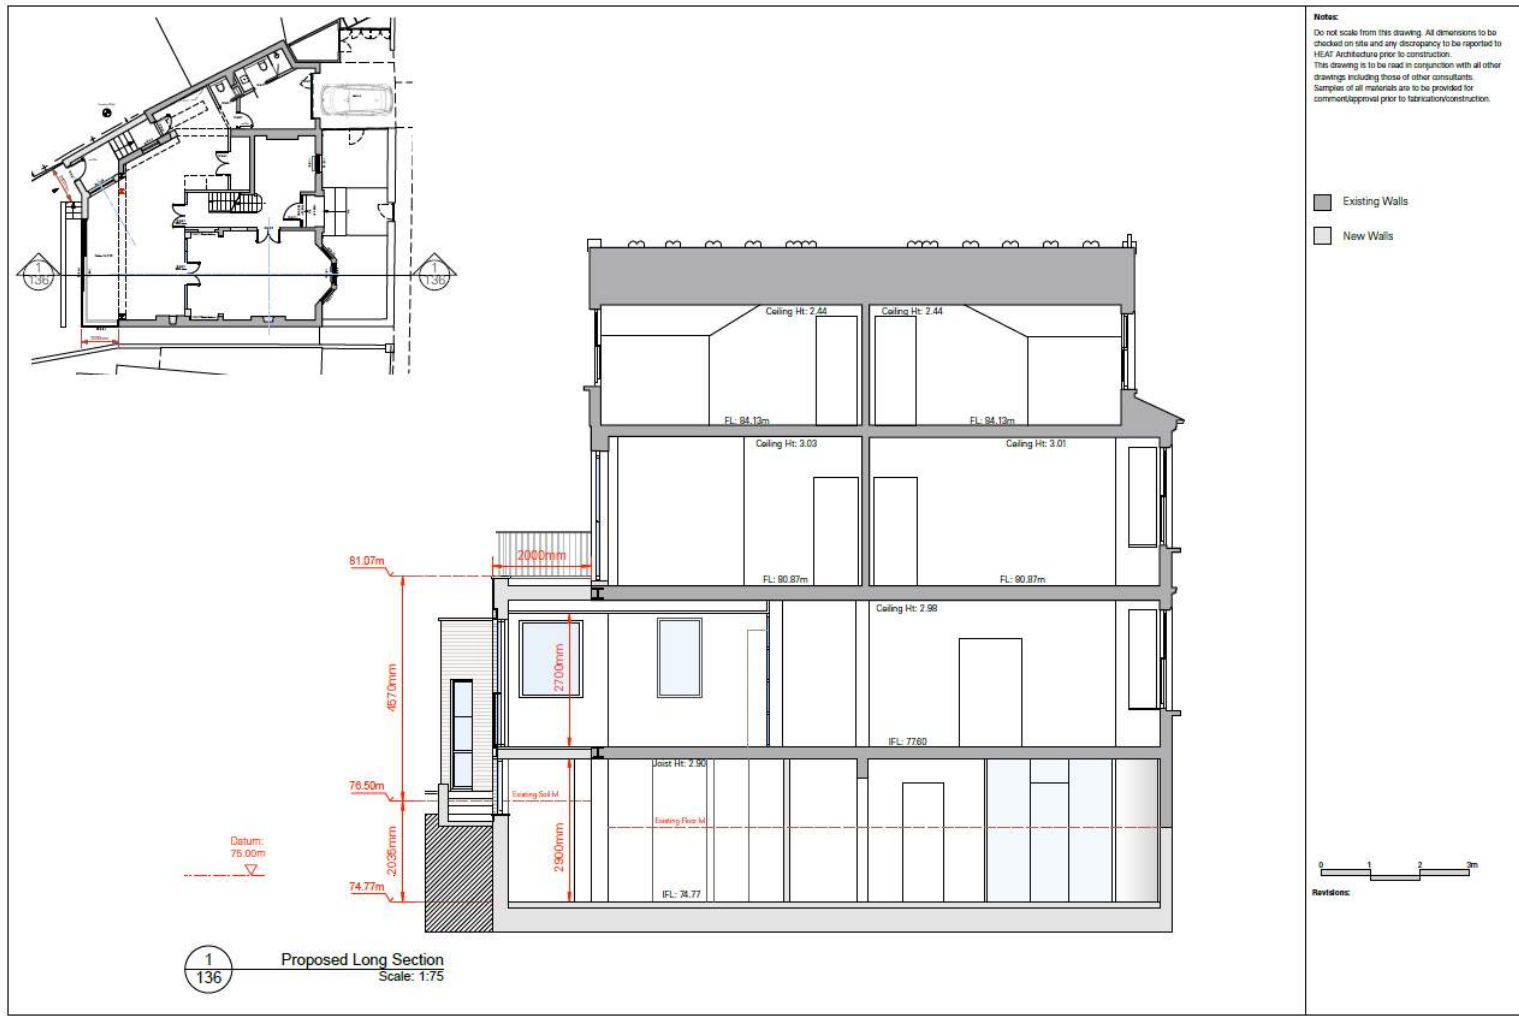
**Figure 9: Proposed Development Section View**

**Proposed Section**

At this stage the proposals are to construct the retaining walls with mass concrete and to then construct a reinforced concrete basement box within this. The retaining walls were noted to have a 2.70m long stem, with a 1.40m wide, 500mm thick base; therefore the overall depth from ground floor level was to be 3.20m, and the foundations relating to the basement were to be formed at 74.40m AOD. However, given there is already an undercroft below the existing ground floor level to 75.96m AOD, the actual underpin/excavation was noted to be ~1.60m. The maximum length and width of the basement were ~11.70m and 11.30m respectively. The retaining walls were noted to have a load of 51kN/m<sup>2</sup> based on the structural calculations provided within Appendix B.

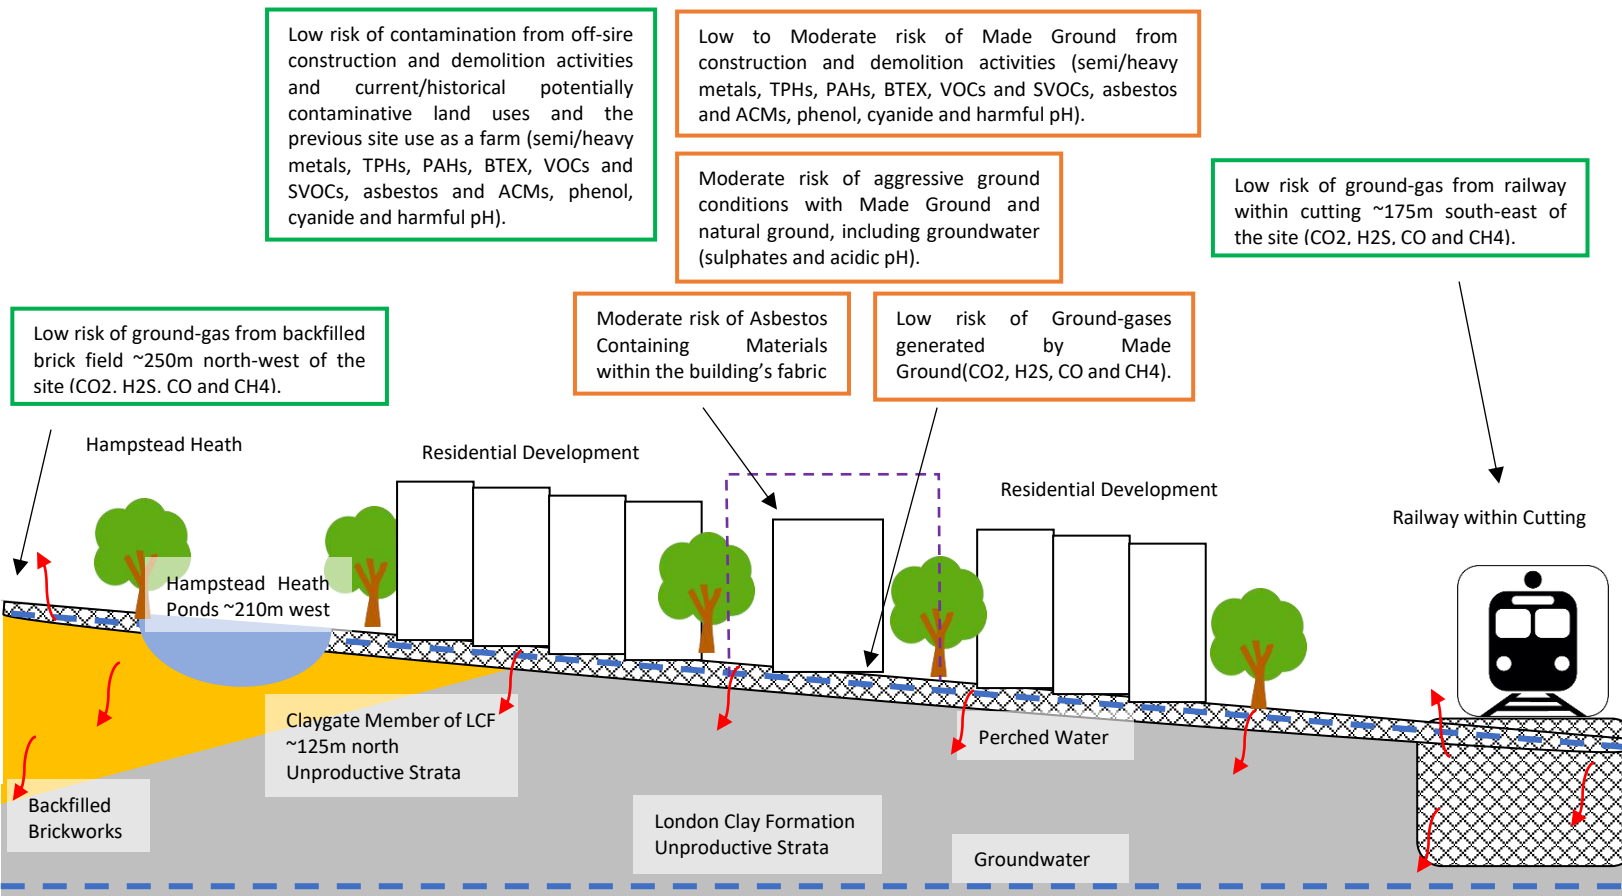
**Figure 10: Diagrammatic Conceptual Site Model**

**Human Health;** Direct ingestion of soil and soil derived dust, Dermal contact of soil and soil derived dust, Inhalation of dust, Ingestion of home-grown produce and soil attached, Inhalation of volatile vapour, Inhalation of ground gases, and Explosion.

- Site Boundary
- Made Ground
- London Clay Fm.
- Claygate Member of LCF
- Groundwater

- On-site Sources
- Off-site Sources
- Potential Contaminant Pathways
