No. 5 Denmark Street Heritage Statement Prepared for John Farrell August 2021

This report has been prepared in support of planning and listed building consent applications in relation to No. 5 Denmark Street (listed Grade II).

It sets out the history and significance of the site and assesses the heritage impact of proposals for repair and refurbishment, developed by Ian Chalk Architects.

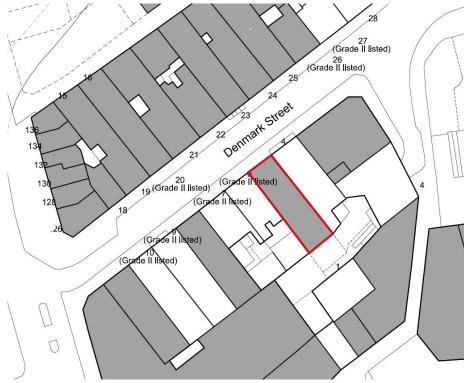
Fig. 2: Site plan (site outlined in red)

The site is No. 5 Denmark Street, located on the south side of Denmark Street in the London Borough of Camden. The former workshop block at the rear of the site fronts Book Mews Yard.

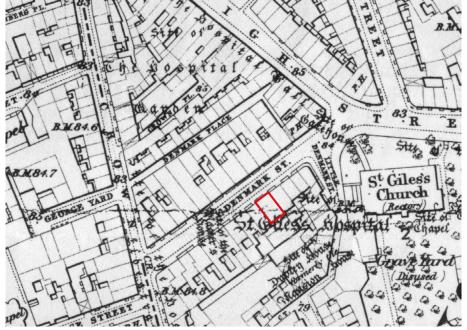
Fig. 6: 1870, Ordnance Survey, before the widening of Crown Street to create Charing Cross Road

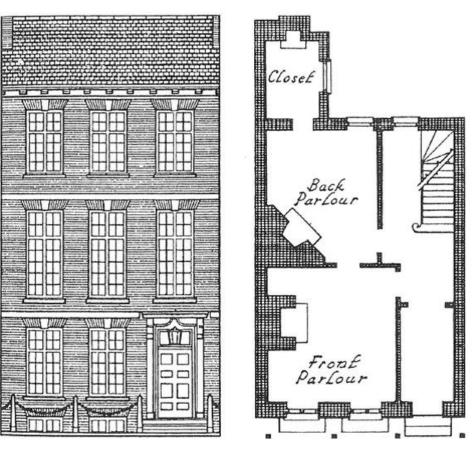
Fig. 9: Typical house c. 1670-1700, with casement windows and eaves cornice, as illustrated in Summerson, 2003

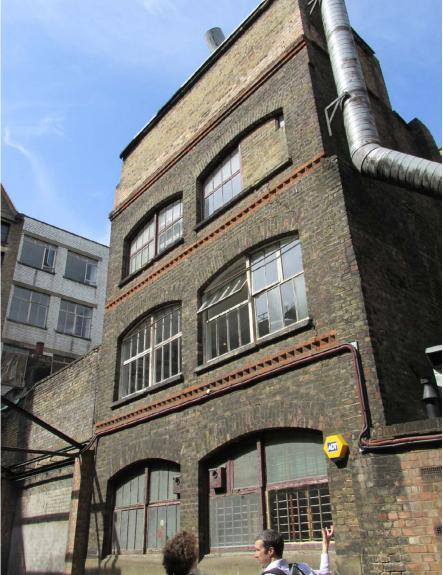
Fig. 10: View of rear workshop built c.1876

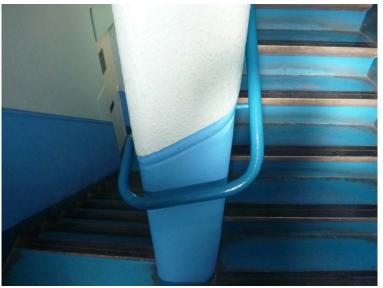
Fig. 15: Main staircase at 3rd floor

The main staircase was entirely rebuilt in brick in the twentieth century and has **neutral significance**. The proposal is to remove the upper flight of stairs. This did not exist when the house was built in the 1680s. As this flight of stairs possesses no significance, its loss will have *no impact*.

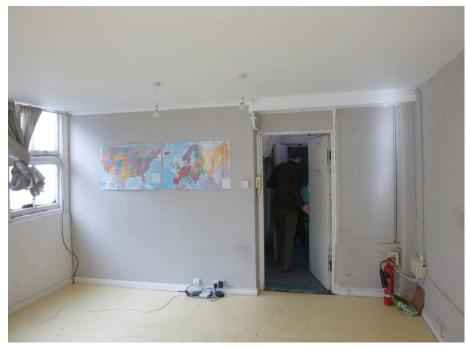
Fig. 16: Typical interior, 2nd floor

The interiors of the rear workshop have been modernised and altered with the insertion of columns in the 20th century, but investigations indicate there is an original jack-arch ceiling between second and third floors. This is currently hidden behind a modern ceiling (see fig. 16), but has some significance.

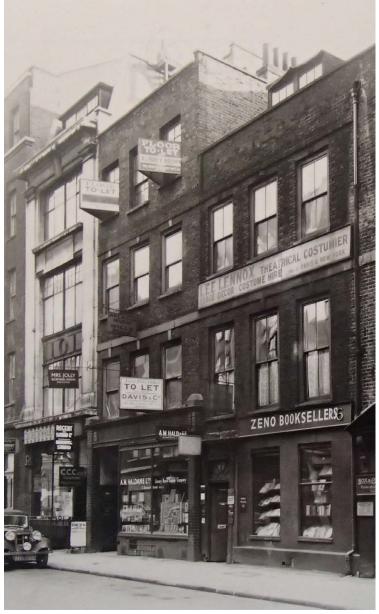
Fig. 17: Nos.4-6 Denmark Street in 1957

Additional single-storey WC block added to rear workshop

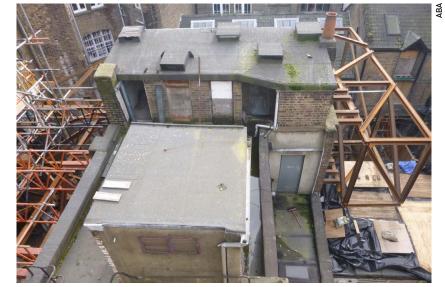
Fig. 18: View of rooftop structures over Victorian workshop, seen from roof of front building

The two brick outbuildings on the roof of the rear extension are utilitarian structures of no architectural merit and their interiors are in a very poor state. They are currently disused and it seems likely that they are causing the structural issues within the building below, risking the long-term survival of the significant Victorian workshop. They are therefore considered to detract from the significance of No. 5 Denmark Street.

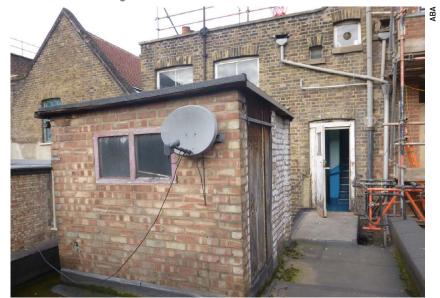
Fig. 19: View of 1950s brick structure on roof of Victorian workshop

The rear façade of the former house is not original, having been reconstructed in the nineteenth century. Its more industrial character can accept greater change without harming significance (see photo, fig. 19). The proposal to fill in one of the window openings will therefore not cause any harm. It is necessary in order to achieve the improvements to the workshop including the installation of modern WCs. The rhythm of the rear façade will be maintained, by expressing the blocked window as a recess, so as to maintain the traditional character of the elevation. This aspect of the proposals will therefore have *no impact* on significance.

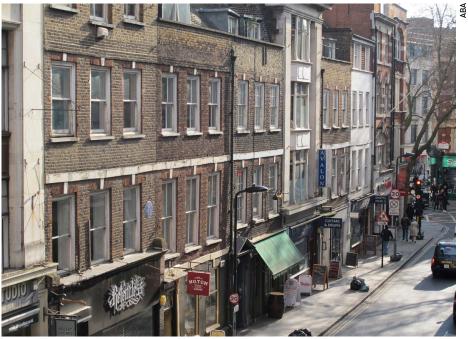
Fig. 20: General view of the south side of Denmark Street looking west. No.5 is in the foreground

Overall, No. 5 makes a positive contribution to the Conservation Area. In particular, the combination of house and workshop is highly characteristic of the area. There is a distinction between the formal street frontage and the more industrial character at the rear. However, at present, the crude roof-top extensions detract from the robust, industrial character of this location.

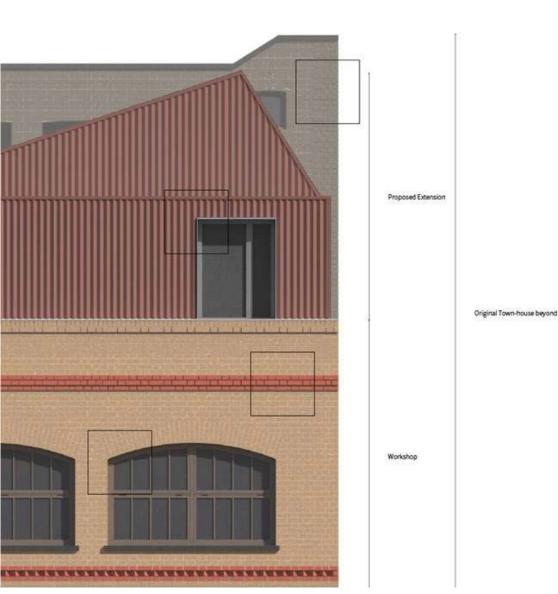
Fig. 21: Exterior of workshop as proposed, façade study by ICA

The building may have originally had a pitched roof of some kind, but no illustrations have come to light. The proposal is for a pitched sawtooth roof with skylight (to allow a view of the church spire from within). This design therefore introduces elements that are appropriate to the industrial character of this part of the listed building and conservation area.

The existing south front of the former workshop has a more formal character and the design here is differentiated to respond to that character, with a more horizontal emphasis. This is similar in massing to the existing brick structure, but in a more lightweight material (CLT), without the weight of masonry (which has caused structural problems – see ICA report). The original cornice of the 1870s south front is incomplete due to the damaging early twentiethcentury alterations. The proposals envisage the reinstatement of a simple, period-appropriate cornice, based on the brickwork details found on the host building.

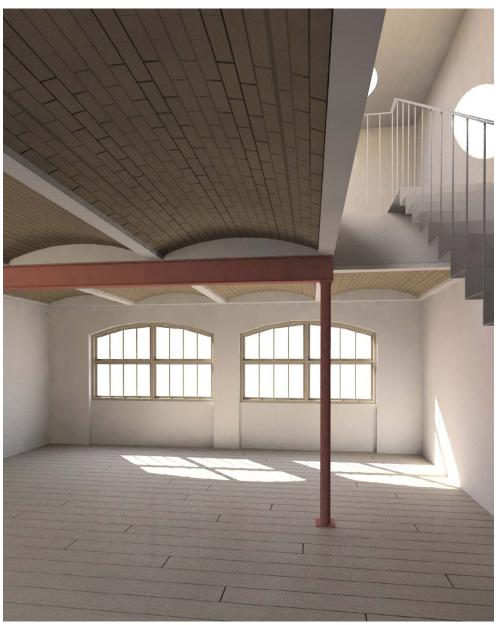
Fig. 22: Interior of workshop as proposed, visualisation by ICA

The refurbishment will reveal and restore the jackarch ceiling of the former workshop, thereby better revealing the significance of the listed building (NB original ceiling finish unclear and subject to investigation). Some poor quality later fabric of no significance will be removed. Overall, because of the way that the historic character of the building will be internally revealed, these alterations will be beneficial in heritage terms.
