**Pool house at 14 Greenaway Gardens, Hampstead,
London NW3 7DH**

Written Scheme of Investigation

September 2021

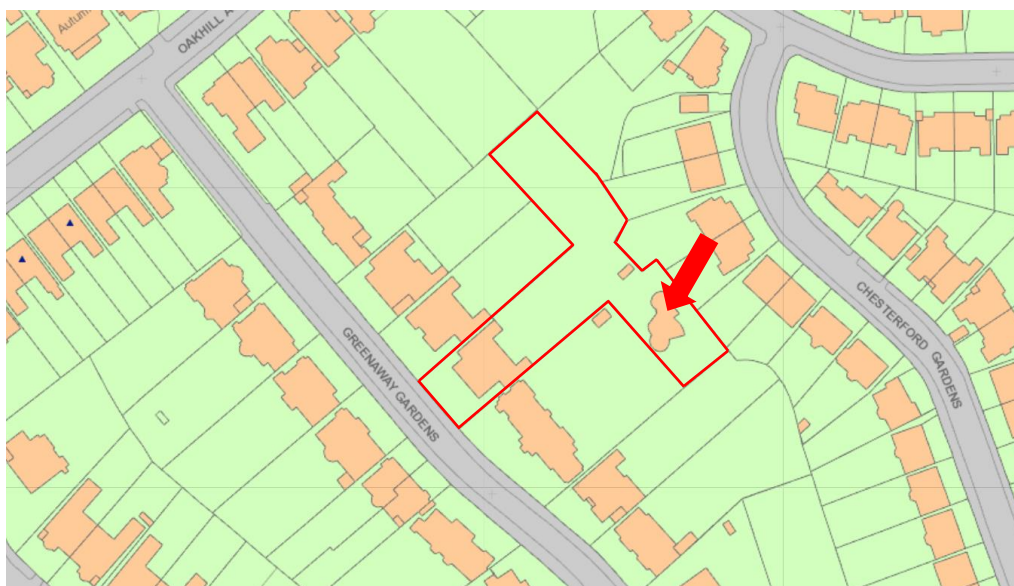
Figure 1: Location of no. 14 Greenaway Gardens is outlined in red. Location of the pool house is indicated by the red arrow.

- 2.1. The pool house is located within the rear garden of no. 14 Greenaway Gardens (grid ref: TQ 25858 85621). The plot of no. 14 Greenaway Gardens is approximately “T-shaped” [Figure 1], with the main lawn to the immediate rear (east) of the house, a paved terrace with a swimming pool [Figure 5] and a built-in barbecue located further east, a tennis court in the north “wing” to the rear of no.s 12 and 12a Greenaway Gardens, and the pool house in the south “wing” to the rear of no. 16 Greenaway Gardens [Figure 5 & Figure 6]. South of the pool house is a secluded grassy area.

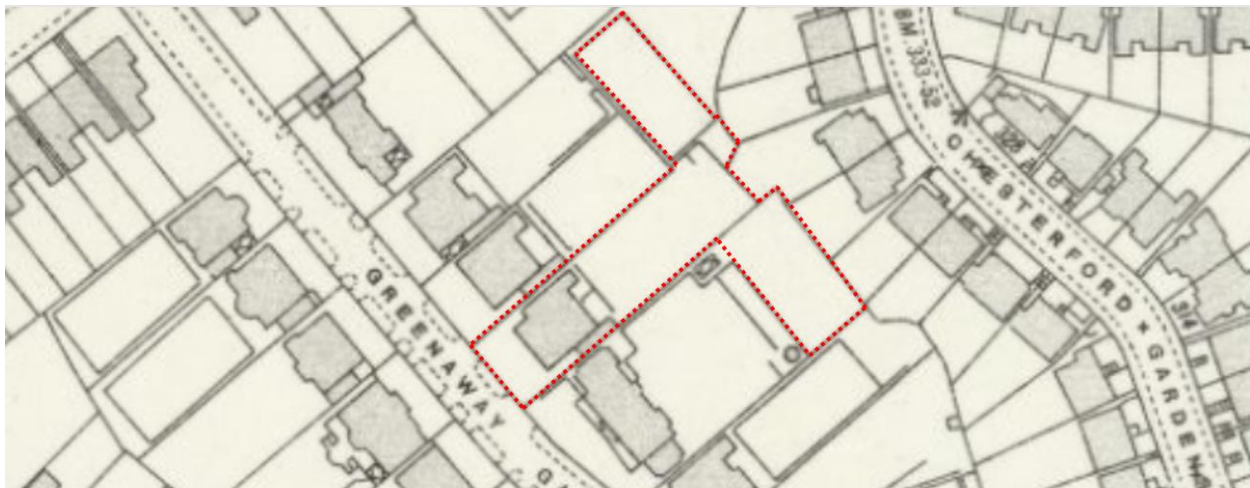
Figure 3: 1934-36 map. Location of no. 14 Greenaway Gardens is outlined in red.

- 3.1. Greenaway Street along with the houses along it, was likely constructed in the 1920s [Figure 2 & Figure 3]. The houses (including the house at no. 14) were built in a style inspired by that of C. H. B. Quennell. Due in part to the recent coronavirus restrictions (including library/archive closures), little could be found of the history of the house between the 1920s and the 1960s. An aerial photograph taken in 1948 [Figure 4] shows the front elevations of no.s 12, 12a, 14 and 16 Greenaway Gardens as being approximately the same as they are today. The rear garden to no. 14 can be seen before the plot was extended (and relandscaped, with a tennis court, swimming pool and pool house added).

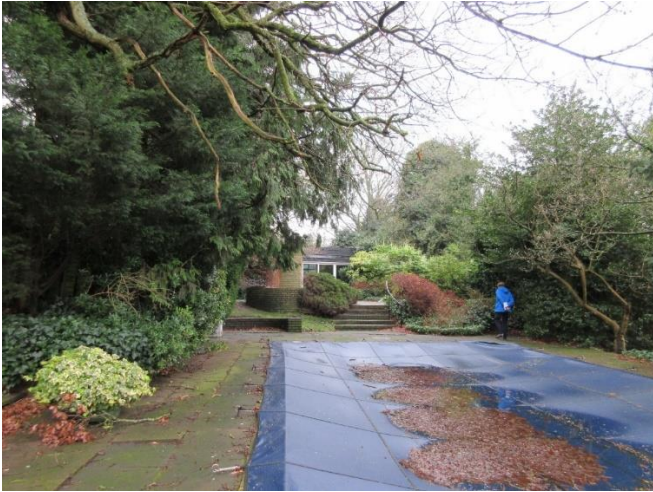
Figure 5 (left): Looking southward across the swimming pool towards pool house in the south part of plot.

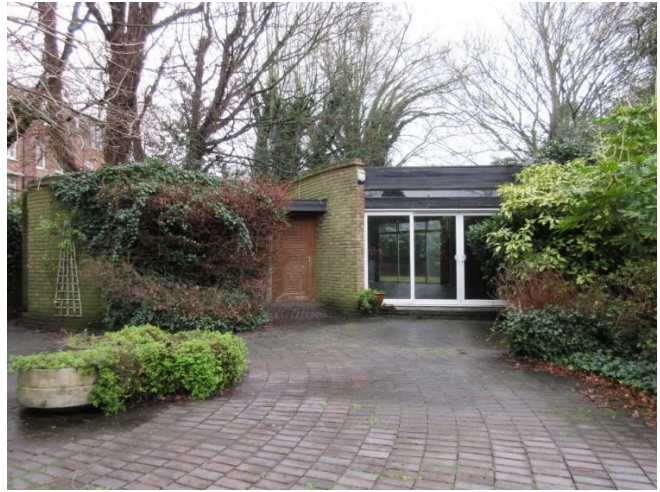
Figure 6 (right): Front elevation of the pool house.

- 4.1. **Exterior:** The pool house is a single-storey round brick building with a flat roof, and uPVC and metal windows. The front elevation of the pool house includes three single-paned French doors leading directly into the reception area, a timber door (i.e. the “front door”), and a wall covered in vegetation [Figure 6]. There are also three single-paned French doors (albeit with fanlights) to the rear elevation [Figure 7]. The curved side (east) elevation is in beige-pink brickwork (weathered with algae), with two timber doors which lead to the changing rooms/showers. The timber doors are carved with a square, international-style motif. The exterior of the building’s west elevation is not visible from within the subject site.

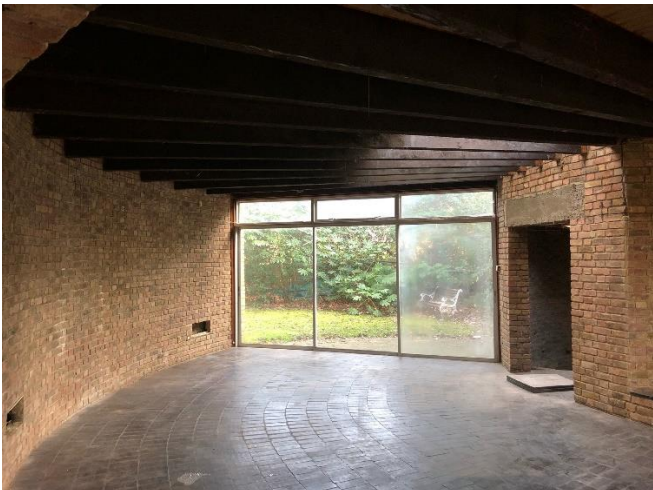
Figure 7 (left): Interior of reception area of the pool house. (Rear window on the left, and “snug” on the right.)

4.2. **Interior:** The main reception space has a curved appearance, due to the curved west elevation of the building, the internal curved walls, the pattern of terracotta tiles on the floor, and the pattern of the timber beams to the ceiling [Figure 7 & Figure 8]. The palette of the interior is dictated by the brown terracotta tiles, the brickwork to the walls, and the timber features. The reception space includes a “snug” with a built-in seated area [Figure 7 & Figure 8]. The east side of the building comprises a kitchen, WC/shower room, and changing rooms. There is a service hatch between the reception space and the kitchen. The building is somewhat run-down, and aspects of its architecture are of poor quality – such as the untidy finish of the brickwork, and detailing between angled walls.

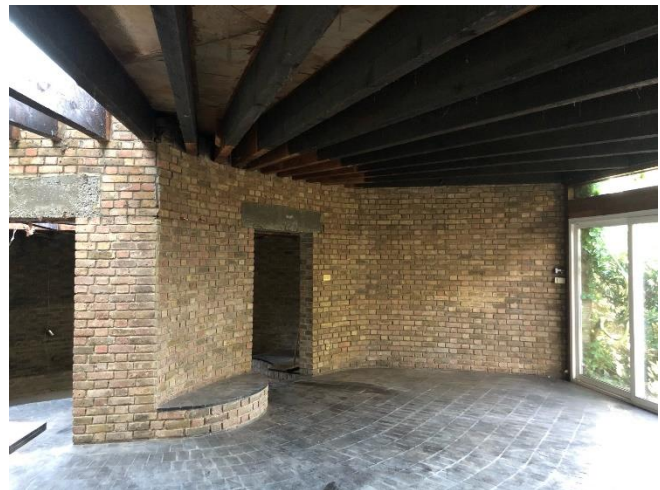
Figure 8 (right): Interior of reception area of the pool house. (“Snug” on the left, and front window on the right.)
