Extract from Planning Compliance Report (23582.PCR.01) from KP Acoustics showing location of testing equipment and AC unit location to be replaced.

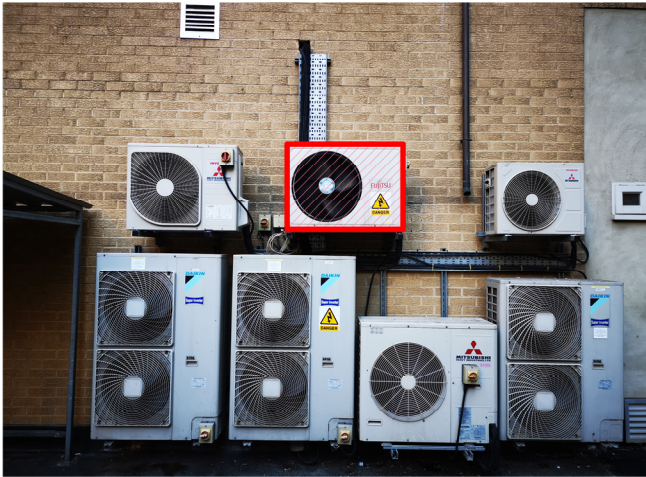
Photo of Air Cooling units to rear of 98 Hatton Gardens

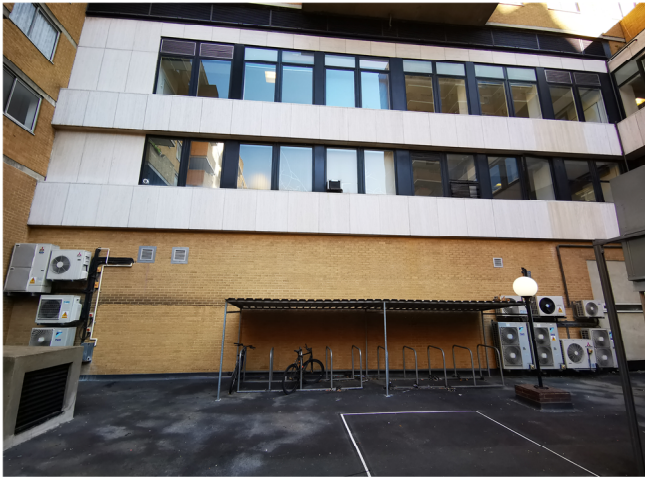
Photo of Air Cooling units in internal courtyard to back of 98 Hatton Garden.

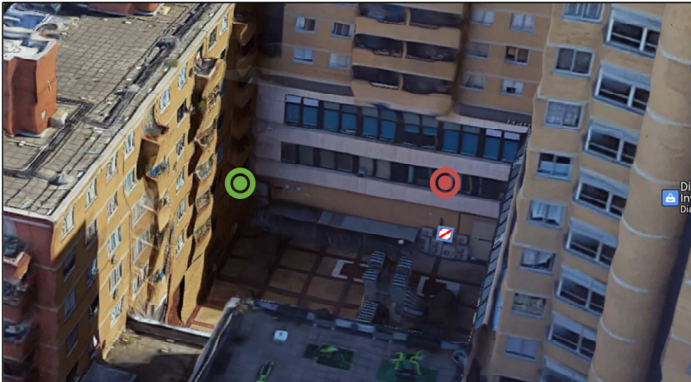
Figure 2.2 Site measurement position, identified receiver and proposed plant unit installation (Image Source: Google Maps)

Icon	Descriptor	Location Description
	Noise Measurement Position	The microphone was installed on an office window on the 1st floor of the 98 Hatton Garden rear façade. A correction of 3dB has been applied to account for non-free field conditions
	Closest Noise Sensitive Receiver	The closest noise sensitive receiver has been identified as a south-facing 1 st floor residential window to the north of the proposed plant installation
	Proposed Plant Installation Location	The proposed plant installation is outlined in Section 5.1
