## **PM<sub>10</sub> Monitoring Report**

**August 2021**

248-250 Camden Road, London

## 248-250 Camden Road, London (NW1 9HE)

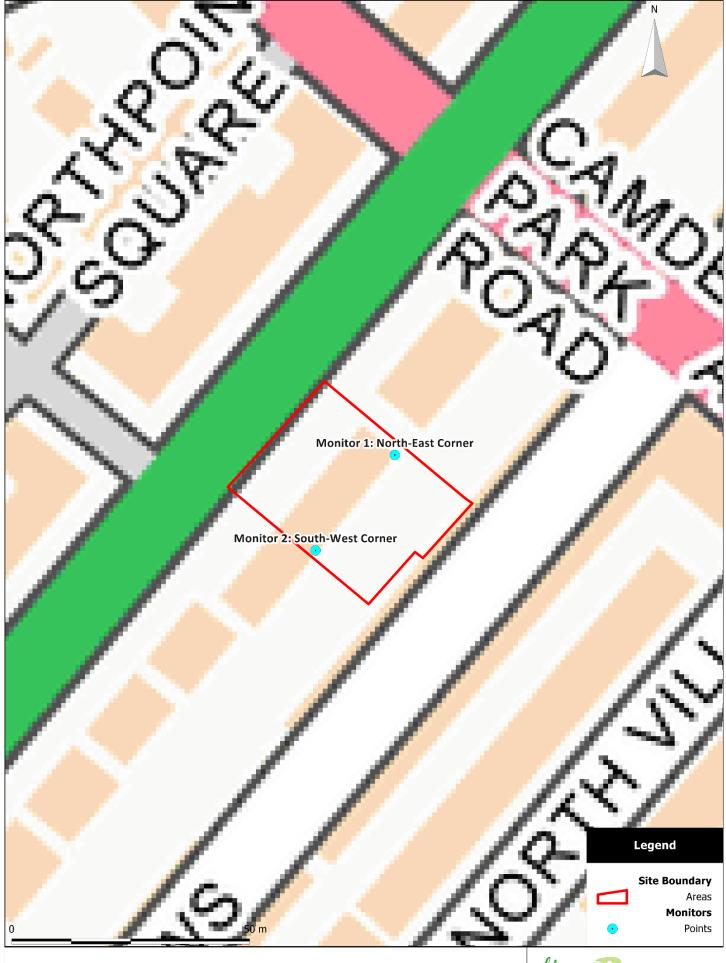
### Figure 1: Map of Monitoring Locations

### Figure 1: Monitoring Locations

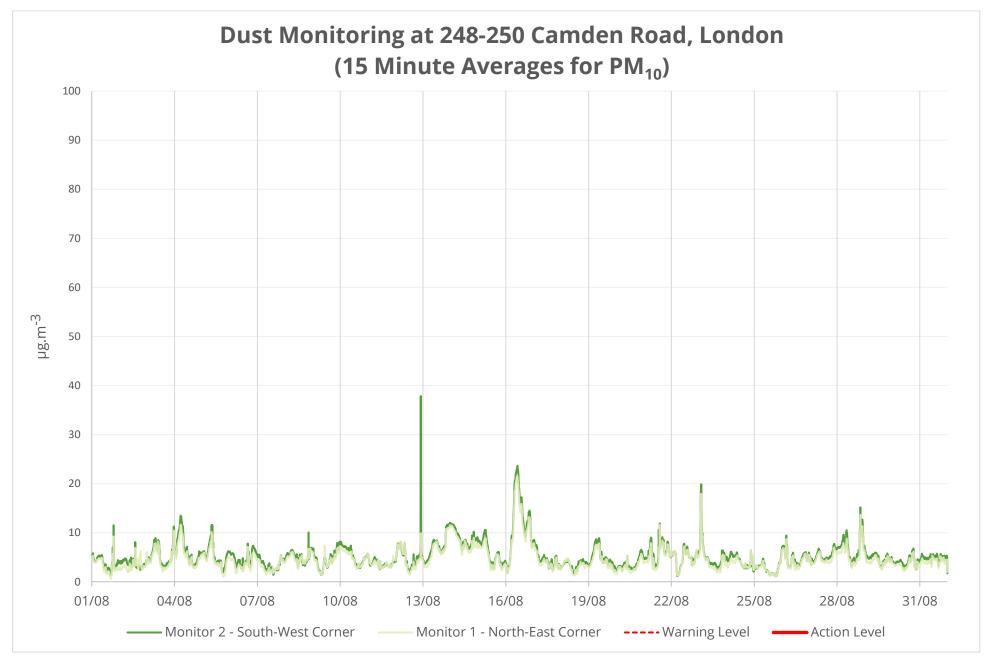
### Graph 1: 15-minute mean time-series

2.4 Graph 1 provides the 15-minute average PM<sub>10</sub> time-series for the monitoring period. It shows that there were no exceedances of the 15-minute 'Warning' level at either monitor during August 2021.

- 2.5 There were no exceedances of the 15-minute 'Action' trigger level at either monitor during this period. Overall, there is good agreement in the trend lines for both monitors which suggests that there are few significant localised dust sources in close proximity to either monitor.
- 2.6 Graph 2 provides the 1-hour average PM<sub>10</sub> time-series for the monitoring period. It shows that there are no exceedances of the 'Action' trigger level. Again, there is good agreement in the trend lines for both monitors, suggesting that there are few significant localised dust sources in close proximity to either monitor.
