PACA GEOTECHNICAL ENGINEERING LTD

Description	Basement Impact Assessment & Ground Movement Assessment & Predicted Damage Category.
Site	73 Goldhurst Terrace NW6 3HA
Reference	A704.21
Status	Final rev n.1
Client	Basement Consulting Ltd
Issue date	28/10/2021

1.1 Basement Consulting Limited commissioned this Basement Impact Assessment as a supporting document to the planning application for the proposed basement at 73 Goldhurst Terrace NW6 3HA. The local planning authority is the London Borough of Camden.

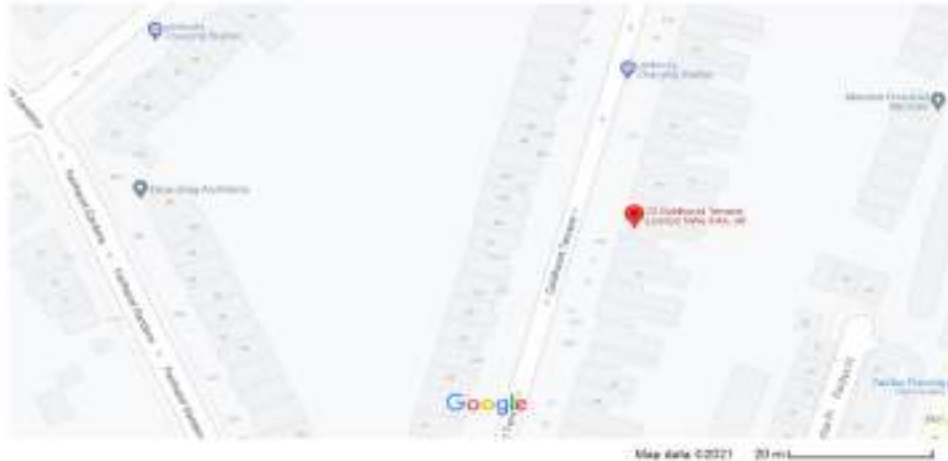
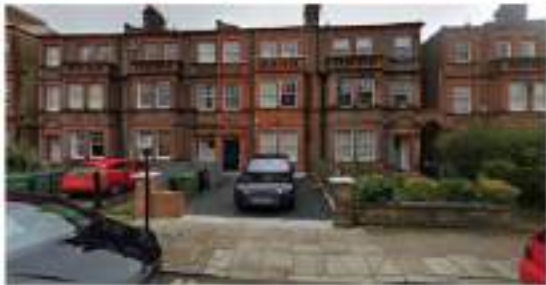
The site location plan is given in Figure below.

73 Goldhurst Terrace
Building

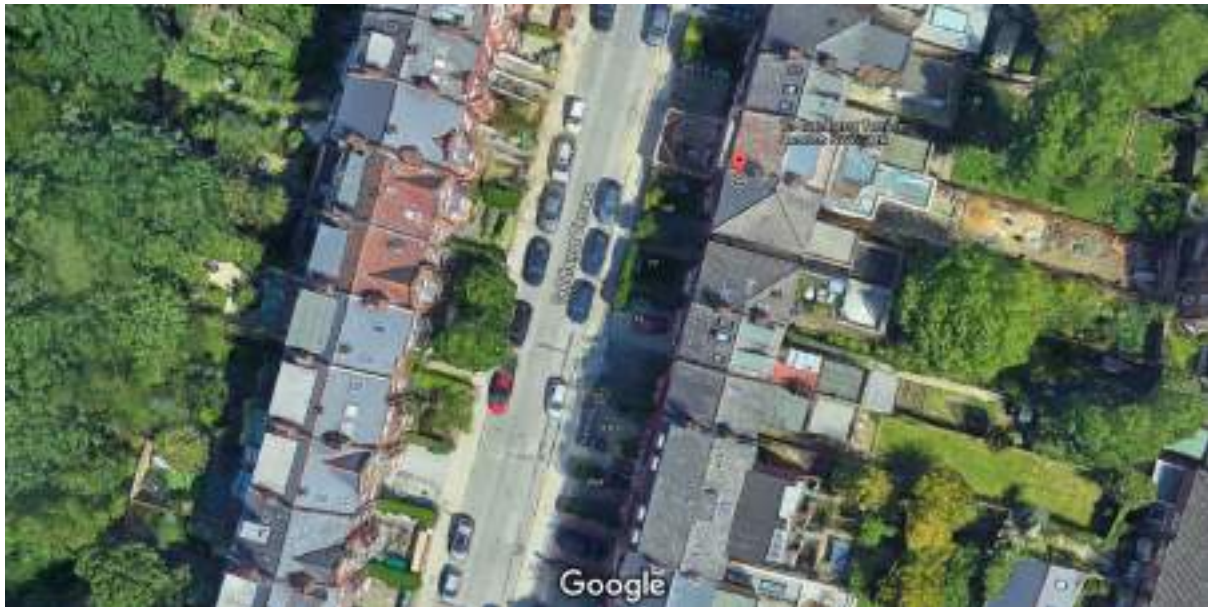
An aerial photograph of the site has been included in the figure below.

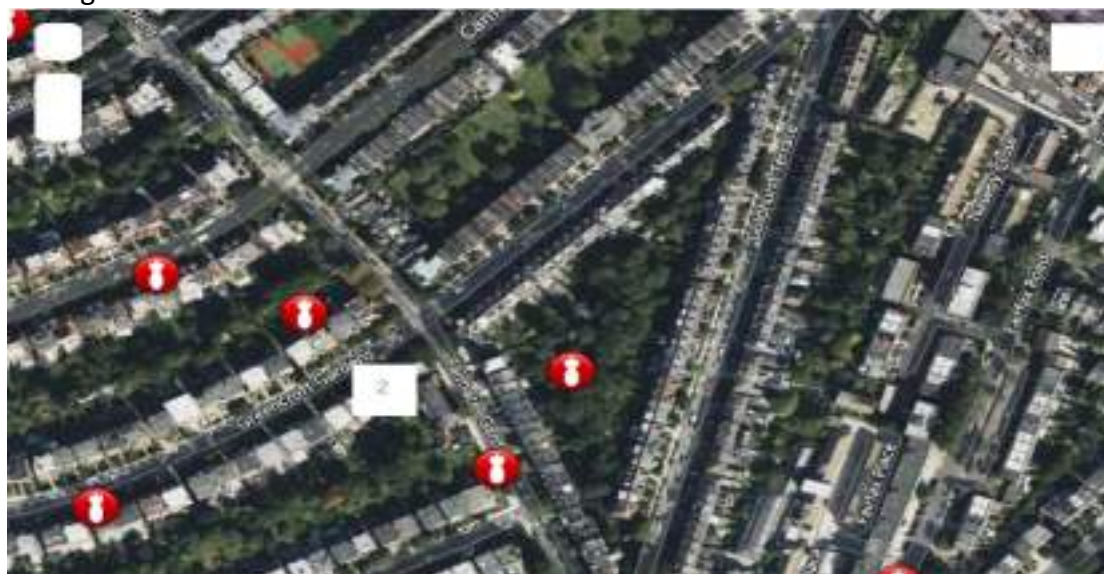
The London bomb map shown in attached figure (extracted from website www.bombsight.org) shows no bombs were dropped directly in the immediate vicinity of the proposed site. The nearest bomb was recorded about more than 100m away in the south-west direction of the property

The properties within 150m of 73 Goldhurst Terrace NW6 3HA did not suffer any bomb damage.

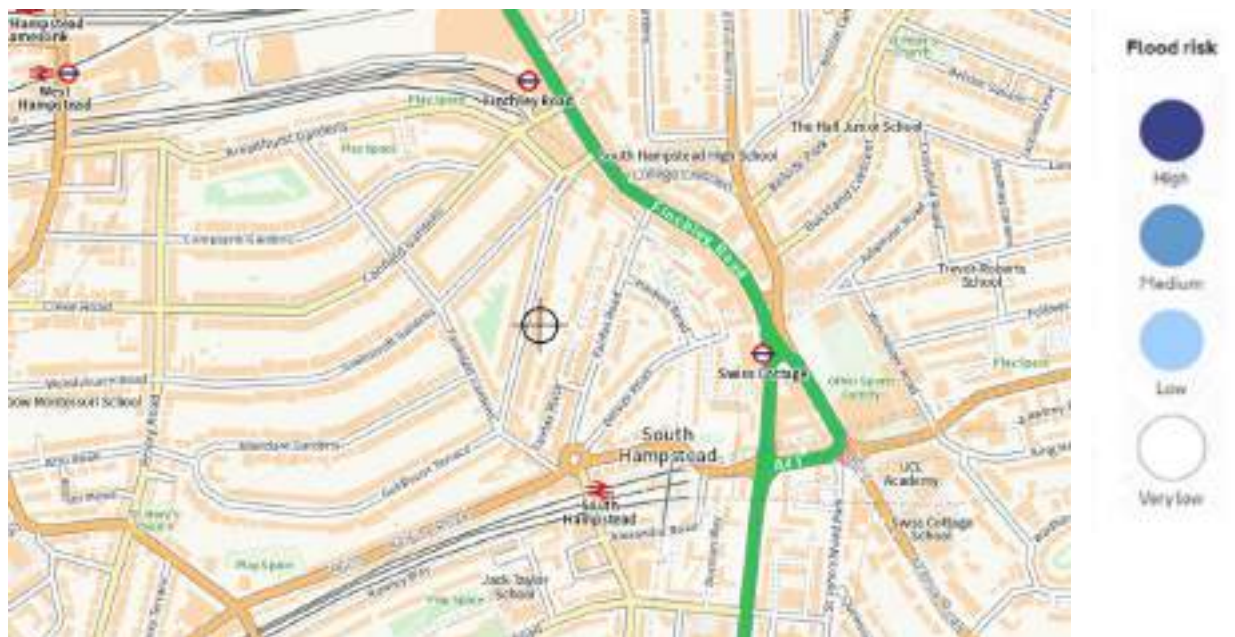
2.9.d This modelling indicates that the area at 73 Goldhurst Terrace NW6 3HA has very low risk of flooding from rivers or sea and the related flood risks map is attached below:

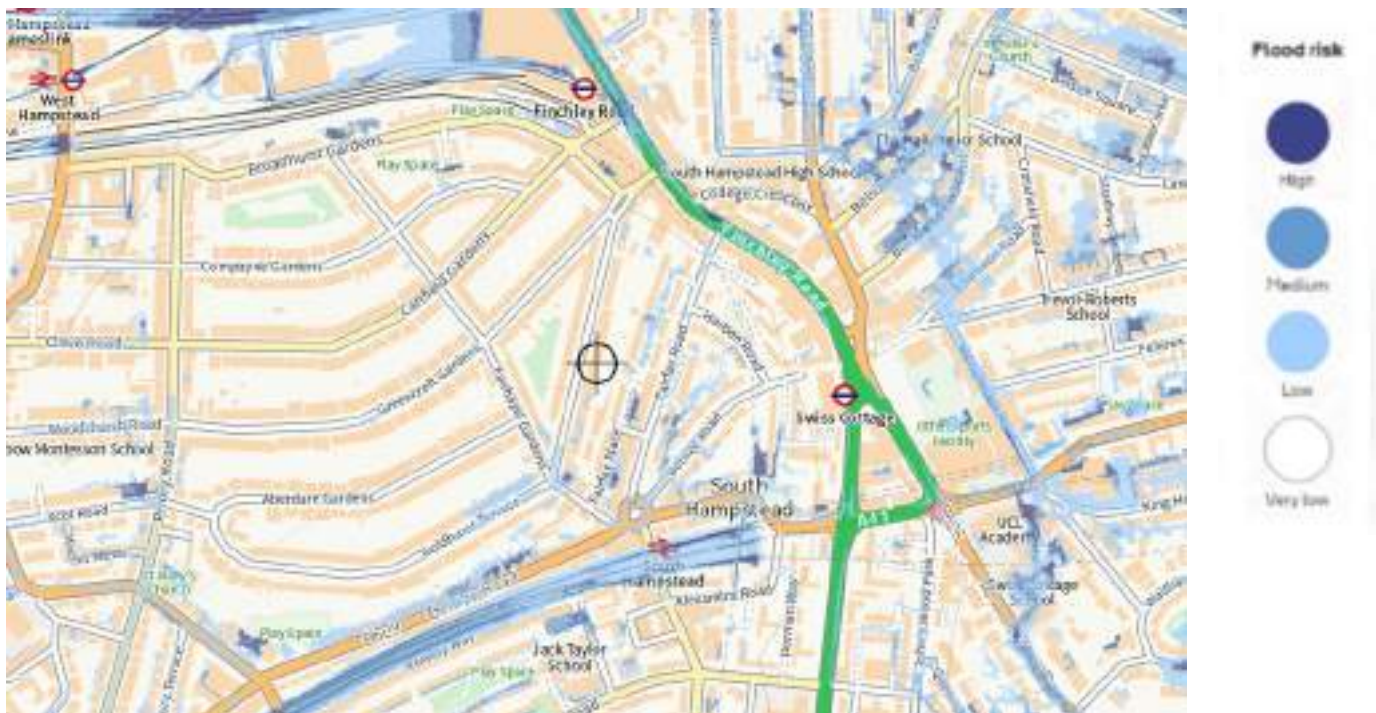
Low risk from surface water or reservoirs and the related flood risks map is attached below.

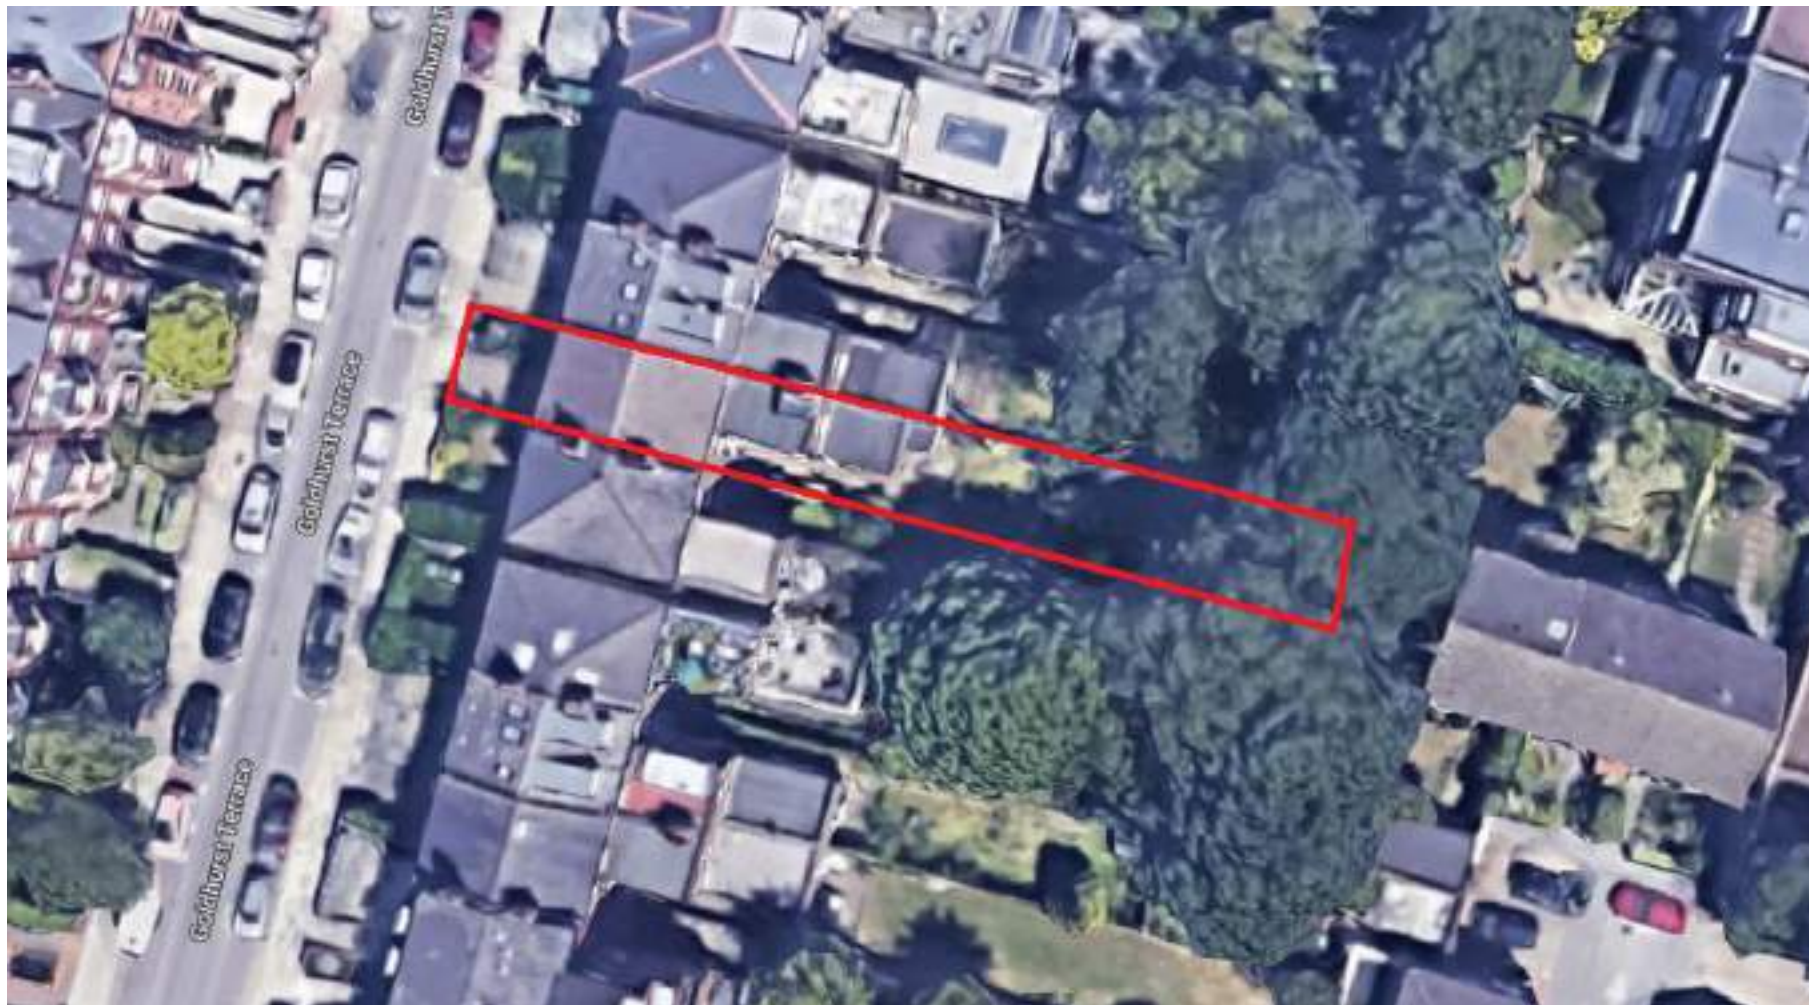
8.b The allowable bearing capacity has been calculated for the London Clay Formation from a depth > 3.30 BGL.

A factor of safety equal =3 is applied to calculate the allowable bearing capacity that will be =179KPa.

The national grid reference for the centre of the site was approximately TQ 26294 84327. A site location plan is given within Figure 1. A plan showing the boundary of the site is provided in Figure 2.
