Geo-Environmental Assessment

Charlie Ratchford Centre, Belmont St, Camden

Presented to McAuliffe Civil Engineering Ltd

Delta-Simons Project No. 21-0166.01

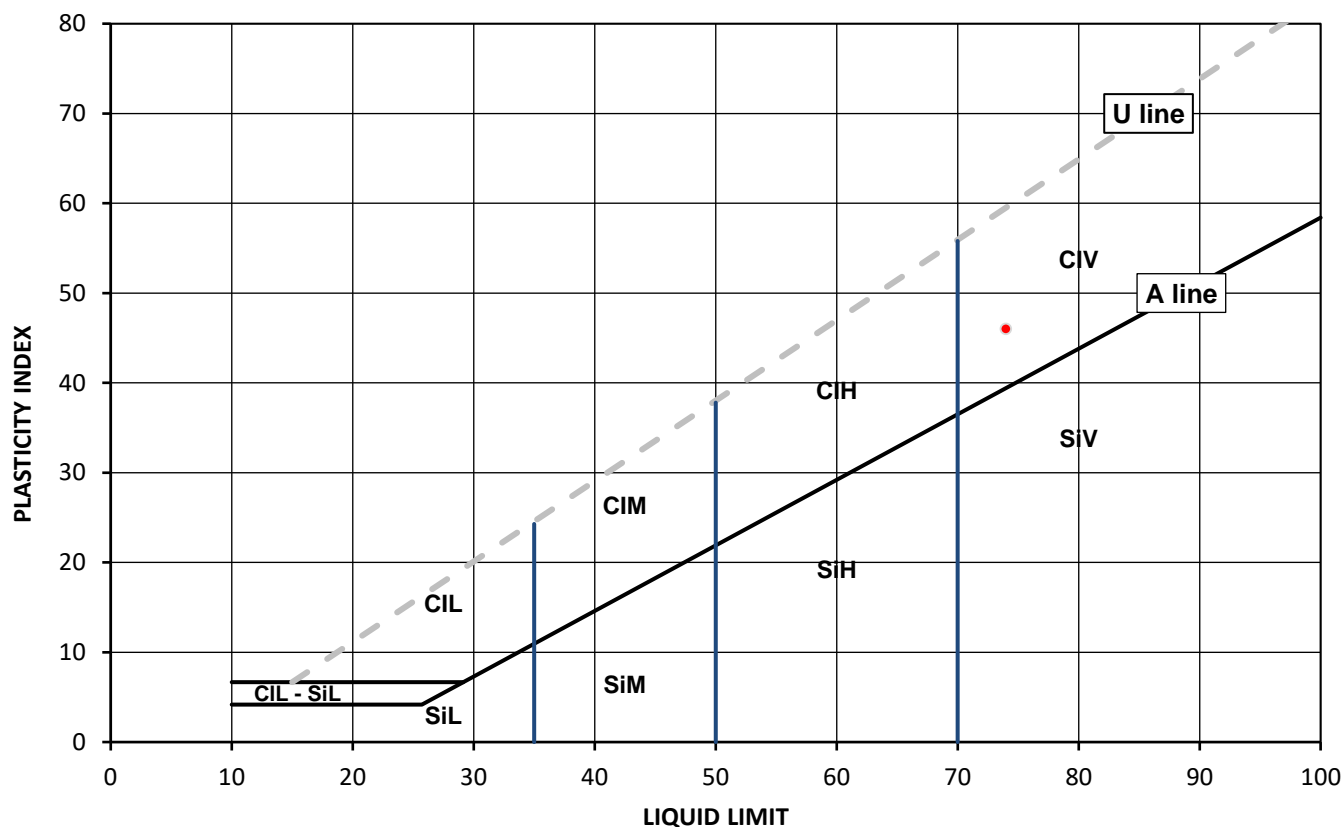
As Received Moisture Content [W] %	Liquid Limit [WL] %	Plastic Limit [Wp] %	Plasticity Index [Ip] %	% Passing 425µm BS Test Sieve
33	74	28	46	100

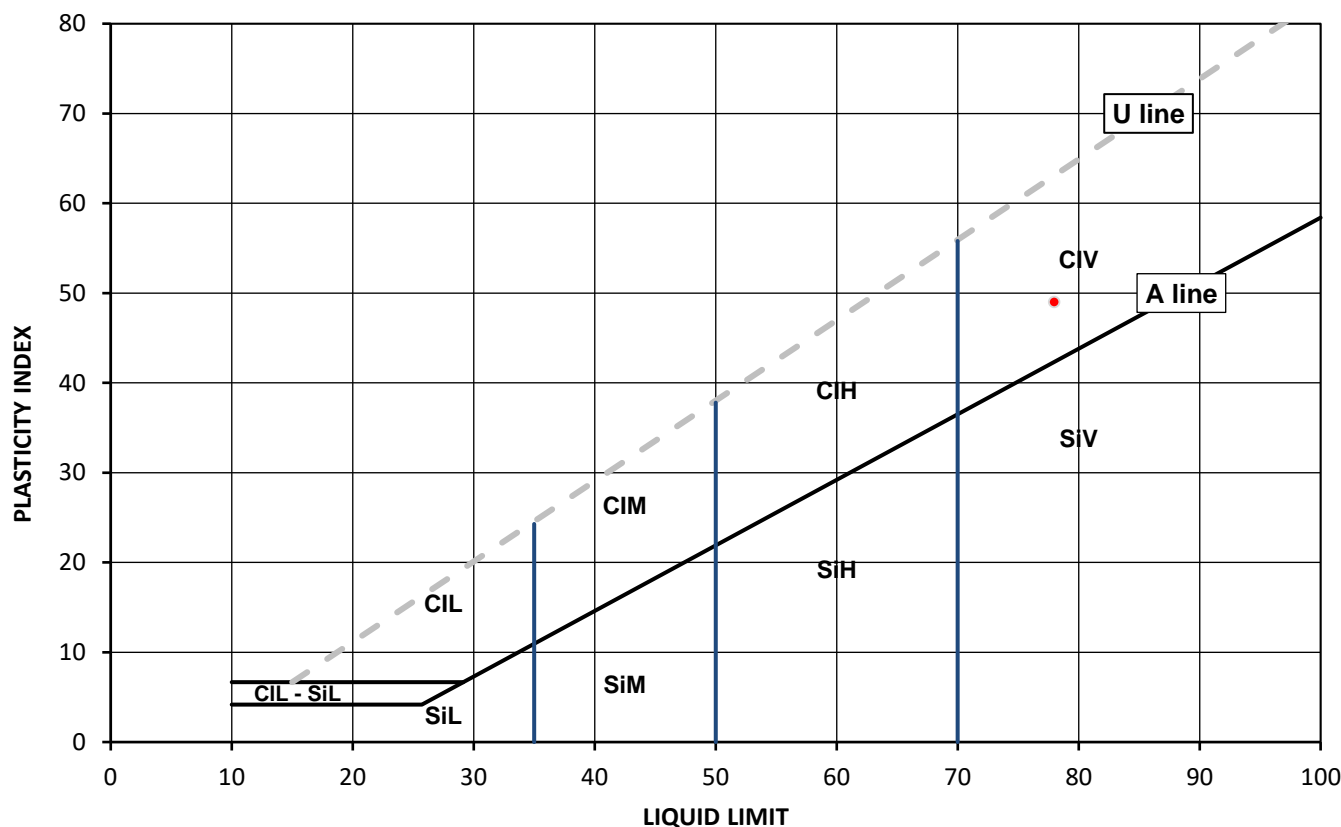
As Received Moisture Content [W] %	Liquid Limit [WL] %	Plastic Limit [Wp] %	Plasticity Index [Ip] %	% Passing 425µm BS Test Sieve
36	78	29	49	100

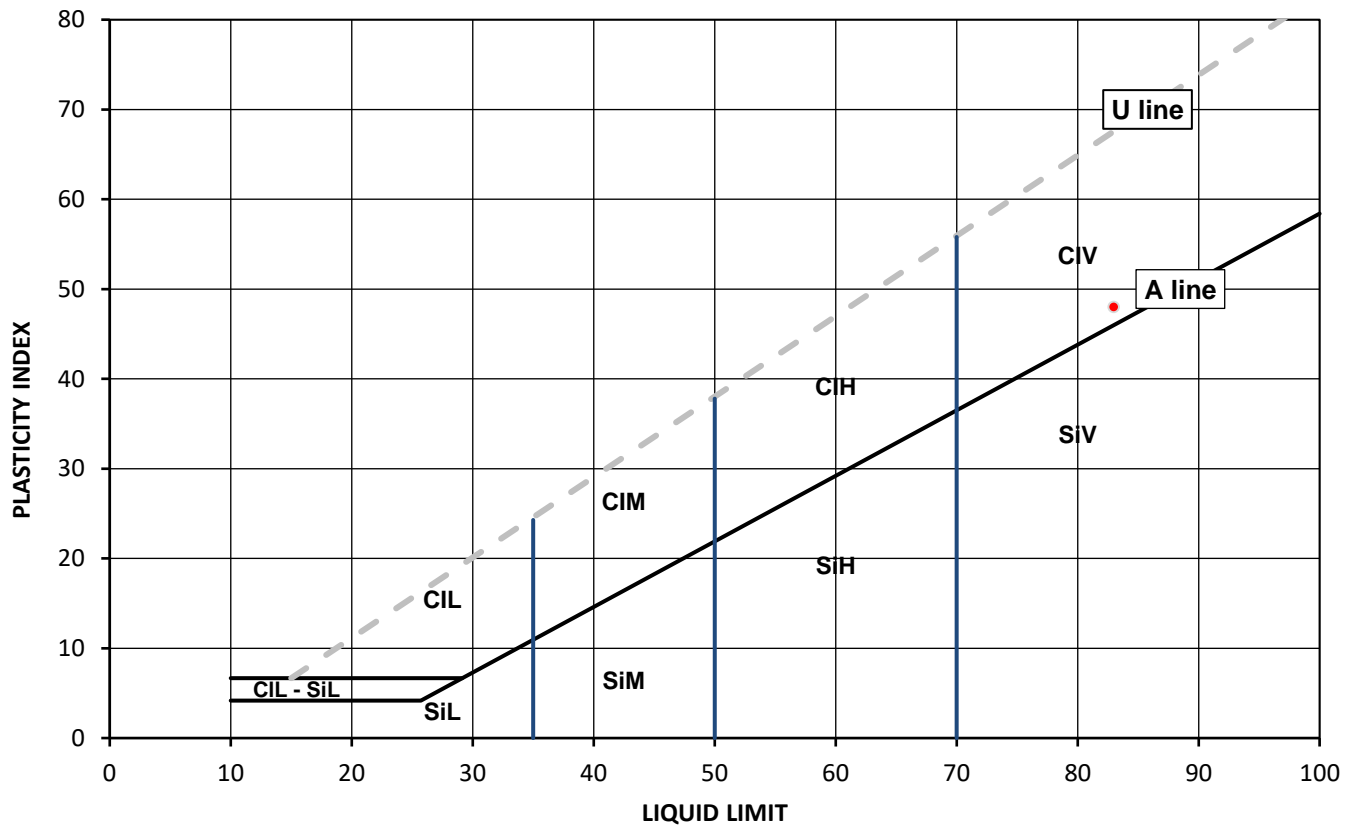
As Received Moisture Content [W] %	Liquid Limit [WL] %	Plastic Limit [Wp] %	Plasticity Index [Ip] %	% Passing 425µm BS Test Sieve
35	83	35	48	100

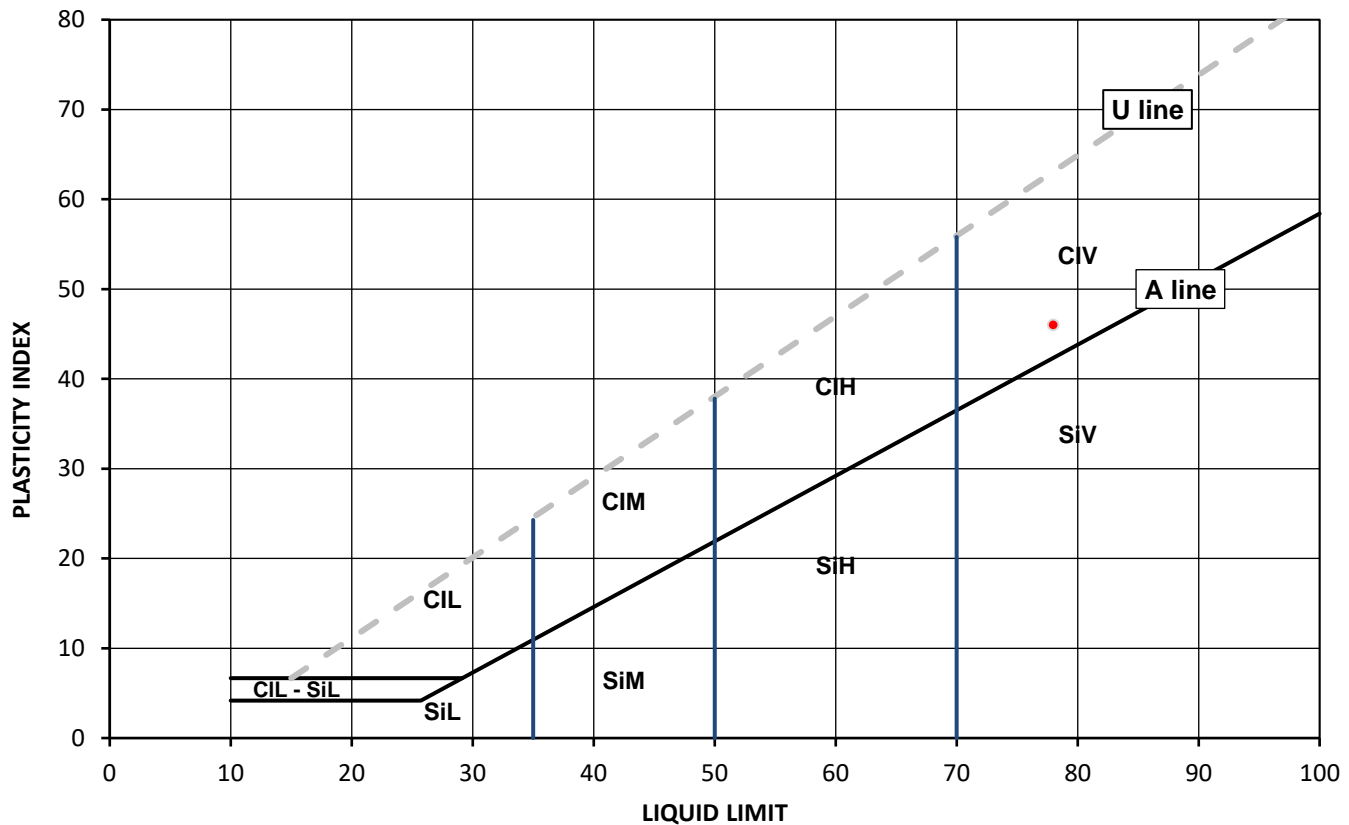
As Received Moisture Content [W] %	Liquid Limit [WL] %	Plastic Limit [Wp] %	Plasticity Index [Ip] %	% Passing 425µm BS Test Sieve
33	78	32	46	100

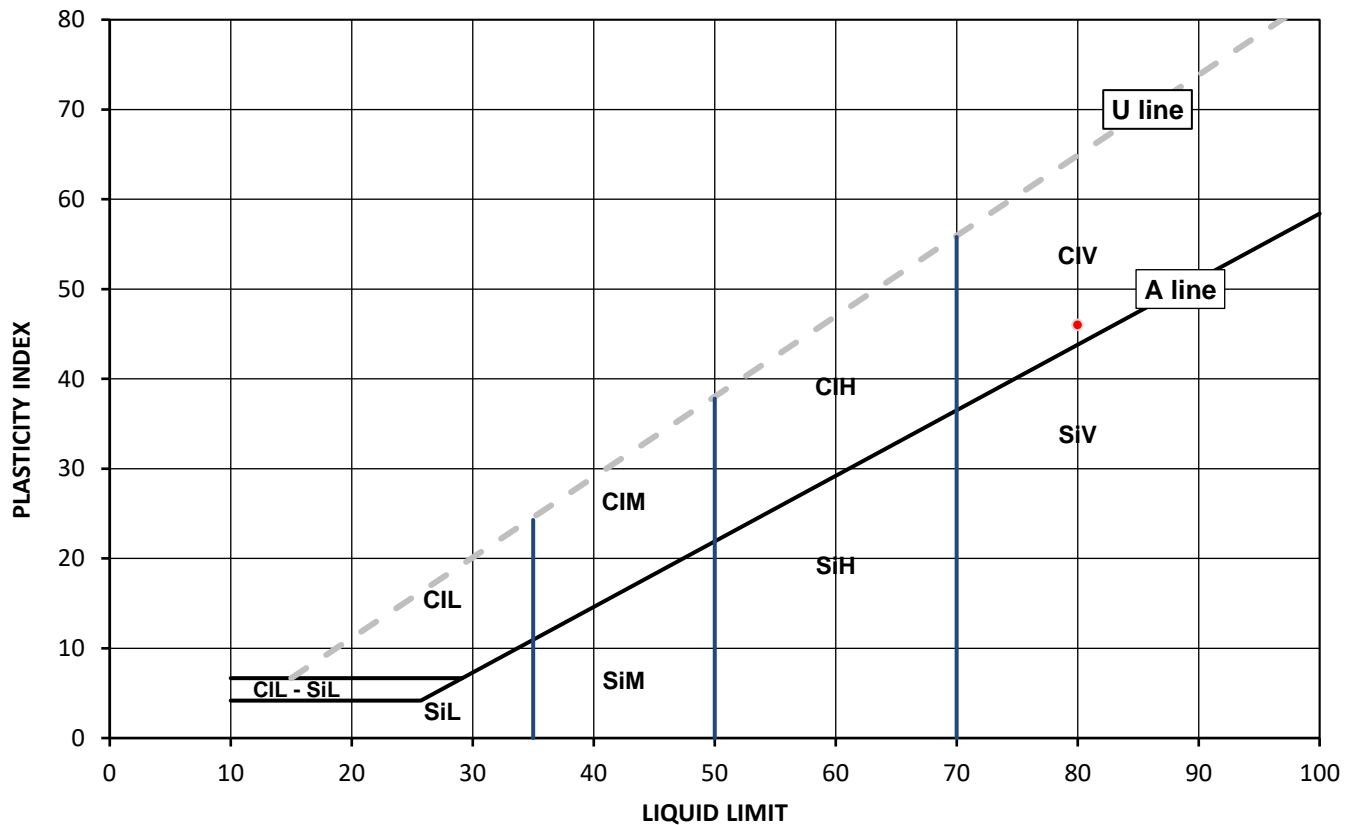
As Received Moisture Content [W] %	Liquid Limit [WL] %	Plastic Limit [Wp] %	Plasticity Index [Ip] %	% Passing 425µm BS Test Sieve
34	80	34	46	100

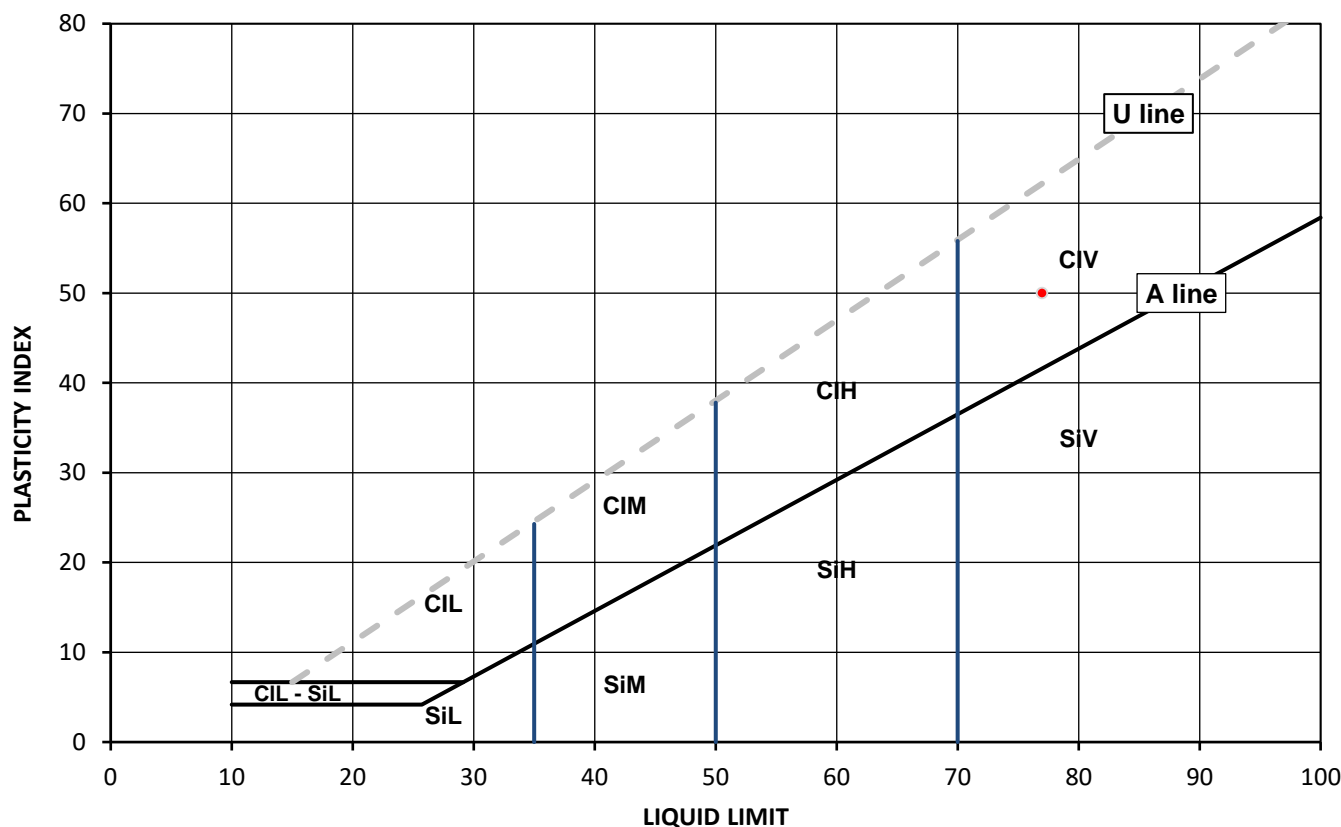
As Received Moisture Content [W] %	Liquid Limit [WL] %	Plastic Limit [Wp] %	Plasticity Index [Ip] %	% Passing 425µm BS Test Sieve
32	77	27	50	100

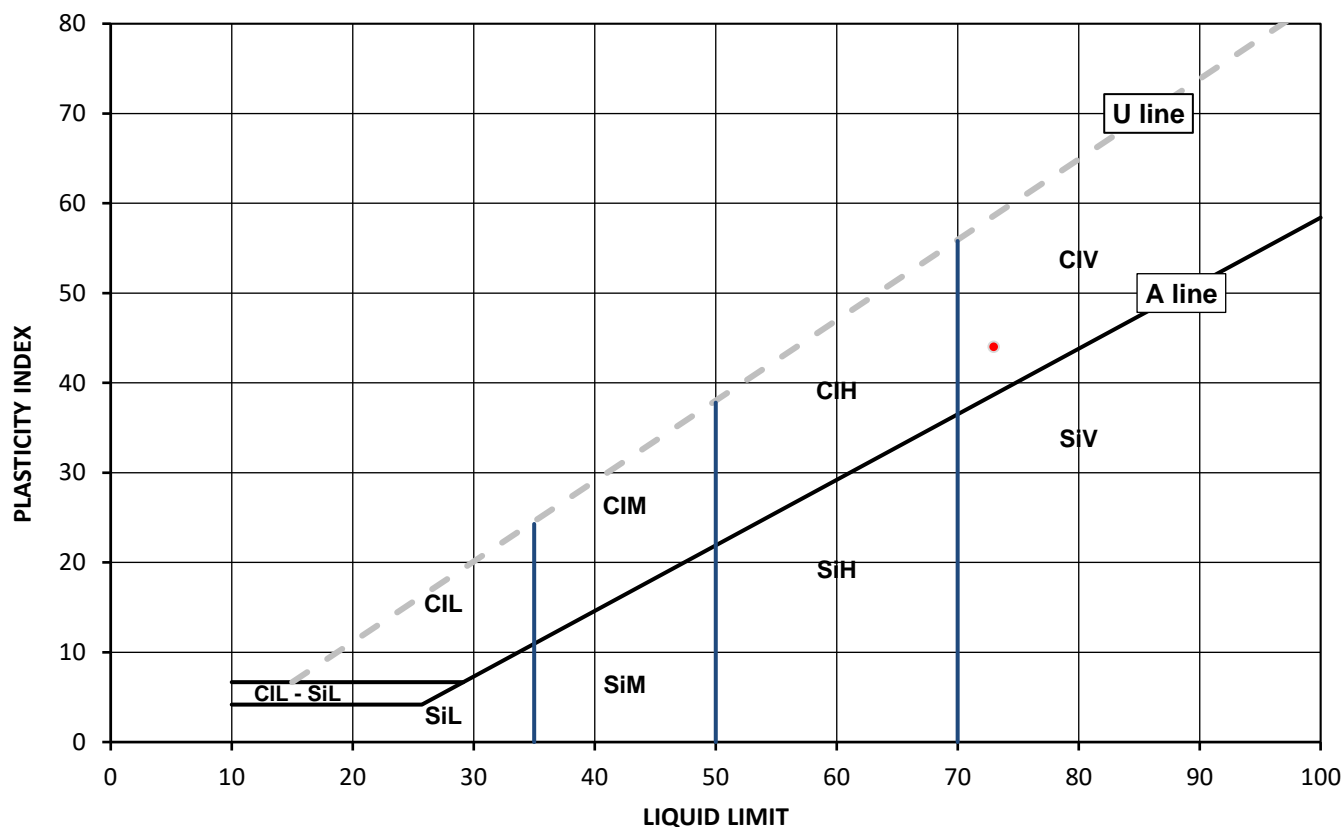
As Received Moisture Content [W] %	Liquid Limit [WL] %	Plastic Limit [Wp] %	Plasticity Index [Ip] %	% Passing 425µm BS Test Sieve
33	73	29	44	100

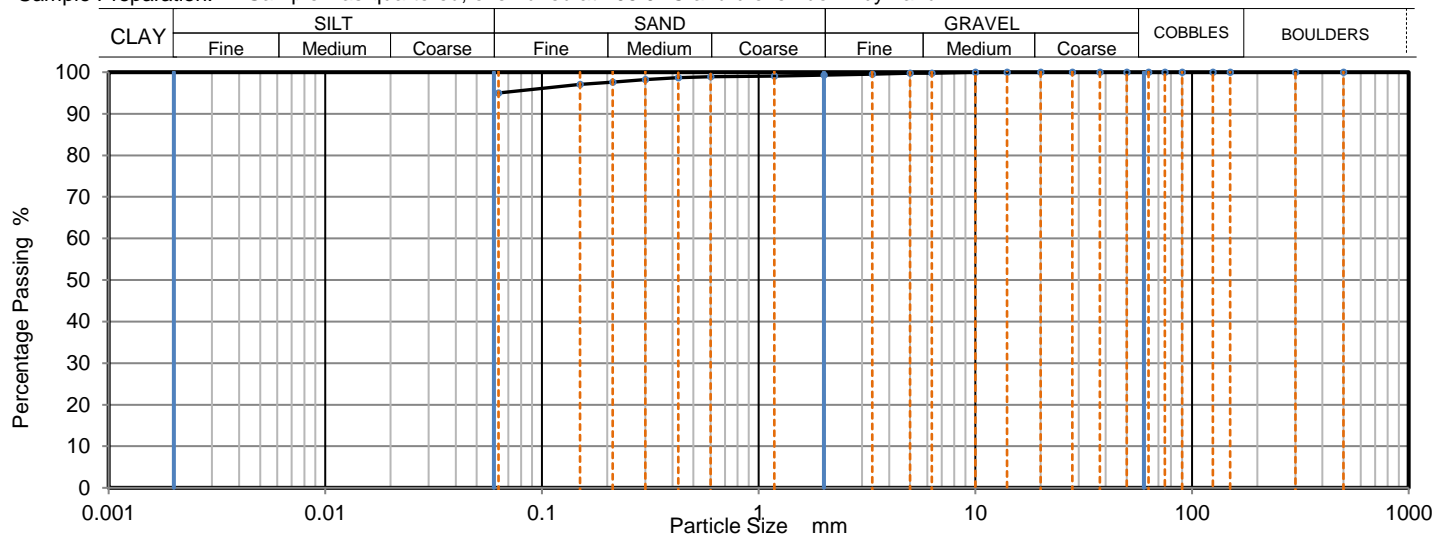
Depth Top [m]: 9.00
Depth Base [m]: Not Given
Sample Type: B

Sieving		Sedimentation	
Particle Size mm	% Passing	Particle Size mm	% Passing
500	100		
300	100		
150	100		
125	100		
90	100		
75	100		
63	100		
50	100		
37.5	100		
28	100		
20	100		
14	100		
10	100		
6.3	100		
5	100		
3.35	100		
2	99		
1.18	99		
0.6	99		
0.425	99		
0.3	98		
0.212	98		
0.15	97		
0.063	95

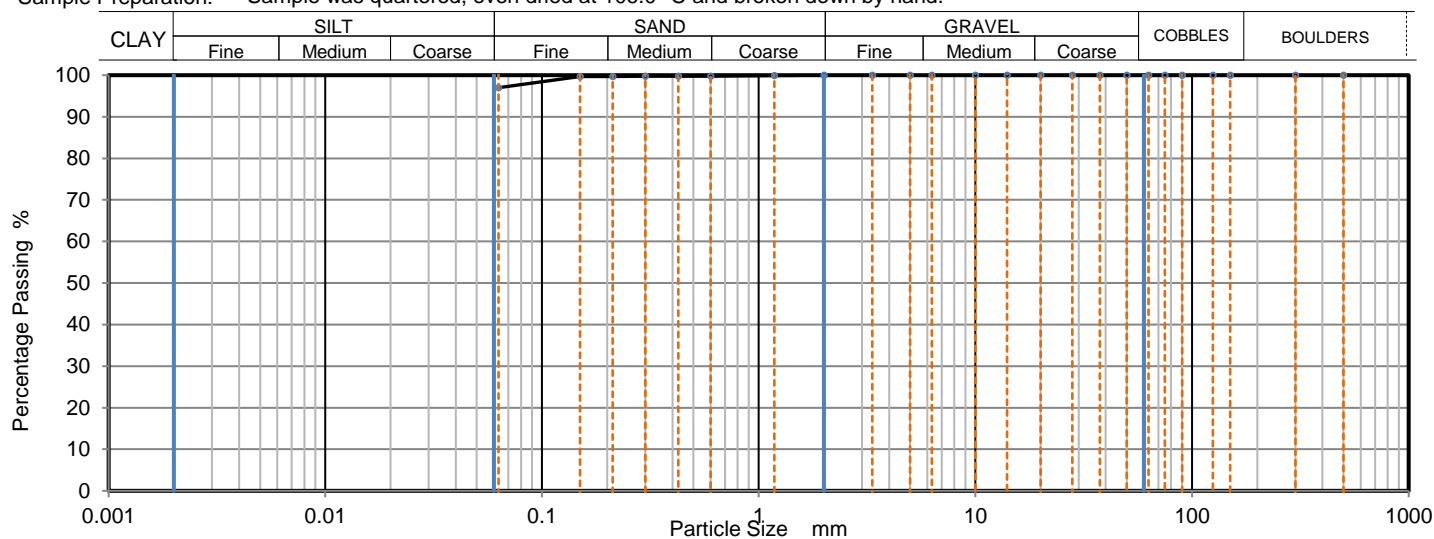
Sieving		Sedimentation	
Particle Size mm	% Passing	Particle Size mm	% Passing
500	100		
300	100		
150	100		
125	100		
90	100		
75	100		
63	100		
50	100		
37.5	100		
28	100		
20	100		
14	100		
10	100		
6.3	100		
5	100		
3.35	100		
2	100		
1.18	100		
0.6	100		
0.425	100		
0.3	100		
0.212	100		
0.15	100		
0.063	98

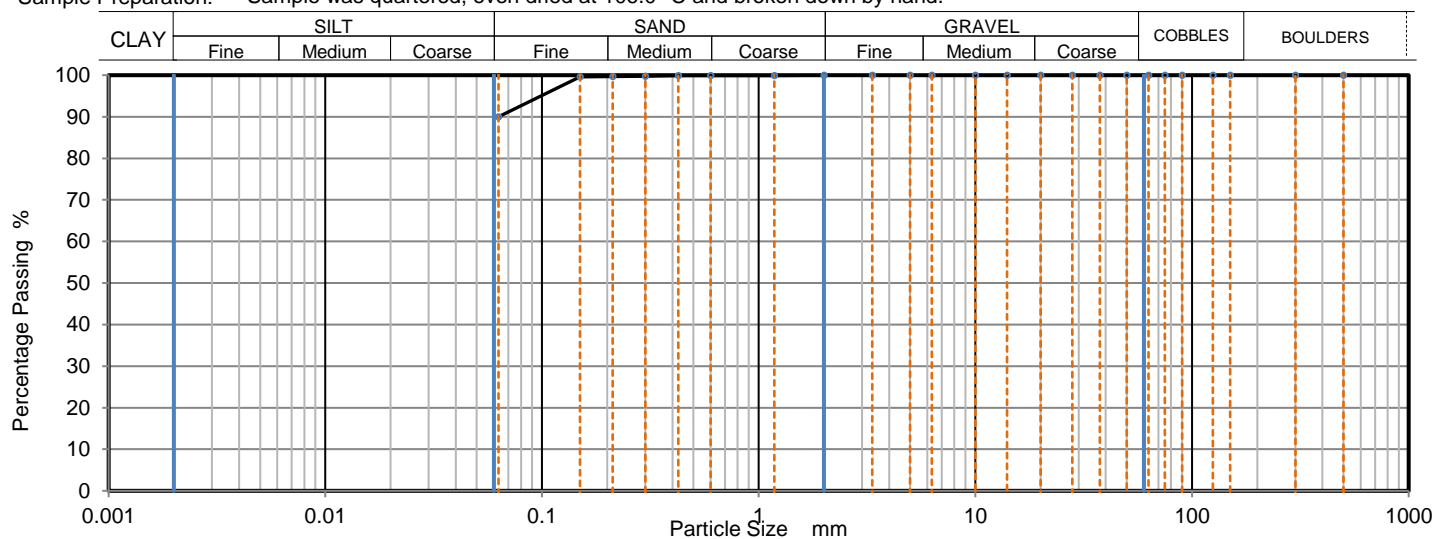
Sieving		Sedimentation	
Particle Size mm	% Passing	Particle Size mm	% Passing
500	100		
300	100		
150	100		
125	100		
90	100		
75	100		
63	100		
50	100		
37.5	100		
28	100		
20	100		
14	100		
10	100		
6.3	100		
5	100		
3.35	100		
2	100		
1.18	100		
0.6	100		
0.425	100		
0.3	100		
0.212	100		
0.15	100		
0.063	91

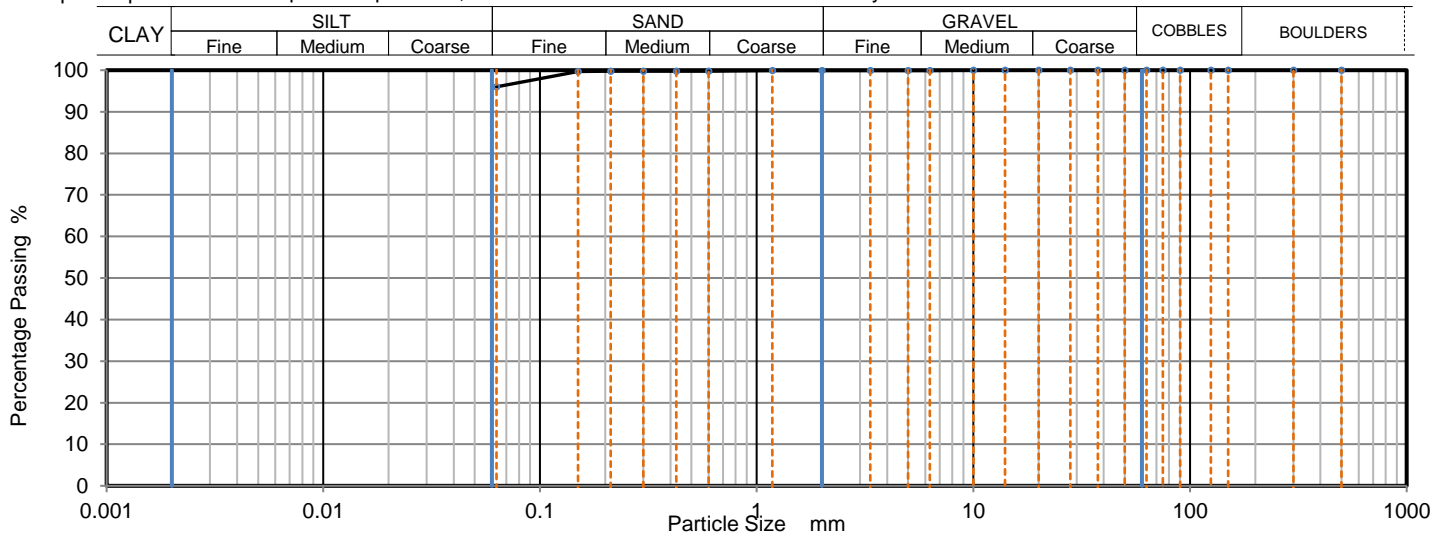
Sieving		Sedimentation	
Particle Size mm	% Passing	Particle Size mm	% Passing
500	100		
300	100		
150	100		
125	100		
90	100		
75	100		
63	100		
50	100		
37.5	100		
28	100		
20	100		
14	100		
10	100		
6.3	100		
5	100		
3.35	100		
2	100		
1.18	100		
0.6	100		
0.425	100		
0.3	100		
0.212	100		
0.15	100		
0.063	97

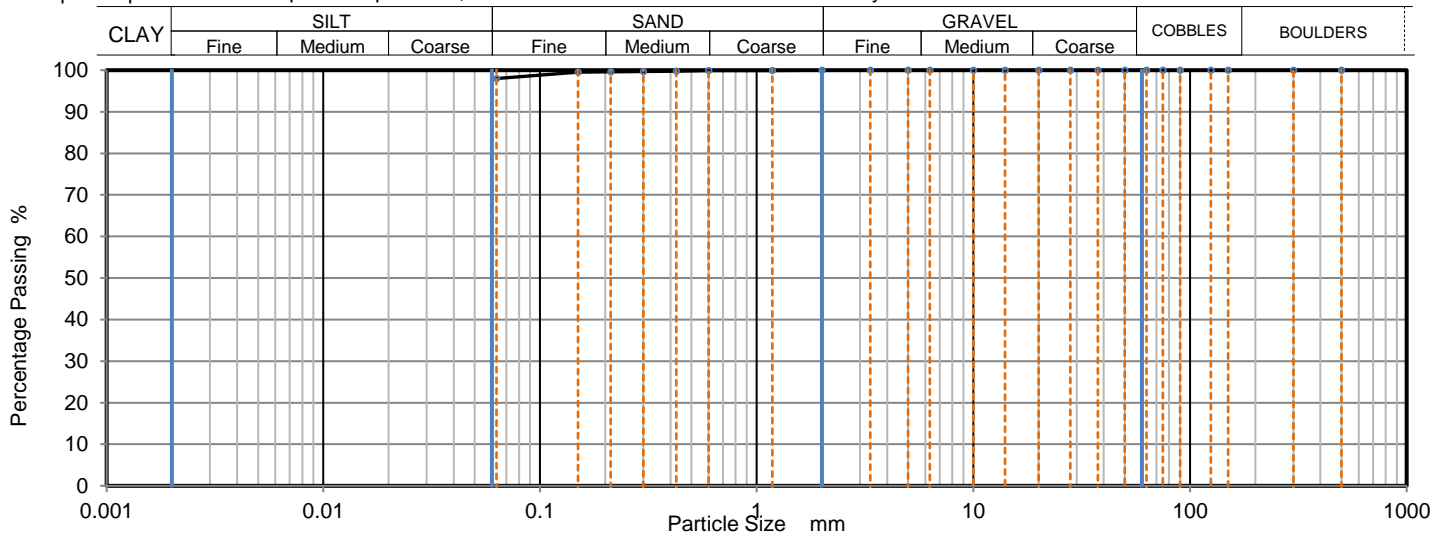
Sieving		Sedimentation	
Particle Size mm	% Passing	Particle Size mm	% Passing
500	100		
300	100		
150	100		
125	100		
90	100		
75	100		
63	100		
50	100		
37.5	100		
28	100		
20	100		
14	100		
10	100		
6.3	100		
5	100		
3.35	100		
2	100		
1.18	100		
0.6	100		
0.425	100		
0.3	100		
0.212	100		
0.15	100		
0.063	98

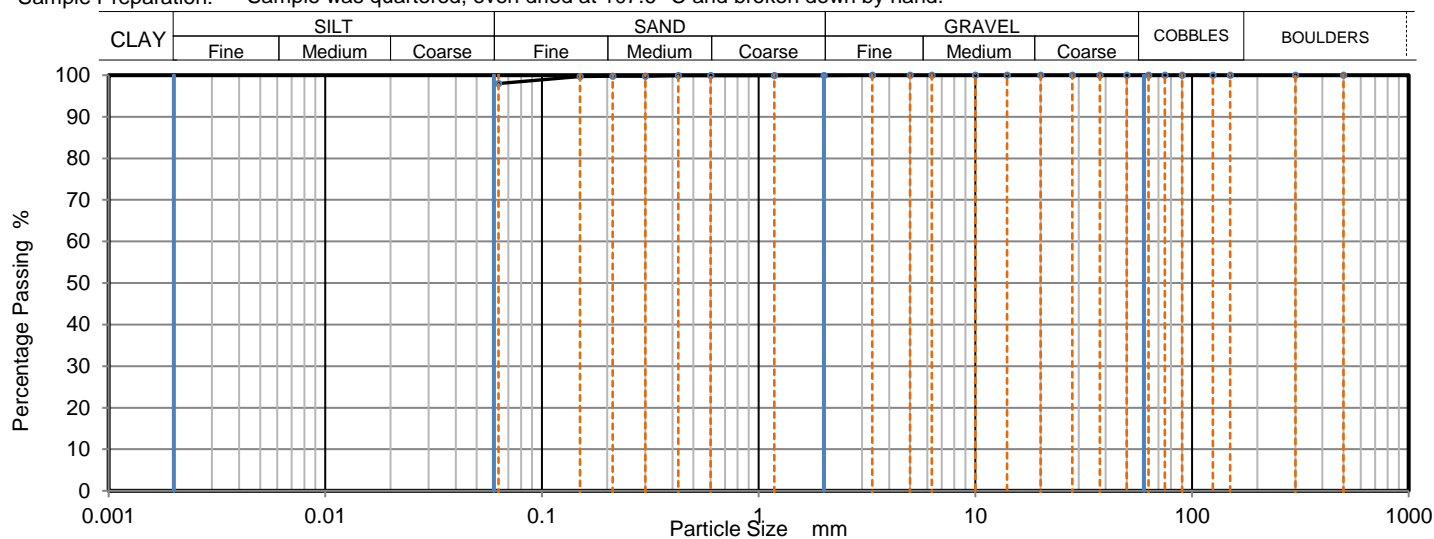
Sieving		Sedimentation	
Particle Size mm	% Passing	Particle Size mm	% Passing
500	100		
300	100		
150	100		
125	100		
90	100		
75	100		
63	100		
50	100		
37.5	100		
28	100		
20	100		
14	100		
10	100		
6.3	100		
5	100		
3.35	100		
2	100		
1.18	100		
0.6	100		
0.425	100		
0.3	100		
0.212	100		
0.15	100		
0.063	99

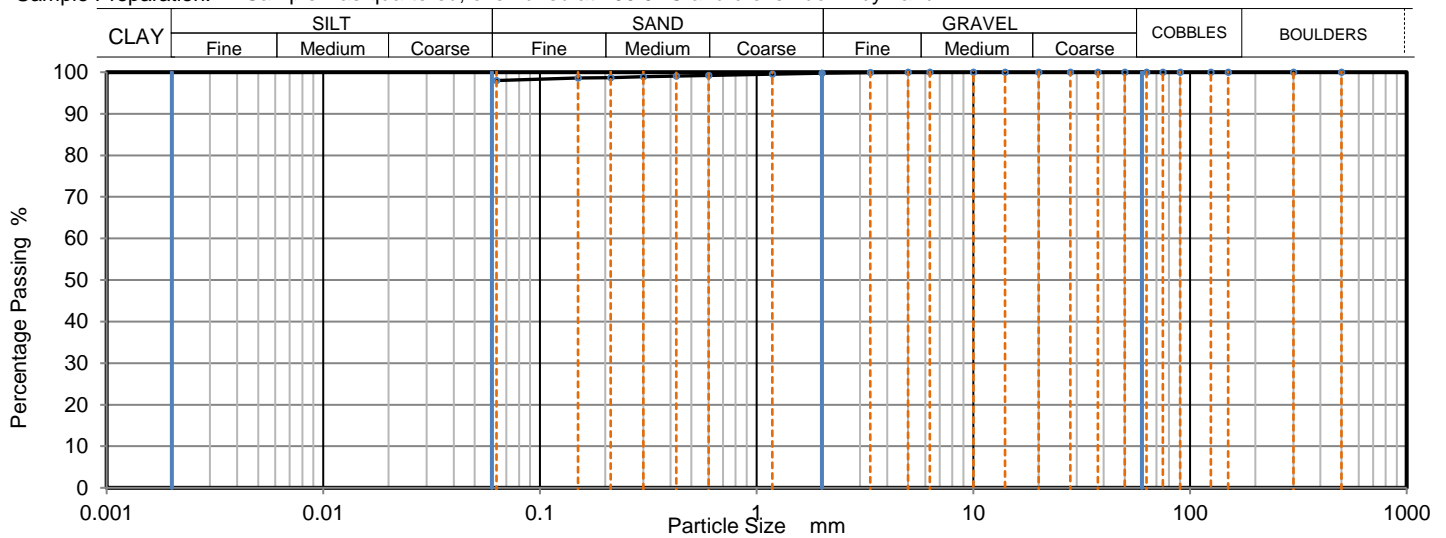
Sieving		Sedimentation	
Particle Size mm	% Passing	Particle Size mm	% Passing
500	100		
300	100		
150	100		
125	100		
90	100		
75	100		
63	100		
50	100		
37.5	100		
28	100		
20	100		
14	100		
10	100		
6.3	100		
5	100		
3.35	100		
2	100		
1.18	100		
0.6	99		
0.425	99		
0.3	99		
0.212	99		
0.15	99		
0.063	98

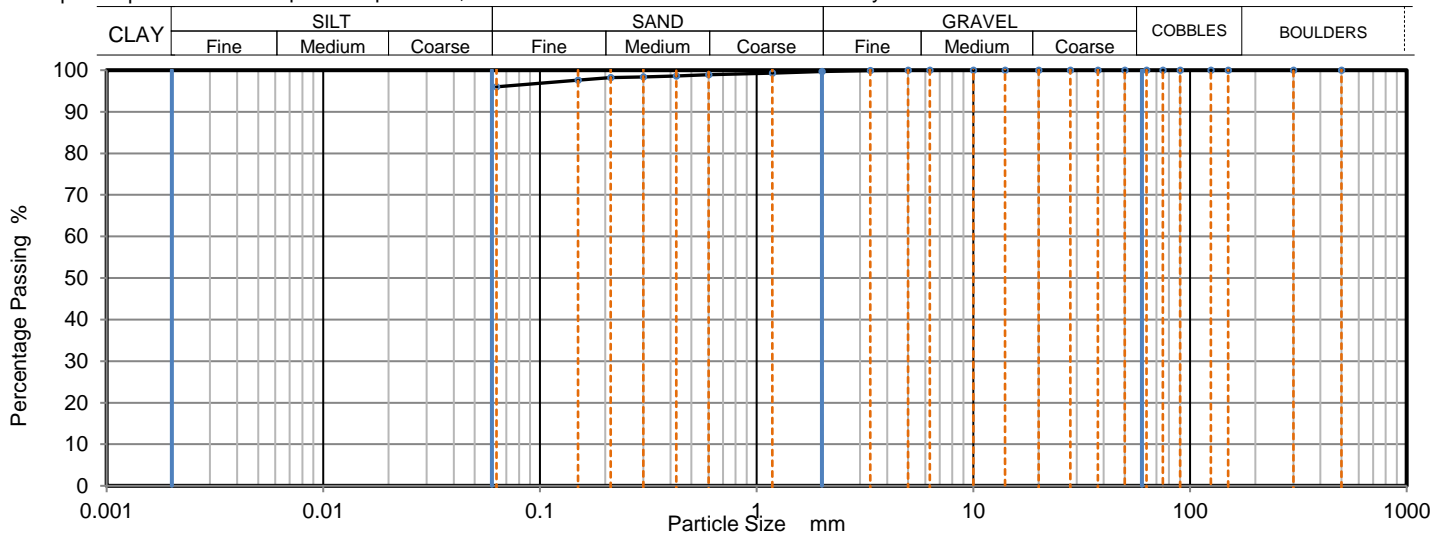
Sieving		Sedimentation	
Particle Size mm	% Passing	Particle Size mm	% Passing
500	100		
300	100		
150	100		
125	100		
90	100		
75	100		
63	100		
50	100		
37.5	100		
28	100		
20	100		
14	100		
10	100		
6.3	100		
5	100		
3.35	100		
2	100		
1.18	99		
0.6	99		
0.425	99		
0.3	98		
0.212	98		
0.15	98		
0.063	96

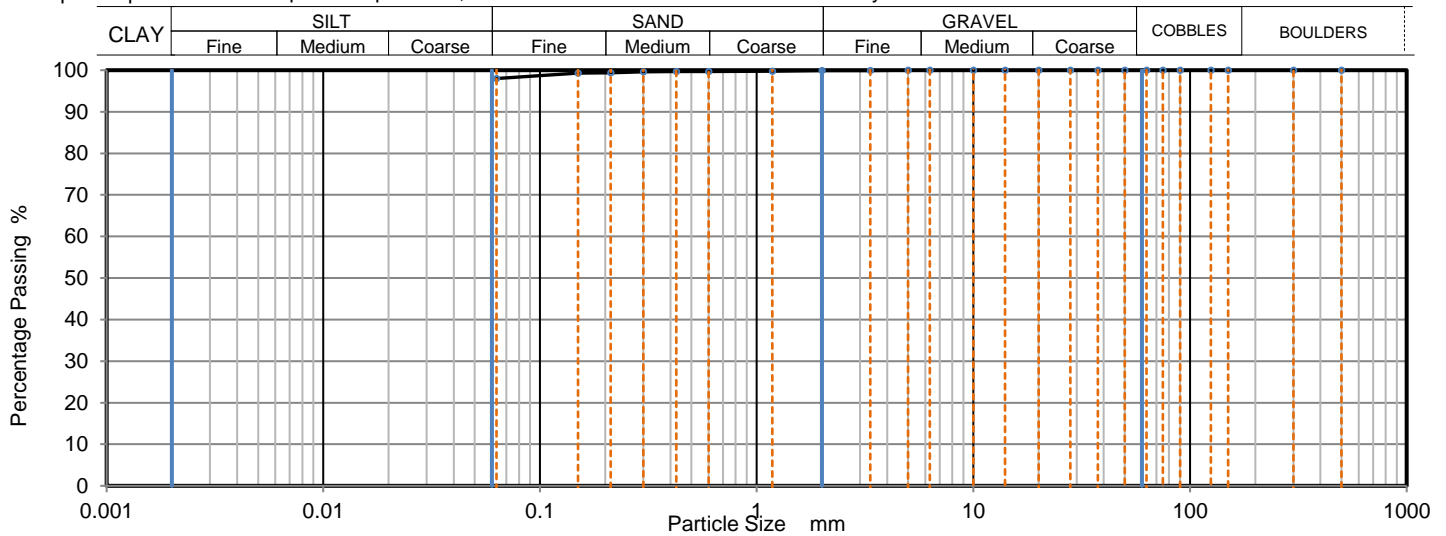
Sieving		Sedimentation	
Particle Size mm	% Passing	Particle Size mm	% Passing
500	100		
300	100		
150	100		
125	100		
90	100		
75	100		
63	100		
50	100		
37.5	100		
28	100		
20	100		
14	100		
10	100		
6.3	100		
5	100		
3.35	100		
2	100		
1.18	100		
0.6	100		
0.425	100		
0.3	100		
0.212	99		
0.15	99		
0.063	99

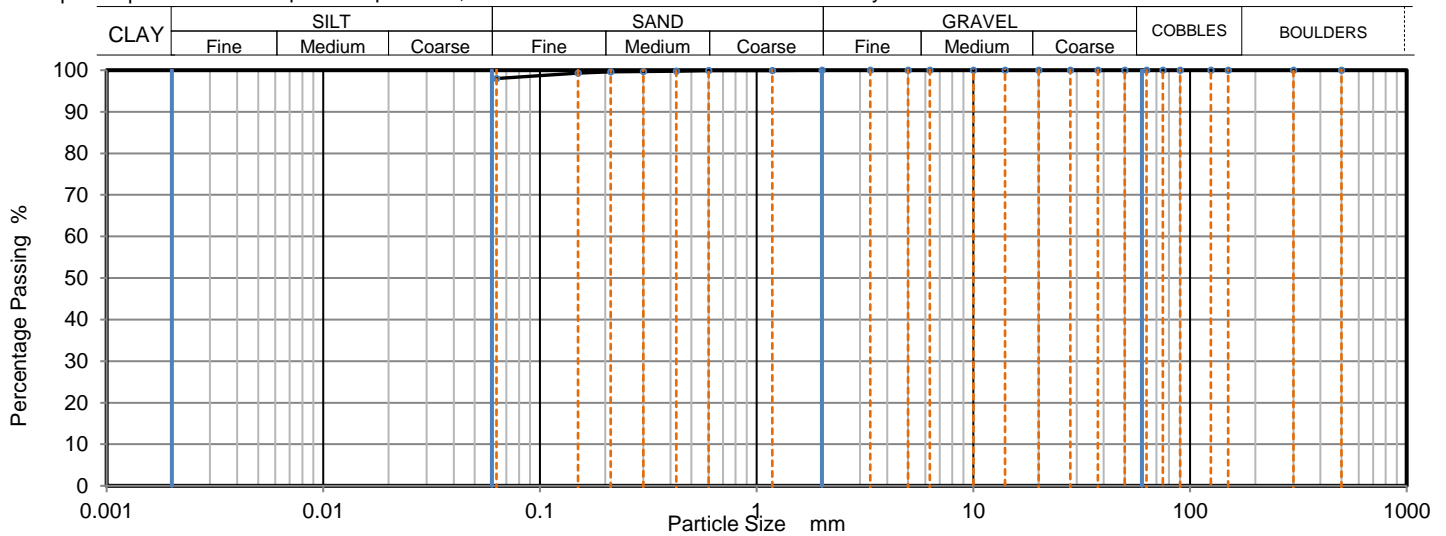
Sieving		Sedimentation	
Particle Size mm	% Passing	Particle Size mm	% Passing
500	100		
300	100		
150	100		
125	100		
90	100		
75	100		
63	100		
50	100		
37.5	100		
28	100		
20	100		
14	100		
10	100		
6.3	100		
5	100		
3.35	100		
2	100		
1.18	100		
0.6	100		
0.425	100		
0.3	100		
0.212	100		
0.15	99		
0.063	98

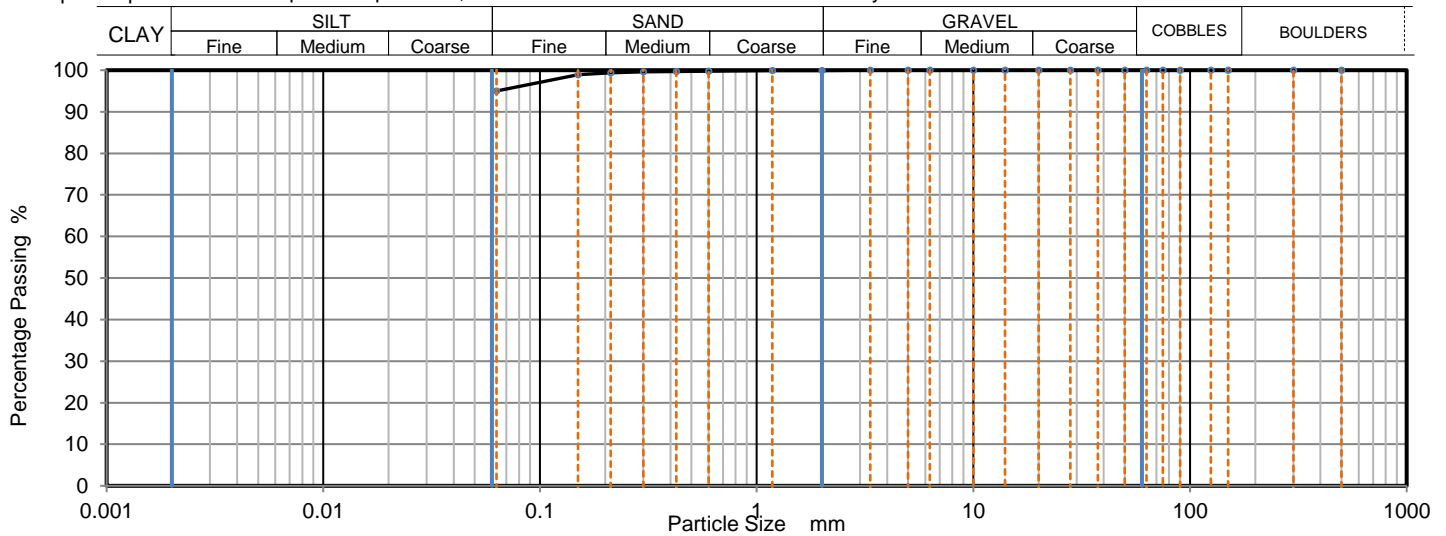
Sieving		Sedimentation	
Particle Size mm	% Passing	Particle Size mm	% Passing
500	100		
300	100		
150	100		
125	100		
90	100		
75	100		
63	100		
50	100		
37.5	100		
28	100		
20	100		
14	100		
10	100		
6.3	100		
5	100		
3.35	100		
2	100		
1.18	100		
0.6	100		
0.425	100		
0.3	100		
0.212	99		
0.15	99		
0.063	95
