18 Grove Terrace, NW5 1PH

Design and Access Statement & Method Statements - Repointing

This Design and Access Statement is for the proposed repointing works on the front facade.

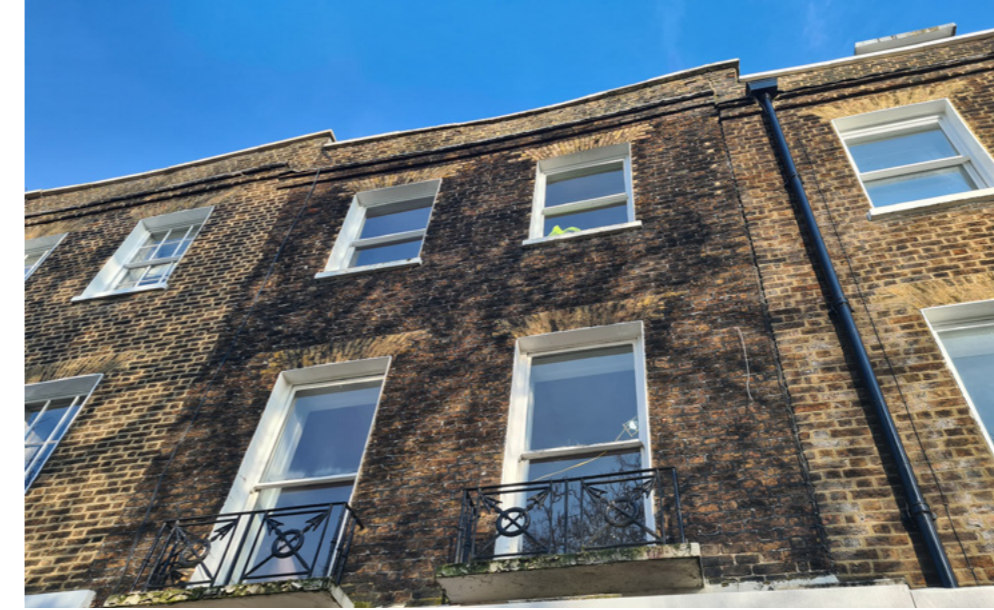
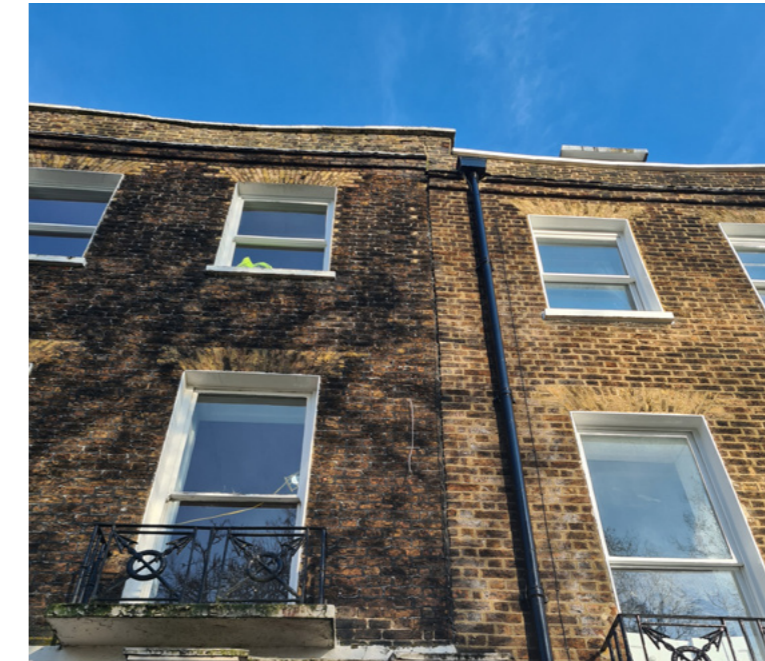
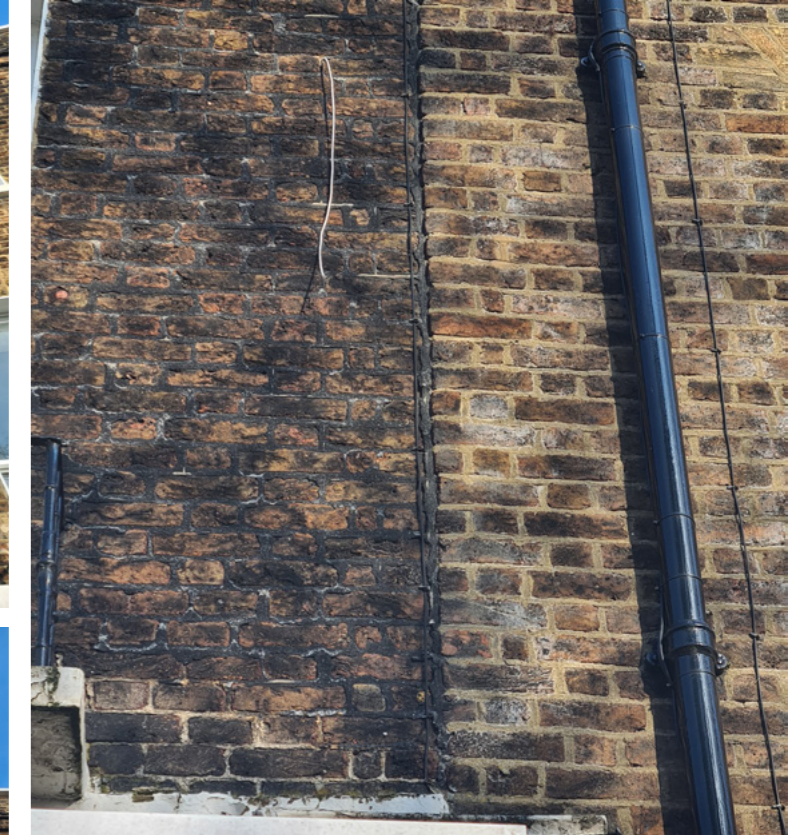
Images of exterior and existing pointing conditions - poor, weathered and dirty.

See photos showing current condition of front façade. Photos of properties either side also supplied for context.

Note 19 Grove Terrace was refurbished in the past 10 years and the difference between the façades.
