**GROUND APPRAISAL REPORT**

**1 WADHAM GARDENS, LONDON, NW3 3DN**

**MARCUS COOPER GROUP**

Report:	GROUND APPRAISAL REPORT
Site:	1 WADHAM GARDENS, LONDON, NW3 3DN
Client:	MARCUS COOPER GROUP
Date:	NOVEMBER 2018
Reference:	GE17691 – GARv2JT181109
Version:	2.0
Prepared by:	 
	Jonathan Tingley CEnv, BEng (Hons), MSc, FGS, MEnvSc TECHNICAL DIRECTOR
Reviewed by:	 
	Gavin Roberts CGeol, BEng (Hons), MSc, FGS TECHNICAL DIRECTOR
Geo-Environmental Services Limited Unit 7, Danworth Farm, Cuckfield Road, Hurstpierpoint, West Sussex, BN6 9GL +44(0)1273 832972 <a href="http://www.gesl.net">www.gesl.net</a>

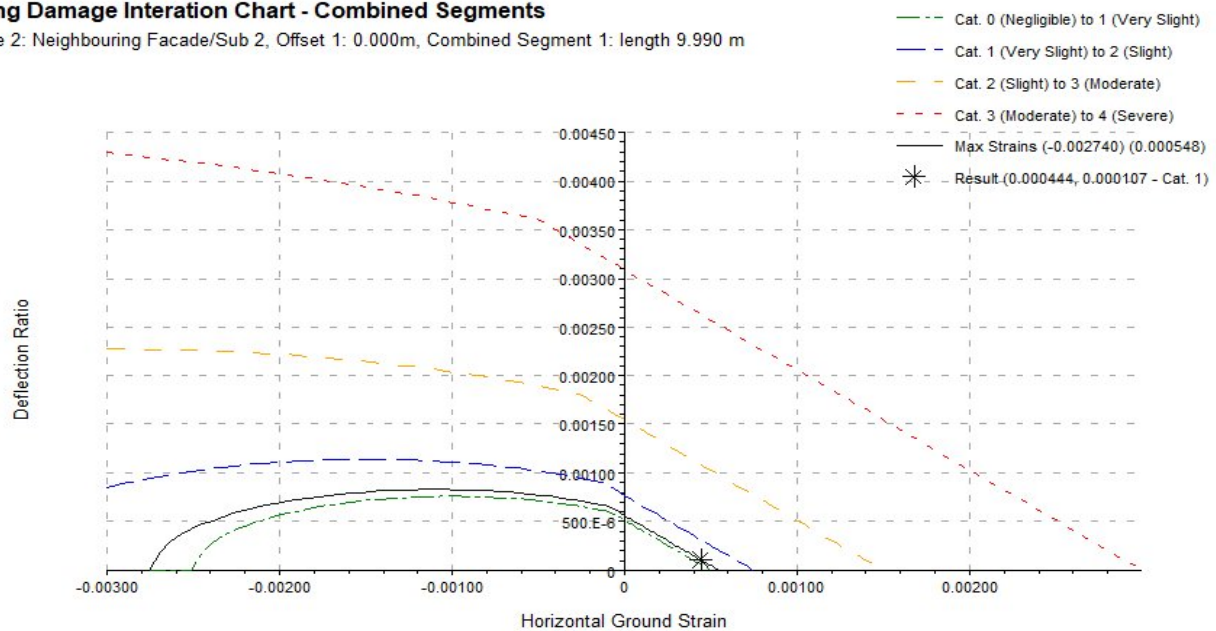
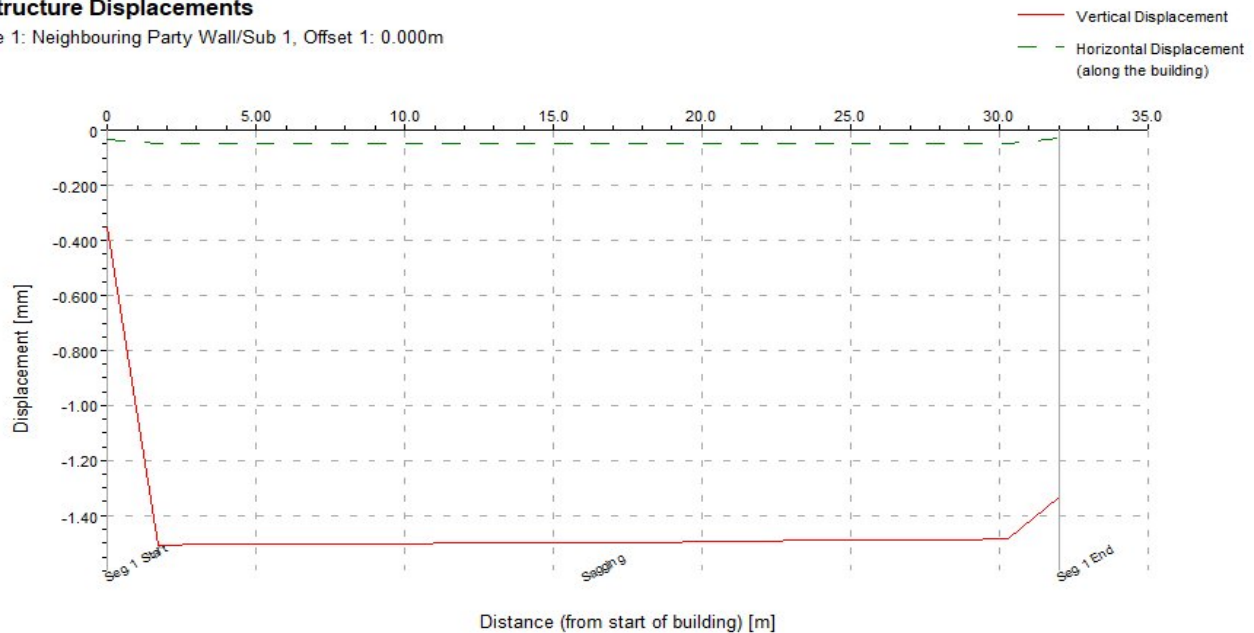
Structure 2: Neighbouring Facade/Sub 2, Offset 1: 0.000m, Combined Segment 1: length 9.990 m

Structure 1: Neighbouring Party Wall/Sub 1, Offset 1: 0.000m

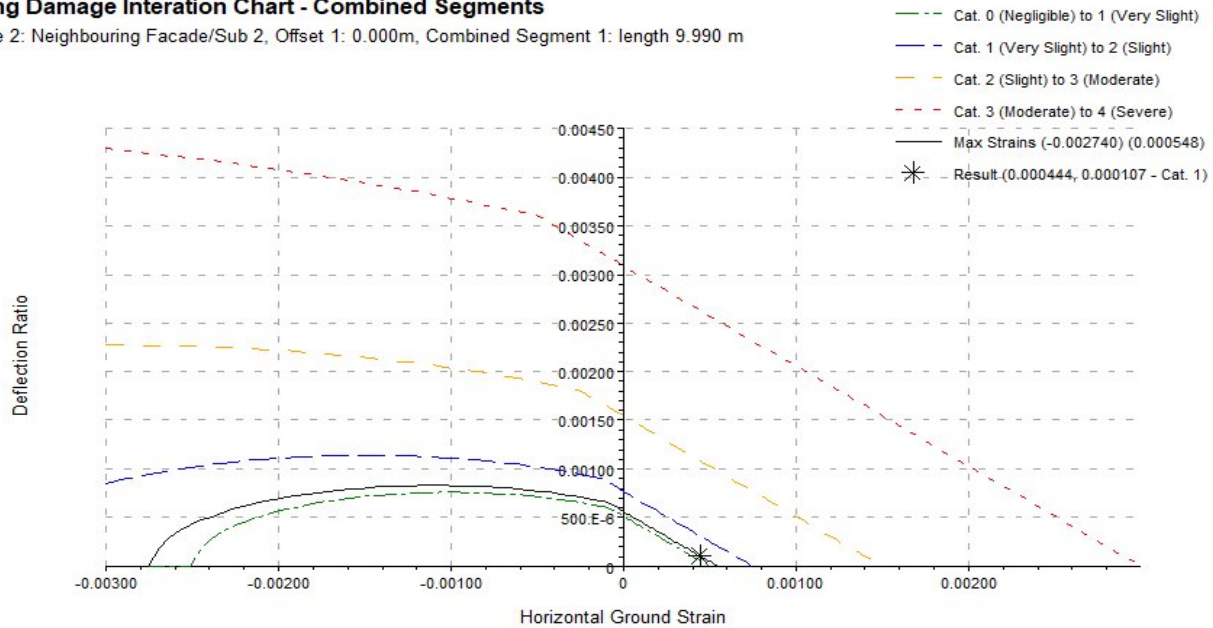
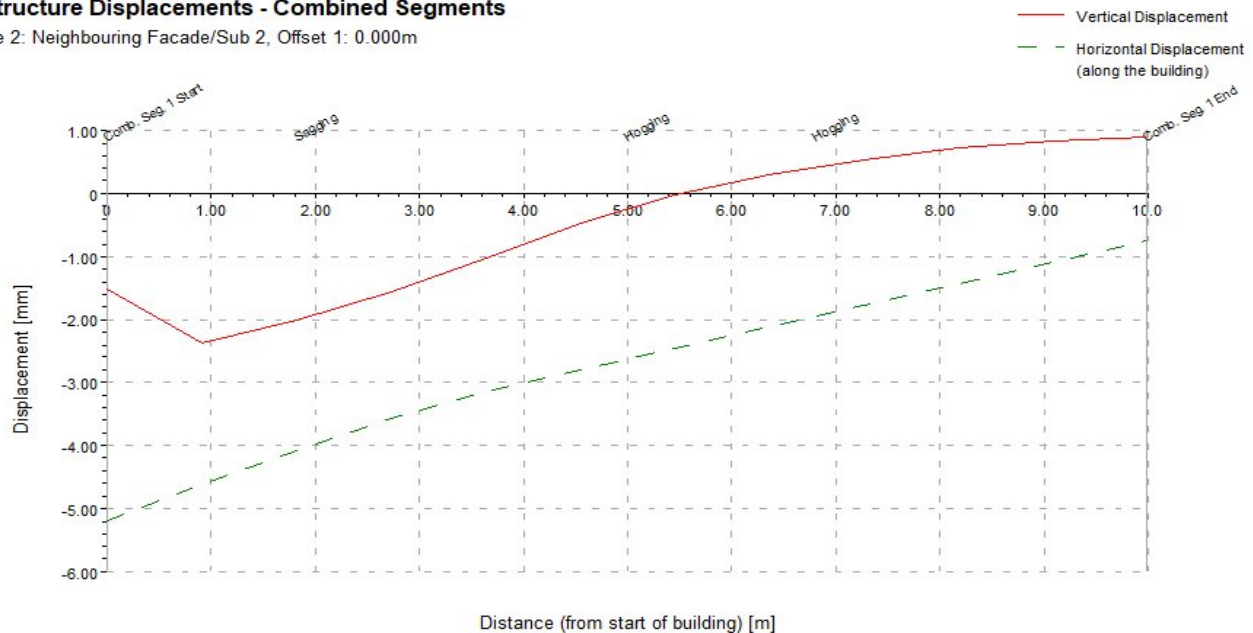
Structure 2: Neighbouring Facade/Sub 2, Offset 1: 0.000m, Combined Segment 1: length 9.990 m

Structure 2: Neighbouring Facade/Sub 2, Offset 1: 0.000m

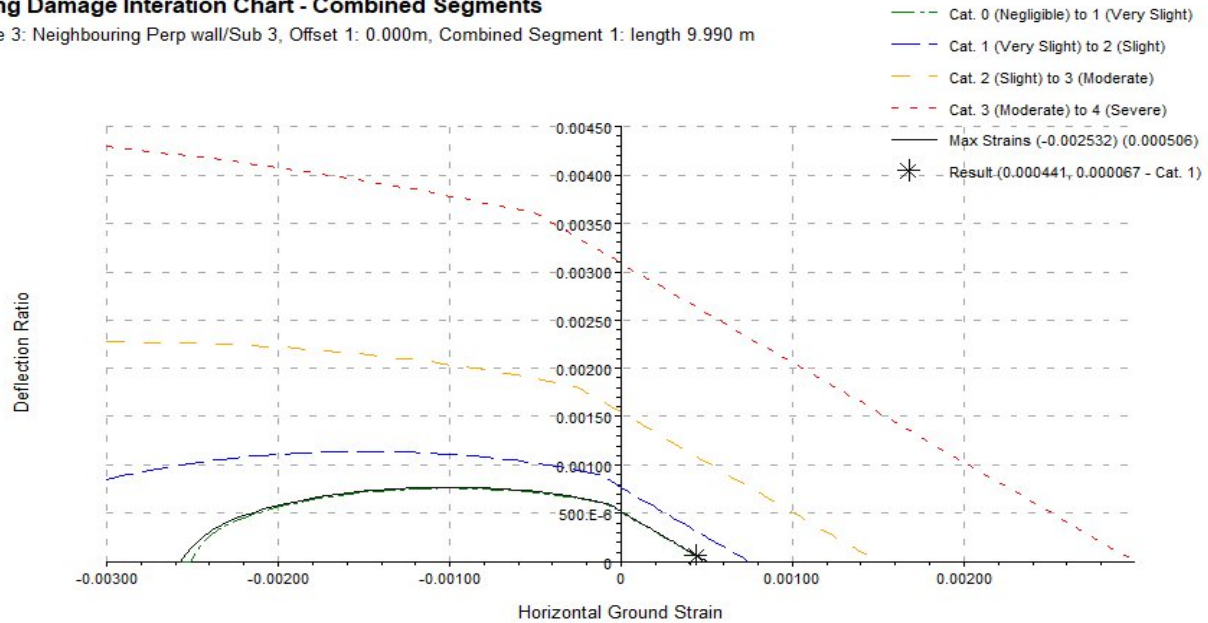
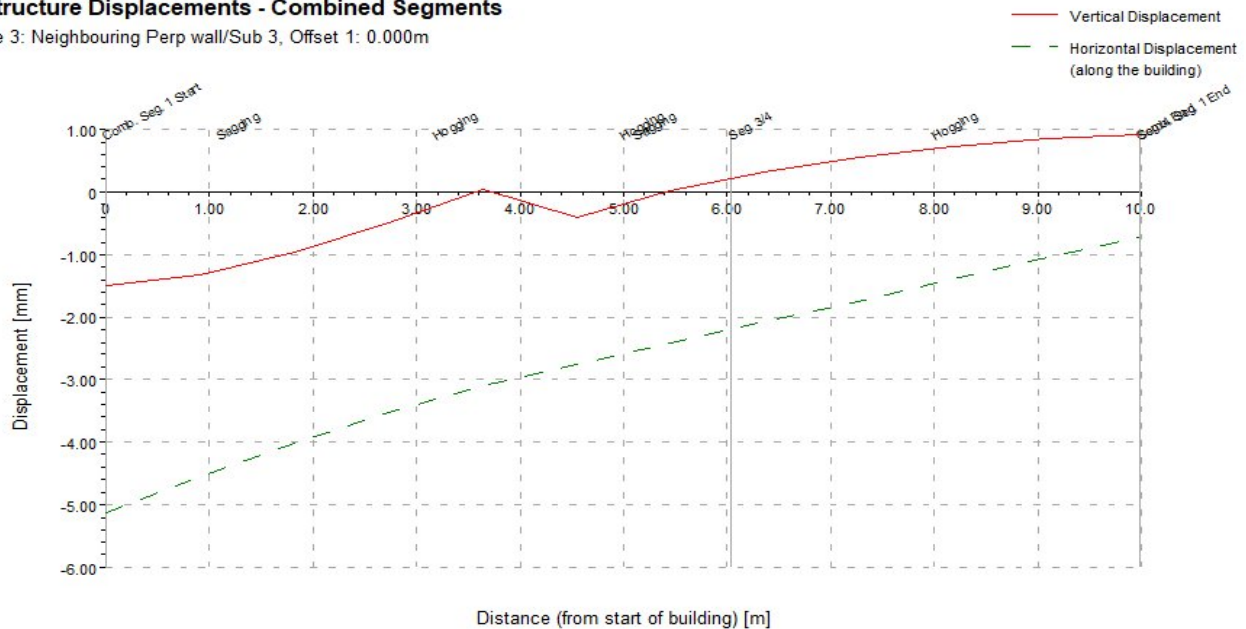
Structure 3: Neighbouring Perp wall/Sub 3, Offset 1: 0.000m, Combined Segment 1: length 9.990 m

Structure 3: Neighbouring Perp wall/Sub 3, Offset 1: 0.000m
