BS 5837:2012 Tree Survey, Arboricultural Impact Assessment, Arboricultural Method Statement & Tree Protection Plan

31 Downside Crescent
London
NW3 2AN

10th January 2022

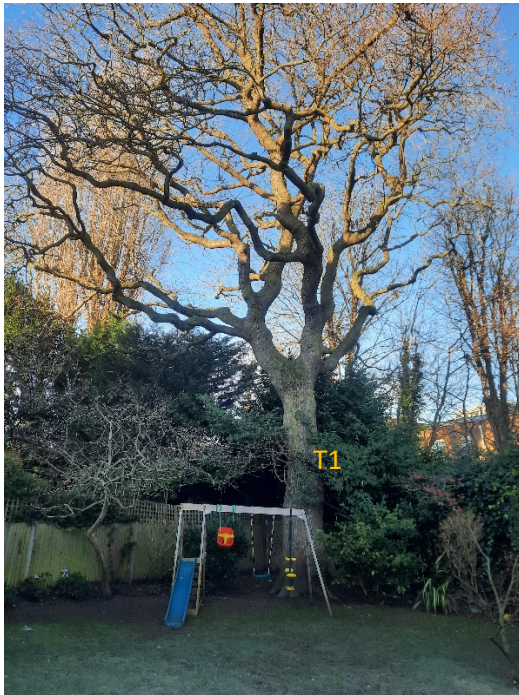
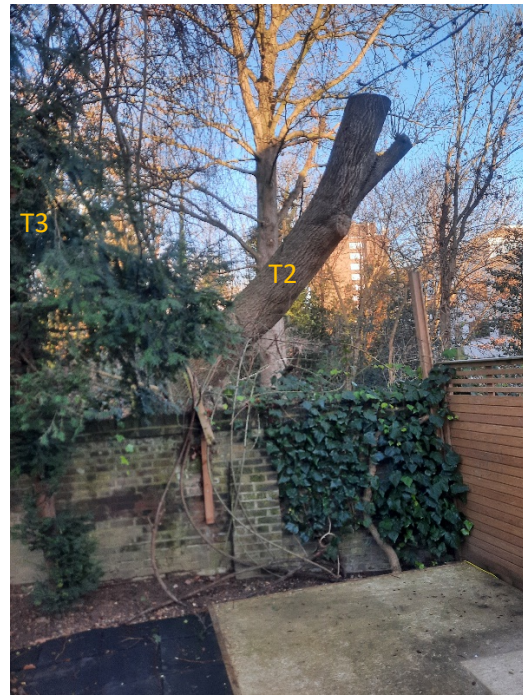
T1 Oak & T2 Off-site Ash

Images above of the mature category A Oak tree situated in the north-east corner of the garden and the second image of T2 off-site category C Ash, recently topped to a 5m high monolith with no remaining vegetative growth, so no longer considered a constraint to the proposed development.

At a distance of over 11 metres from T1, the careful excavation and pad construction should have no impact upon the category A Oak tree.

The category C off-site Common Ash tree (T2) would previously have been considered a constraint to development, however, the tree has recently been ‘topped’ to a five metre high standing monolith with little potential to develop a meaningful crown, therefore, a root protection area has not been shown for T2.

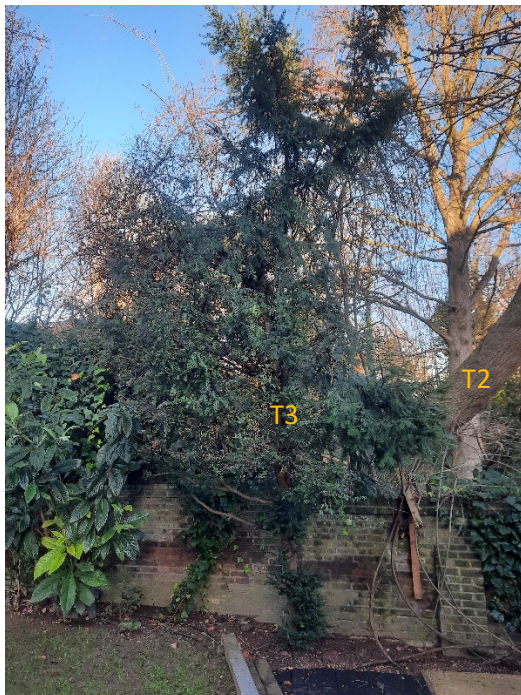
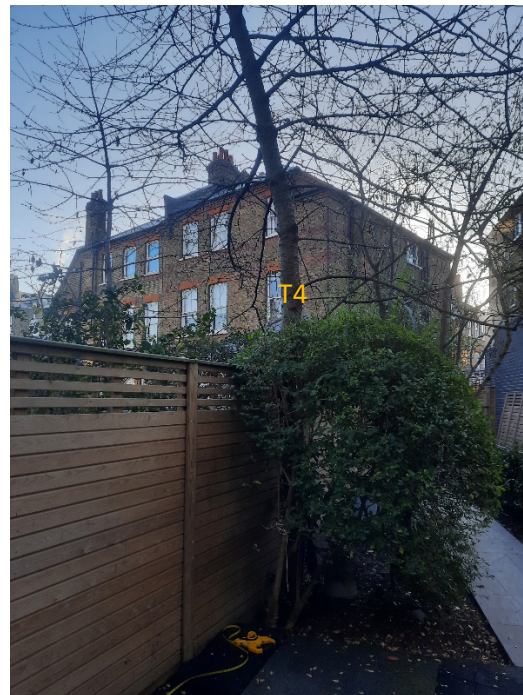
T3 Common Yew & T4 Ornamental Cherry

Images above of the category C Common Yew to be removed to facilitate construction and T4 early mature Cherry that will remain in situ alongside the proposed garden outbuilding.

A single category C Yew tree (T3) will require removal but could easily be replaced elsewhere within the subject garden.

- Remove T3 Yew and reduce lateral branch spread of T4 Cherry in the northerly direction.
- Project arboriculturalist to mark out location of tree protective fencing.
- Fencing has been positioned to allow sufficient space to excavate additional ground and construct the timber outbuilding.

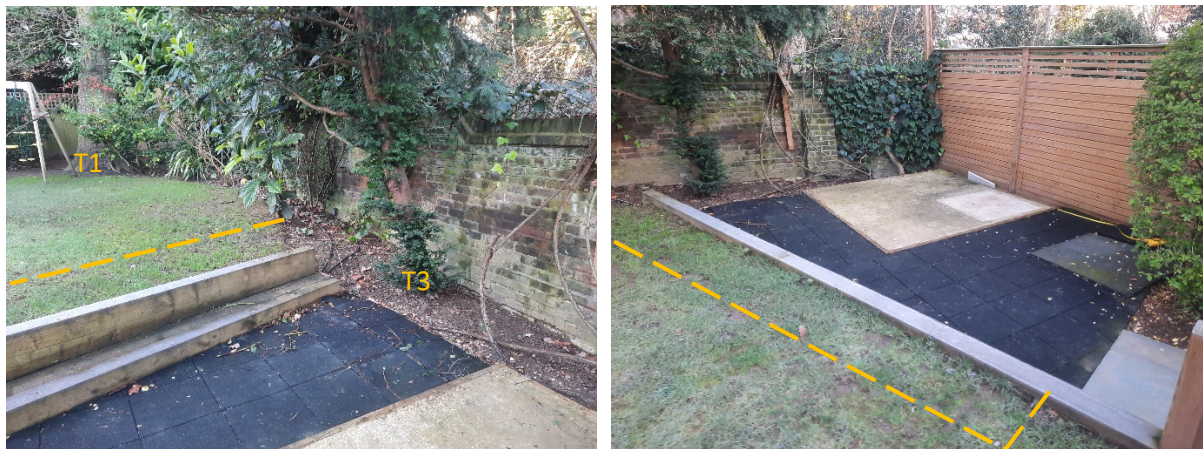
T1 category A mature Oak grows in the north-east corner of the garden which is largely level and laid to lawn. The proposed building will be situated on the opposite side of the garden in a location approximately 400mm lower than the surrounding ground as shown below.

Images above showing the proposed location for the garden building, set at a lower level than the main part of the garden and divided with a stepped sleeper arrangement. The lower section of garden is currently laid to a small section of hardstanding and rubber tiles, to be removed prior to construction. The yellow dashed lines represent the potential area of ground to be cut back.

The proposed building will extend a small distance into the higher ground, requiring careful hand excavation of a small section of ground within the root protection area of T1 as shown on the arboricultural impact plan at appendix 3.

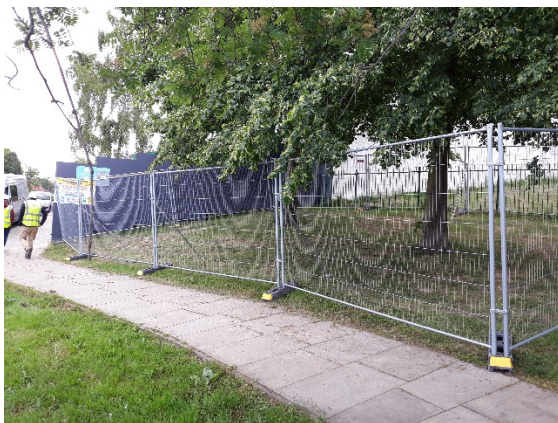
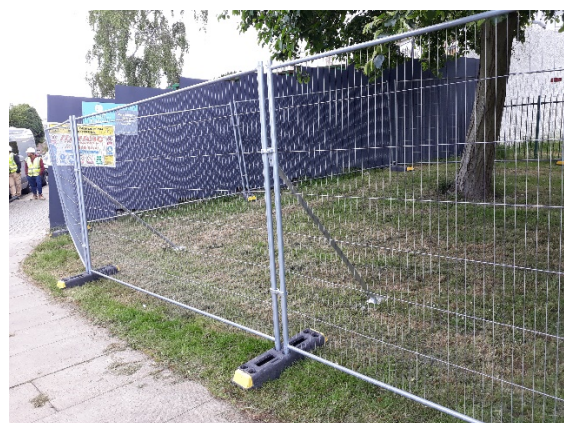
Photos above show protective fencing installed as per BS5837:Fig 3A with rubber feet and stabilizer struts.

- Erect protective barrier fencing in locations shown on the tree protection plan at appendix 4. Tree protection positions will have already been marked out by the project arboriculturalist during phase 1. A protective fencing diagram can be found at appendix 5. Barriers will consist of a heras type panel inserted into rubber 'elephants feet' and reinforced with a stabelizer strut. Two clamps either end of each section will ensure the area within the fence (CEZ) remains out of bounds to demolition activities throughout the duration of works.
