Boundary Wall at
82 Fitzjohn's Avenue
London NW3 6NP

HERITAGE ASSESSMENT:
To accompany a planning application

82 Fitzjohn's Avenue: Boundary Wall Heritage Assessment

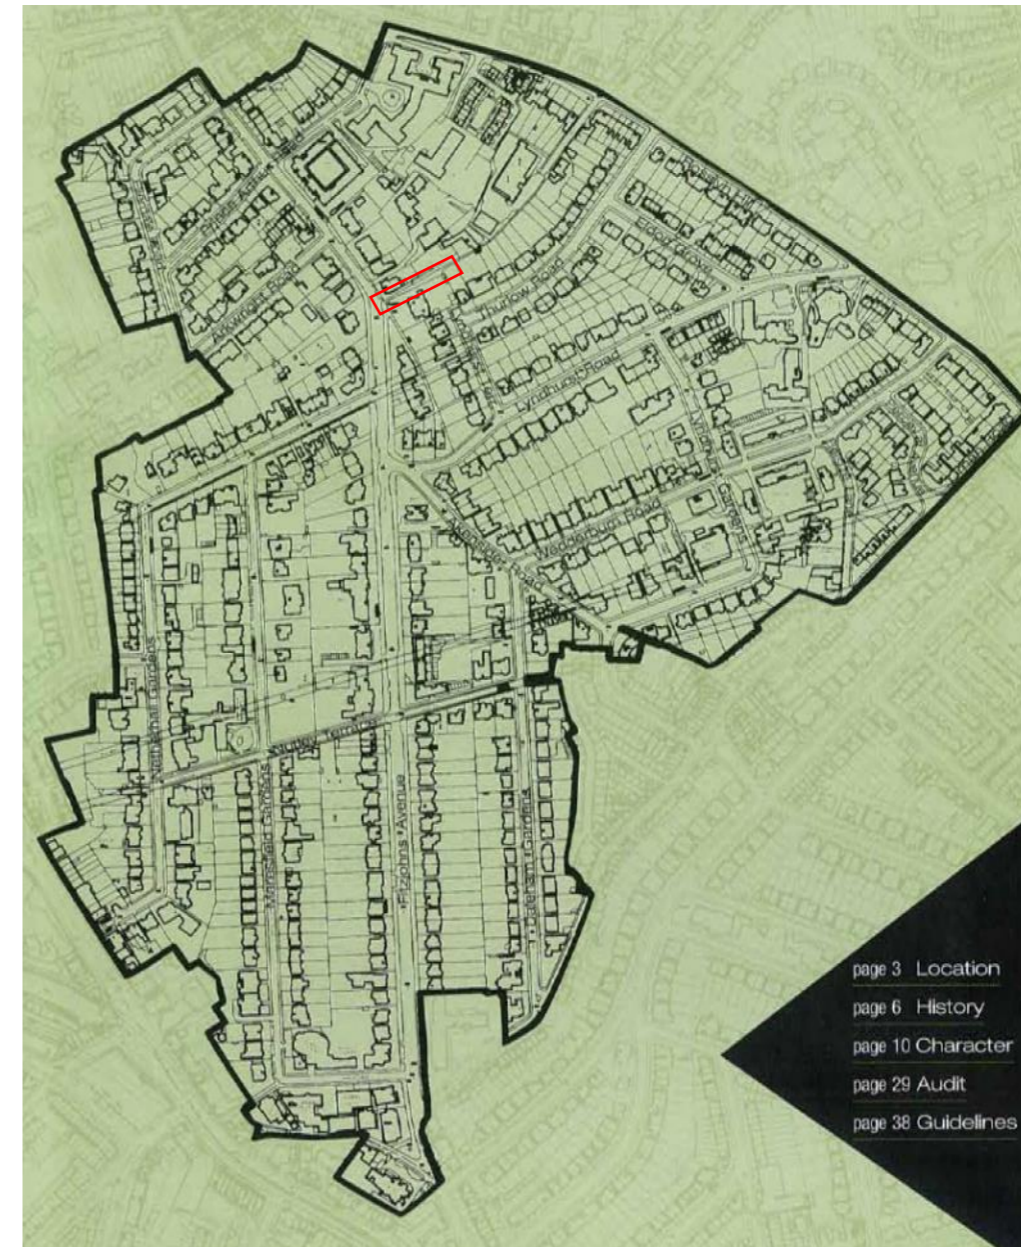
Figure 1: Aerial view of 82 Fitzjohn's Avenue, relevant section of boundary wall marked in red (source: Fitzjohn's and Netherhall Conservation Area Appraisal, LB Camden)

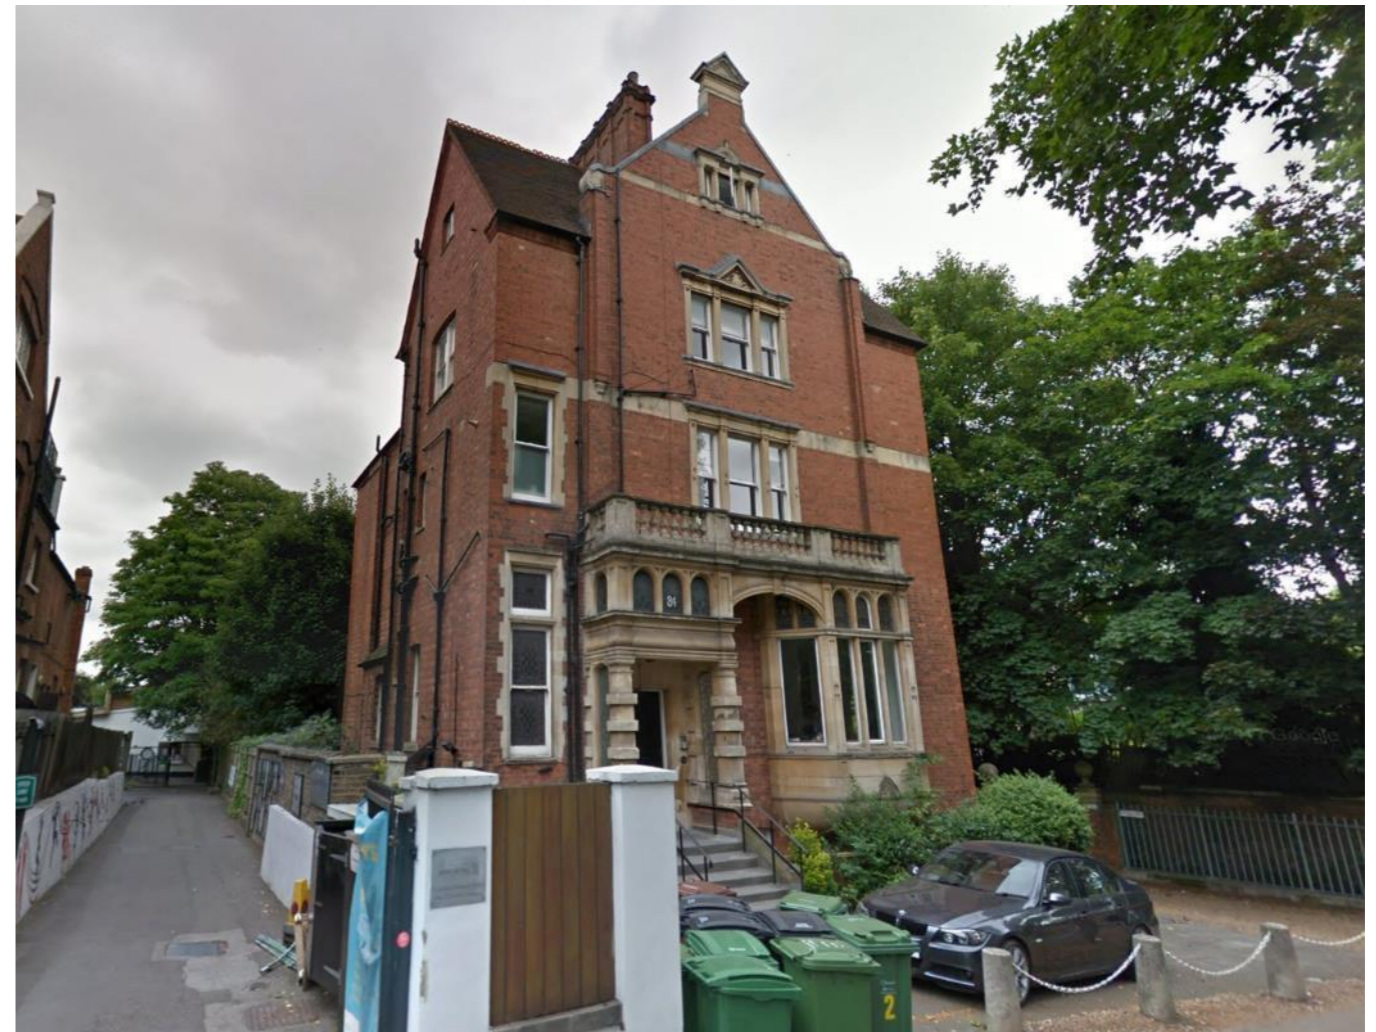
Figure 16: 84 Fitzjohn's Avenue, red brick with classical features and tall, articulate gable forming a parapet (source: Google)

84 Fitzjohn's Avenue (Figure 16), the building which stands in front of the subject site, shielding it from view from the street, is of a similar overall form. It is detached, rather than semi-detached, probably due to the fact that it was built at a later date to those on the surrounding its streets, including its neighbours at Fitzjohn's Primary School, yet it is very much in keeping with the buildings in the conservation area and conceals the, very divergent building of the subject site behind it.

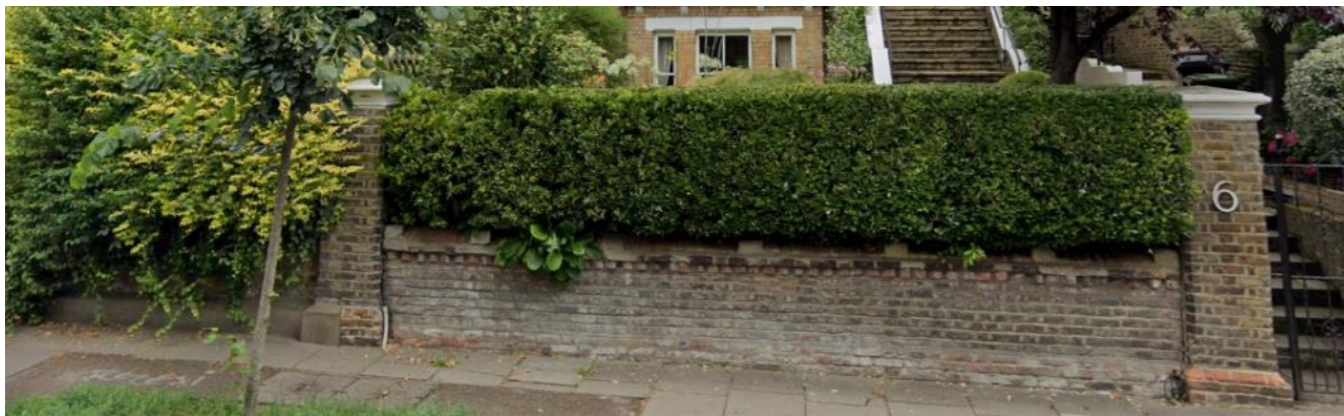
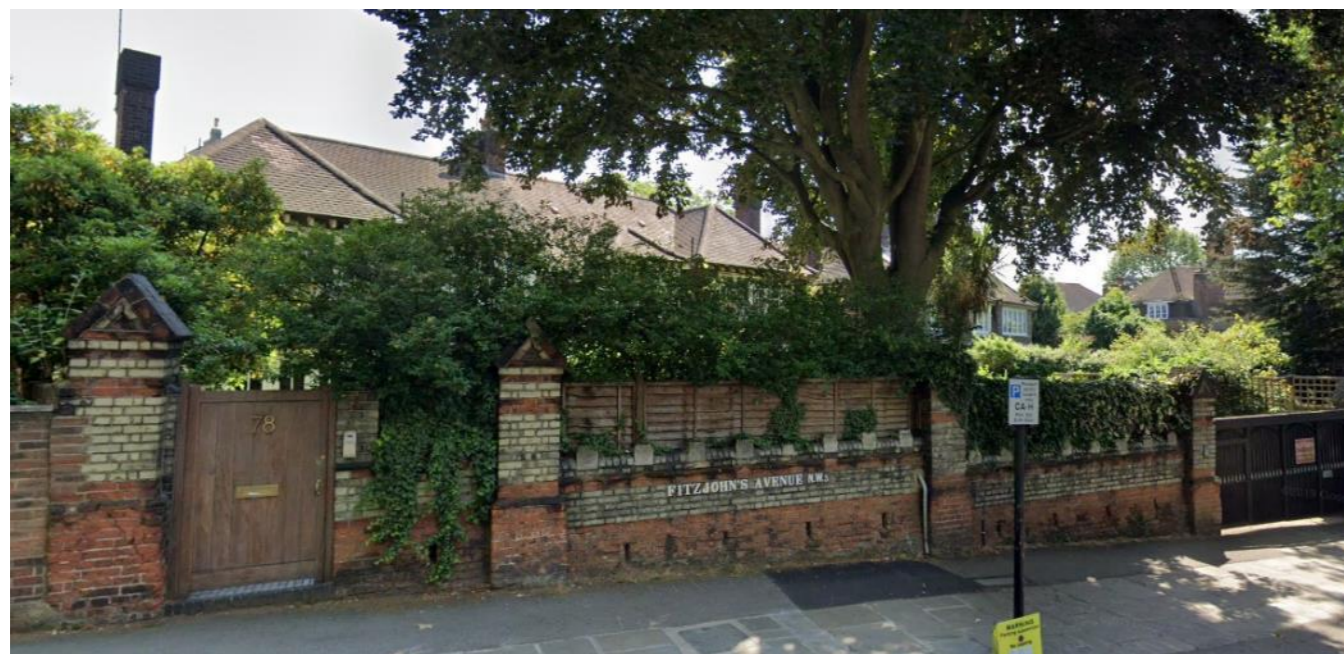
Figure 26: Plot boundaries on Lyndhurst Road (above) and Fitzjohn's Avenue (below), both are typical of the area - mid-rise with hedges and foliage protruding above.

There is some variety in plot size with some detached and semi-detached houses standing in generous plots behind mid-rise boundary walls (such as those shown on Lyndhurst Road Figure 14). Others, such as the houses on Maresfield Gardens (Figure 11) are more densely developed with smaller gaps between plots, and indeed the houses themselves. Boundaries with hedges help to contribute to the overall sense of greenery in the area. Some plot boundaries are higher (Figure 26), offering the passer-by glimpses of architectural flourishes on the buildings within.

Furthermore, there are numerous other boundary and garden walls in the conservation area that make a much stronger impression and have a greater contribution to the conservation area, as set out in Figure 26 in Section 5: Characterisation Appraisal. When considering the boundary wall, in relation to these other walls it is evident that the boundary wall in question does not make such a strong contribution to the significance and special interest of the Fitzjohn's and Netherhall Conservation Area. As such the boundary wall makes a **neutral contribution** to the conservation area.

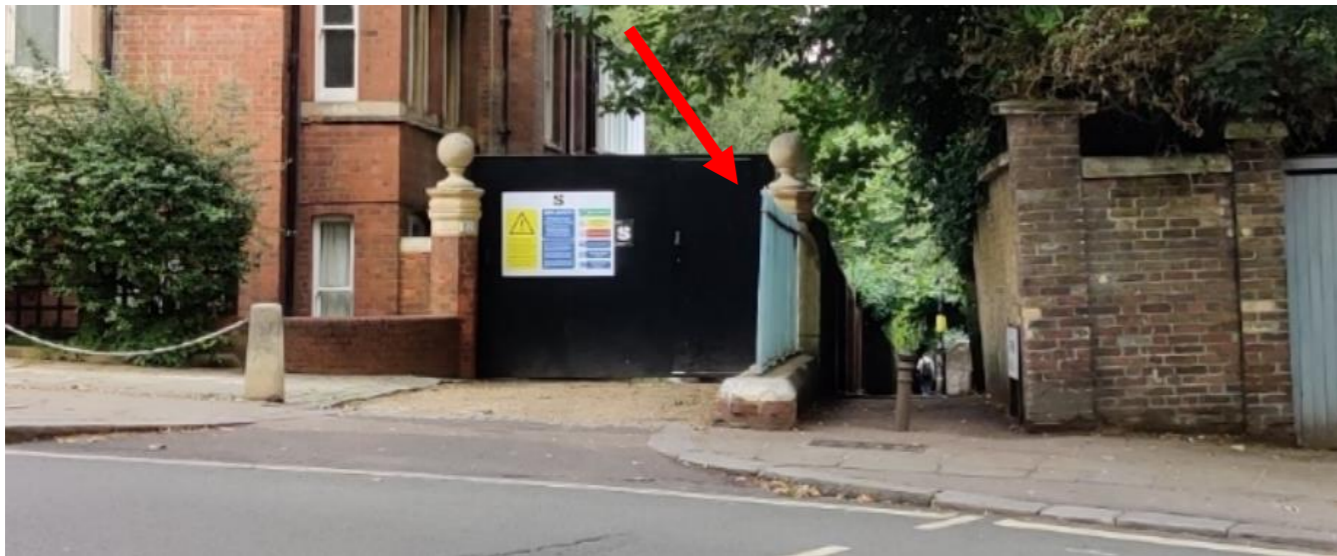
Figure 28: Boundary Wall viewed from Fitzjohn's Avenue (indicated with arrow), showing presumed 1970s extension at the front with stone finial, and the corresponding finial above the low curved wall de-marking the driveway entrance to 82 Fitzjohn's Avenue.

When walking from east to west the wall starts with some red brick footings with iron railings above before becoming full-height with a pier and a stone finial (Figure 28). Then a full-height wall in red brick with dark brick copings continues for a time before meeting a juncture where there was a former gateway which then becomes stock brick. The wall is one brick thick, the thickness of the coping, and is built-out at the piers on either side of the wall.

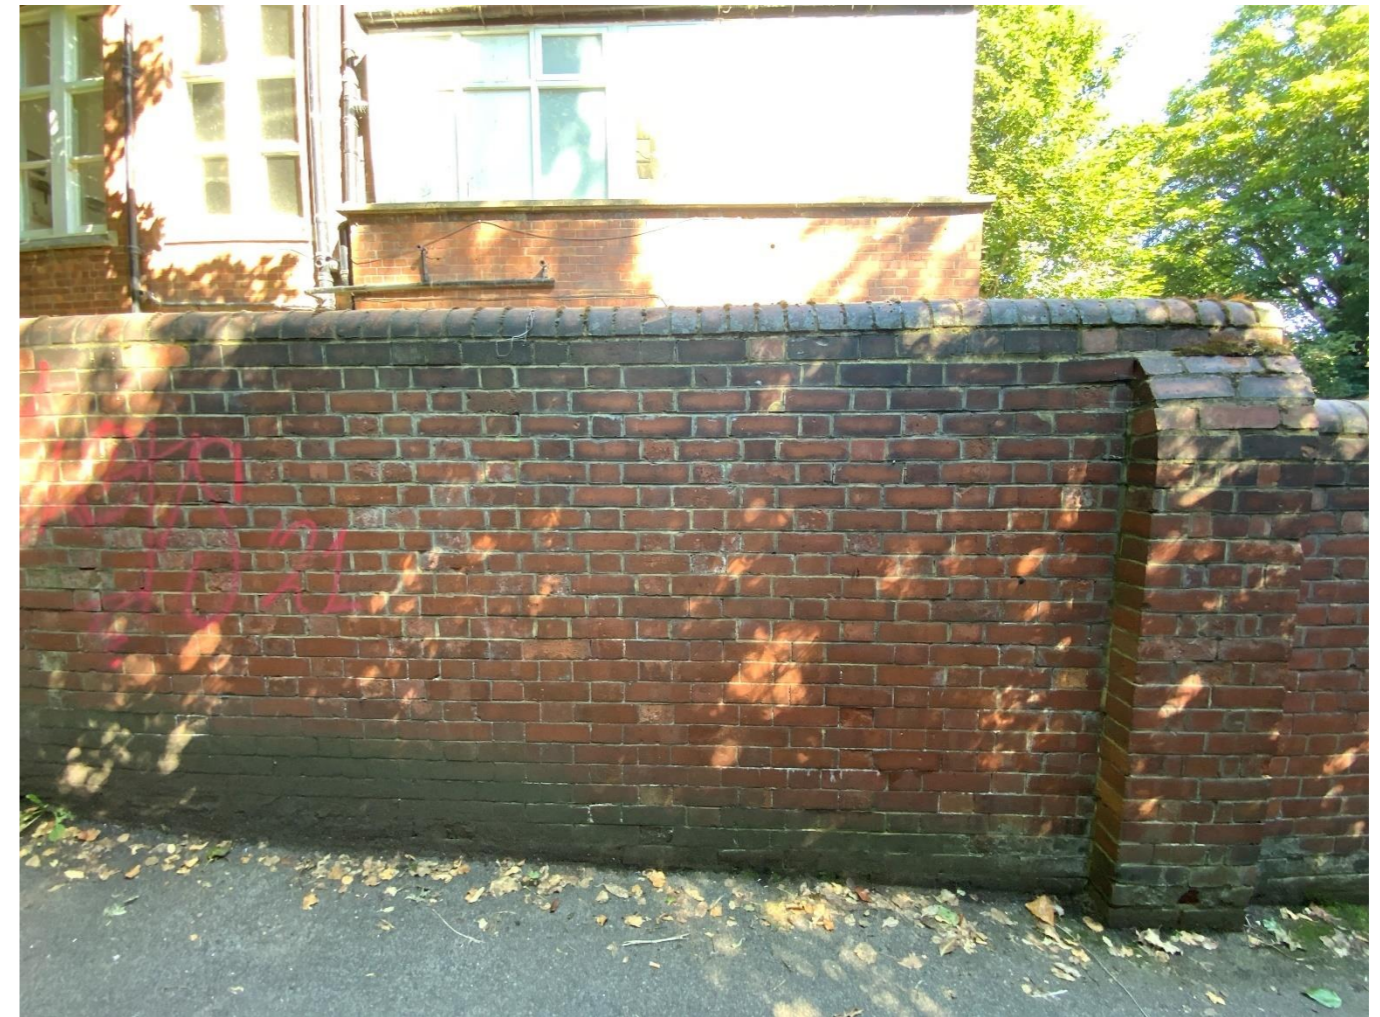
Figure 29: Section of the wall viewed from Spring Walk, No 84 Fitzjohn's Avenue is visible behind

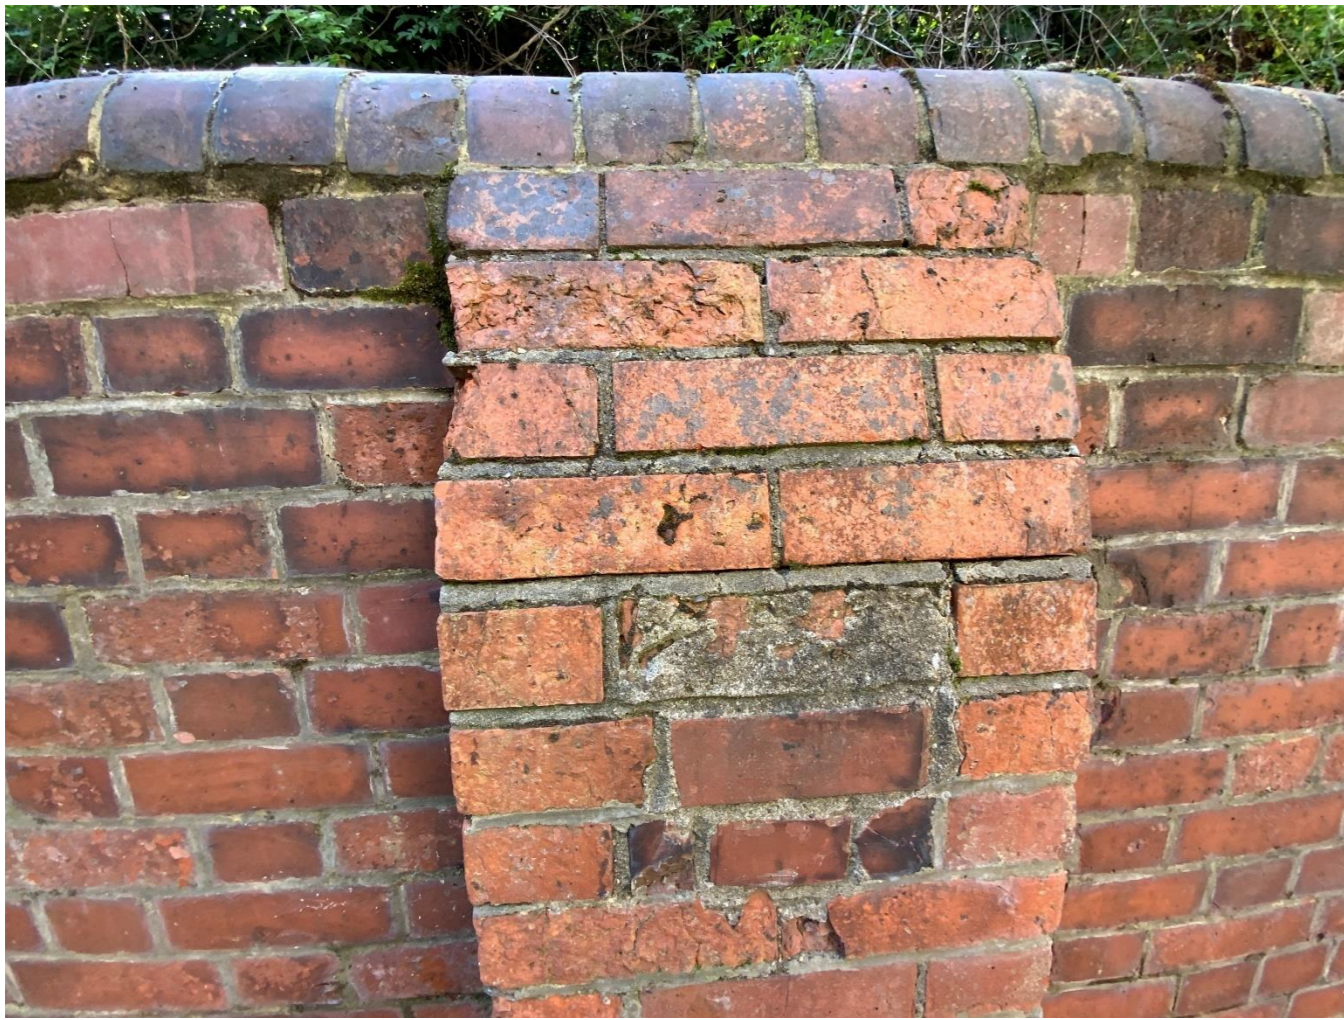
Figure 30: Photograph of the additional buttress showing poor quality cement mortar that is beginning to fail, cement mortar has been poorly applied to the brickwork in the main wall also and there are signs of decay.

As described in the Map Regression in Section 3.2, it is thought that the red brick section of wall near 84 Fitzjohn's was built when the house was built at the turn of the 20th century. This part of the wall is in stretcher bond and steps-down consistently at certain junctures with piers supporting the wall at each step. There is one separate buttress which does not line-up with a step in the wall, and is thought to be a later addition. It appears as though the brick of the buttress has been built against the wall and not tied-in, it also seems to have been built with cement mortar.

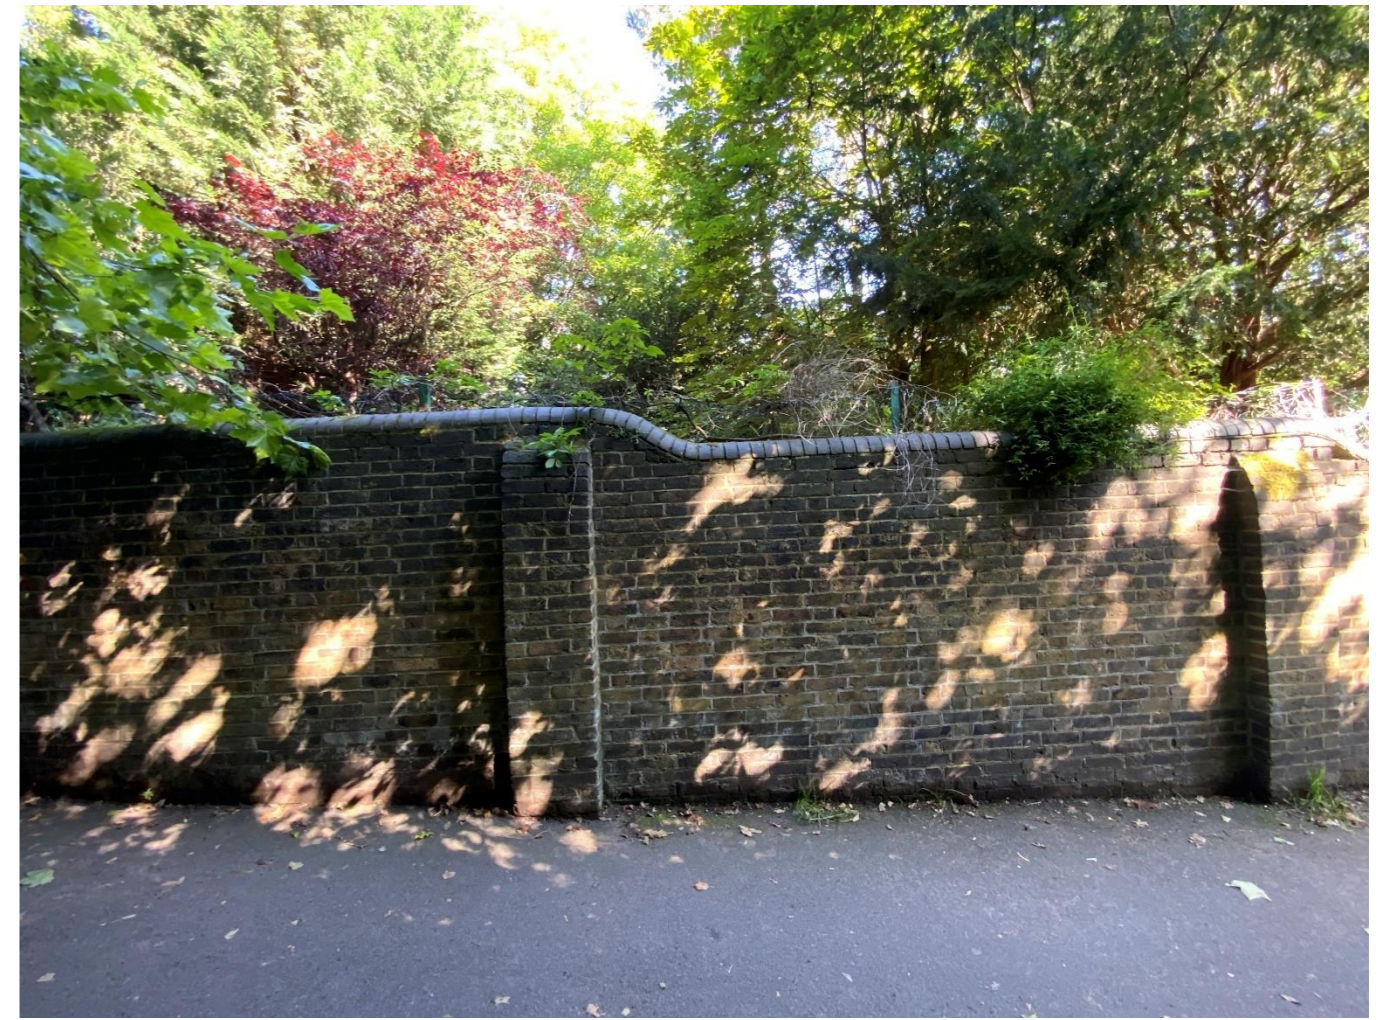
Figure 31: Area of the boundary wall that is thought to be more historic, constructed in stock brick in Monk bond with Staffordshire blue half round coping bricks.

The stock brick section, which starts further east on the wall, is thought to be earlier, pre-dating both no. 82 and 84 Fitzjohn's Avenue. The stock brick section of the wall is in Monk Bond (two stretchers to one header in each course).

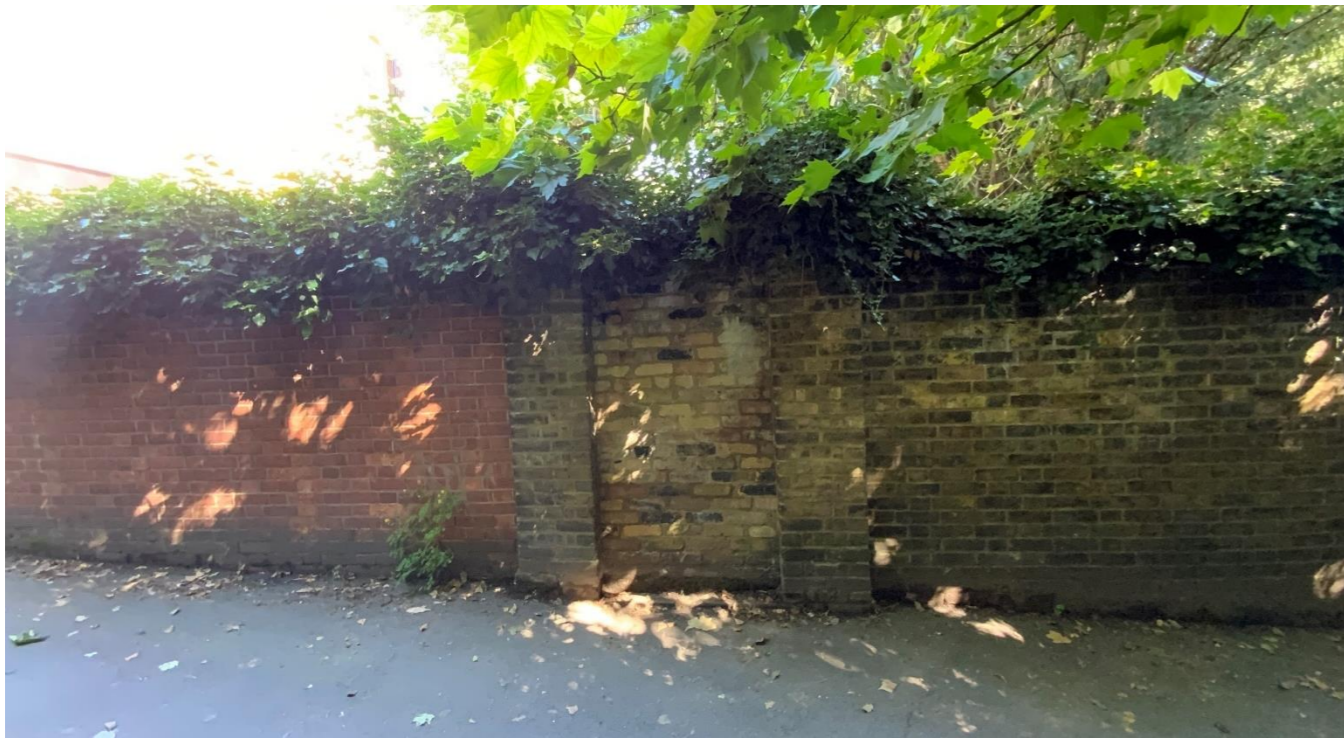
Figure 32: Point in the garden wall where the red brick meets the stock brick, and the location of a former gateway, now bricked-up. The replacement brick panel is in stretcher bond.

The exception to this is a section of stock brick which is built into the garage of No.82, this section is a later build (re-built when the garage was built) and has been built in English bond (alternate courses of header and stretcher). The other modern section of wall stands near the junction with the red brick wall and is an in-fill panel of new brick, blocking-up a former gate opening. This new section of wall has been constructed in stretcher bond (Figure 32). There is no evidence of an opening in the wall on the map regression, despite the remnants of gate posts still standing on the interior of the wall.

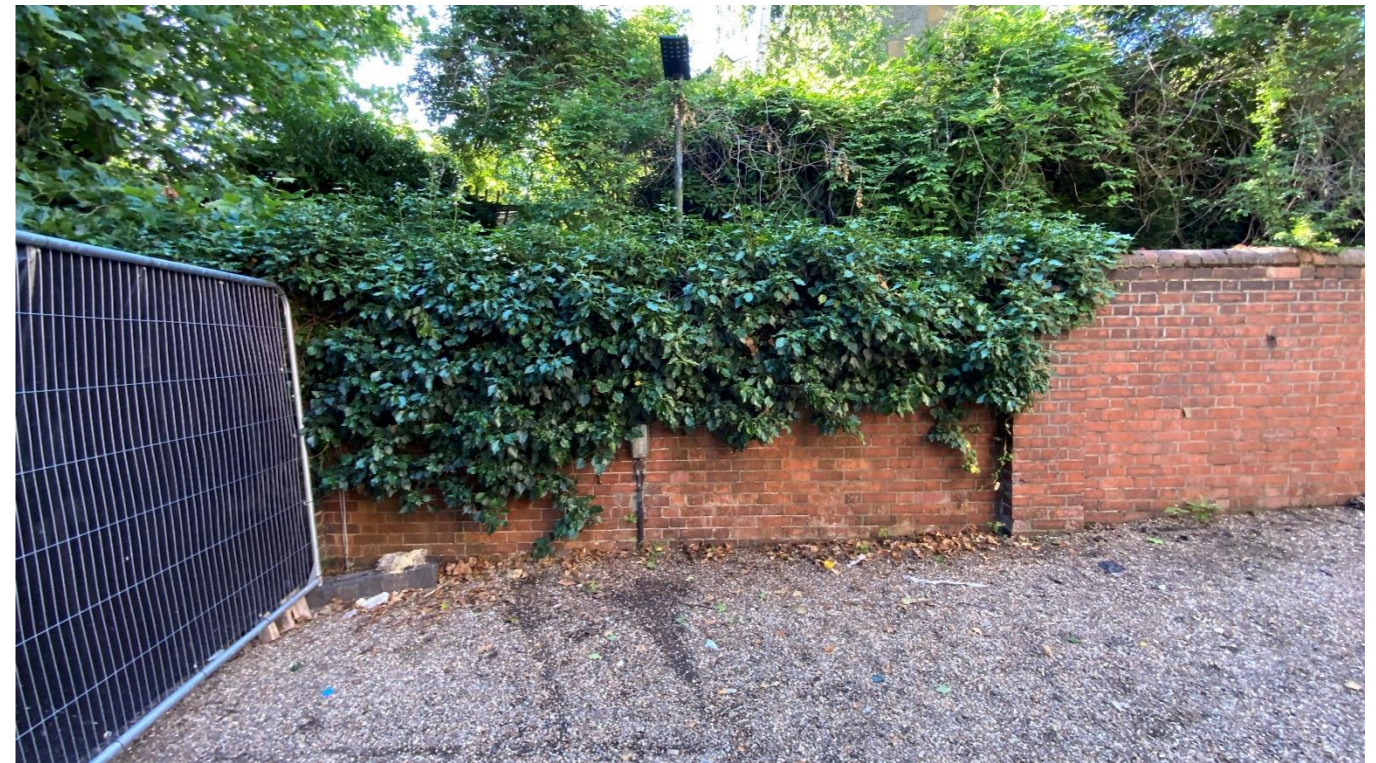
Figure 34: North elevation of the boundary wall taken from the driveway of 82 Fitzjohn's Avenue showing the wall covered in significant quantities of foliage. A defunct light and cabling dating from the middle of 20th century is visible.

On the northern elevation of the wall (Figure 34) (facing into 82 Fitzjohn's Avenue garden), the wall is largely featureless, with the exception of a hook attached to the wall which appears to be quite historic, possibly early 20th century and an old light and cabling, possibly mid-20th century. There is also significant amounts of foliage in places. The wall is in an overall moderate condition. For a more detailed assessment of the condition of the wall, please see the appended condition assessment.

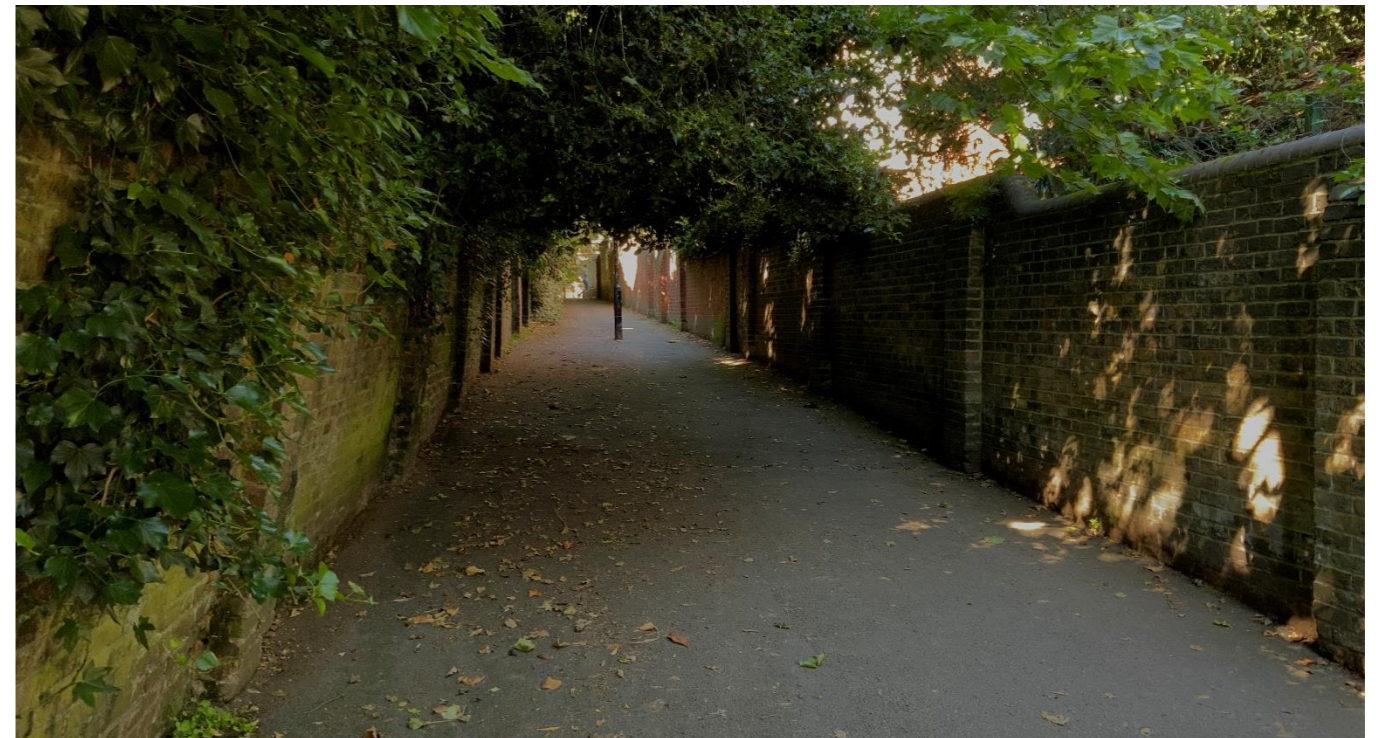
Figure 35: View looking west along Spring Walk towards Fitzjohn's Avenue, the view is taken from the widest point of the passageway with the boundary wall on the right of the image.

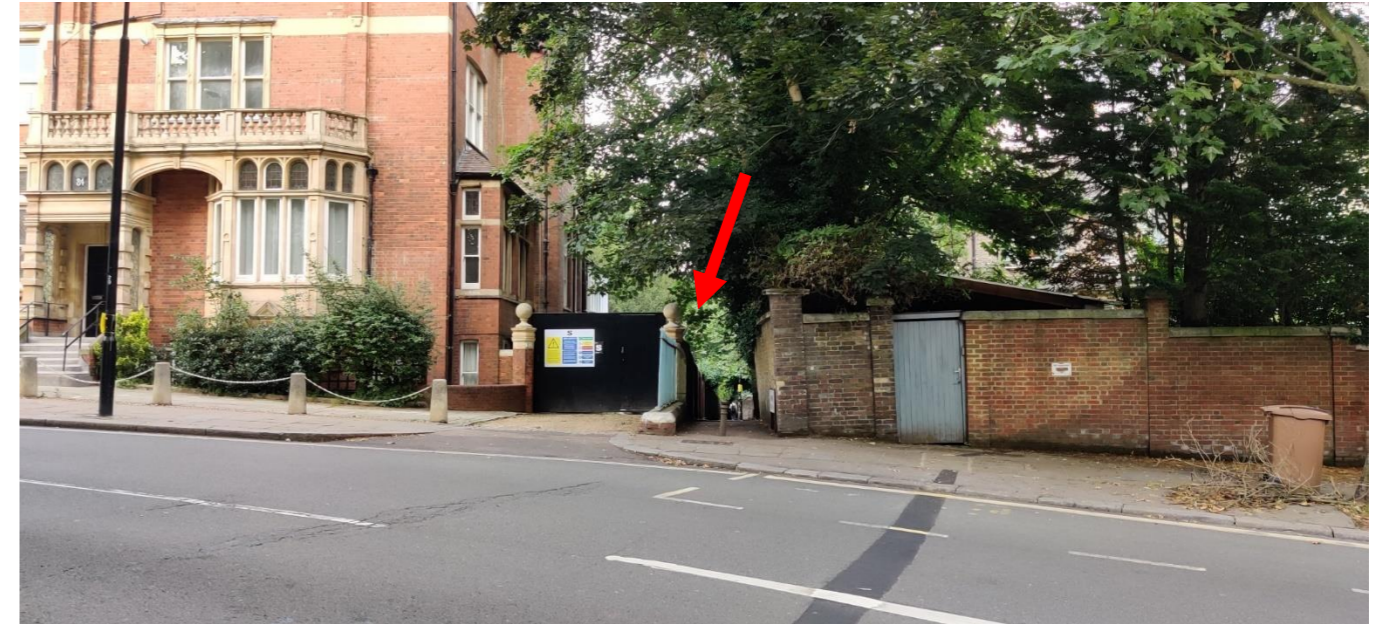
Figure 39: Photo looking eastwards down Spring Walk from Fitzjohn's Avenue, the boundary wall is annotated with a red arrow.

As shown in Figure 39 above, the wall is not highly visible from the main thoroughfare within the conservation area so the only people who will experience the wall are users of Spring Walk itself. The fact that the applicant proposed to carefully re-assemble the wall using salvage bricks will help to preserve the visual impression made by the wall and so the overall and lasting impact on the wall will be extremely minimal. The proposals will have an overall **negligible impact** and will cause **no harm** to the Fitzjohn's and Netherhall Conservation Area as a whole.

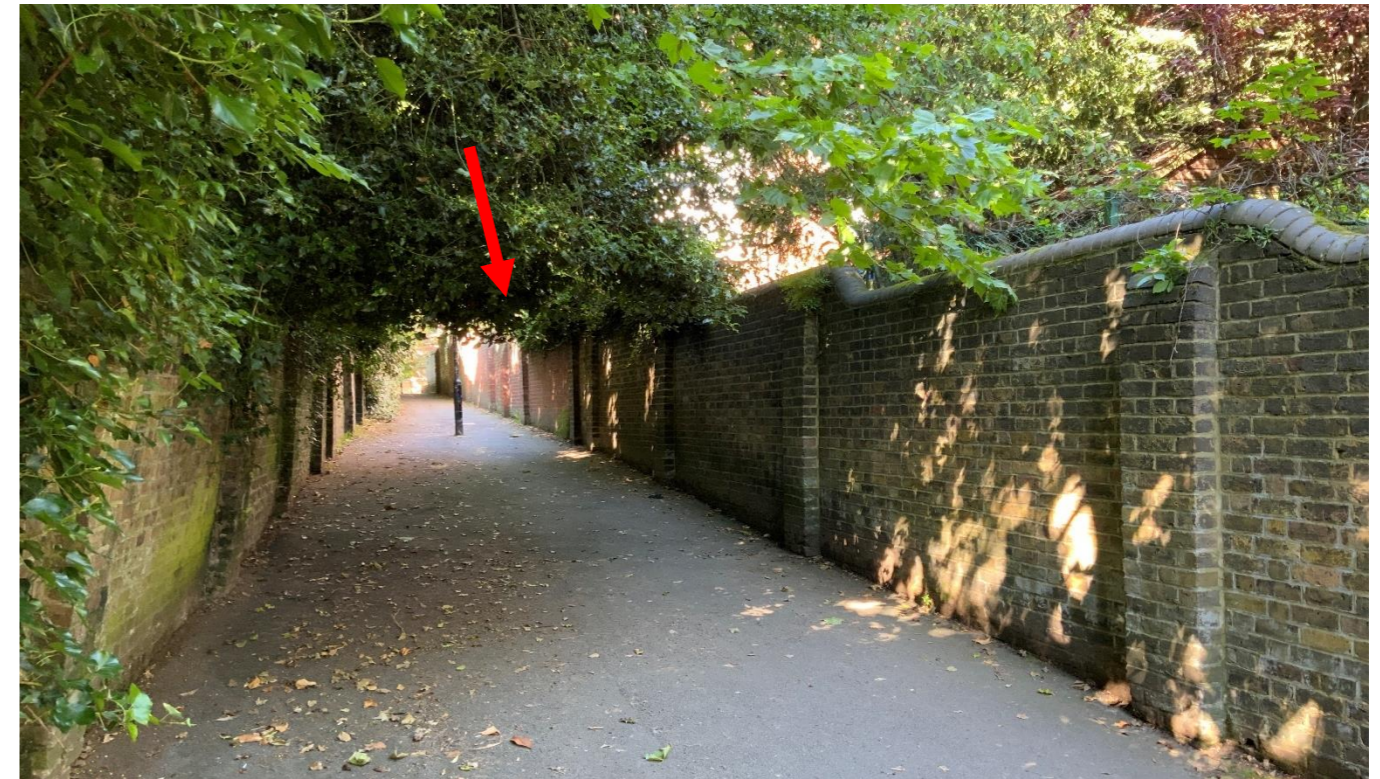
Figure 40: Photo looking westwards down Spring Walk towards Fitzjohn's Avenue. The red brick section of wall that is proposed to be dis-assembled and re-assembled is on the far right annotated with a red arrow.

As already demonstrated in the Significance Assessment in Section 6, the area of wall considered to be of somewhat greater interest is the stock brick part of the wall. The proposals seek only to remove the section of wall in red brick, which is the part of the wall that is not thought to be original, is of less architectural and artistic interest, and is in a relatively worse condition (refer to Condition Report for further detail) as well as the section which has already been altered between the former gate piers.
