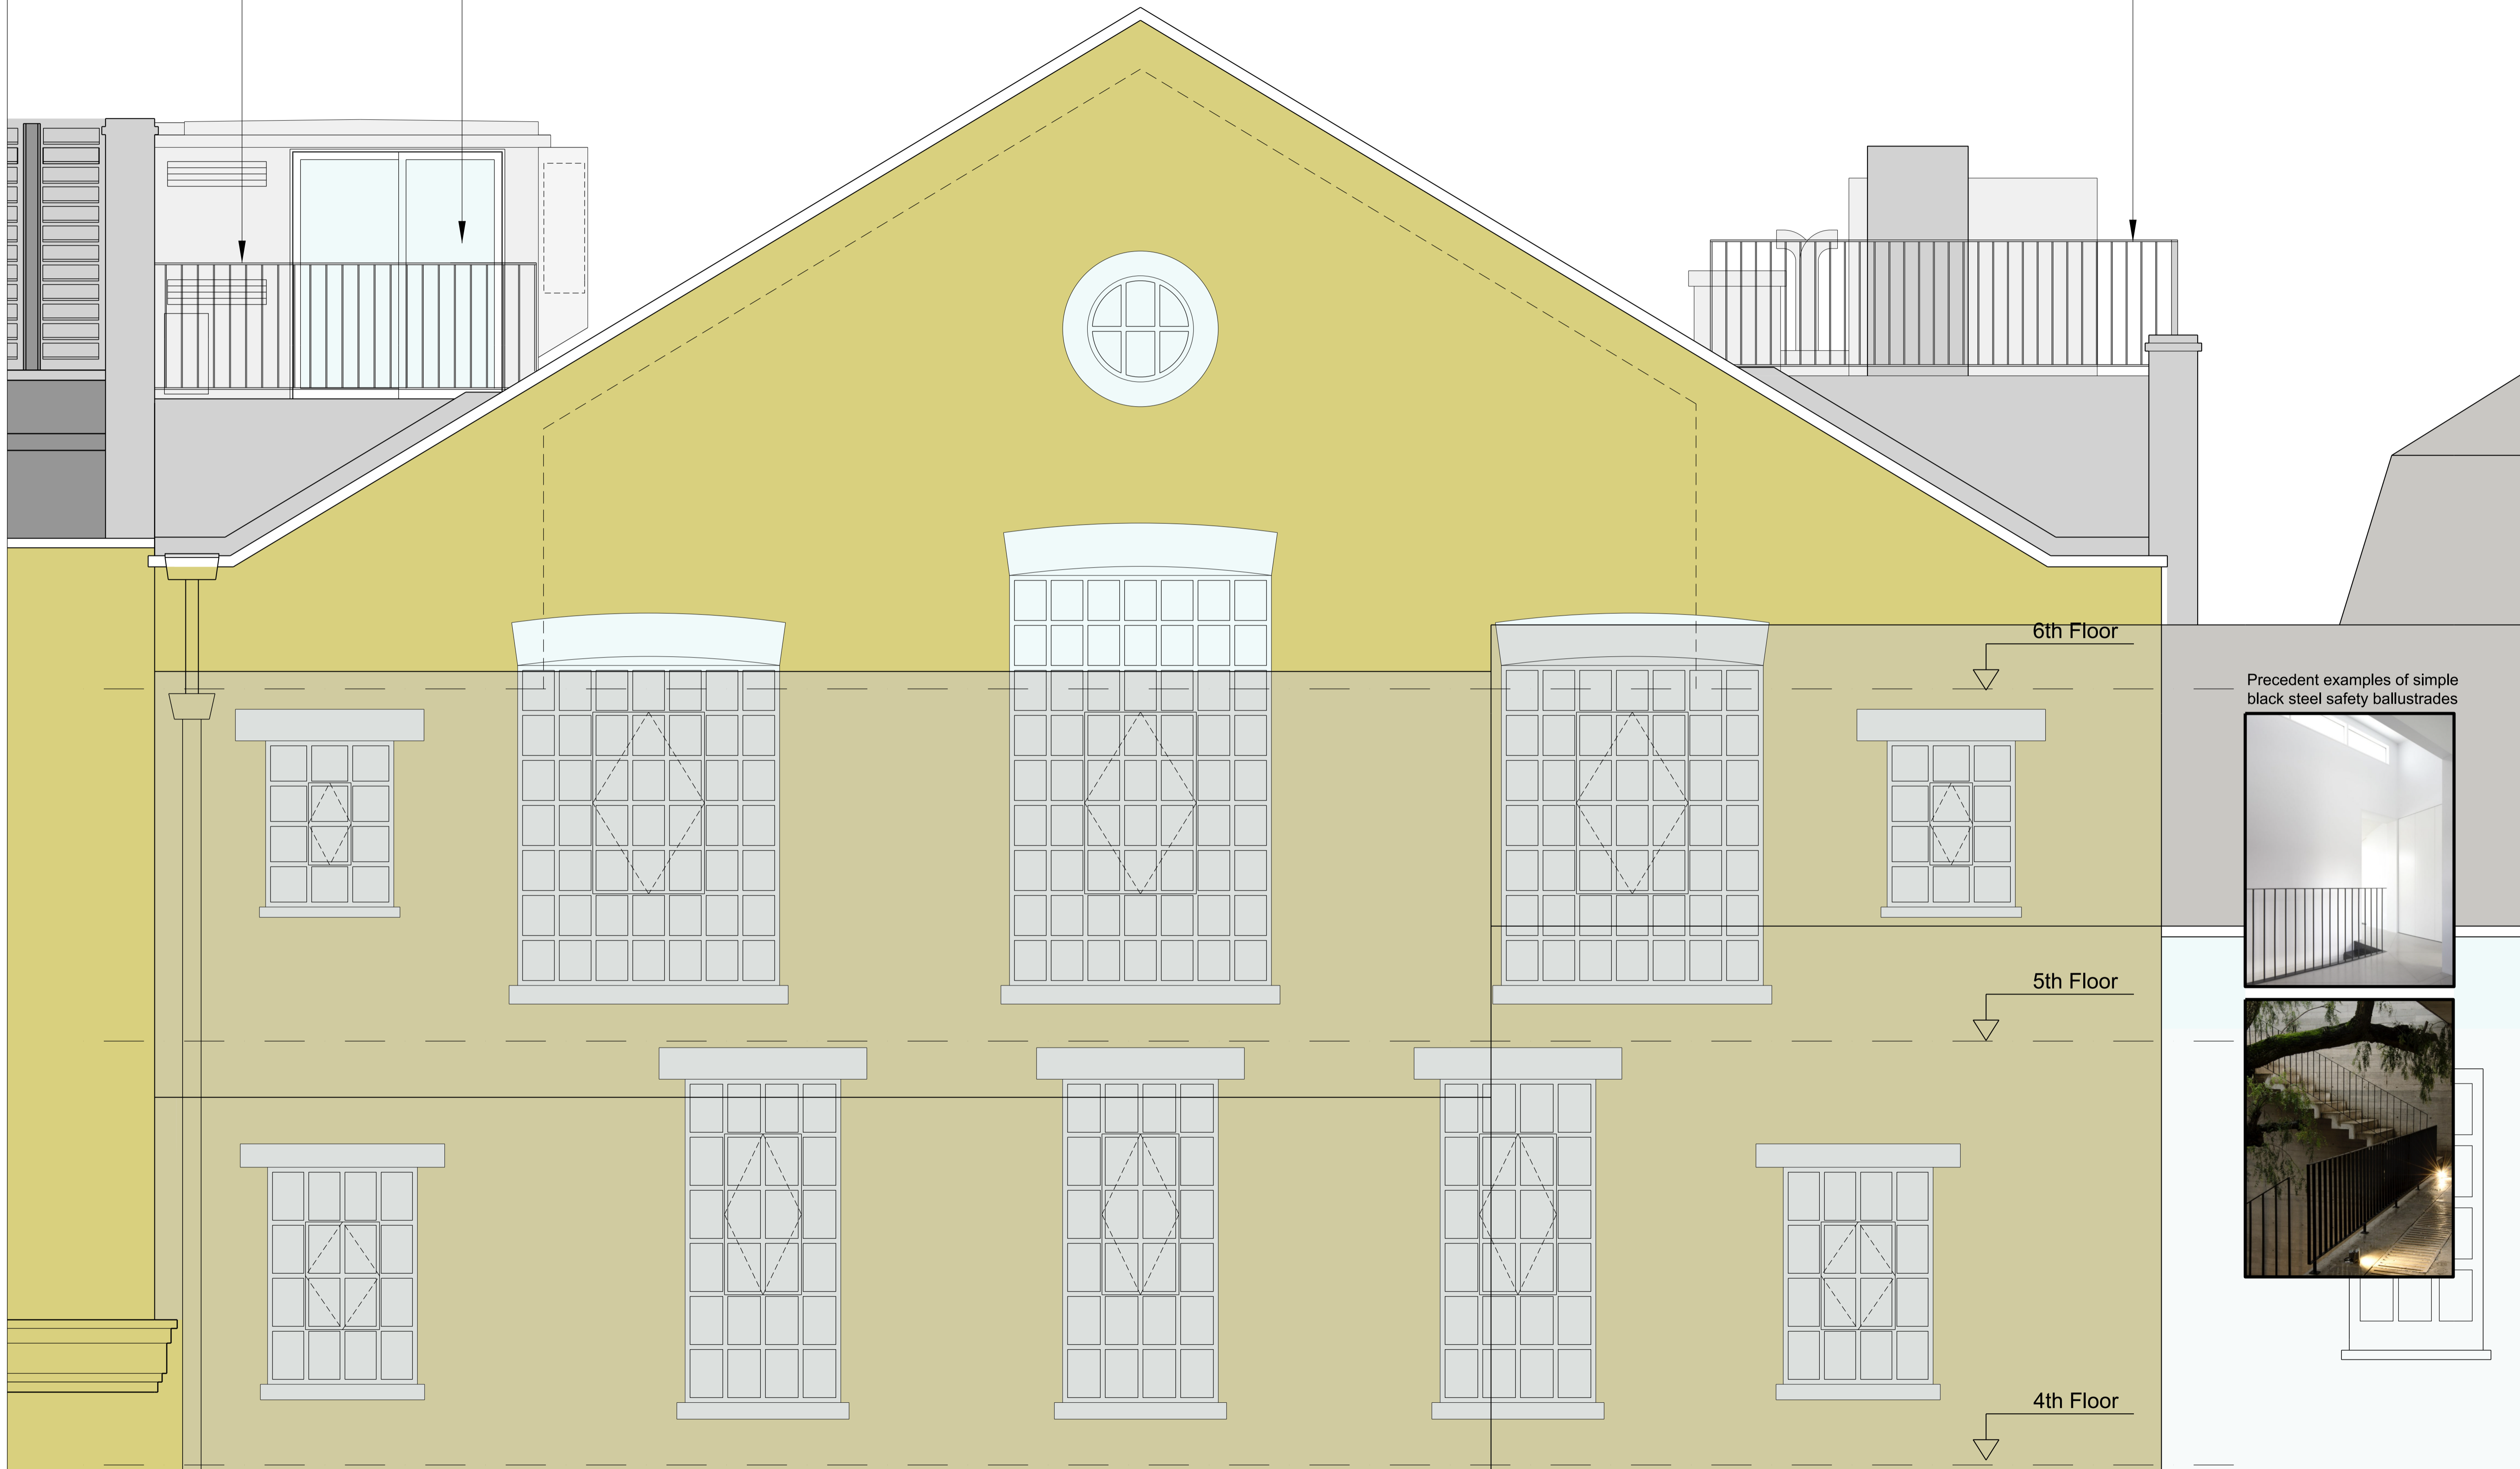
Steel safety ballustrade painted black for edge safety to facilitate safe cleaning of windows for flat 14. This roof is non accessible other than for intermittent maintenance

Steel safety ballustrade painted black for edge safety for landlords maintenance operatives to service existing air handling equipment and to facilitate safe cleaning of windows for flat 14. This roof is non accessible other than for intermittent maintenance

Glass door solely for maintenance access only.

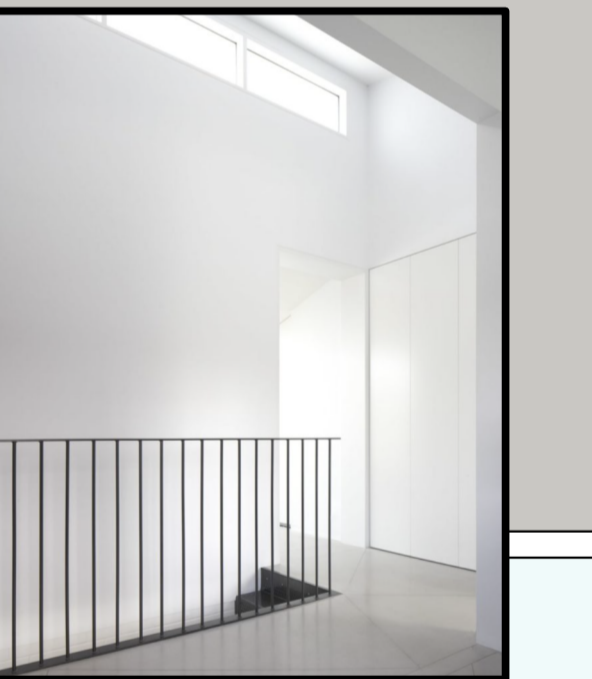
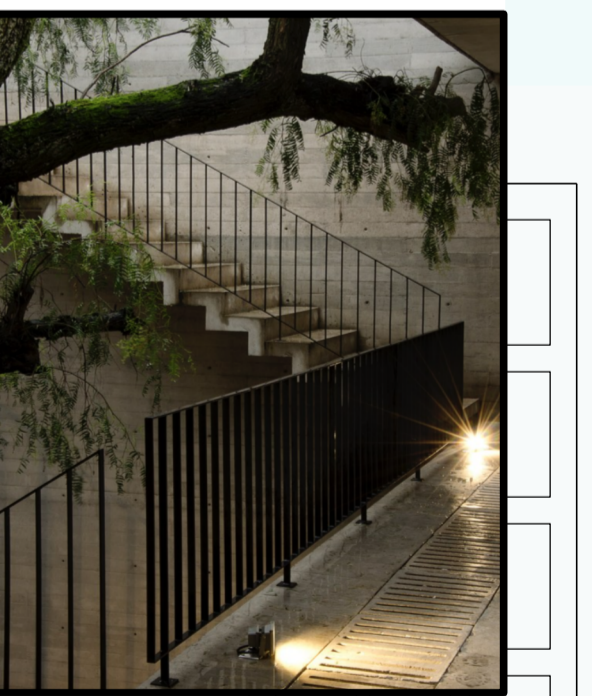
Precedent examples of simple black steel safety ballustrades
