Barton Engineers

Heritage Statement

Providence Corner
Well Road, NW3 1LH

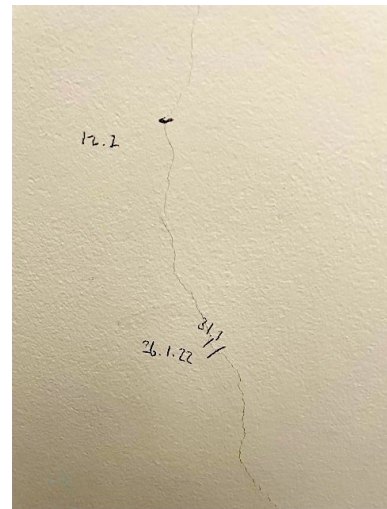
- January and February 2022: Further measured crack progression occurs (see image).

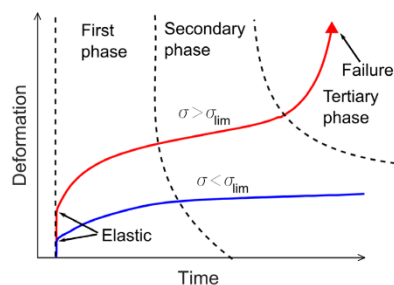
Figure 1: Three phases of creep: 1) primary, 2) secondary and 3) tertiary.

- When loads are applied to structural timber there will be an instantaneous elastic deformation and, if the load is continuously applied over time, a further visco-elastic deformation referred to as creep will also occur. The amount of creep will depend on the level of stress induced and the duration of loading. Provided stress levels are kept below defined limits the creep deflection effectively ceases after a period of time. However, if very high stresses are maintained then creep deformations will keep increasing and even accelerate during what is known as the Tertiary or Failure phase (see graph below taken from a research paper - Granello and Palermo, 2018). It seems clear that deformations within the beam and ceiling below are ongoing and have been for at least the last twelve years, and that creep deformations have or will enter the Failure phase.

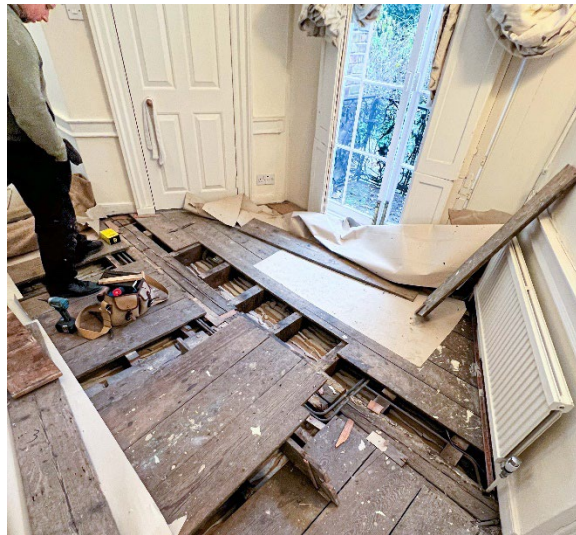
- The condition of the timber structure is generally reasonable, although the primary beam spanning across the rear bay is of relatively small section size for its span, and has also suffered a significant number of historic notches cut into the top surface, as well as having original mortices cut into both sides. This beam has a measured sagging deformation of 72 millimetres at its mid span point under only dead loading. Given that the span is 3.3 metres this deformation represents a Span/45 deformation ratio, which is far in excess of any sensible limit for structural timber floors (current design maximum limit recommended within BS EN

Overall view of beam area showing	Aerial image from 1921 showing the Duveen room under construction (Historic England)

Using the above principles we have developed a design for strengthening work, and attach our working drawing showing this. We have designed steel plates to be screw fixed to the top surface of this beam. The plates comprise four layers of 4 millimetre thick steel allowing them to be lighter than a single plate, and more easily bowed to fit the curvature of the existing timber beam. They can be simply screwed into the timber, and will act compositely with the timber and so stiffen the beam and reduce timber stresses to relatively low levels. The existing floor boards can then be re-laid over these plates, and with thin furring pieces to support adjacent floor boards.
