43a Redington Road, London, NW3 7RA

Geotechnical Interpretative Report

Report/Project No: 2021-028-SYM-RED

Date: 14/01/2022

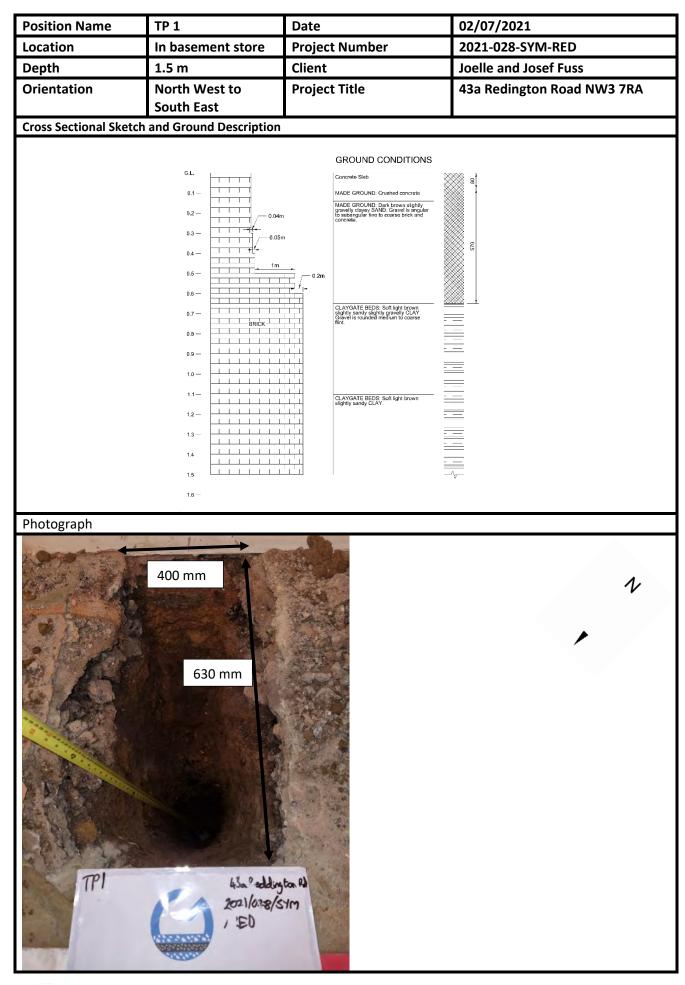
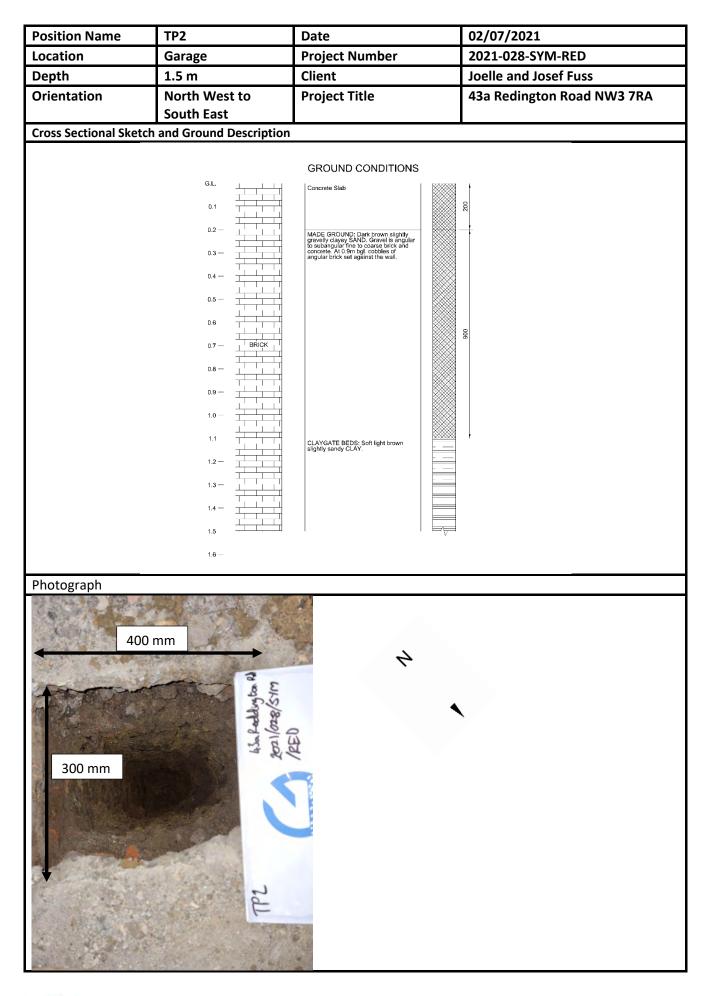
APPENDIX A – EXPLORATORY HOLE RECORDS

Hand dug inspection pit then hole advanced using Premier 110 window sample rig. Slotted pipe installed on completion. Seepage at 2.3mBGL. No rise noted. Water at 4.41mBGL at end of hole.

Hand dug inspection pit then hole advanced using Premier 110 window sample rig. Slotted pipe installed on completion. Water strikke at 4.0mBGL. No rise noted. Water at 5.0mBGL at end of hole.

Full details of the ground conditions encountered are presented on the exploratory hole records included in Appendix A.

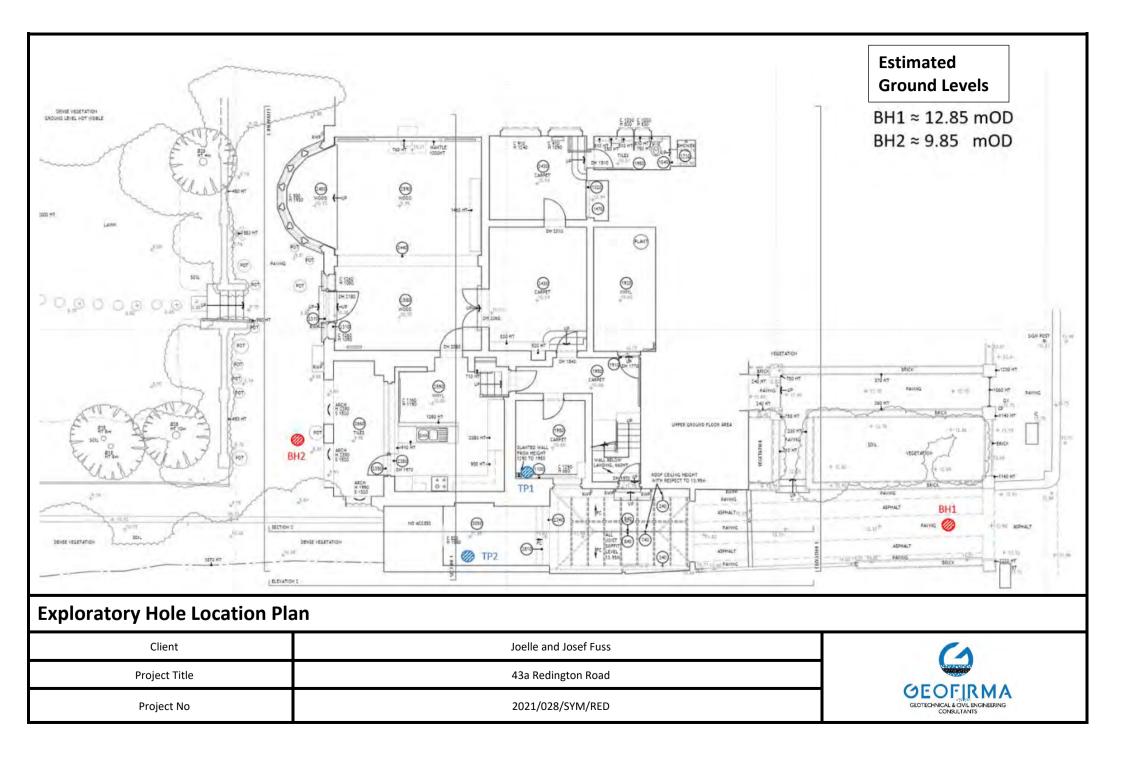
APPENDIX B – EXPLORATORY HOLE LOCATION PLAN

The locations of the exploratory holes are shown on the Exploration Hole Locations Plan.

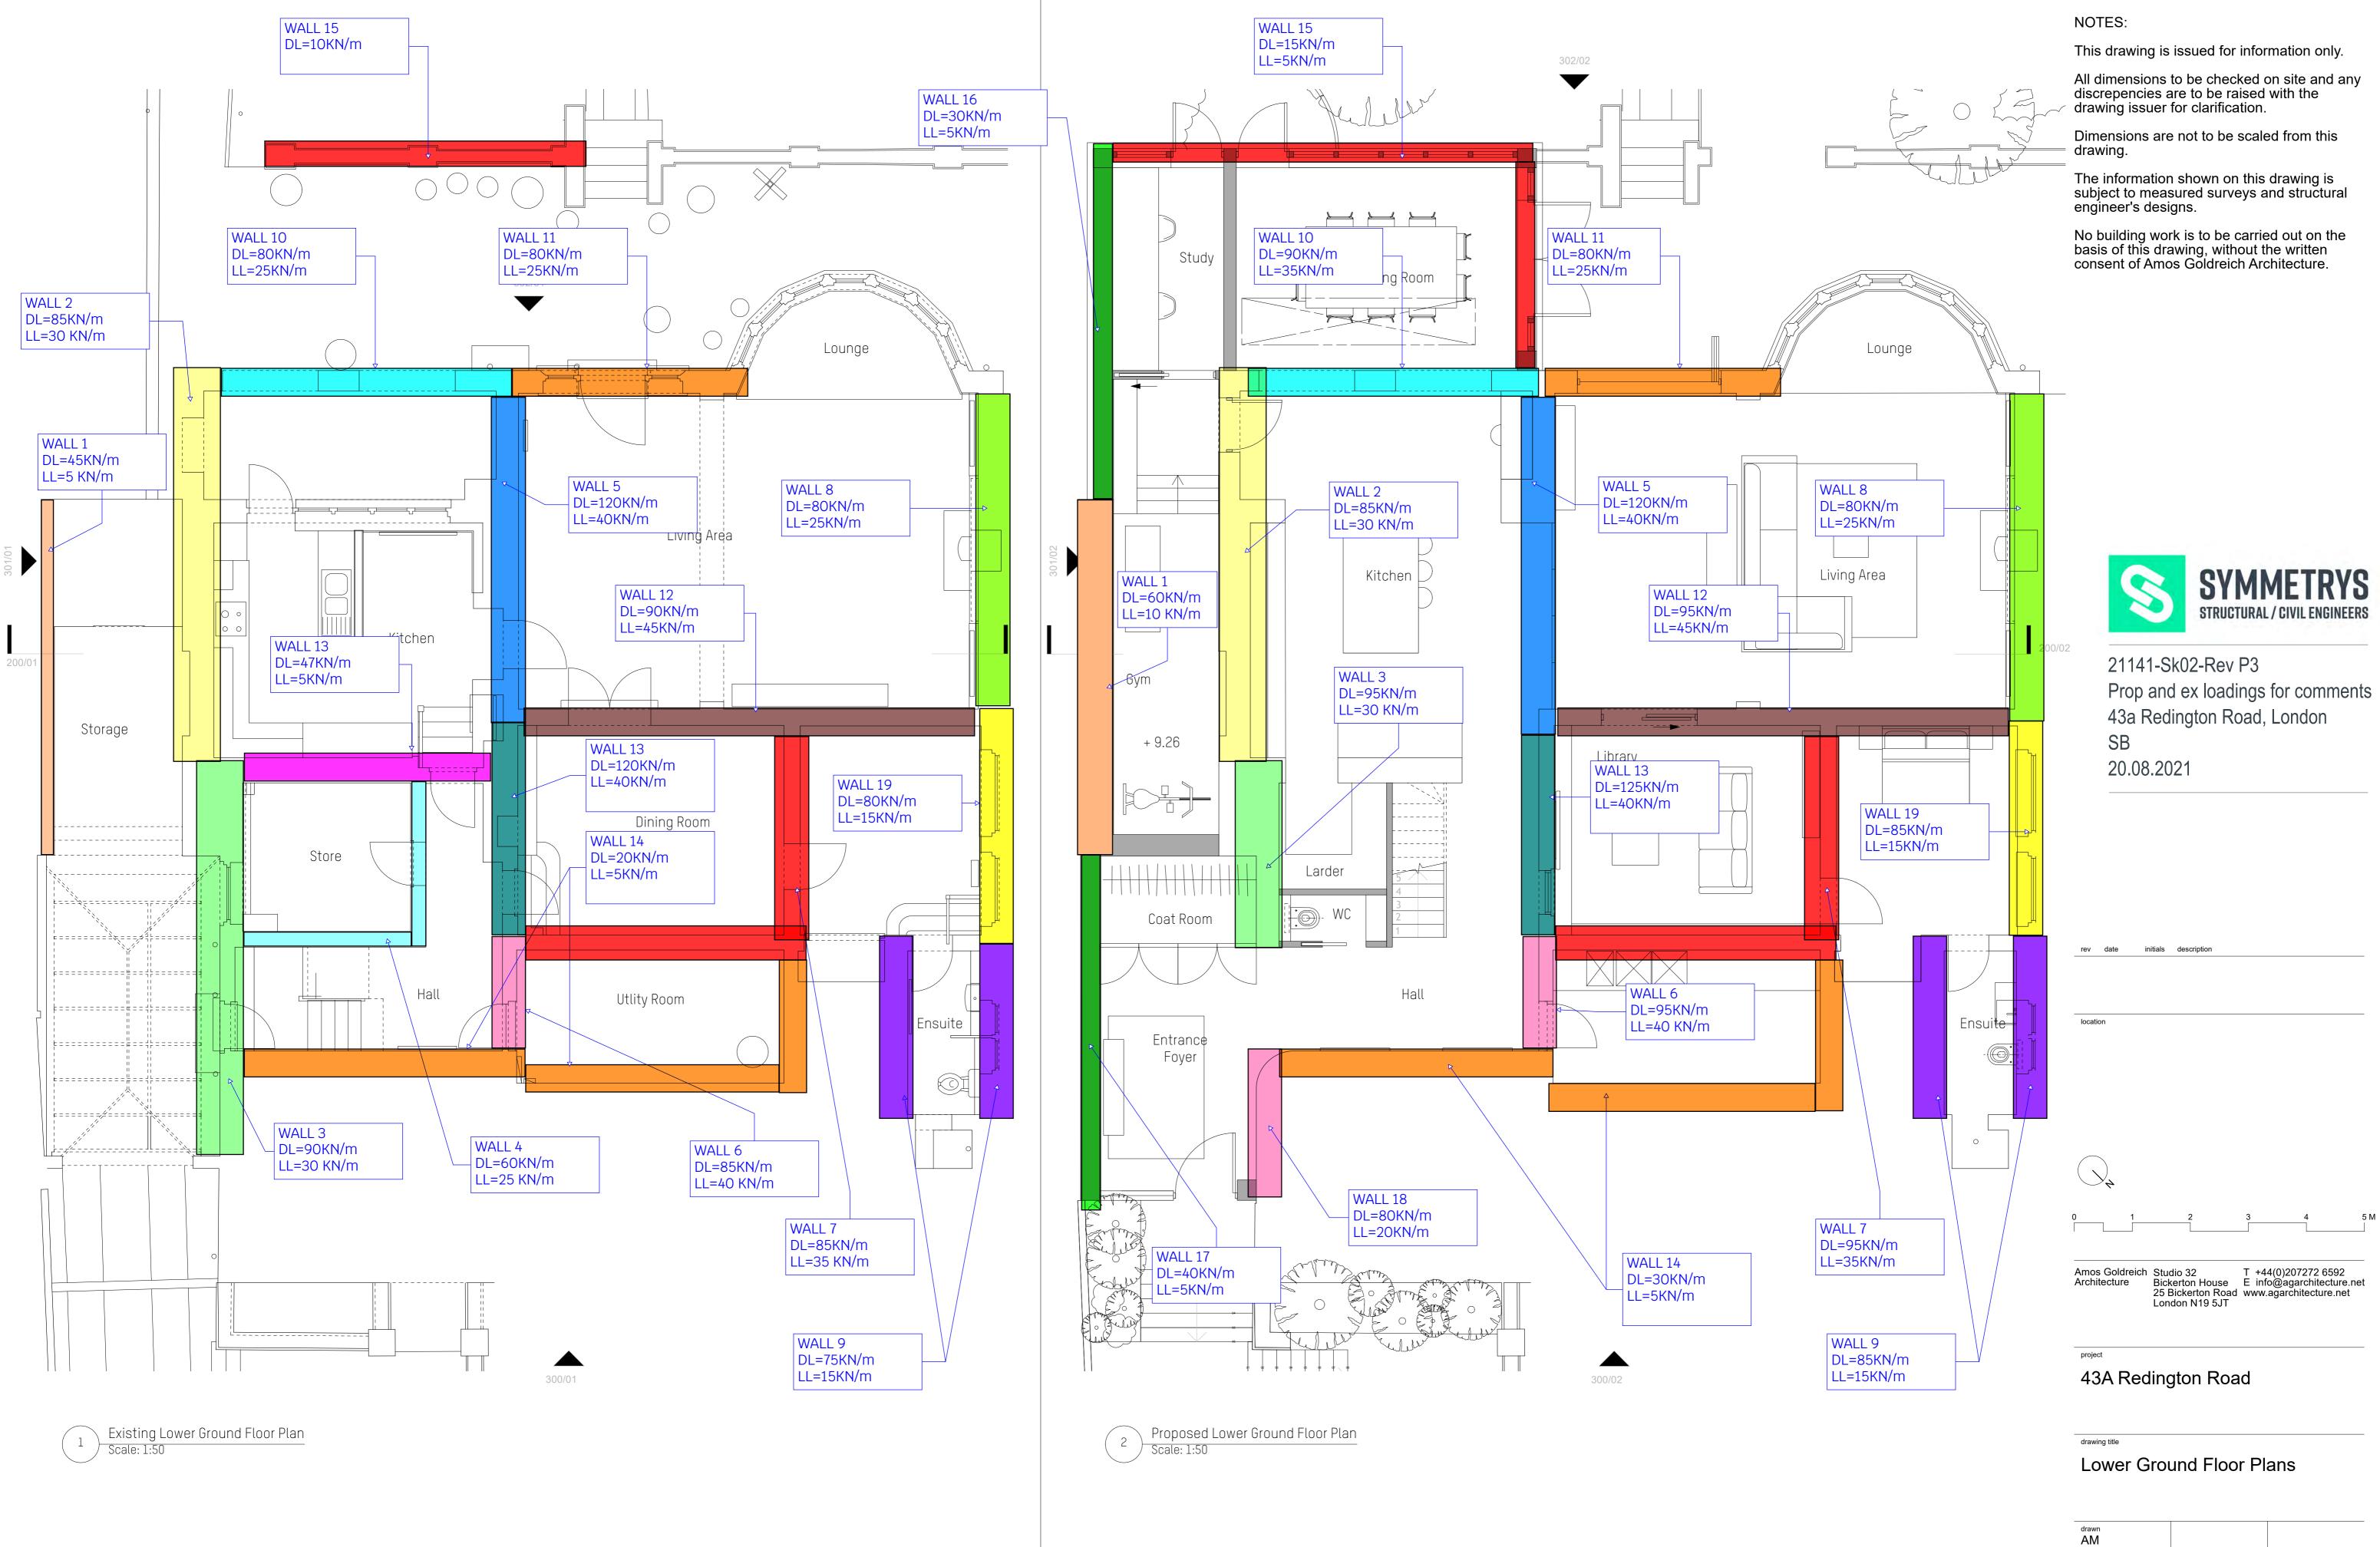
APPENDIX E – LOAD TAKE DOWN SKETCHES

As part of this redevelopment new foundations may be required and existing foundations may have to be underpinned to form the basement boundary walls. Based on the available load takedown sketches provided by Symmetrys (21141-SK02-Rev P3 dated 20/08/2021 in appendix E). The sketch indicates most of the existing walls shall be left in place with only small increases in the current loads (5kN/m or 10 kN/m). In the redeveloped building there are approximately 4 new walls with the most heavily loaded wall exerting a maximum load of 105 kN/m at formation level. It is important to note this load is considerable less than the loads currently acting on the current foundations as the maximum estimated load is approximately 165 kN/m. This implies that bearing capacity is unlikely to be an issue. This observation also indicates the undrained shear strengths assumed from the ground investigation of the Claygate Beds are conservative because if the estimated loads were half the estimated 165 kN/m, with an assumed factor of safety of 3, the undrained shear strength are twice that assumed in Table 7.
