## **Torrington Place / Tavistock Place Corridor Tavistock Place Zebra Crossing**

Combined Stage 1 & 2 Road Safety Audit

Ref: 2000-RSA-04

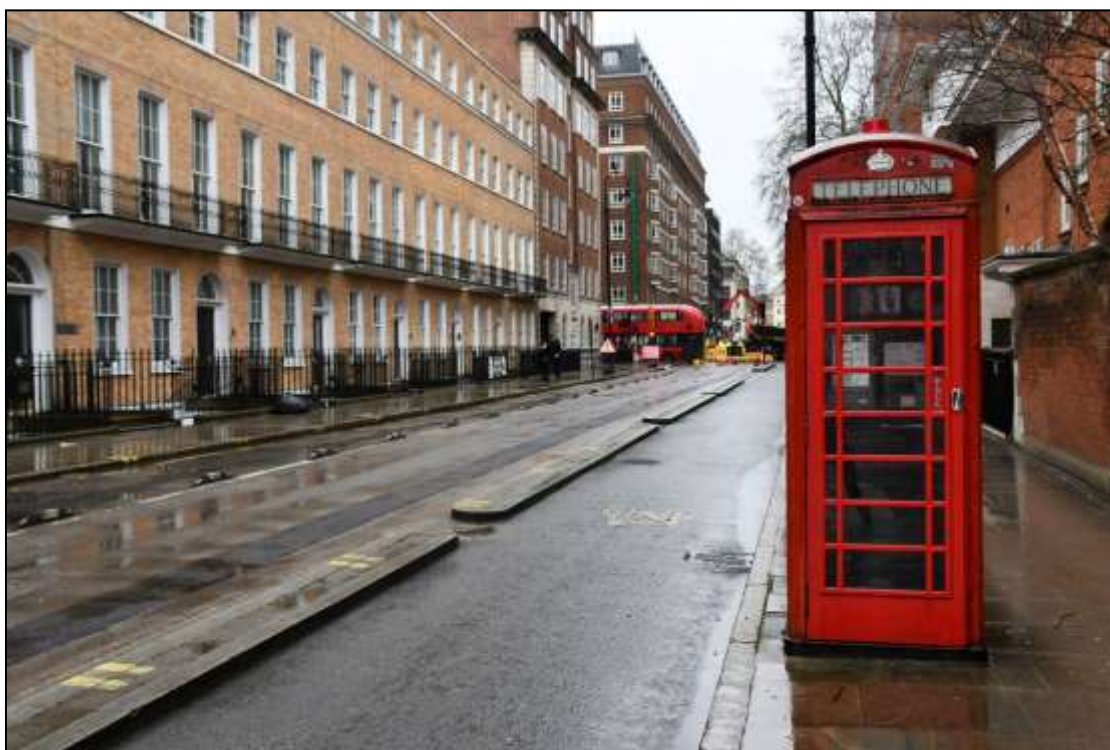
**Location:** A – Zebra crossing, northern crossing point.

**Summary:** Telephone box blocks intervisibility.

At the northern crossing point for the proposed Zebra crossing, a telephone box will block intervisibility. This may make it difficult for pedestrians to safely assert precedence to cross, particularly over eastbound cyclists. This may increase the risk of collisions with pedestrians on the crossing. Those unable to stand close to the kerbline may be most affected, e.g. anyone using or pushing a wheelchair, or pushing a buggy.

Adequate intervisibility should be available at both crossing points.
