Phase I GeoEnvironmental Desk Study

57 Fortress Road
Camden

February 2022

Report No. A4593/22

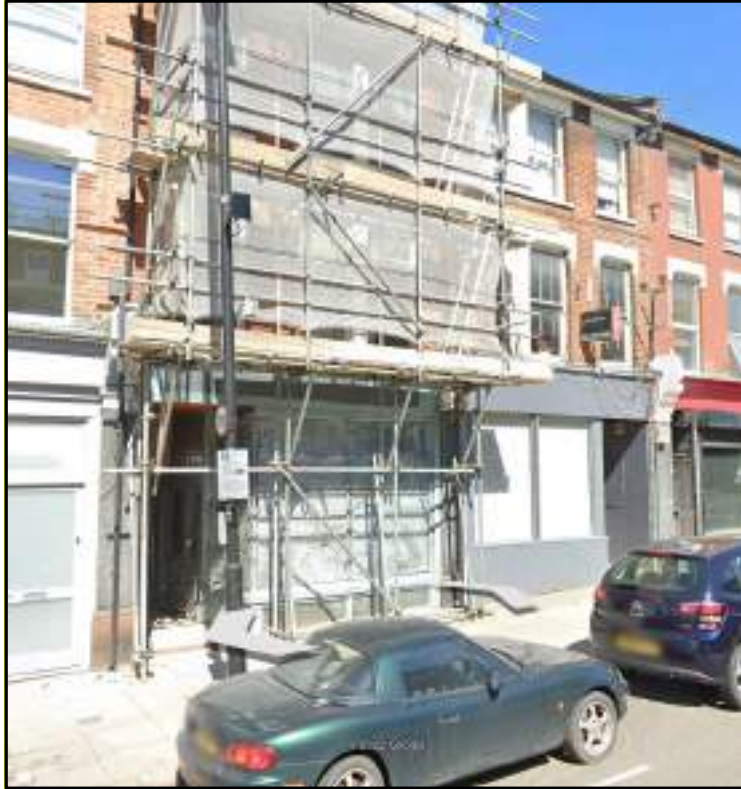
Figure 3 Site Photograph

- 2.2 The site is one of a line of three storey, brick built, Victorian terrace houses, most of which have shop fronts below. The front door opens out on to Fortress Road and looks out onto a yard to the rear.

- 2.3 The site is currently vacant and previously served as a commercial property with a shop front at ground level.
- 2.4 The maximum dimensions of the proposed site are 5m north to south and 26m east to west. The site occupies an area of approximately 130m².

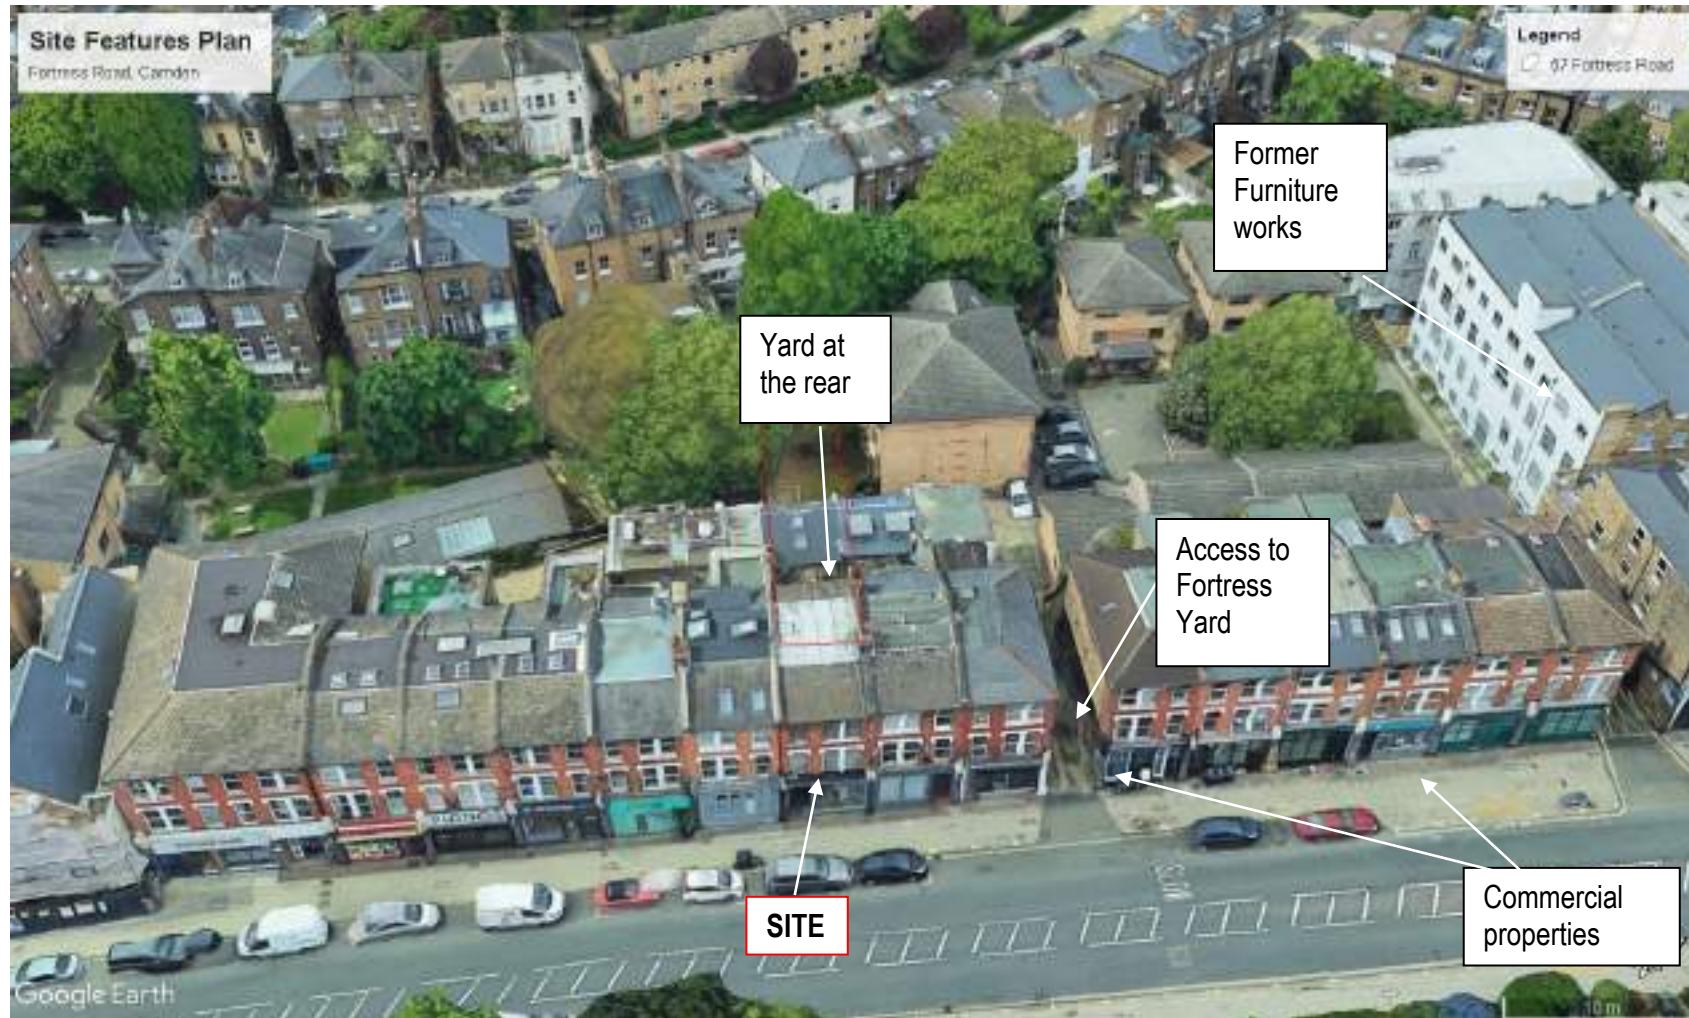
Figure 12 Site Features Plan

- 5.1 A walkover survey was completed on 26th January 2022. The photographs and notes from this survey are appended to this report as Appendix 2 and Appendix 3 respectively.
- 5.2 The site access is from Fortress Road to the west.
- 5.3 The site is currently being developed and undergoing a change of use from a commercial property to a self-contained apartment over two floors.
- 5.4 The property overlooks a small yard to the rear which backs onto a residential property in Fortress Yard.
- 5.5 The foundations and ground surface of the property will remain the same.
- 5.6 There were no obvious signs of contamination identified at the property or in the surrounding area.
- 5.7 The surrounding area is residential housing (brick three storey terrace houses) above shop fronts.
- 5.8 A site features plan is presented as Figure 12 overleaf.

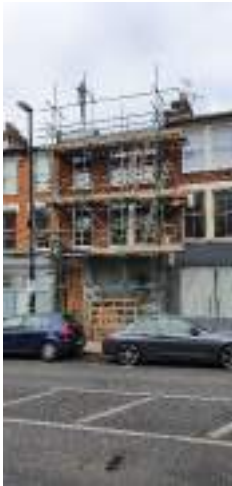
<p align="center">Job No.: A4593/22</p>	<p align="center">Site: Fortress Road, Camden</p>
<p>Plate 1 Viewing west towards the property from Fortress Road</p>	<p>Plate 2 Viewing north along Fortress Road, number 57 on the left</p>

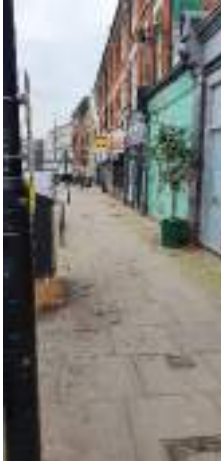
<p align="center">Date: 26th January 2022</p>	<p align="center">Date: 26th January 2022</p>
<p>Plate 3 Viewing south along Fortress Road, number 57 on the right</p>	<p>Plate 4 View of the interior of the property looking east.</p>

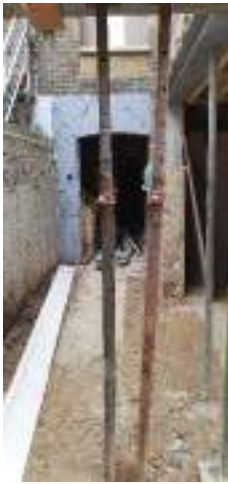
<p>Job No.: A4593/22</p>	<p>Site: Fortress Road, Camden</p>
<p>Plate 5 View of the interior of the property (the void space) looking west.</p>	<p>Plate 6 View of the rear of the property looking west</p>
