## HERITAGE AND DESIGN STATEMENT

Proposed Replacement Garden Wall at 18 Holly Mount, London NW3 6SG

First Issued: 06/04/22

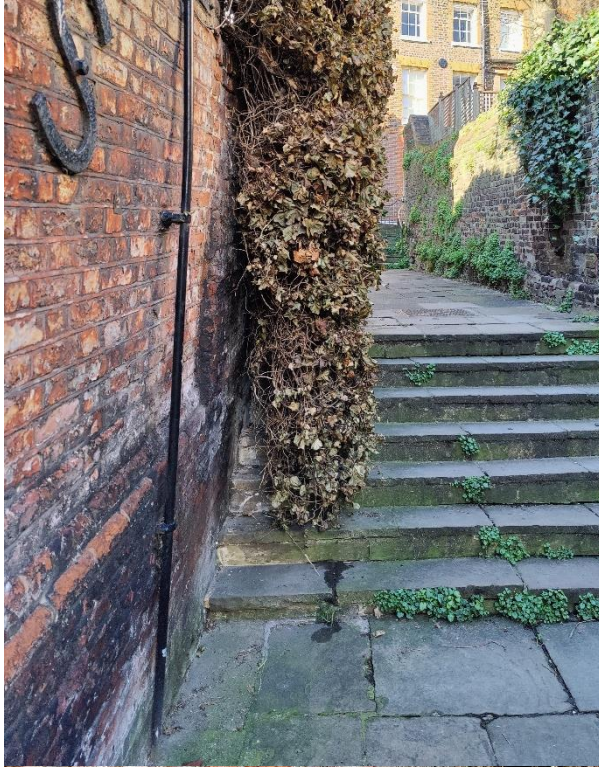
The leaning wall, obscured by hedging,  
looking west along Holly Bush Steps

- C) Carefully dismantle the brick garden wall by hand, clean sound bricks (e.g. non-spalled) and set aside for re-use
- D) Implement a hidden and permanent structural base – this solution cannot be designed until the wall is dismantled and ground conditions are exposed (refer to appended structural sequencing drawing)
- E) Rebuild the garden wall to match existing, using salvaged bricks where possible (and matching bricks where not possible, with matching bond and joints, soldier course, and lime mortar. Replace timber gate to match existing.

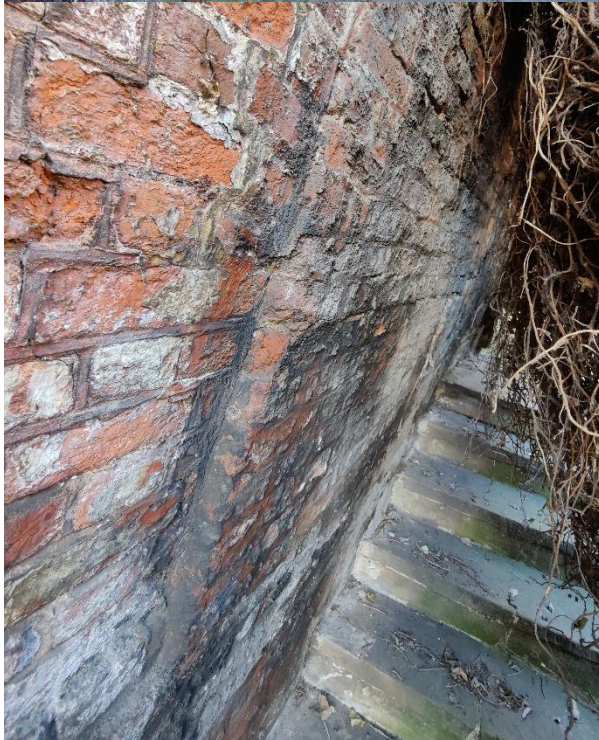
Close up of the poor condition brickwork

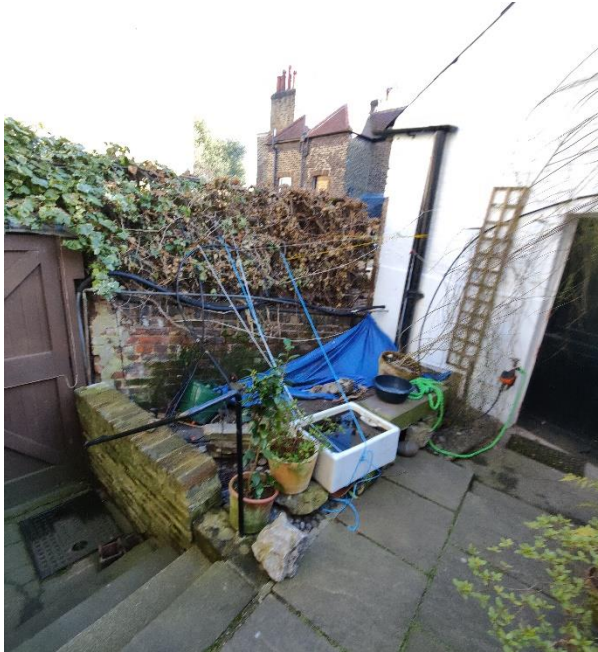
Photo from inside the courtyard of a makeshift attempt to prevent collapse (not sufficiently robust)

- A) Hoard off the affected part of the Holly Bush Steps footpath, temporarily, with a 6-month Building Licence Application submitted to LB Camden.
- B) Install timber raking shores to support the wall
