**THE BRITISH MUSEUM**

**ROOM 35 REFUBISHMENT**  
**JOSEPH HOTUNG GREAT COURT TEMPORARY GALLERY**

DESIGN AND ACCESS STATEMENT INCORPORATING HERITAGE STATEMENT  
MARCH 2022 REV\_P03

631-DJA-RP-A-10001\_P03

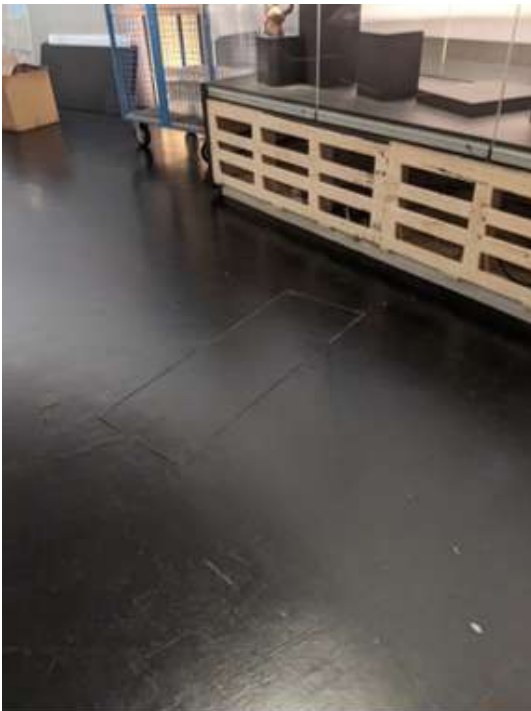
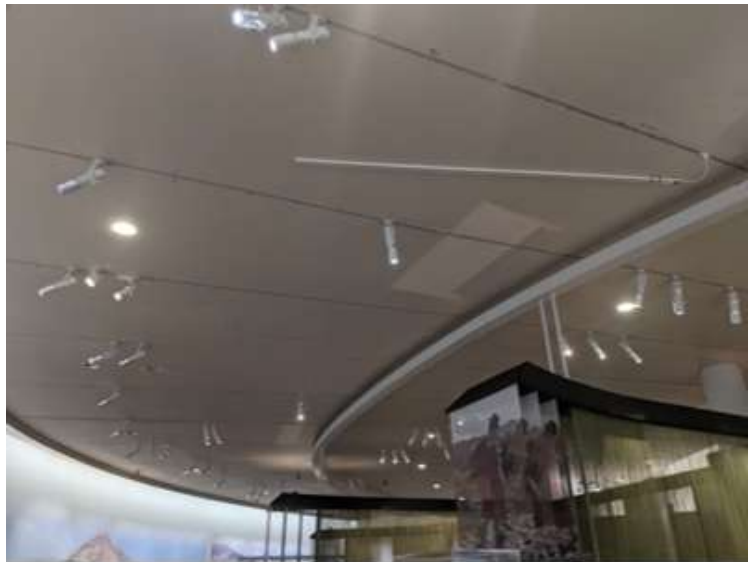
*Above: existing ceiling, recessed lighting track and surface mounted fixtures to painted plasterboard ceiling.  
Left: existing cork floor tile finish, with inset floor box*

Room 35 has been in constant use and over time has sustained considerable wear and tear. The existing cork floor and additional sub floor were installed in 2017 and now require complete refurbishment to ensure a robust surface and to provide vital access to power and data. The ceiling is no longer fit for purpose due to access panels not being securely suspended and no hanging points to facilitate flexible exhibition display. A more secure structure is required that will also improve access to the recessed lighting track currently embedded within the ceiling.

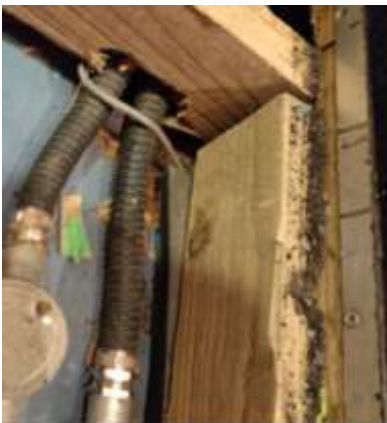
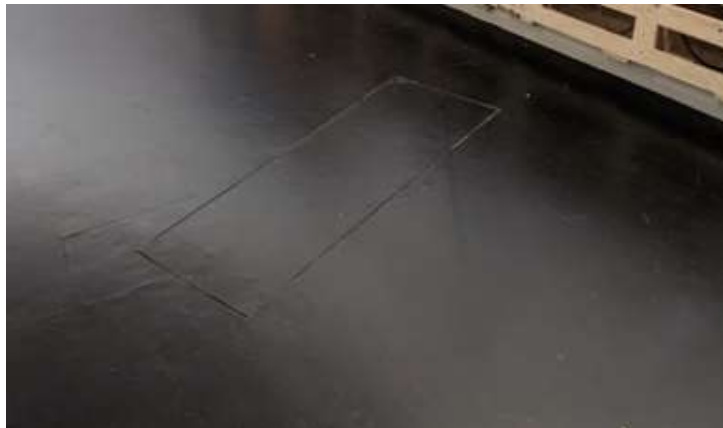
Above: existing timber subfloor.  
Right: existing varnished cork tile floor finish.

The existing floor is a suspended timber-framed structure of 4" x 2" joists, lined with 24mm and 6mm ply board. The timber structure is set on 20mm timber packing battens on the existing concrete slab. The existing construction depth varies 130-150mm. The existing electrical installation is run in metal conduit through this construction to 13 number floor boxes set into the floor with recessed covers.

The floor has a cork tile finish of 300 x 600mm tiles with a dark varnish finish.

The existing floor is inflexible in terms of power and data layout which inhibits the design of exhibitions in the space. The cork finish is robust but requires recoating between exhibitions, a wet process which requires the space to be cleared and additional drying time. The timber subfloor has been altered, notched, cut into and repaired for past exhibitions to the extent that the Museum cannot be confident of the performance of the floor and have concerns over vibration and loading.
