Former Horse Hospital, Chalk Farm Road, Camden NW1

Historic Building Report

For IE (Peaker Blinders) Ltd

March 2022

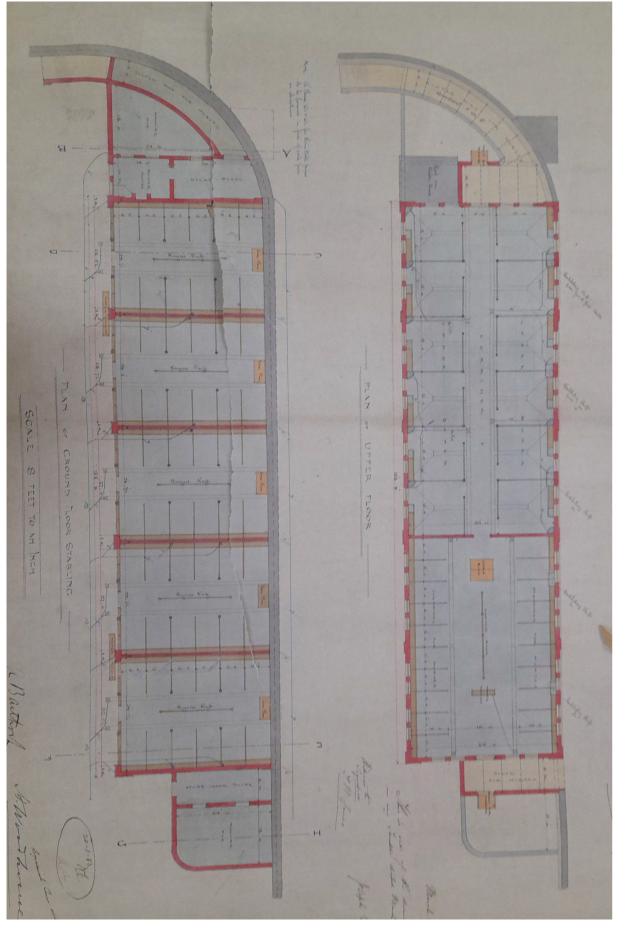
2.9 Proposed plans to the Horse Hospital, 1883 (National Archives)

The stables were built in two phases: the western and larger part for 92 horses in 1883 and the eastern third in 1897. Plans of the first phase record that's that the ground floor was to include 60 stalls and the first floor a further 20 stalls and 12 loose boxes [Plate 2.8]. This is a high number of loose boxes which, as mentioned above, were generally used for sick horses. This may have given the stables the name the 'Horse Hospital' as the plans only refer to it as 'stables for 92 horses'. The later 19th century understanding of the need for ventilation in stables is evident in the ventilation shafts marked at regular intervals along the plan.

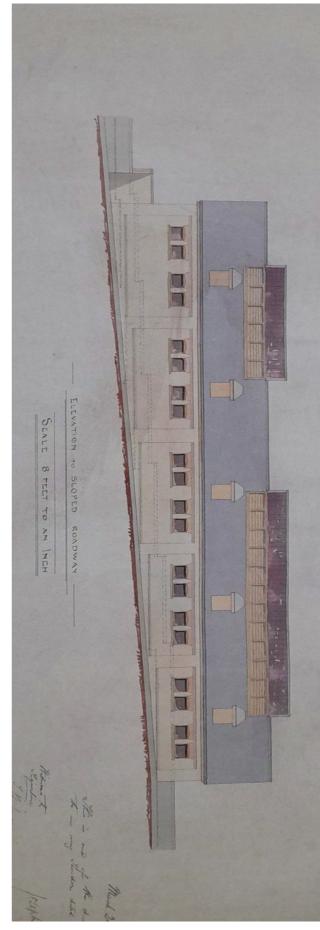
2.10 Proposed elevations to the Horse Hospital,1883 (National Archives)

Proposed elevations record the original appearance of the south façade of the Horse Hospital [Plate 2.9]. Each of the five bays had cast-iron classically finished columns to central openings which lead through the centre of the stalls in each bay. The upper half of the ground floor was glazed. The modern replacement openings in the ground floor reflect this historic layout although all original narrow doors have been replaced with wider doors which span the width of the cast-iron columns.

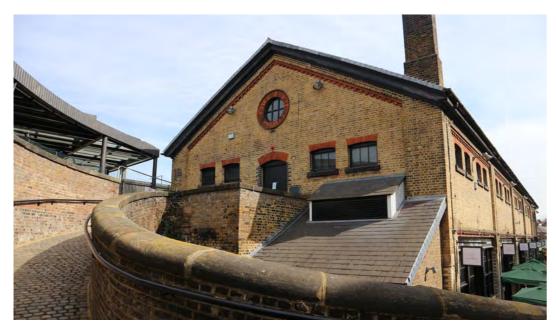
3.1 West elevation and horse ramp

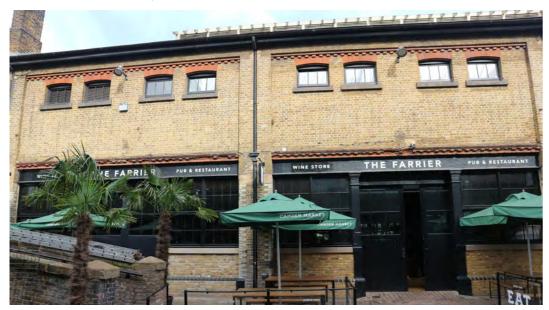
3.2 South elevation of 1883 building

The first floor has four original 3-pane windows with red-brick lintels and stone sills [Plate 3.1]. There is a round window directly above the modern door. The opening is original. There are various holes created for modern services and as fixings in the brickwork above the doorway. The eaves are wooden with ornamental red-brick detailing below. There is a chimney in the south west corner of the roof. An outbuilding, originally designed to hold the boiler room, is at ground floor level, and this has modern brick repairs.

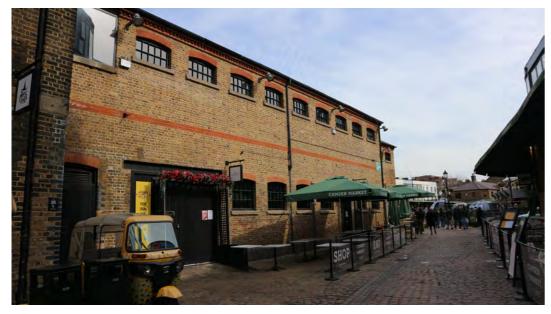
3.4 South Elevation of 1897 stable range

This later extension steps back from the 1882 building. The elevation is simpler and there is no rhythm created by bays in this front [Plate 3.4]. The red brick detailing in the 1883 Horse Hospital is referenced in plainer red brick bands between ground and first floor and under the eaves. At ground floor there is a historic door to the west with a wide modern inserted door to the east of this. The windows are 15-pane metal windows with stone sills. There are 9 metal 10-pane windows at first floor level. To the west is a modern window insertion which adjoins the 1883 building. Part of the east

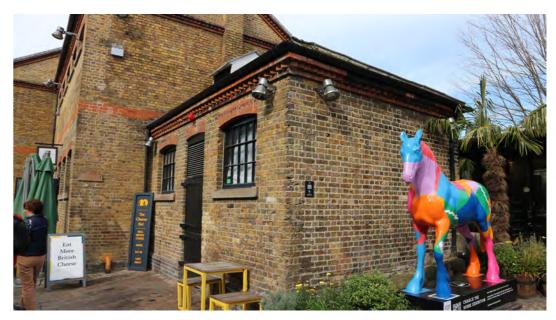
3.5 South and east elevation of single storey extension

A further extension with the same materials and detailing adjoins the 1890s extension to the east. It steps back again from the walkway. It is single storey, with four 15-pane metal windows, a central door and

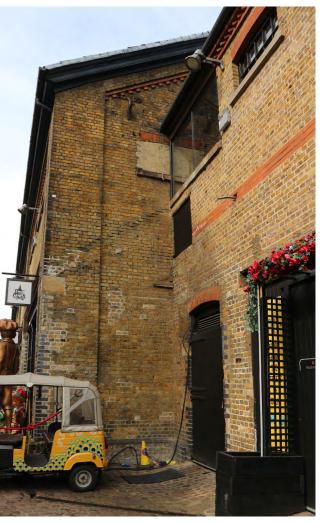
3.3 East Elevation of 1882 stable

There is a scar line of a pitched roof at first floor level on the east elevation of the 1883 building and a blocked-in window suggesting there was a small addition to the original building which was replaced by the 1890s

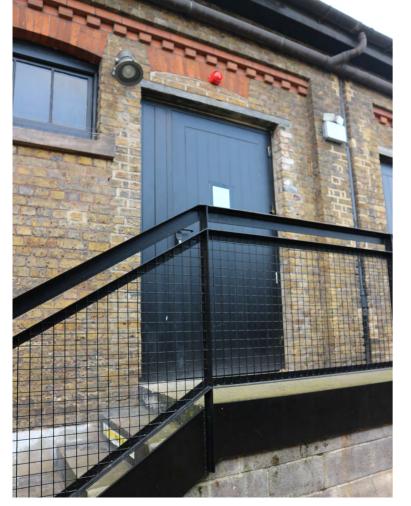
3.7 Doors and Concrete extension on North elevation

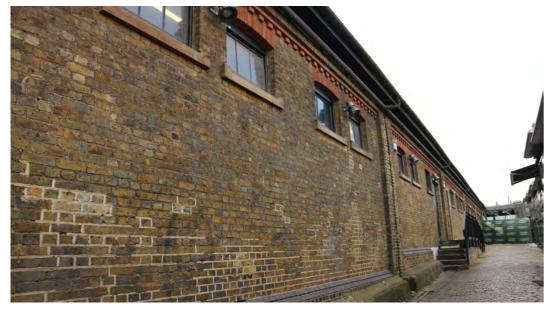
3.6 North elevation, 1883 stable range

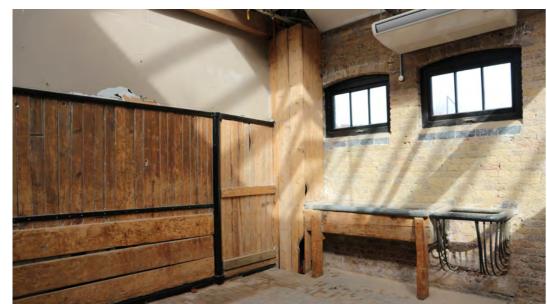
3.11 Loose box at north western corner of stable F4

This is the first loose box in the north-west corner of the open plan first floor area. It has an original brick floor except at the centre where this has been replaced in modern brick. It is enclosed by an original sliding timber door and partitions which have been stripped of their original paint finish. In the north-east corner is a trough and on the north wall is a hay rack and manger [Plate 3.11]. This stable box like the others is divided from the other boxes by means of two original painted cast iron columns on which rest historic timber beams which hold the roof.

The brickwork has been sandblasted and the original painted plaster finish has been lost. There are two high-level three-paned timber casement windows which are both modern replacements.

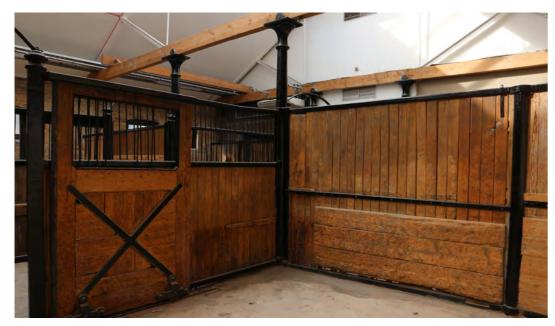
3.12 Loose box and door F5

This is another loose box [Plate 3.12].. Most of the floor has been covered in a modern cement screed that the original brick is visible at the perimeter the timber enclosures are as in F4. On the north wall is a trough and corner sink [Plate 3.13]. At the East end of the North Wall is an area of boxing-in formed from historic boards but probably of a recent date. The windows are at high level and are 3-paned. Timber casement to the east is a modern replacement window, that to the west appears to be historic

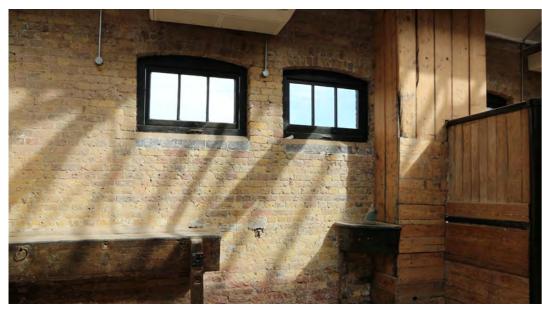
3.13 Loose box F5

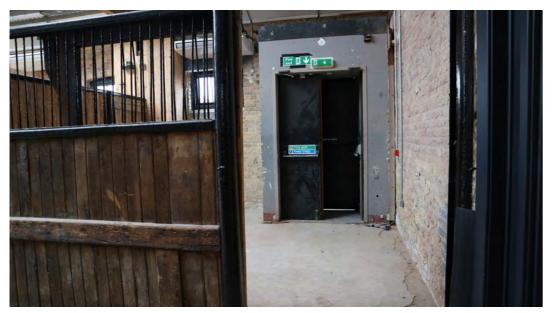
3.14 Loose box with modern alterations F8

This loose box is similar to F6 and F7. It has a projecting lobby which is a modern addition and gives access onto a modern timber door to the outside [Plate 3.14]. There is only one high-level window which appears to be historic; the second window was removed in favour of the modern door.

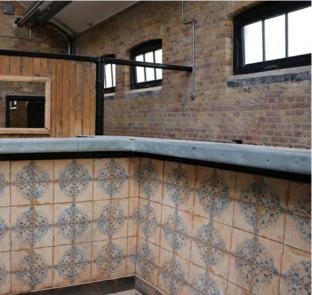
F14

This is the westernmost larger space which includes stable boxes that are described individually above **[Plate 3.16]**. At the centre is the original brick floor with drainage channels to either side; this has some localised repair work in the form of new bricks. It is uneven and has some significant dips, particularly towards the east end.

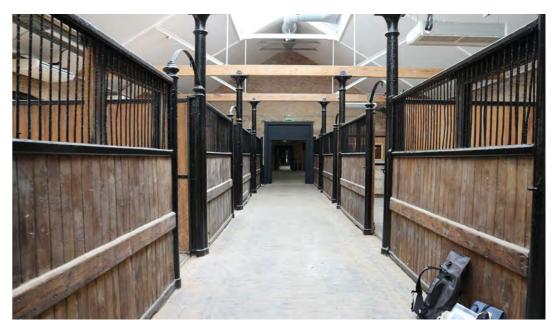
3.16 Loose box entrances F14

The roof structure is in part made from timber with some metal struts and there is a full length modern replacement roof light over the centre of the main space. The roof timbers are concealed from view by means of modern plasterboard ceilings. Near the external walls are cable trays and modern service runs. Suspended from these are air-conditioning units which have some brackets that are screwed into the north elevation.

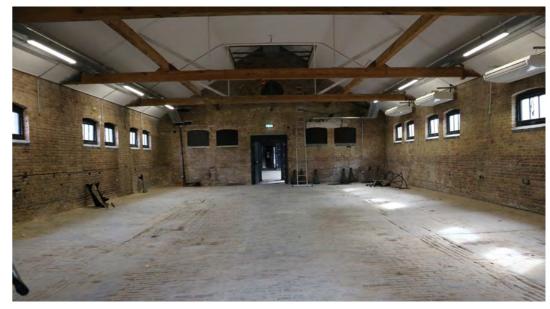
3.17 Former horse stalls F15

The ceiling is formed by modern plasterboard and includes modern service enclosures. The timber beams which hold the roof structure appear to be original and have metal struts. The fenestration in the north and south walls is similar to that further east. Seemingly historic 3-pane casement windows. The white double door opening into F14 has a modern door and may have replaced a slimmer opening. The double door opening to the east is also a modern incision, the original door was slimmer and can be read by the retained brick arch above it. There is a modern replacement door in the north elevation of the West End which has seemingly replaced a slimmer door. The floor finishes by the door have been built up in modern times and in cement. On the south wall are air-conditioning units. There are cable trays resting on the original timber beams at the north and south end which continue into the adjoining spaces.

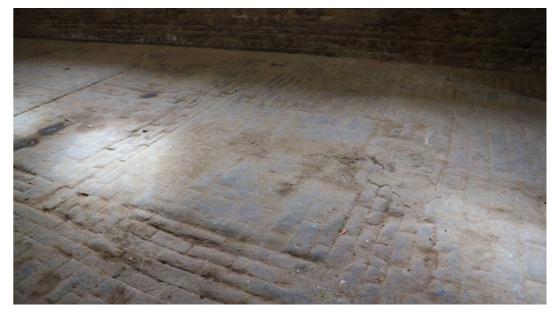
3.18 Evidence of former stalls F15

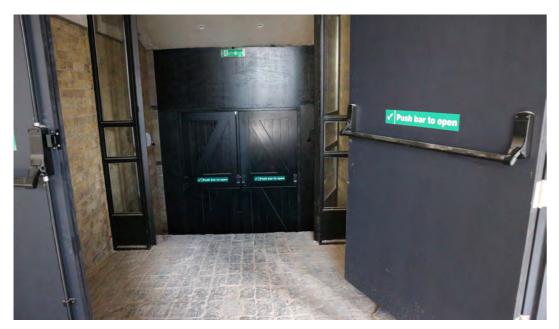
3.19 Western end of 1897 extension F16

This is the first space in the 1890s extension. It has a historic floor and in the south elevation is a modern large glazed opening at high level. The north elevation is a modern double timber door with suspended ceiling above **[Plate 3.19]**. The suspended ceiling continues into the main space and there is a modern riser **[Plate 3.20]**. There is a further lowlevel modern window in the south elevation. On the west wall are modern services and some historic services including a plaque reading FP NOI 22. The brick walls here have also been sandblasted.

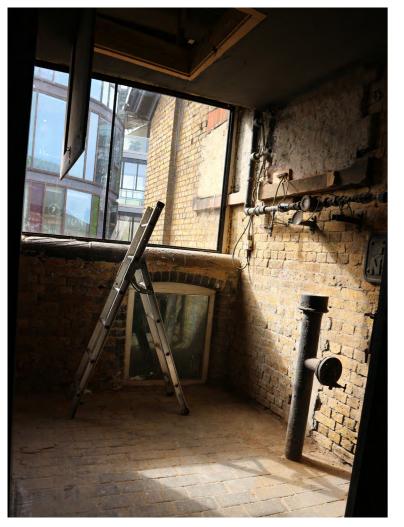
3.20 Modern window insertion F16

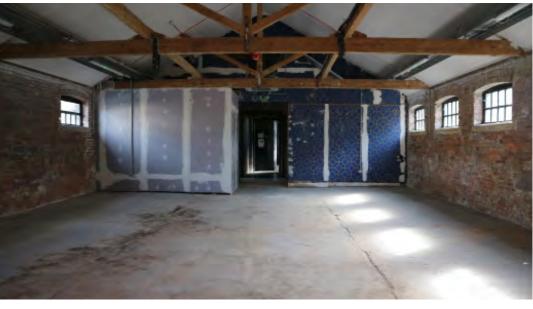
3.21 1897 extension F12, F20 and F21
