Arboriculture and Forestry: Research and Consultancy

Tree Survey regarding proposed garden building at 17 Crossfield Road NW3 4NT

Prepared by: Jack Stewart
Current revision: 6.3.2022
Survey date: 22.2.2022
Surveyor: Jack Stewart
Client: Lorcan Clarke
Reference: AFRC/js/134
Checked: ECG

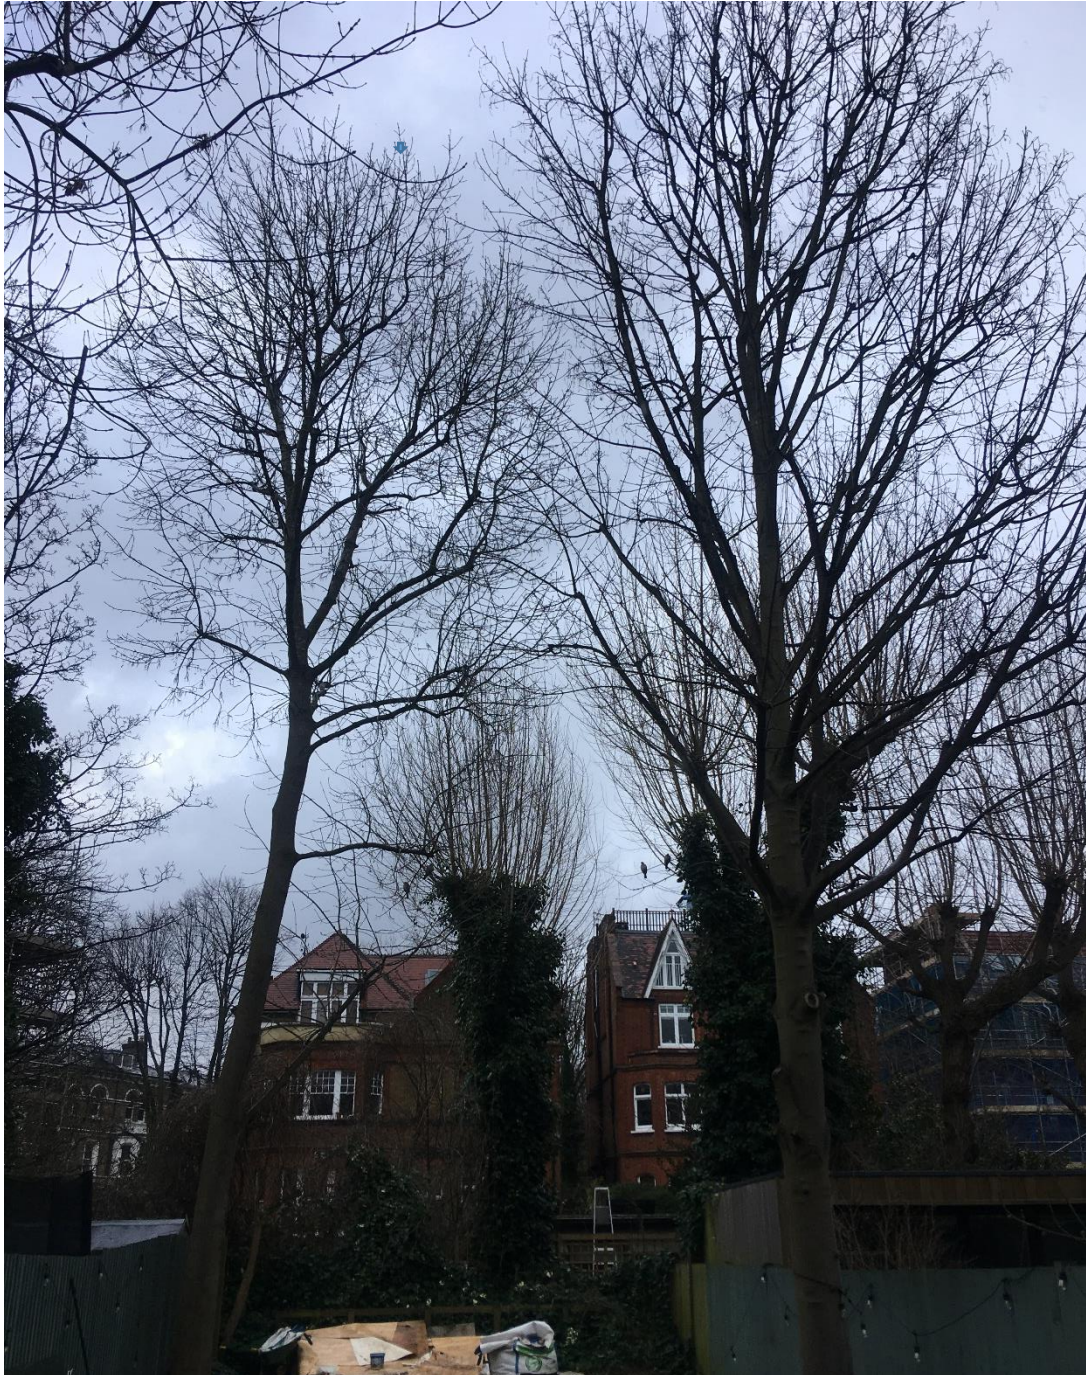
Photo 1: Ash and Sycamore trees in garden of 17 Crossfield Road NW3, Poplar trees behind in gardens of 2 and 4 Strathray Gardens

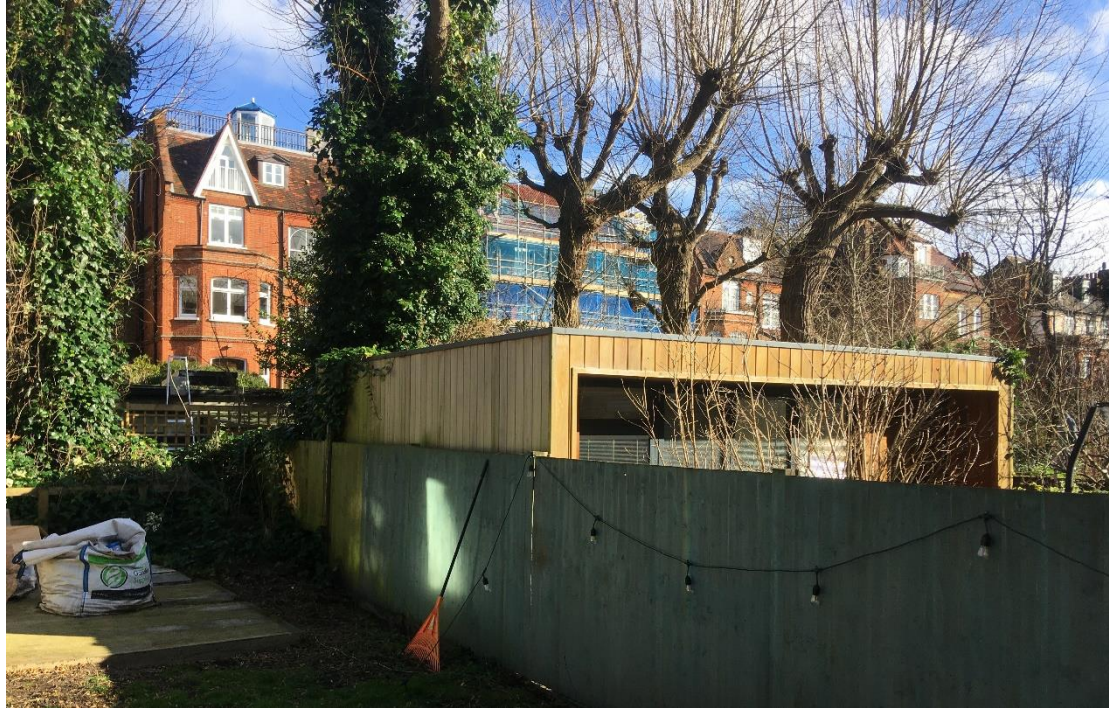
garden of 17 Crossfield Road, the existing garden building in 18a Crossfield Road (see Photo 2, below), and the trees referred to in this survey indicates that the proposed development may well take place without any harm to the trees.

Photo 2: Garden of 17 Crossfield Road, showing T.4-T.8 in rear, garden building in 18a Crossfield Road to right
