DEVISE ENGINEERS

53-54 Doughty Street, London WC1N 2PL

Structural engineer's report and feasibility

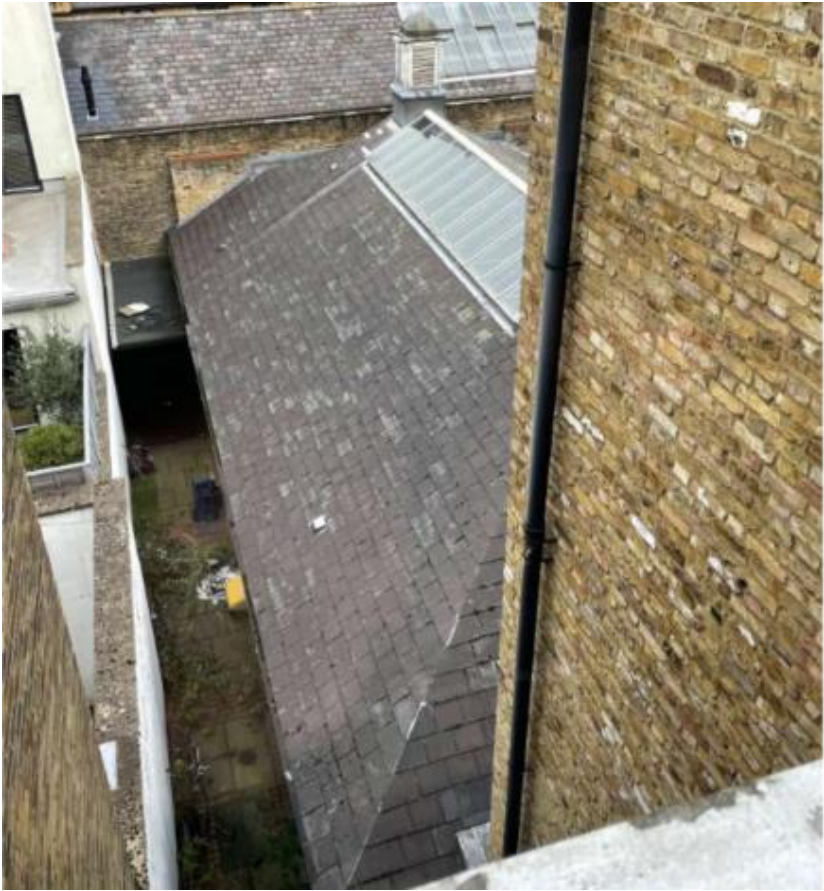
Figure 2: View of rear extension

Beyond the main volume of the property is a single storey extension with hip roof which is of more recent construction.

No significant structural defects were observed to the single-storey rear extension.

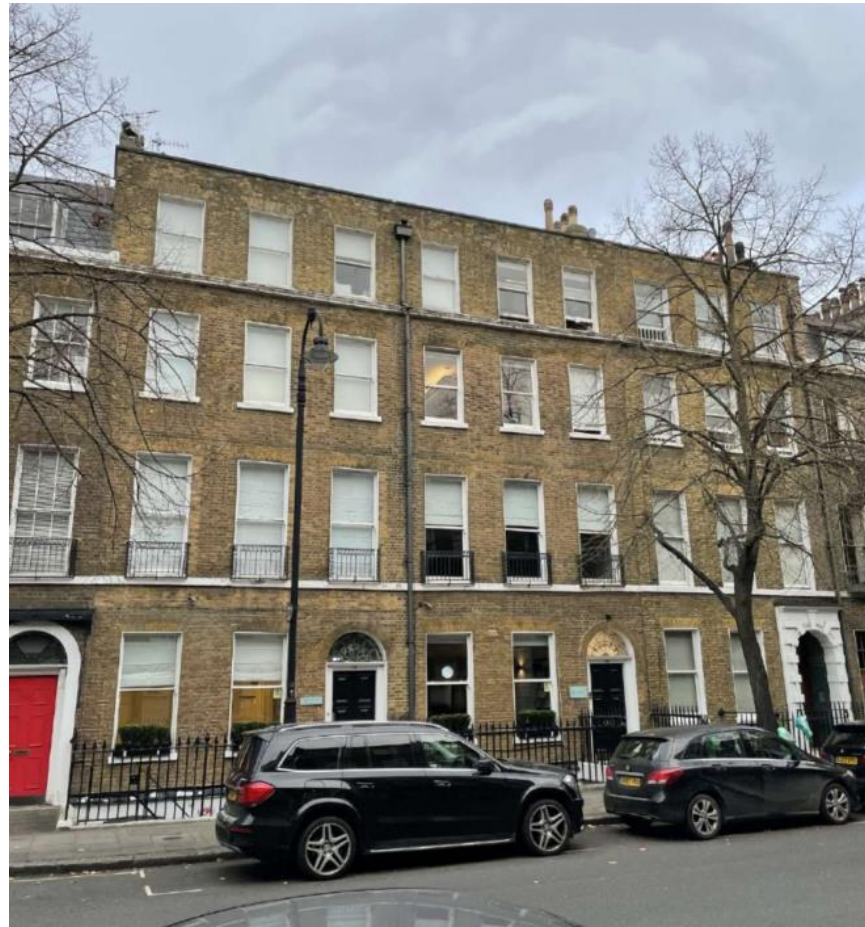
Figure 3: Front Elevation

The front elevation appears to be in reasonable condition and comprises of rendered up to ground floor with exposed brickwork above.

Some slight staining to the brickwork below was observed and some spalling to the brickwork seen but no significant structural defects were observed.

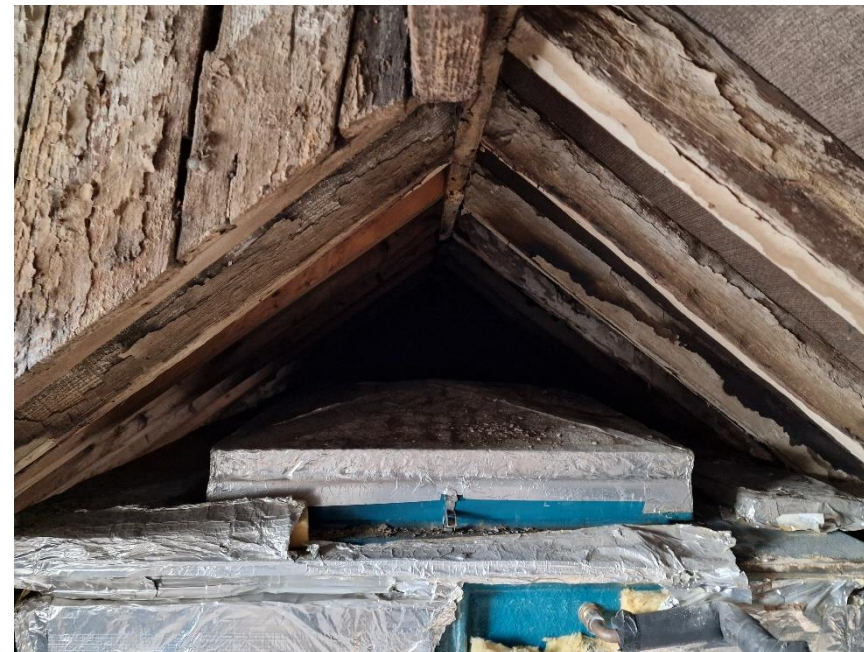
Figure 4: Existing Roof Construction

The main roof rafters are 95x60 timbers at c.380mm centres with central ridge board.

There are signs of historic water ingress, and some local areas of damp however no significant structural defects were observed in the areas that were accessible.

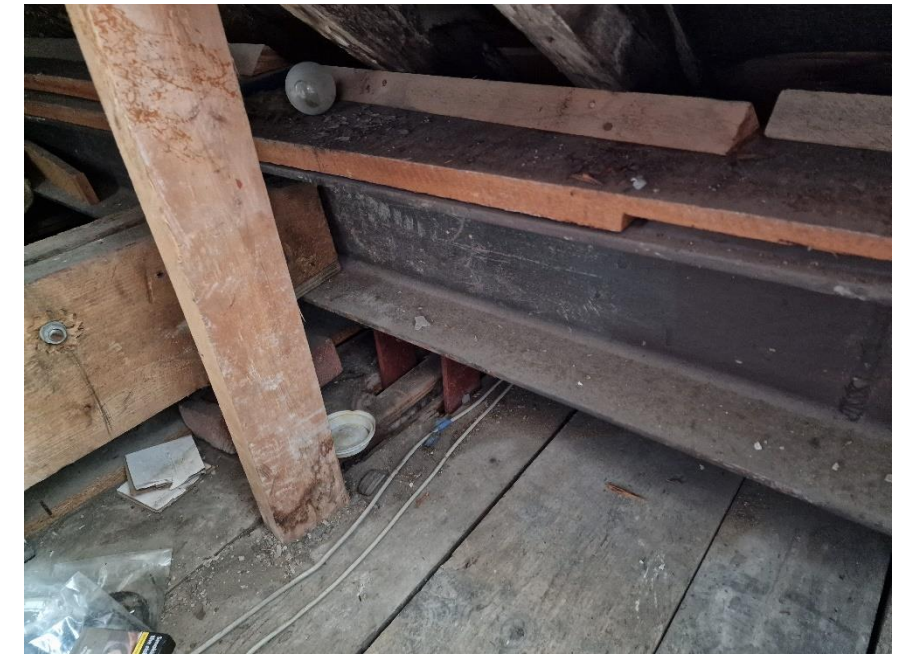
Figure 5: Strengthening Works

Strengthening works have been carried out to support the water tanks within the roof space. These works include the addition of a new steel beam and doubled up timber joists positioned above the existing loft floor construction.

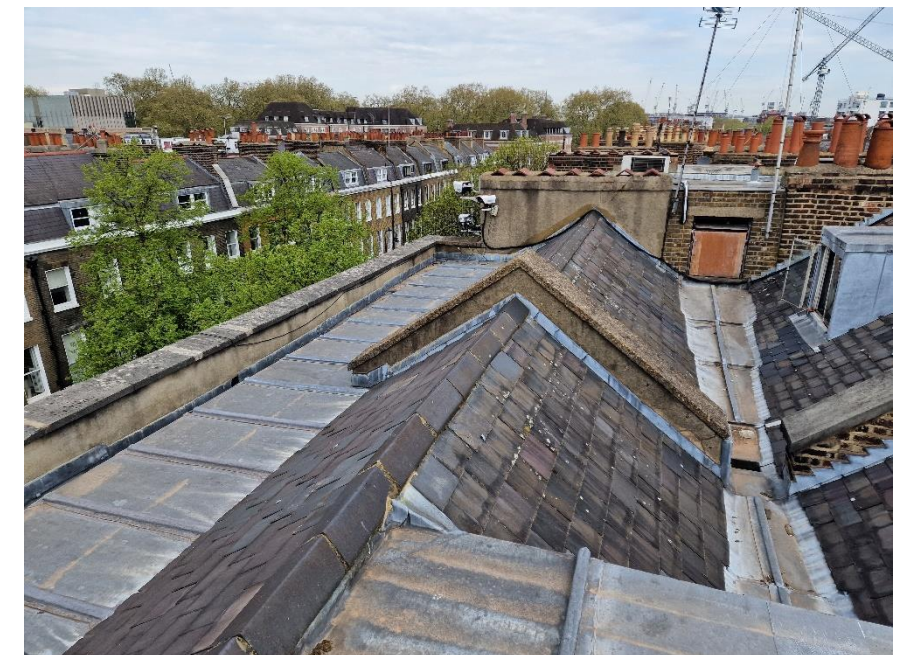
Figure 6: Existing Roof Construction

The existing gable roofs have a slate tile finish with lead work to the areas of flat roof. The finishes seem to be in reasonable condition with no significant defects observed.
