61 REDINGTON ROAD, HAMPSTEAD, LONDON

Ecological Assessment

April 2022 10485.EcoAss.vf

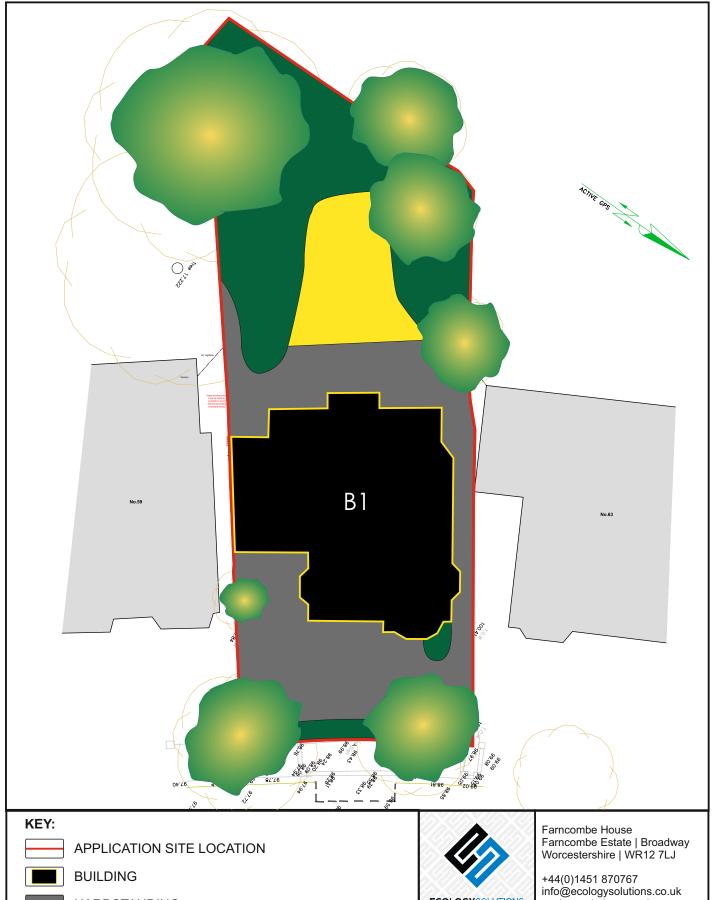
PLAN ECO2: **ECOLOGICAL FEATURES** Rev: A Mar 2022

Ecological Features

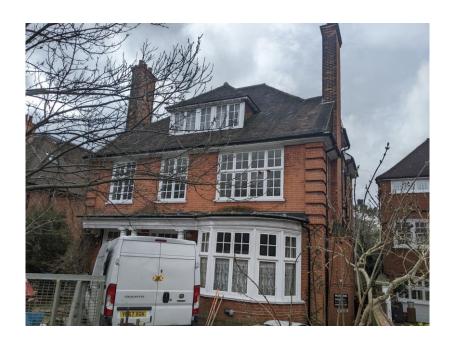
Photo 1: Front aspect of existing building

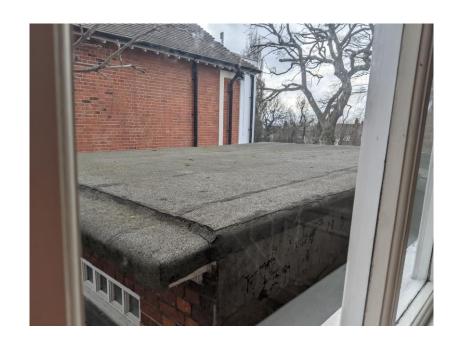
Photo 3: Flat felt roof covering the rooms over the garage on the southern side of the existing building

- 6. The rear of the building was recorded to be in excellent condition, with brick walls and some areas of pebbledash screed.
- 7. On the southern side of the property is a garage, above which sit some ground floor rooms. This part of the property is covered by a flat felt roof at the level of the first floor. The garage roof was recorded to be in good condition, with no gaps or holes observed.

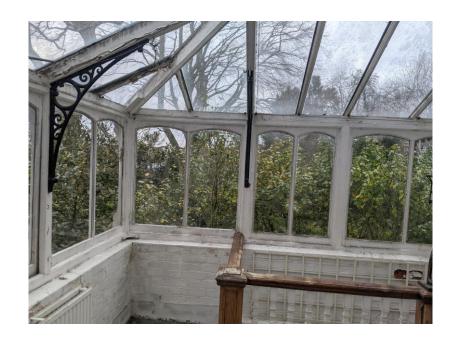
Photo 7: Conservatory/orangery at the rear of the existing building on the ground floor

- 4.2.5. In the southwestern corner of the existing building lies a greenhouse and orangery. Both have roofs constructed from glass plates, some of which have fallen loose. Despite providing potential means of entry to the interior, no signs of the presence of bats were observed within either of these areas, with very light internal conditions present, and it is considered highly unlikely that they provide any opportunities for this group.
