1EW02 Enabling Works – Area South

Document Title: Heritage Agreement Method Statement for the Installation of Instrumentation and Monitoring at the Royal George Public House

Document number: 1EW02-CSJ-EV-MST-S003-000016

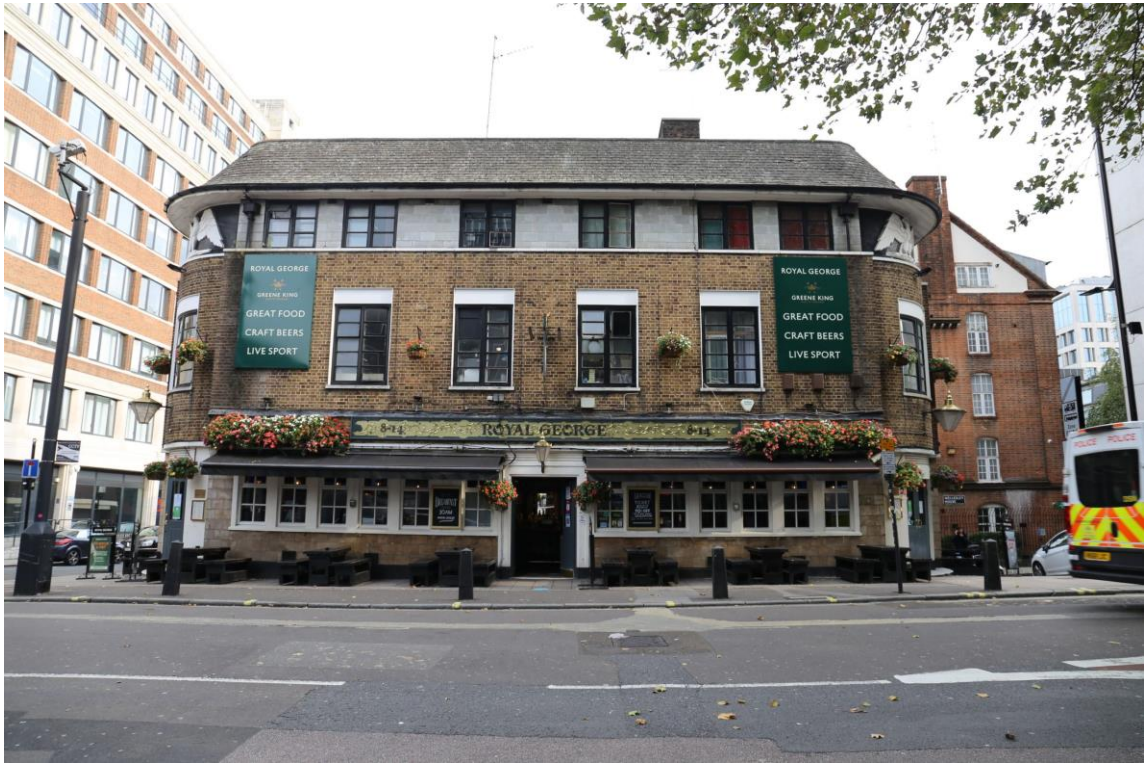
Figure 1. Front (east) elevation of the Royal George. Mott MacDonald (2020).

- 2.1.1 The Royal George is a public house constructed in 1939, located approximately 30m to the east of Euston Station, at 8-14 Eversholt Street, between Lancing Street and Wellesley Place in London, UK.
- 2.1.2 The asset is located on National Grid Reference TQ2971182697.
- 2.1.3 The Royal George is designated Grade II listed (National Heritage List for England 1342046) and was first designated 11-Jan-1999. See Appendix 1 for List Description.
- 2.1.4 The extent of the asset as presently understood is recorded in a Location Plan in Appendix 2.

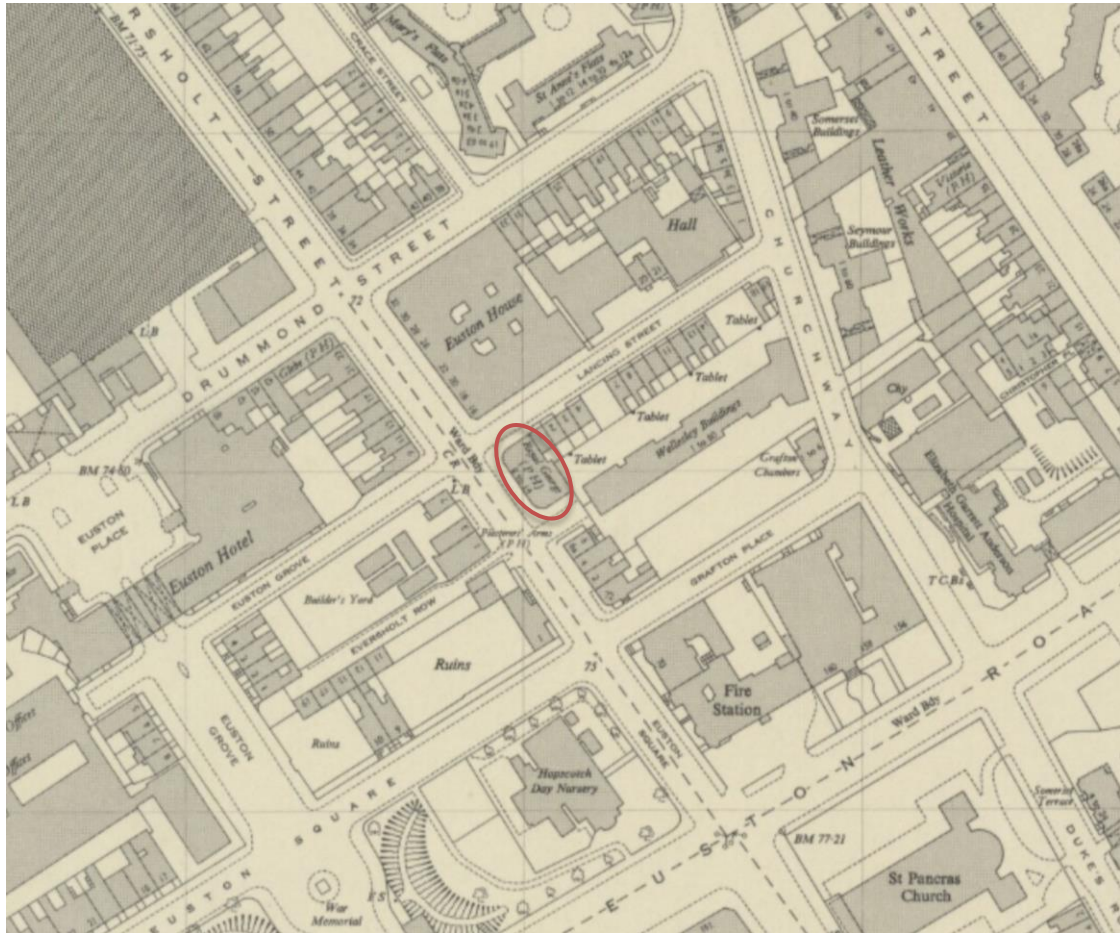
Figure 3. Map illustrating the site of the Royal George prior to the redevelopment of Euston Station. Ordnance Survey, TQ2982NE - A (includes: Holborn; St Marylebone; St Pancras) Surveyed: 1953; Published: 1953

- 2.2.2 Truman's Brewery had purchased the previous Royal George pub and commissioned their lead in-house architect, A. E. Sewell, to construct the replacement pub nearby, replacing nineteenth century terraced housing (see Figure 2 and Figure 3). Sewell was responsible for around 50 pubs constructed during the early twentieth century, including the Royal George, which is believed to be his last (Historic England, 2015).

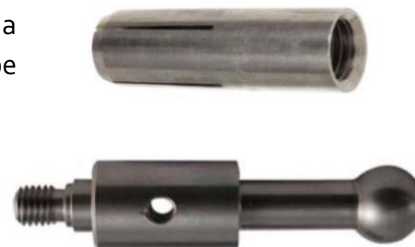
Figure 10. Example of the 'shell anchor' (top) and BRE level bolt (bottom).

3.3.7 **BRE sockets.** BRE Level bolts are to be fixed to the façade at a low level to allow a surveyor and assistant to be able to take a reading on each bolt on a regular basis (Figure 10). They will be installed by drilling a 10mm diameter hole into the masonry substrate so that a brass or stainless steel 'shell anchor' can be installed. A non-percussive drill with a built-in dust extractor will be used. A survey level bolt is then screwed into the anchor and hand tightened, once the survey reading is taken, the level bolt is removed leaving only the 'shell anchor' in place with no visual impact.

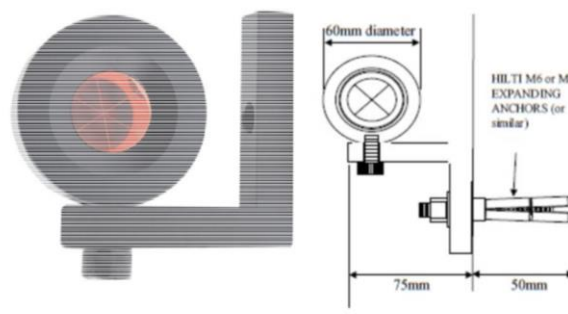
Figure 11. Example of a mini circular prism with L-shaped support bracket

3.3.8 **Mini Circular Prism.** It is expected that the majority of the targets to be installed onto the Royal George will be mini circular prisms because they are durable and easy to target by the total station. **Error! Reference source not found.** These have been widely used at Paddington Station, Kings Cross Station and St Pancras Station during rail infrastructure works as well as other listed buildings. The target bracket colour will be changed to adapt as best as possible to the building façade material, such as white or cream to blend into the stock brick or stone. The prisms are installed by drilling a 10mm diameter hole into the masonry substrate so that a brass or stainless steel 'shell anchor' can be installed (see section 3.4). A drill with a built-in dust extractor will be used. A stainless-steel survey spigot is then screwed into the anchor and hand tightened (Figure 2). The prism is then pushed into the spigot and rotated and aligned to the total station positions. This is achieved by rotating the 'L-shaped' bracket and prism head. The prism alignment can be subsequently adjusted and realigned to new station positions if the base station positions change, with no need to change the prism position on the building façade, but

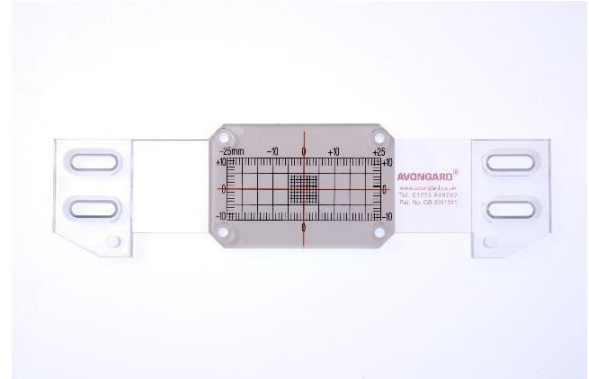
Figure 13. Example of a crack meter with pegs to aid installation.

3.3.9 **Crack meters.** Crack meters consist of two overlapping acrylic plates, one with a black millimetre grid, and one with red crosshairs centred over the grid. The crosshairs shift horizontally or vertically when movement occurs, demonstrating the extent of the movement. They can be installed using either anchors (bolts/screws) or epoxy adhesive, depending on the type of surface the crack appears on, its location and the risks associated with drilling holes with a non-percussive drill or removing some surface when the epoxy is removed. The number and location of the crack meters will be determined following a full survey of the building, and will be re-evaluated throughout the works, in the event of further cracks appearing.

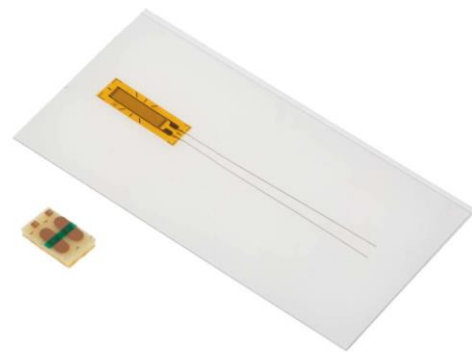
Figure 14. Example of a wire lead strain gauge

3.3.10 **Wire lead strain gauges** consist of a very fine metallic or semiconductor material, bonded to the surface of the building, designed for the measurement of strains in and on structural elements. It consists of an electromagnetic coil to provide a pulse and receive a resonant frequency of a wire tensioned between the end mountings of the gauge used for measuring static strains. A common dynamic strain gauge consists of a very fine metallic wire, foil or semiconductor material in a grid bonded to a surface. Variations in electrical resistance of the grid indicate strain. Typically, the location and size of the gauge makes the wire susceptible to damage. However, their location high in the basement of the Royal George should mean they are somewhat shielded from normal wear and tear and makes them an appropriate choice.

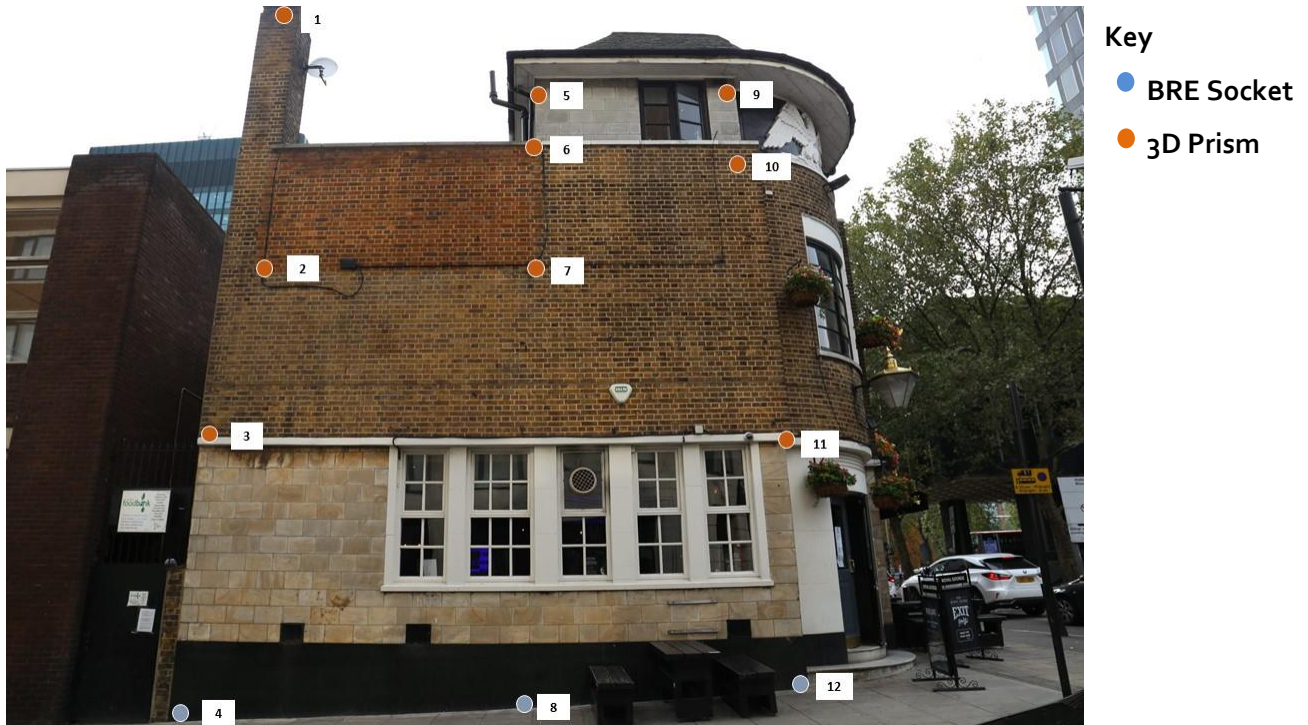
Figure 16. Recommended structural monitoring of north-western façade of Royal George public house.

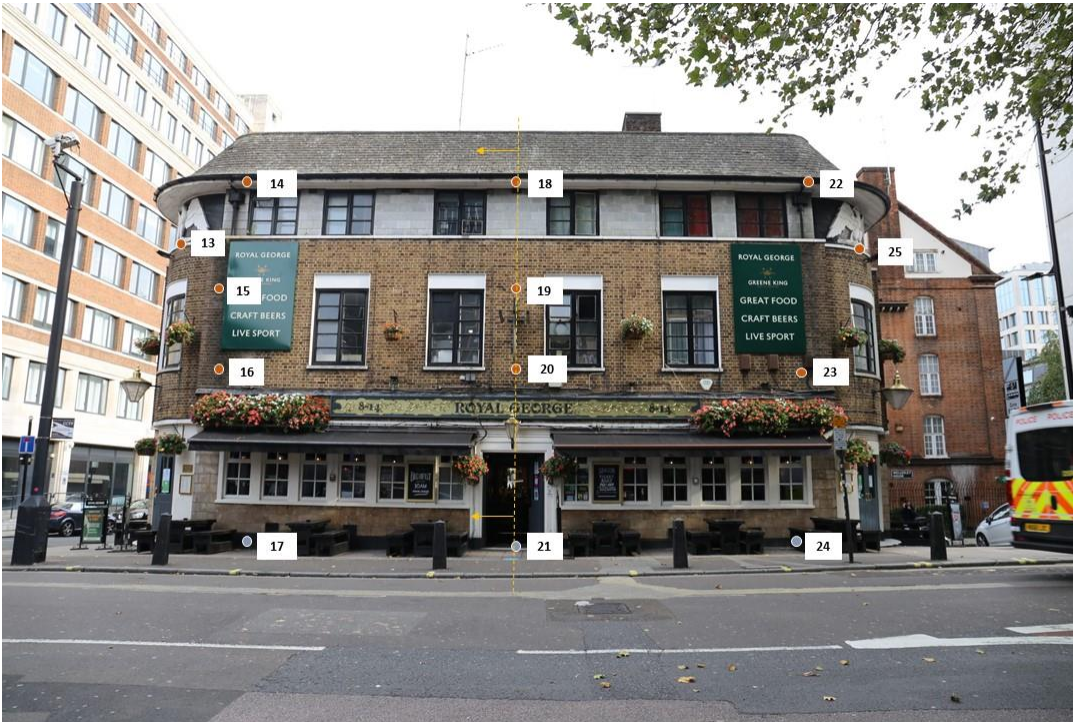
Figure 17. Recommended structural monitoring of south-western façade of Royal George public house.

3.6.3 Monitoring point 15 is located to the north of the green Royal George sign in order to avoid interference with monitoring.

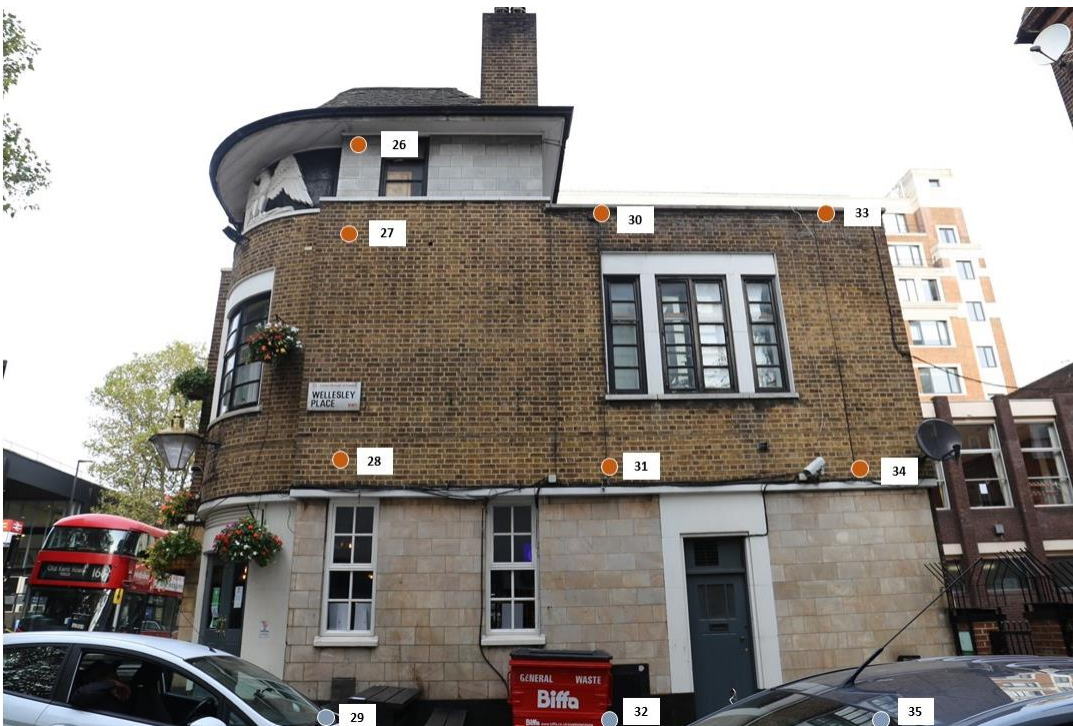
Figure 18. Recommended structural monitoring of south-eastern façade of Royal George public house.
