**RIDGE**  
PROPERTY & CONSTRUCTION CONSULTANTS

ELECTRICAL CUPBOARD RELOCATION

EXISTING AND PROPOSED  
SIDE ELEVATION

PROJECT:	ORG:	ZONE:	LEVEL:	TYPE:	ROLE:	NUMBER:	REV:
5016754	RDG					002	-

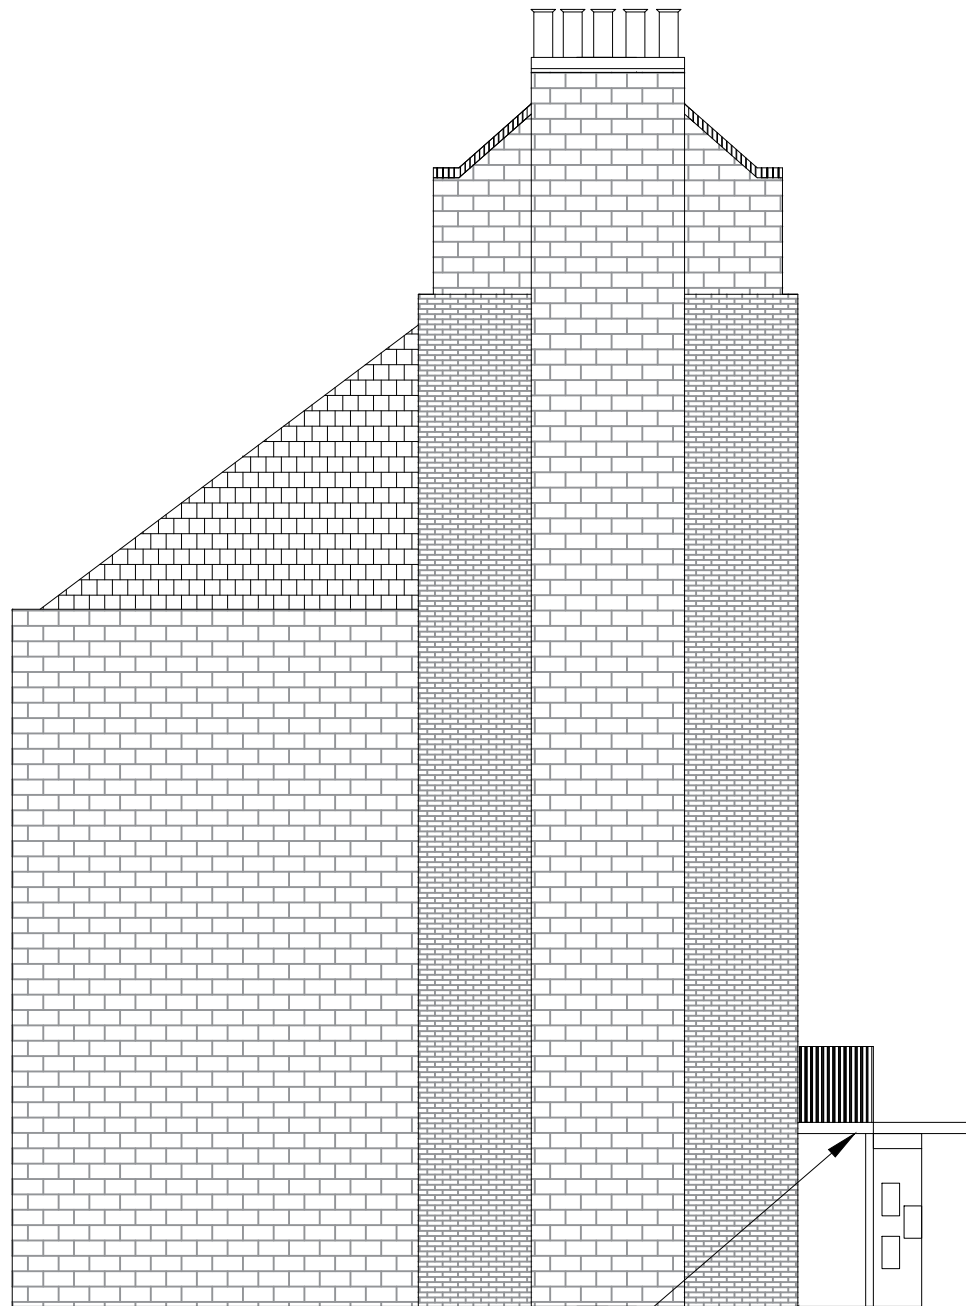
## Existing Elevation

Street level

Basement walkway

Existing electrical cupboard location

Currently the existing electrical cupboard is situated underneath the existing pathway above. The cupboard has been subject to water ingress despite multiple attempts at damp proofing repairs. The water ingress regularly shorts out the electrics within in the cupboard which interferes with the operational use of the building. It is proposed to relocate the cupboard to the end of the walkway at basement level to remedy the water ingress issue. The cupboard will be below street level and not visible from any public highway. The elevations to the rear and sides are not to be altered from this application and will remain the same.

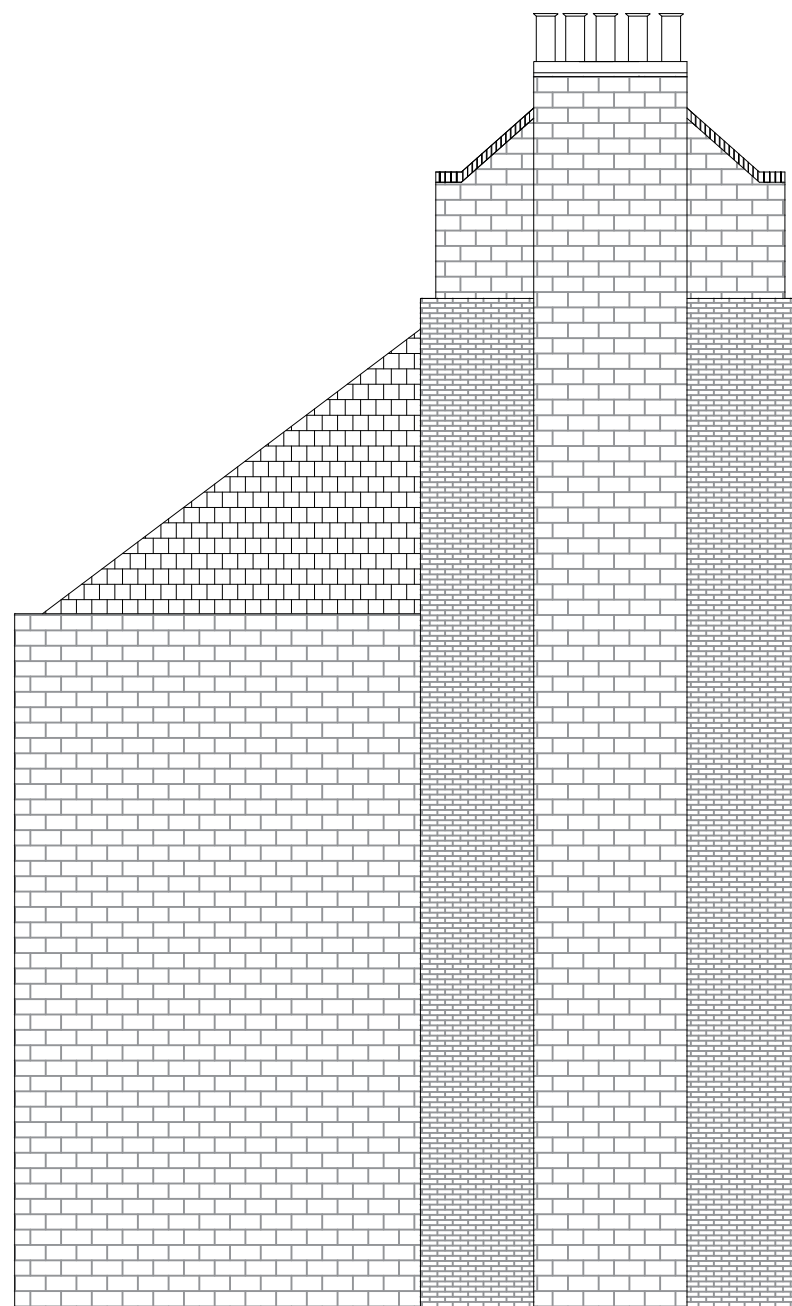
## Proposed Elevation

Proposed electrical cupboard location
