23 Gloucester Crescent

Heritage Impact Assessment

July 2022

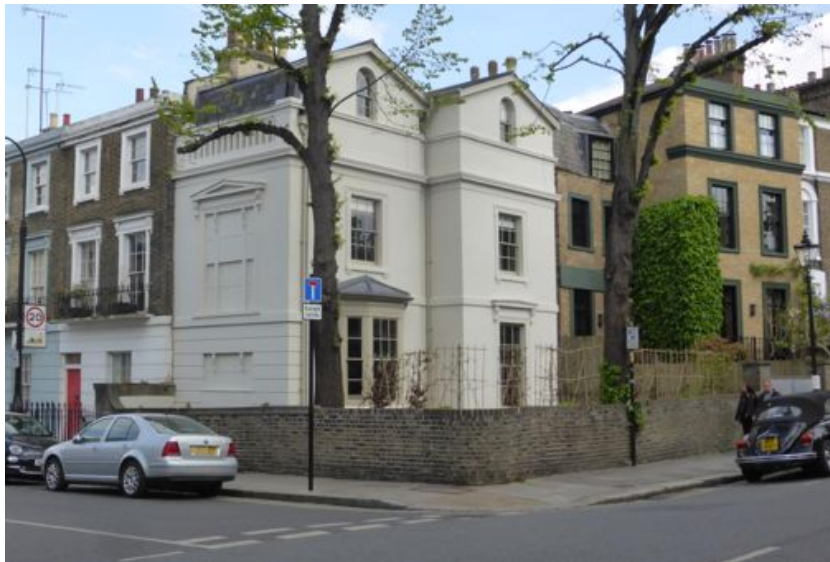
Fig.1 Number 23 Gloucester Crescent viewed from North-West – note low wall in relation to passers-by.

Arts Lettres Techniques obtained consent for amendments to the existing planning and listed building consent on 6th August 2021 (2021/2518/L). Following completion of the works to the house the question of privacy and vulnerability arose, with the low garden wall giving little screening from passers-by, tourists or people with addiction issues who have traditionally used the side streets away from the market area.

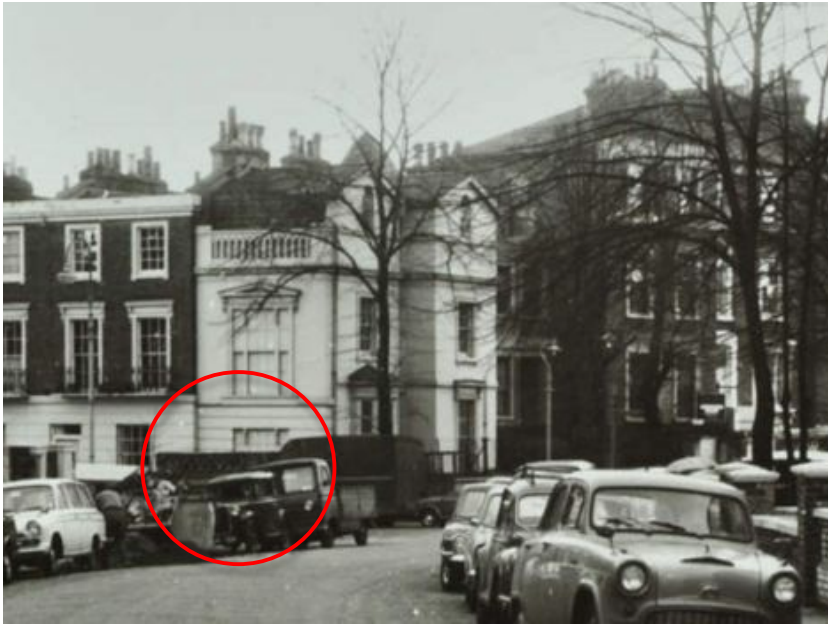
Fig.2 23 Gloucester Crescent viewed from North-West circa 1967 – note original wall indicated – refer to Fig.3.

Figure 2 and 3 show the original North boundary wall, the 'saltire' latticework was a standard boundary detail around the Crescent and wider streets, the remaining examples within the Crescent are documented in the accompanying Design and Access statement. The poor condition of the original wall may have been the reason for its removal – it is evident through the remnants of the 'saltire' details remaining around the Crescent that the fragment shown in Fig.3 extended around the perimeter wall. The rest of the wall is lower because the rest of the 'saltire' details had already been removed by the time Fig.3 was taken.

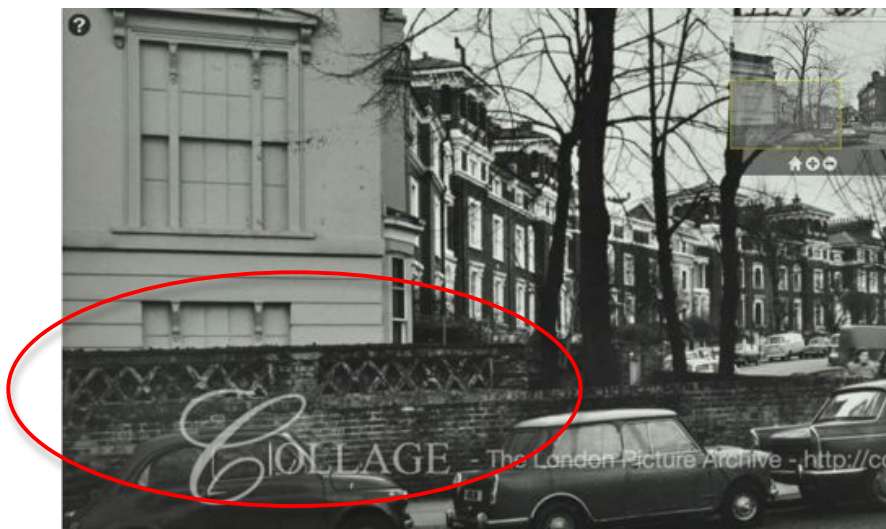
Fig.3 Number 23 Gloucester Crescent detail of North wall circa 1967.

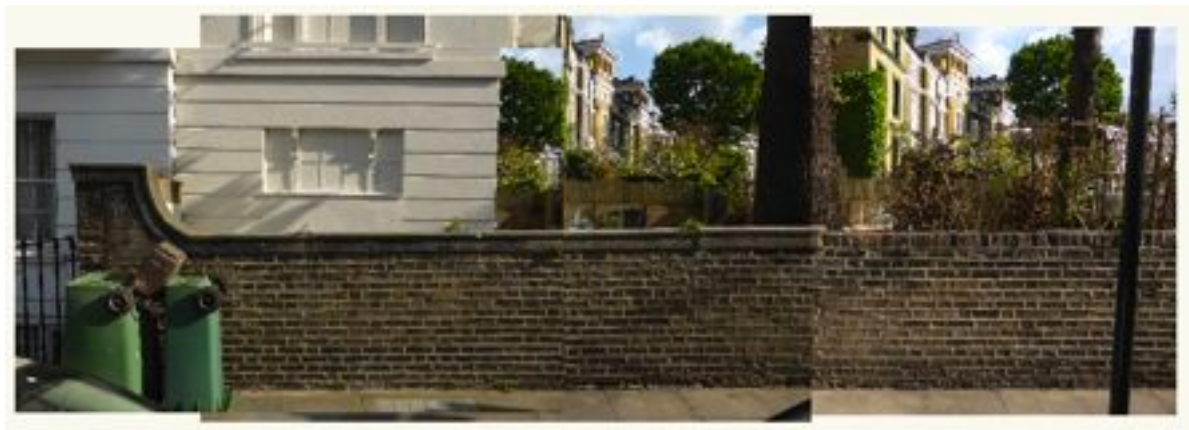
Fig.4 Composite photograph of the North boundary wall, rising with a swept coping detail to the original wall height.

The intervention to raise the wall to its original height requires the removal of the undecorated existing Portland cement coping which is a copy of the original detail, a fragment of which is extant on the return wall from the raised corner seen on the left of the wall in Fig.4 and in detail in Fig.5.

The use of cement on a lime mortar bonded original wall goes against best practice, the inability of the brittle cement coping to move and settle in accordance with the behaviour of lime based mortar creates cracking, water entry, plant growth (seen in Fig.4) and spalling of the masonry. The creation of the swept corner detail post-1967 used modern bricks with cement-based mortar that has created an incompatibility issue between mortars together with a crude bonding method that disfigures the wall (fig.5). The original coping shown in fig. 5 is pale buff coloured and its properties of water release result in the avoidance of staining characteristic to Portland cement.

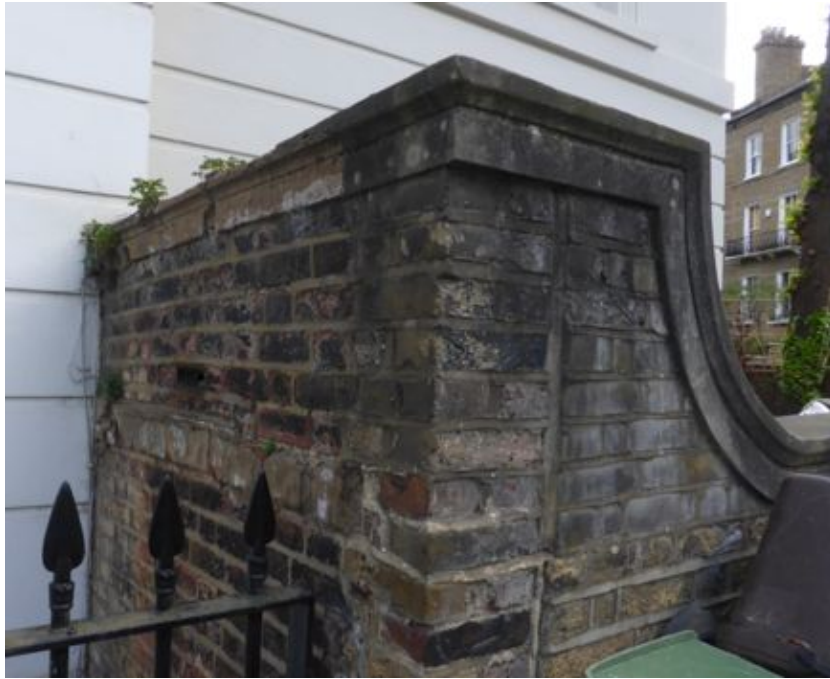
Fig.5 Corner detail showing original Roman cement coping and band which frame the dimension of the 'saltaire' blockwork.

Critical to the reinstatement is to follow original detail, material and scale. The moulding to the original wall fragment (Fig.5) is identical to number 24 and 22 Gloucester Crescent, and the new work will be made using a 'run in-situ' technique using timber guides and a hand-cut profile as per the original wall, executed by the same craft plasterer who reinstated the lime cornices and plasterwork within the house. Mortar will be lime/sand without the use of ordinary Portland cement.

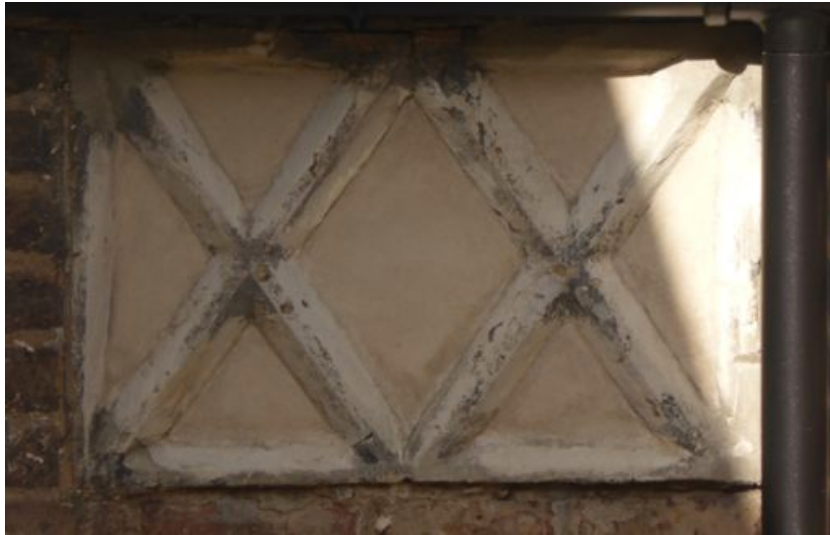
Fig.6 Detail of cast 'Saltaire' on the party wall of 23 Gloucester Crescent.

The 'saltaire' blocks will be cast in Roman Cement, which is as close to the historical cement mix as possible. The detail and dimensions of the mould will be taken directly from the two remaining 'saltaire' blocks present in number 23 – located at high level in the South lightwell party wall (Fig.6), which match the adjoining properties.

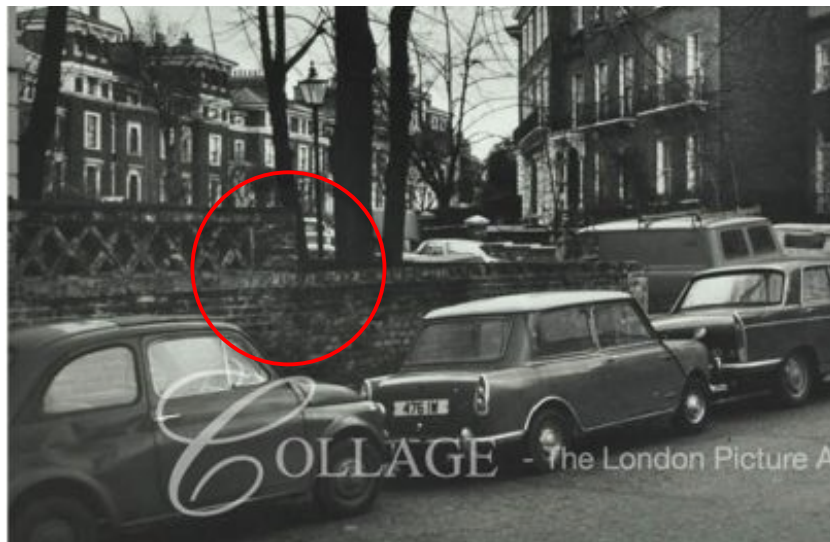
Fig.7 Detail of the truncated end of the original wall circa 1967.

The end of the reinstated wall terminates at the lime tree. Fig.7 indicates the wall was likely simply truncated when the rest of the 'saltaire' panels were removed prior to 1967.

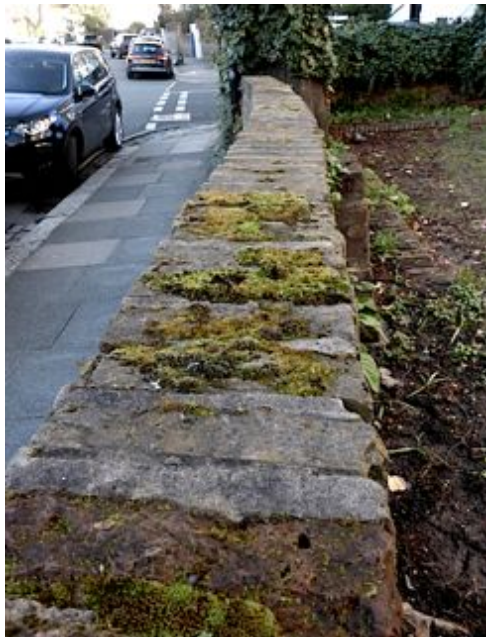
Fig.8 Detail of West wall cement mortar bedded coping using a soldier course

The material loss incurred by the reinstatement has negligible impact, the top of the current wall has a twentieth century soldier course bedded in cement mortar installed when the original

'saltire' blocks were removed – it is in poor condition (Fig.8) and has no heritage value. The significance of the raising of the wall to its original height and design affects the contemporary experience of the house as owned by Alan Bennett, which had during his tenure the lowered wall height. This contemporary image of the house creates a tension between the historic value of the original boundary, the reinstatement of which repairs the loss of original appearance that has happened over time, and the loss of the presentation of Bennett's house, which has the lowered wall revealing more of the garden to the passer-by.
