23 Gloucester Crescent

Design and Access Statement

July 2022

Alterations to the existing boundary wall

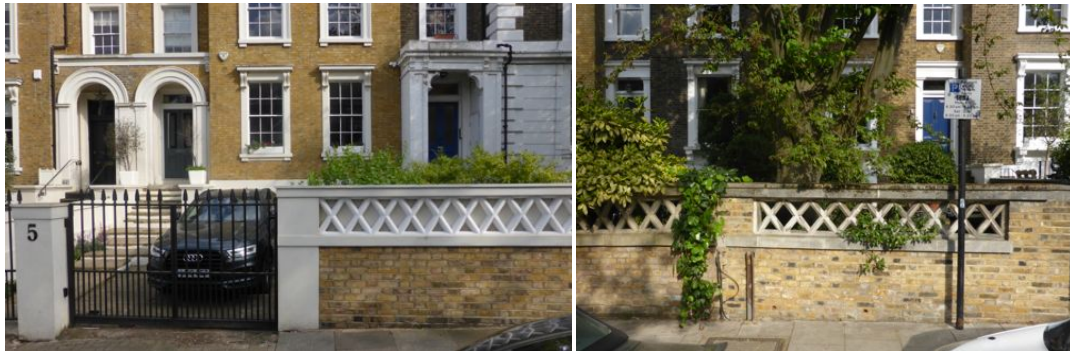
Figs. 1, 2 Numbers 5, 17 and 18 Gloucester Crescent.

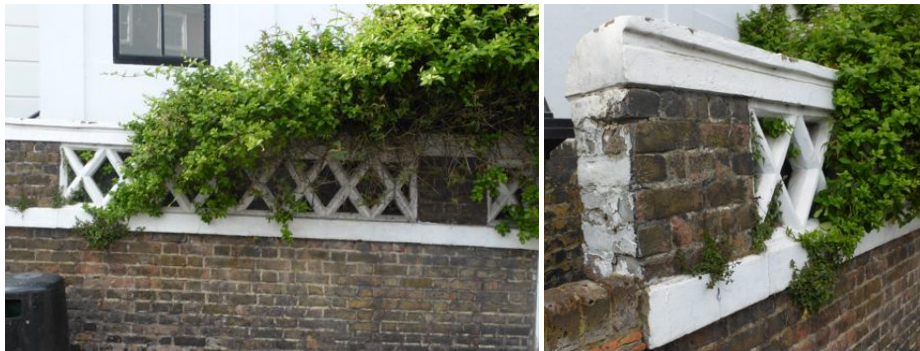
Figs. 3,4 Number 24 Gloucester Crescent – the opposite corner to the proposed site.

The remains of the moulded coping and rendered band below the 'saltire' lattice seen in Fig.4 are extant on the return section of the party wall to the adjoining property (Fig.8) – the details and dimensions of the extant elements are identical to those on numbers 24 and 22 Gloucester Crescent:

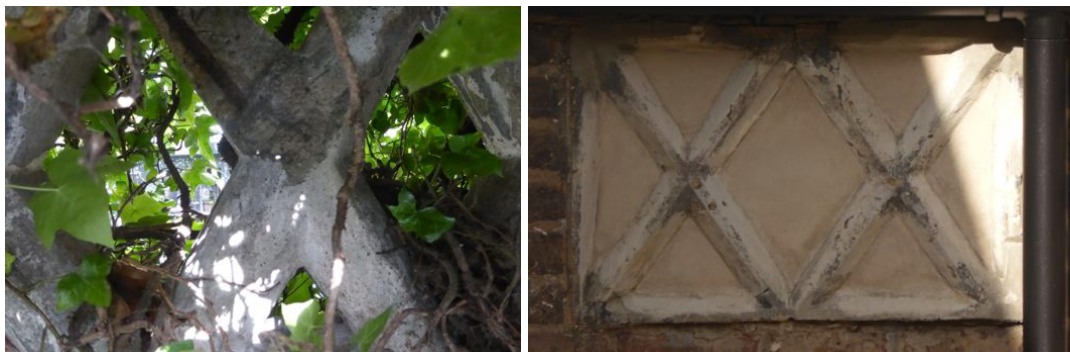
Figs. 5,6 Number 22 Gloucester Crescent – the immediate neighbour to the proposed site with dense ivy covering the original 'saltire' wall panel – note fractured surface revealing corroded iron reinforcement – Fig. 5 shows a pair of original 'saltire' blocks visible on the party wall to number 23 Gloucester Crescent itself.

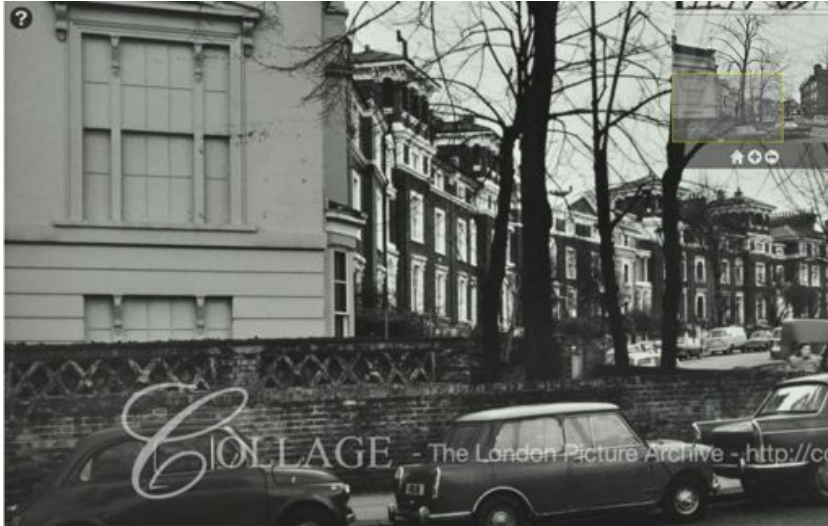
Fig. 6 Number 23 Gloucester Crescent circa 1967.

The archive photograph from 1967 clearly shows the 'saltire' wall in-situ along the North wall (Fig 6), and documents its poor condition, which may explain its subsequent removal. Fig. 7 documents the existing situation:

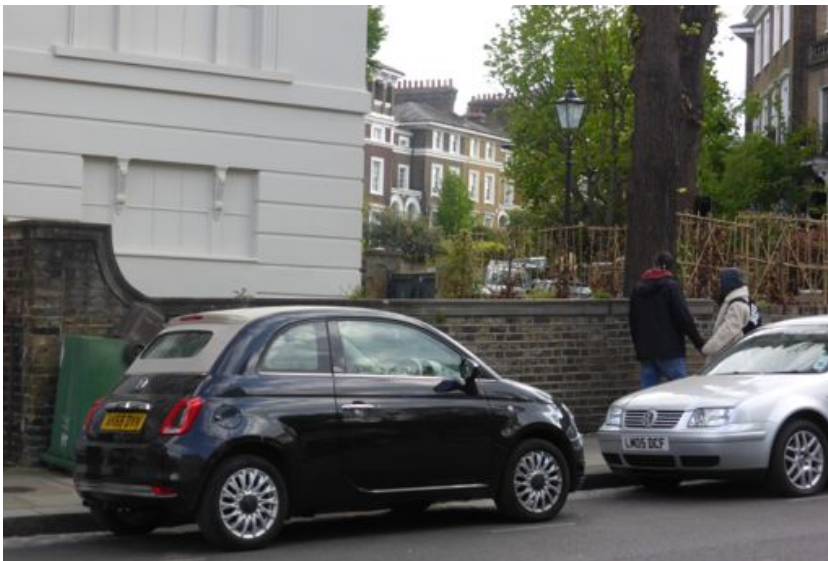
Fig. 7 Number 23 Gloucester Crescent present state – note overlooking passers-by.

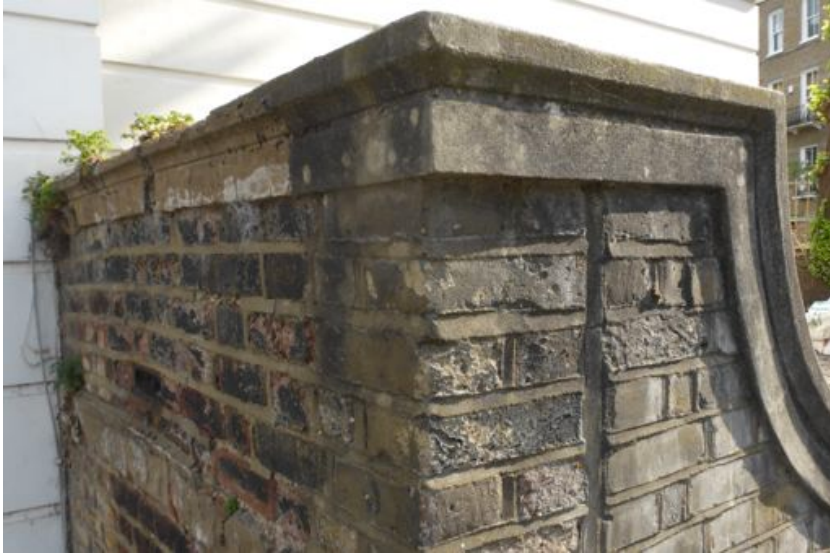
Fig. 8 Number 23 Gloucester Crescent return party wall – note original section of buff coloured Roman cement coping and junction with new corner moulding in grey Portland cement with rebuilt corner in modern bricks with weather struck cement pointing.

The proposal retains the original section of wall shown in Fig.8, removing the new brick and cement mortar down to the base level of the 'saltire' lattice and extending the rendered band around the perimeter wall to the existing/retained brick gatepost (Fig.9). The panels of seven no. 'saltire' blocks shown in the archive photograph (Fig.7) are reinstated on top of the existing wall, which is a modern installation using cement mortar that will have the existing and fragmented soldier coping course removed to continue the 'saltire' blocks.

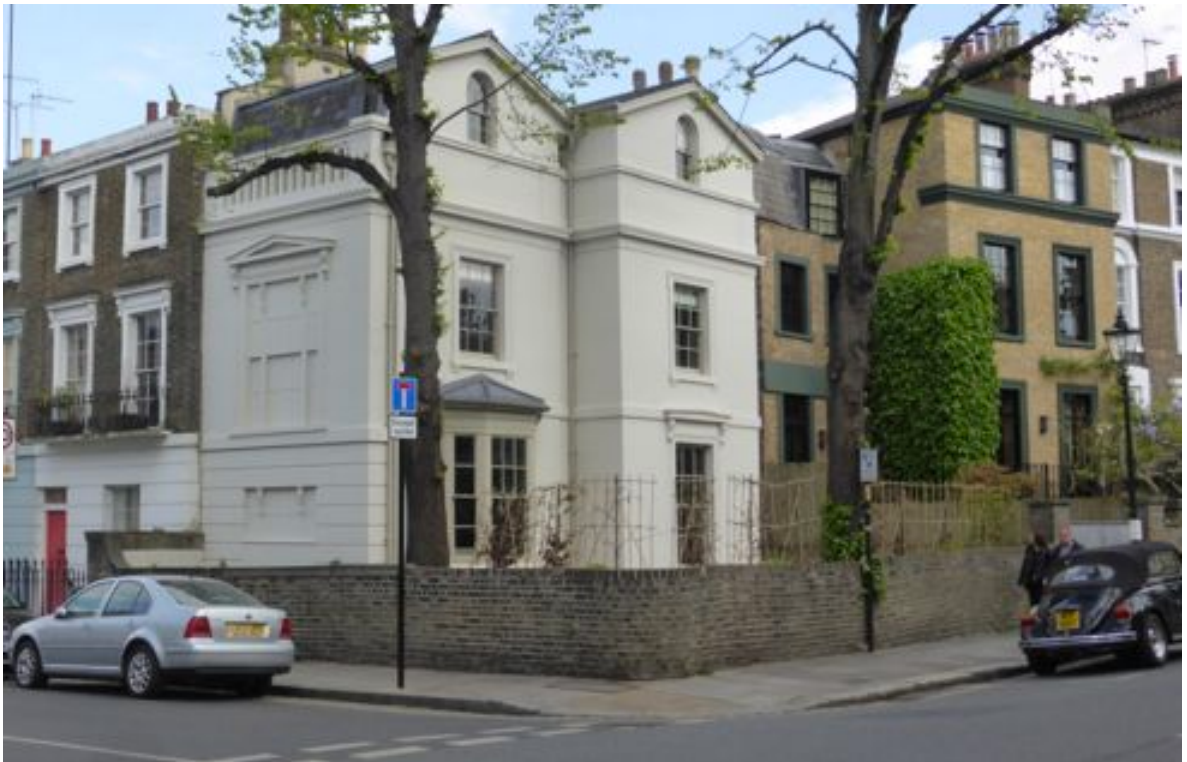
Fig. 9 North and West boundary wall

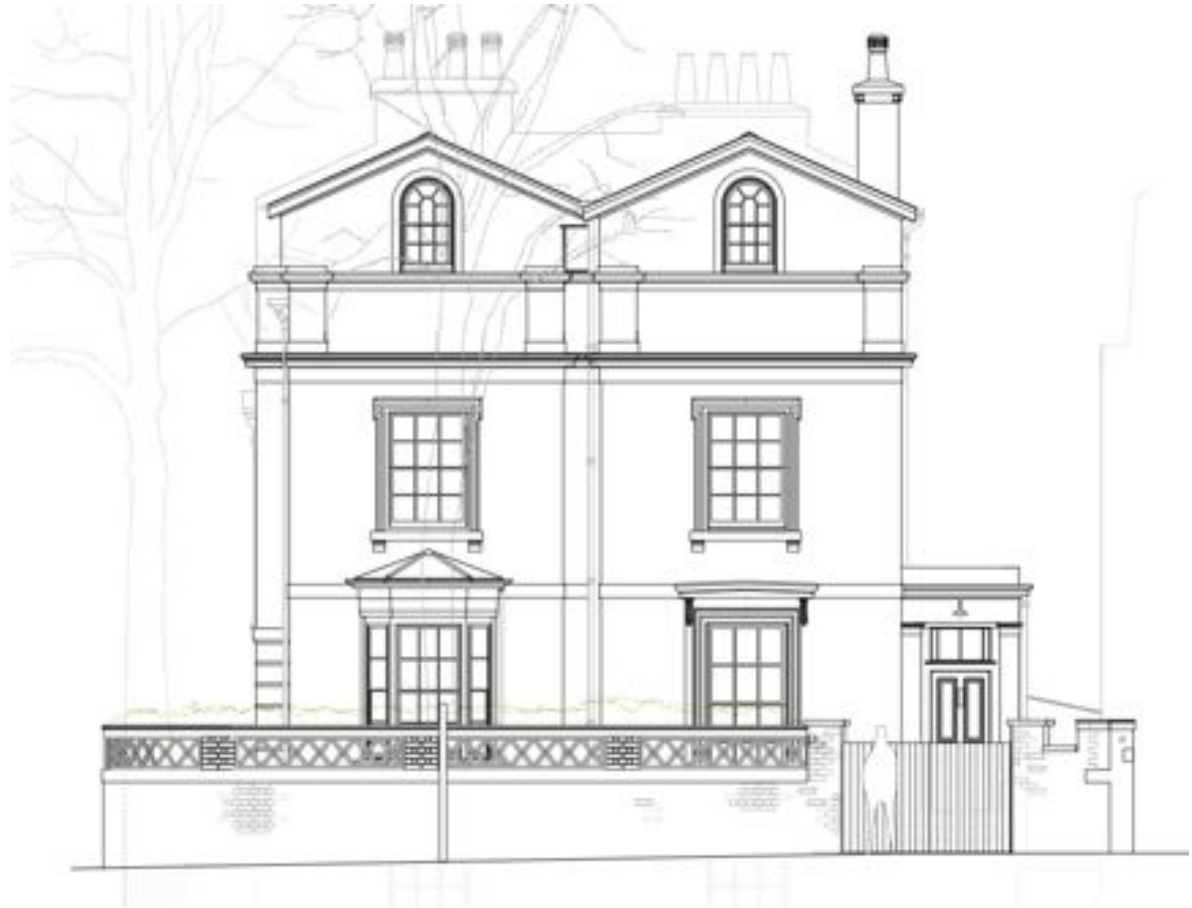
Fig. 10 West elevation of the proposal

The 'saltire' blocks shown in Fig.10 are to be cast using Roman cement form moulds taken directly from existing blocks at 23 Gloucester Crescent, which are identical to those on numbers 22 and 24. The blocks running around the existing curved corner wall will be adjusted to create a smooth transition between each block. The coping is run in-situ so will be run around the curve accordingly.

Matching yellow stock bricks will be used for the piers, bedded in lime/sand mortar without Portland cement, with bagged flush lime pointing in a bond pattern taken directly from the original wall of Number 24 Gloucester crescent (using 60mm wide 'queen' closers on the perpendicular courses).
