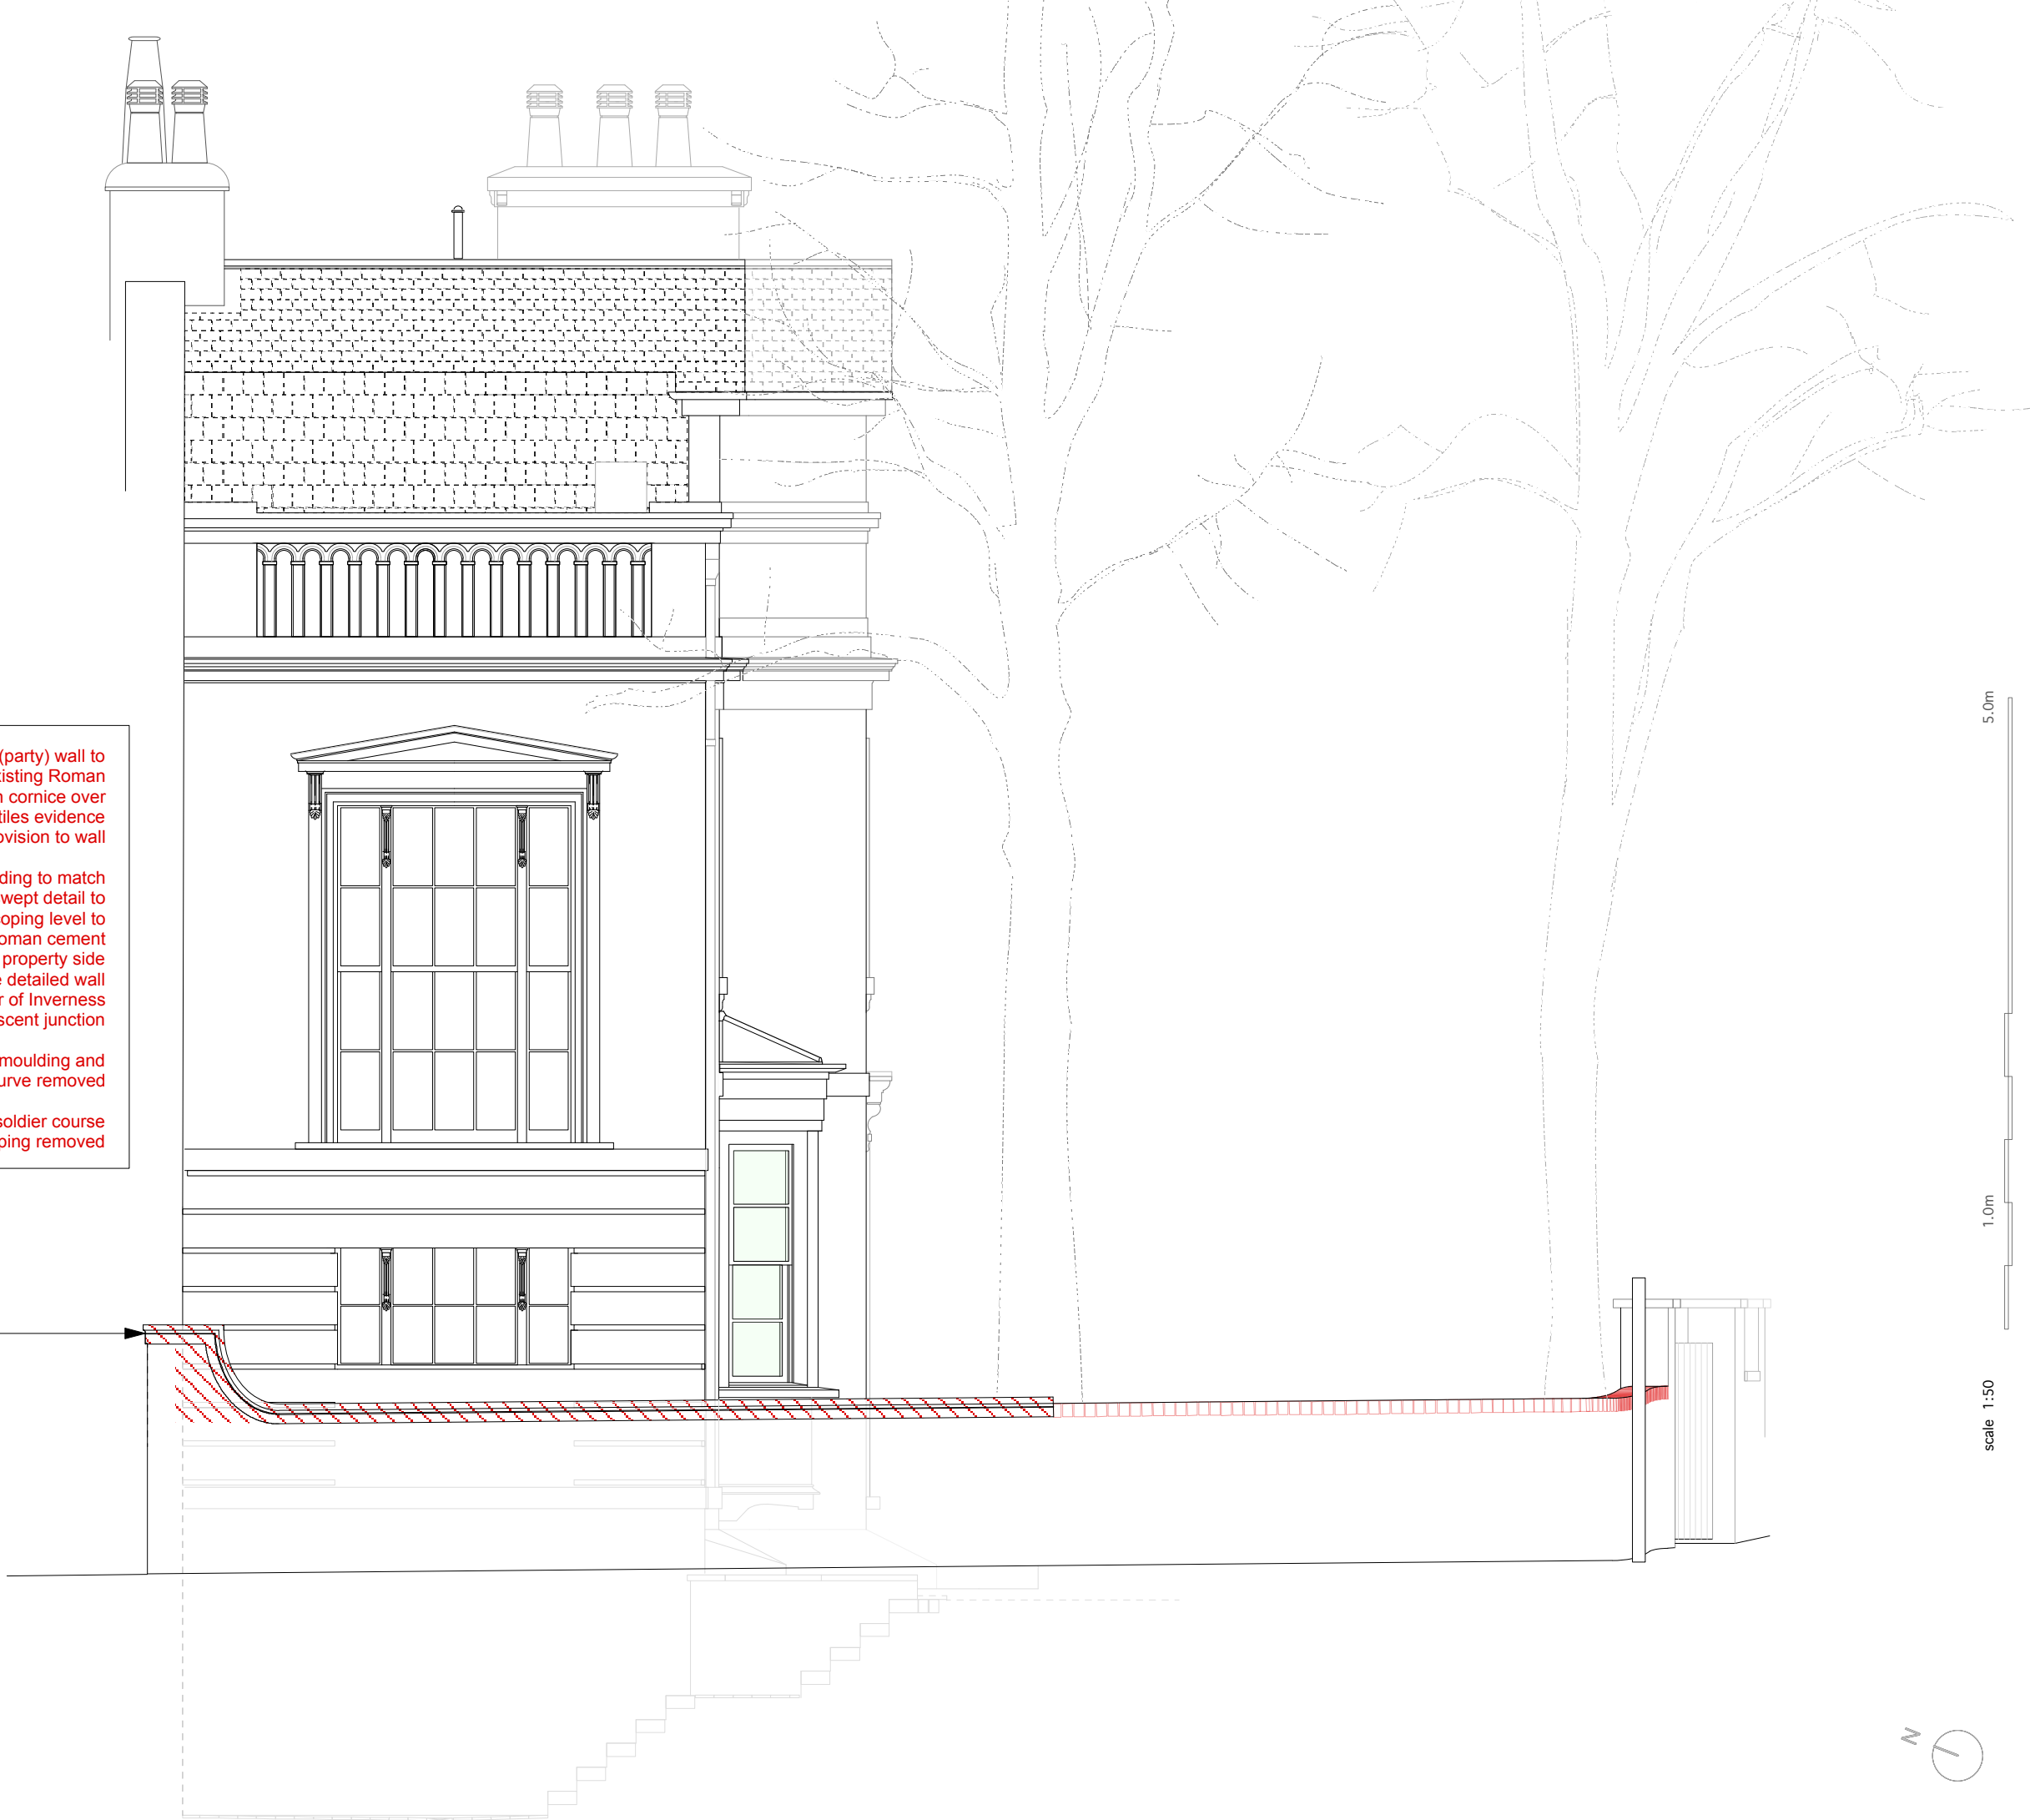
original dividing (party) wall to adjoining house - existing Roman cement in-situ run cornice over terracotta creasing tiles evidence original coping provision to wall

portland cement moulding to match original re-run with swept detail to connect original coping level to reduced wall height. Roman cement band on adjoining property side aligns with saltaire detailed wall on opposite corner of Inverness Street/Gloucester Crescent junction

Portland cement moulding and swept curve removed

decayed soldier course coping removed
