original Roman cement
coping and rendered band
to be repaired in-situ
using Roman cement

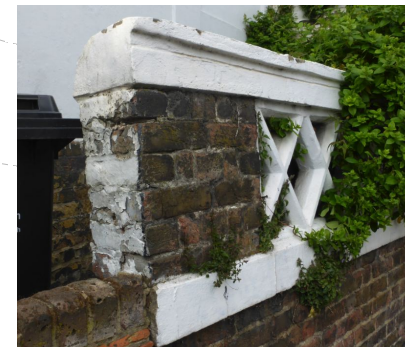
coping moulding identical to
remaining original coping to
23 Gloucester Cres.

photographic detail of house wall
on opposite corner of Inverness St.

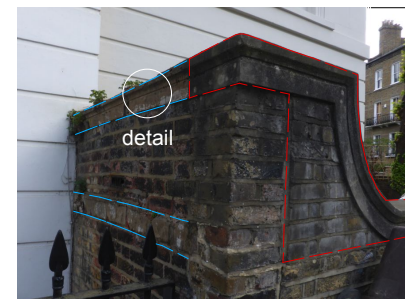
photographic detail of North East wall corner
to 23 Gloucester Crescent
