## Space House

Planning Condition Discharge Report

Conditions 3LBC f)

For Seaforth Land

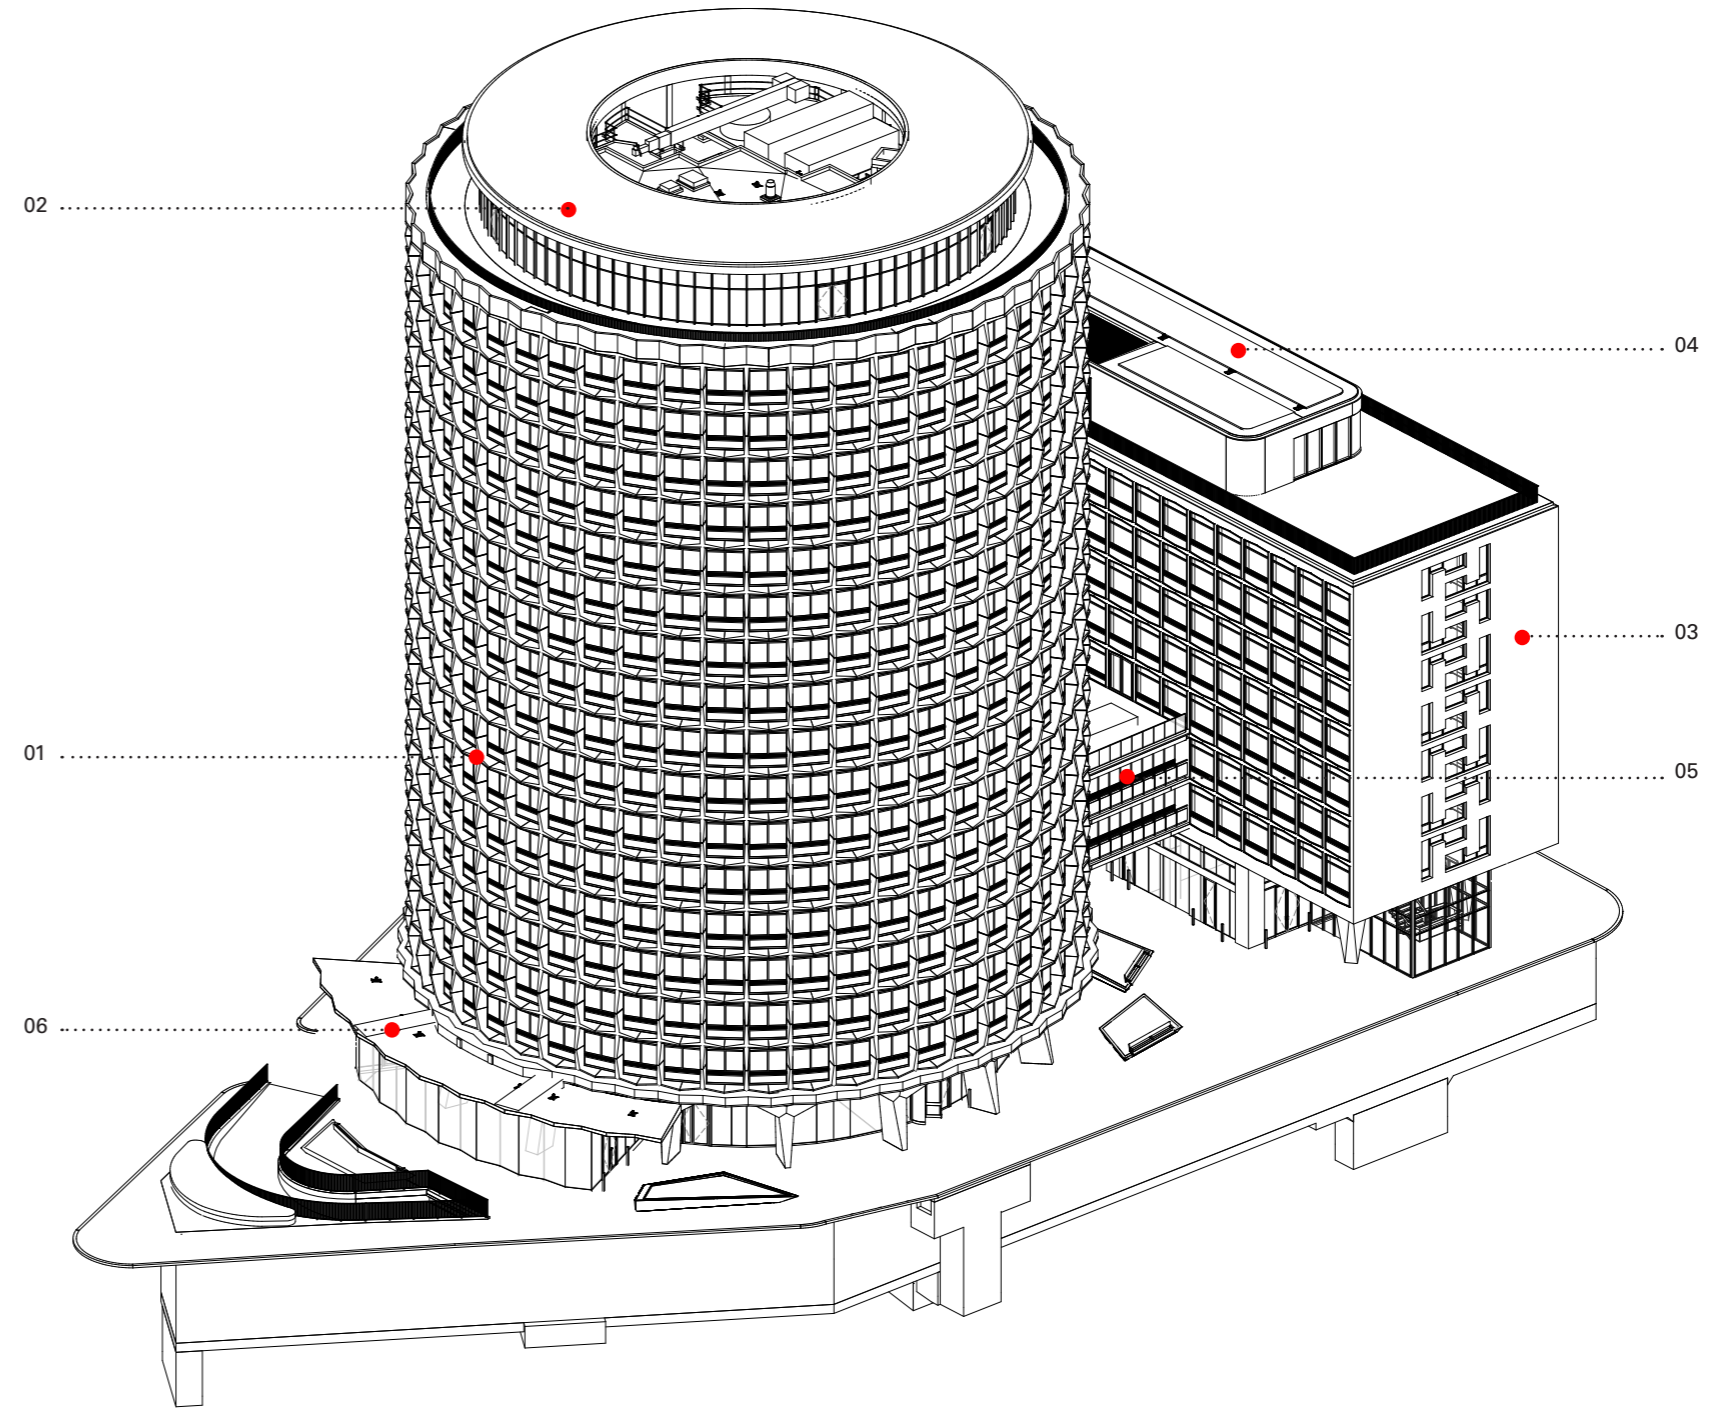
Fig. 1.0.1 Space House Axonometric

- Key:
- 01. Tower building
  - 02. Tower extension
  - 03. Kingsway building
  - 04. Kingsway extension
  - 05. Bridge-Link
  - 06. Western Canopy (Filling Station)

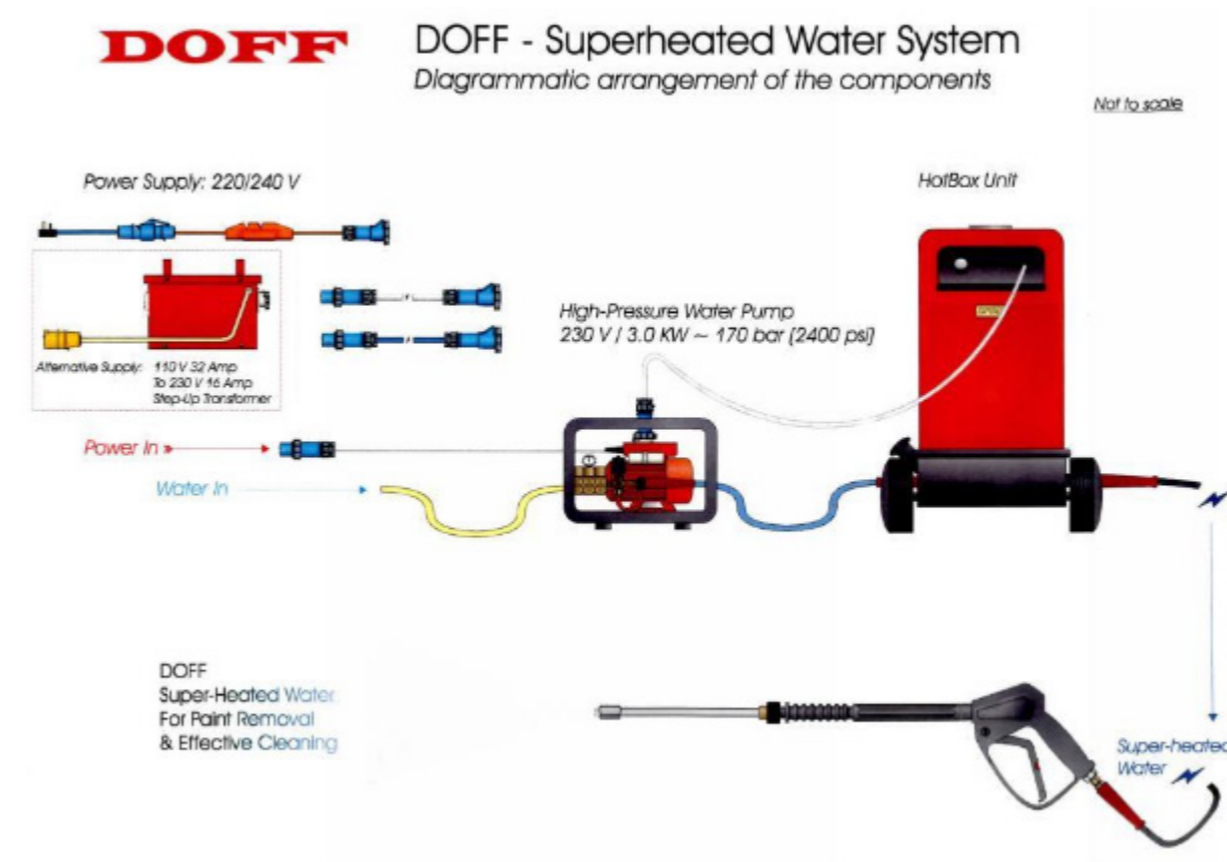
### Superheated water cleaning methodology (refer to Fig. 2.1.1)

- Operatives located the machine and cables on the scaffold adjacent to the work area.
- Temperature was set at 140 Centigrade and pressure was kept to a ‘safe’ level to prevent any abrasion or other disruptions to the substrate.
- Nozzle distance to the surface was set at 400mm – 500mm
- Operating temperature, nozzle pressure and distances to the substrate were controlled and monitored by the cleaning operative throughout the works. Minor alterations were made at the cleaner’s discretion to ensure no damage or abrasion occurred.

Fig. 2.1.1 Superheated water cleaning equipment

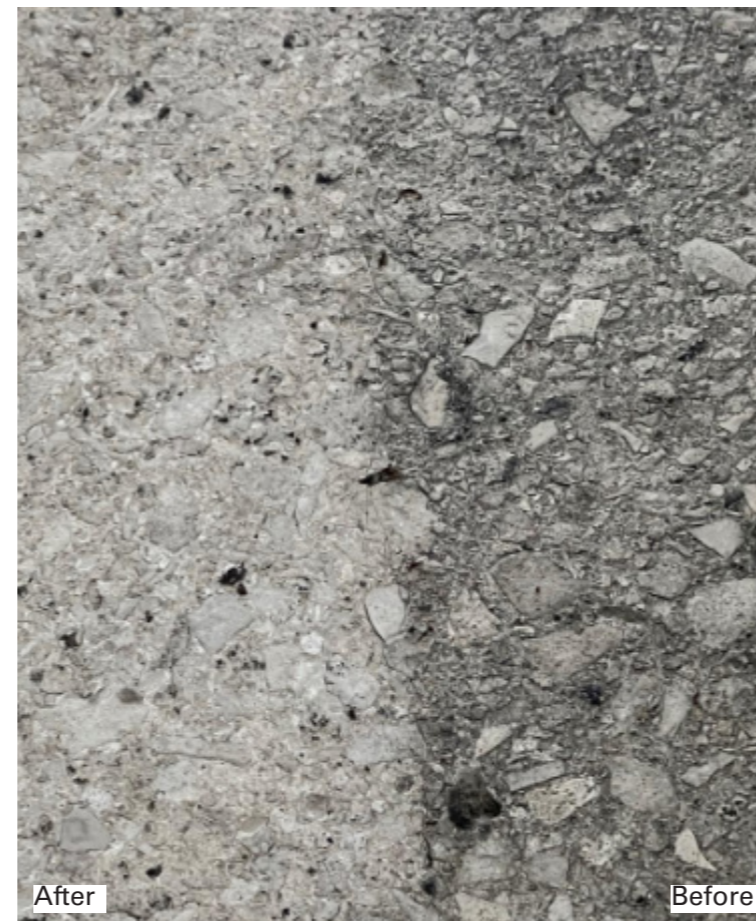
Fig. 2.1.2 demonstrates close up the eroded texture of the concrete surface and the before and after appearance of the cleaned surface.

Fig. 2.1.2 Concrete surface before and after cleaning

Whilst completing the initial survey prior to completing the sample clean it is evident that the surface erosion to the upper levels is greater than the lower levels and the orientation of the surface and water drain off from the cill spandrel above influences the extent of surface discolouring that occurs.

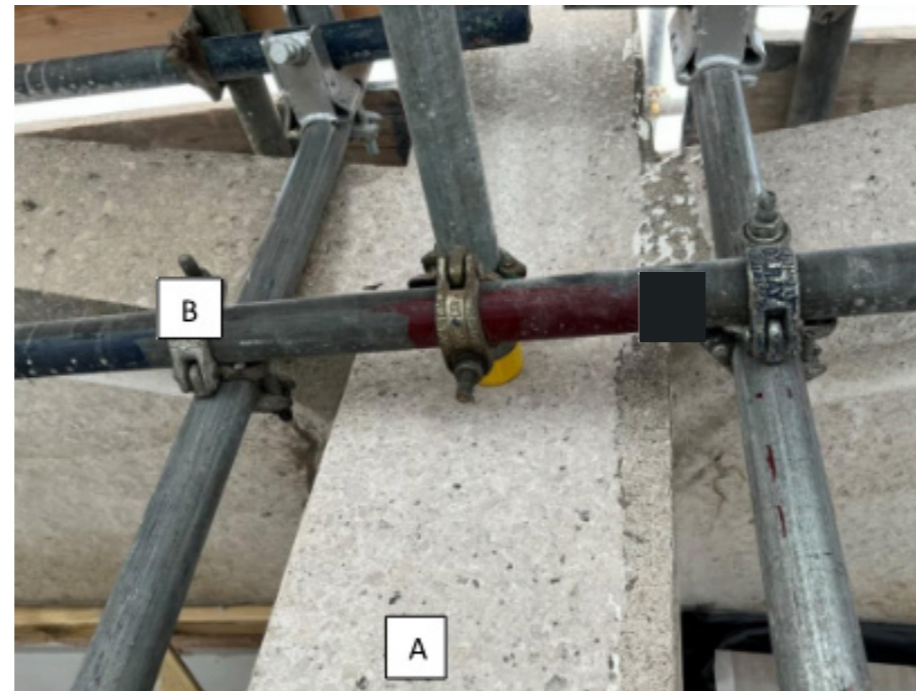
Fig. 2.1.3 shows the cleaned front face of the column 'A', the still dirty face of the spandrel cill 'B'.

Fig. 2.1.3 Cleaned front face

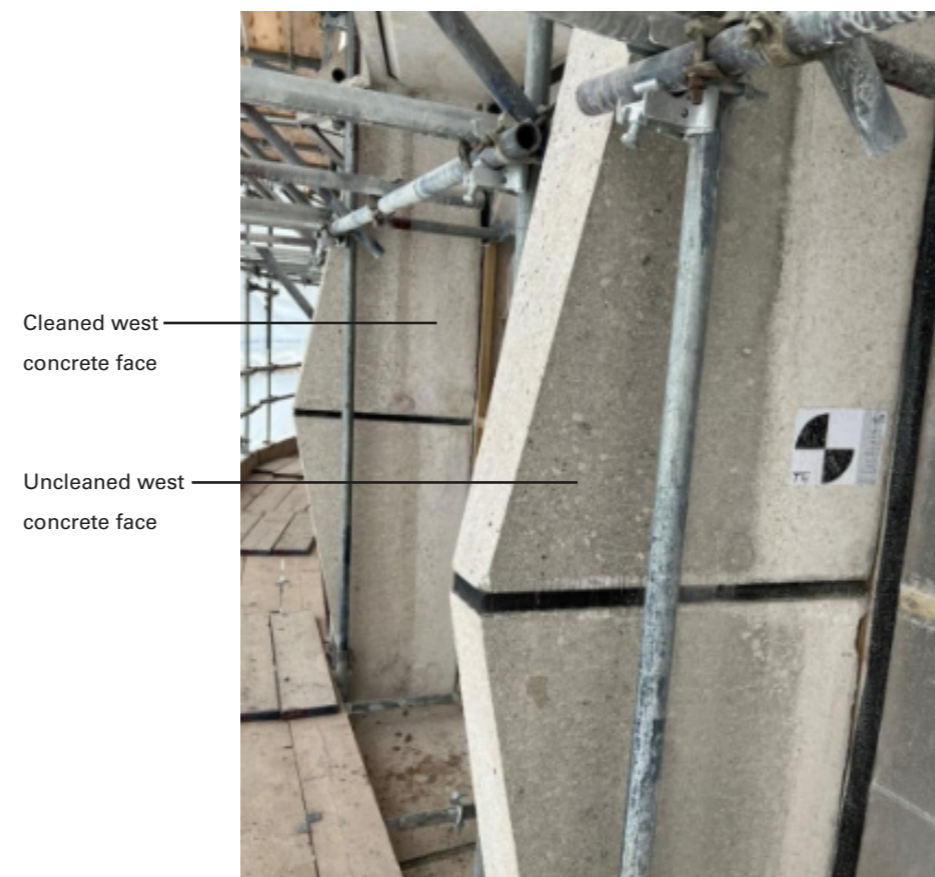
Fig. 2.1.4 and 2.1.5 show the West and East cleaned column faces in comparison to the uncleaned adjacent columns.

Fig. 2.1.4 West concrete faces (cleaned and uncleaned)

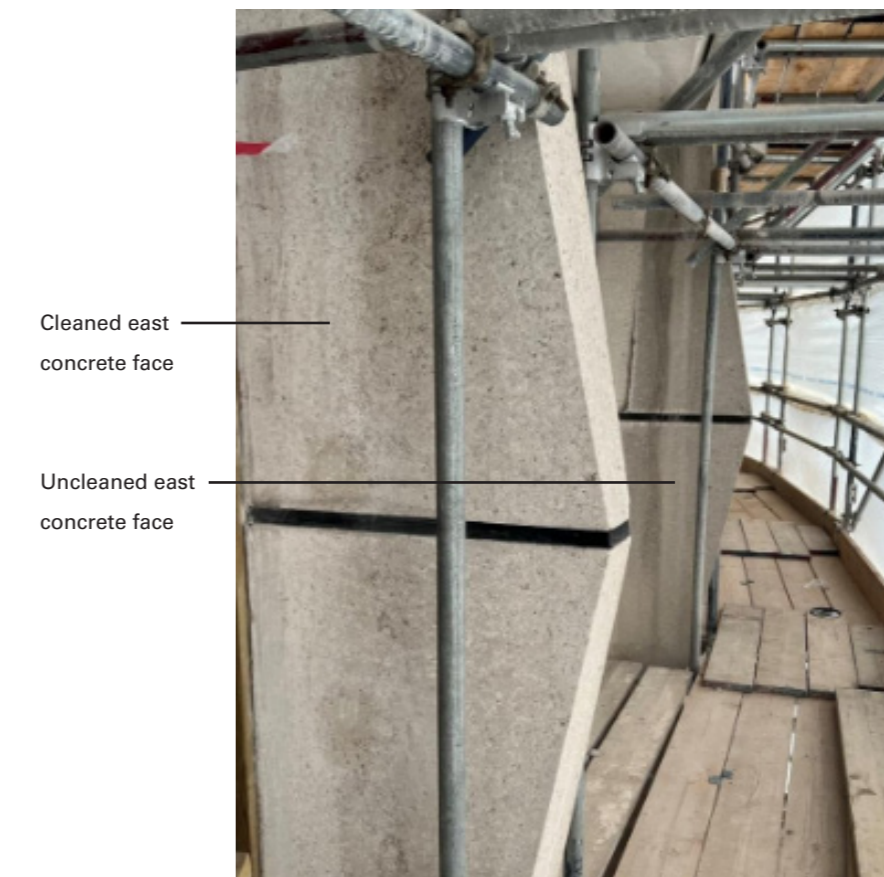
Fig. 2.1.5 East concrete faces (cleaned and uncleaned)

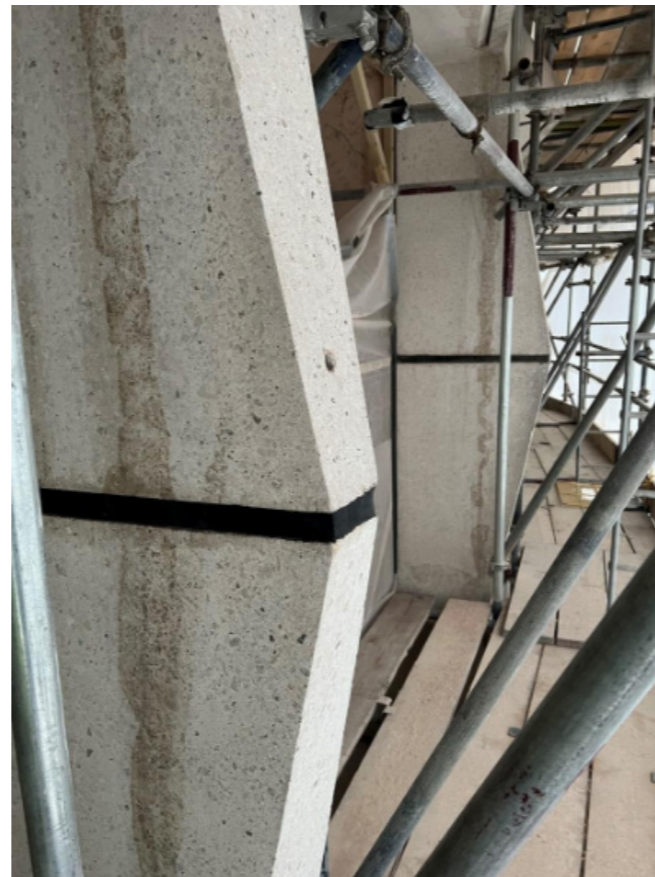
Fig. 2.1.6 shows adhesive residue uncovered after the facade superheated water cleaning sample was undertaken. This residue can be cleaned by using Tensid 510 stripper paste (solvent cleaner).

Fig. 2.1.6 Example of adhesive residue from asbestos removal

Reccommendation is to apply Tensid 510 stripper paste to concrete and if after the first application there's still some residue left then a 2nd application should be carried out in the relevant areas.

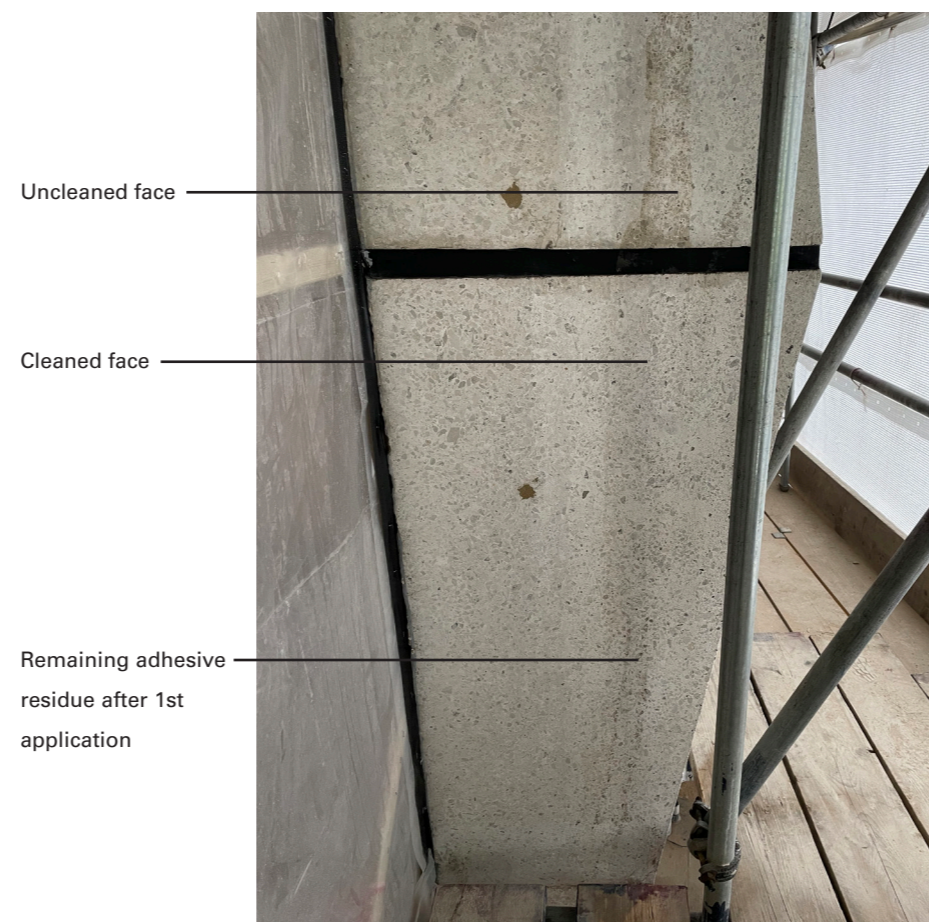
An application of Tensid 510 stripper paste was applied to the sample area of concrete that was affected by spray contact adhesive. The 510 stripper paste was then washed off using a high pressure steam clean - see results in Fig. 2.1.7. Following a drying out period of approximately 1 hour, evidence of the adhesive still remained. Once the concrete had fully dried, a second application was carried out following the same process. A further period of 1 hour was left for the concrete to dry off before the area was inspected again - results can be seen in Fig. 2.1.8.

Fig. 2.1.7 Results from first application of Tensid 510 stripper paste

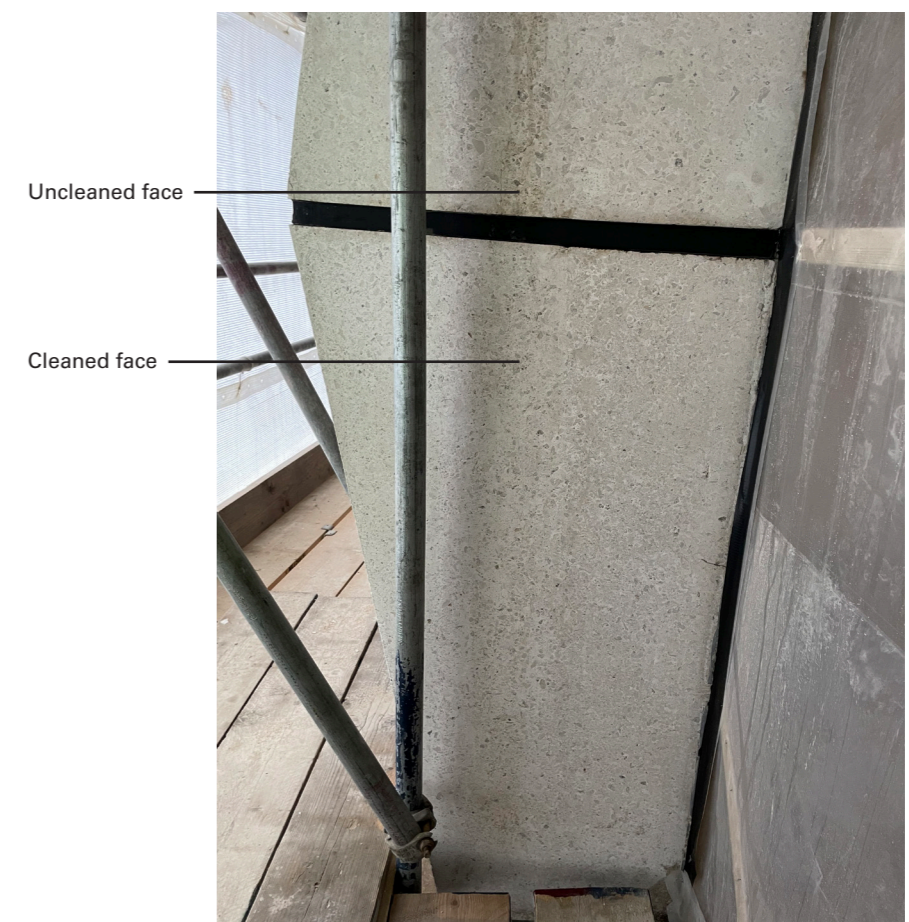
Fig. 2.1.8 Results from second application of Tensid 510 stripper paste
