1-10 Cambridge Gate

Condition Report

Paint Analysis Report

Paint Analysis Report, Catherine Hassall, May 2021

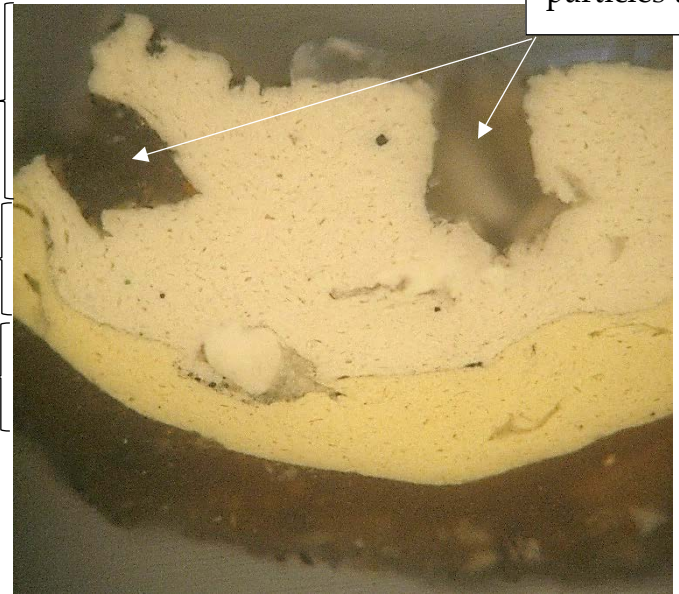
SAMPLE CG1-S2

Drapery, by foot

off-white alkyd paint
post-WW2
buff-coloured alkyd paint
sealant

added sand
particles to

The cleaned terracotta surface of the statues was then coated with an organic layer presumably applied as a sealant. In the cross-sections, that layer appears brown [Sample S2, p.3], but this may be partly due to dirt. The sealant worked its way down between the remains of early layers [see Sample S11, p.4]

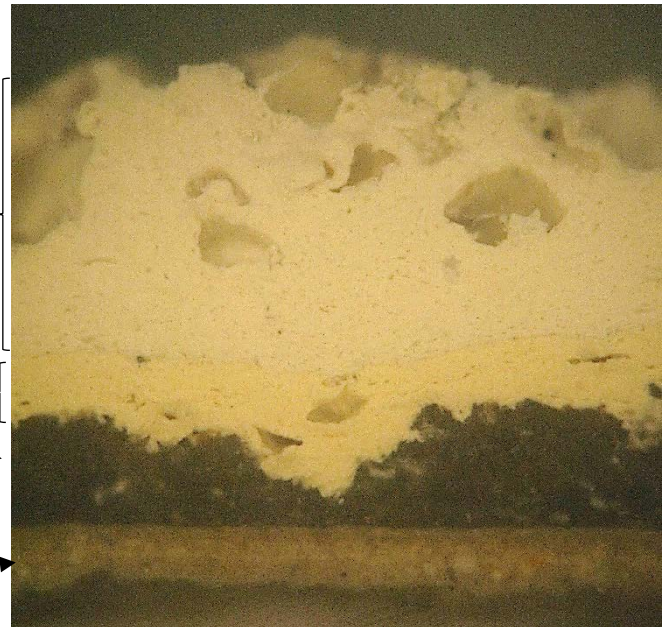
SAMPLE CG1-S3

Drapery over right leg

final paint scheme
post-WW2 buff alkyd paint
dirt and sealant
earlier limewash layer

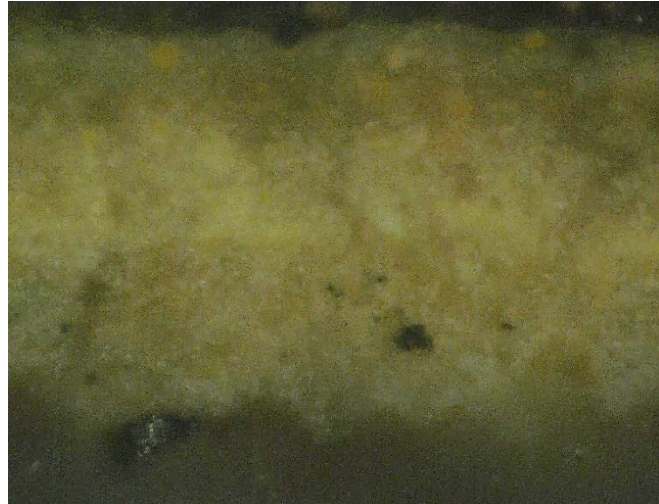
Detail of the limewash

Applied in more than one layer, it is mostly calcium carbonate but contains ochre and carbon black

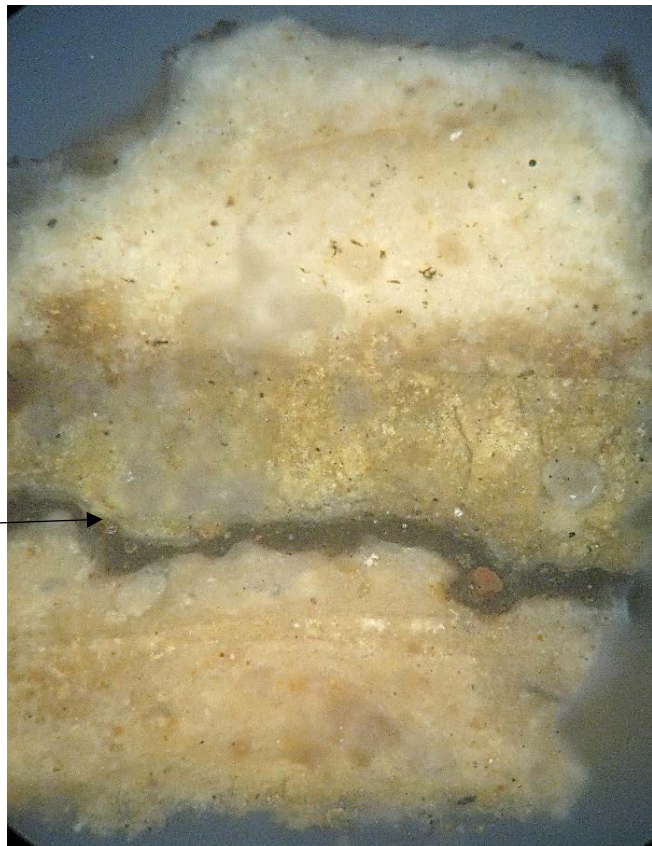
SAMPLE CG2-7

Figure 2 - paint over sulphated underlayers

Showing four, possibly five, layers of stone-coloured limewash

down
Sealant applied after
WW2 has soaked
between the layers

The earliest coatings on the terracotta figures were stone-coloured limewashes [see Sample 7, p.4].

It is not possible to tell if any of these limewashes date back to 1880, but four, possibly five, lots of limewash were found in one sample, and the practice of coating the statues in this fashion must have extended over a long period.

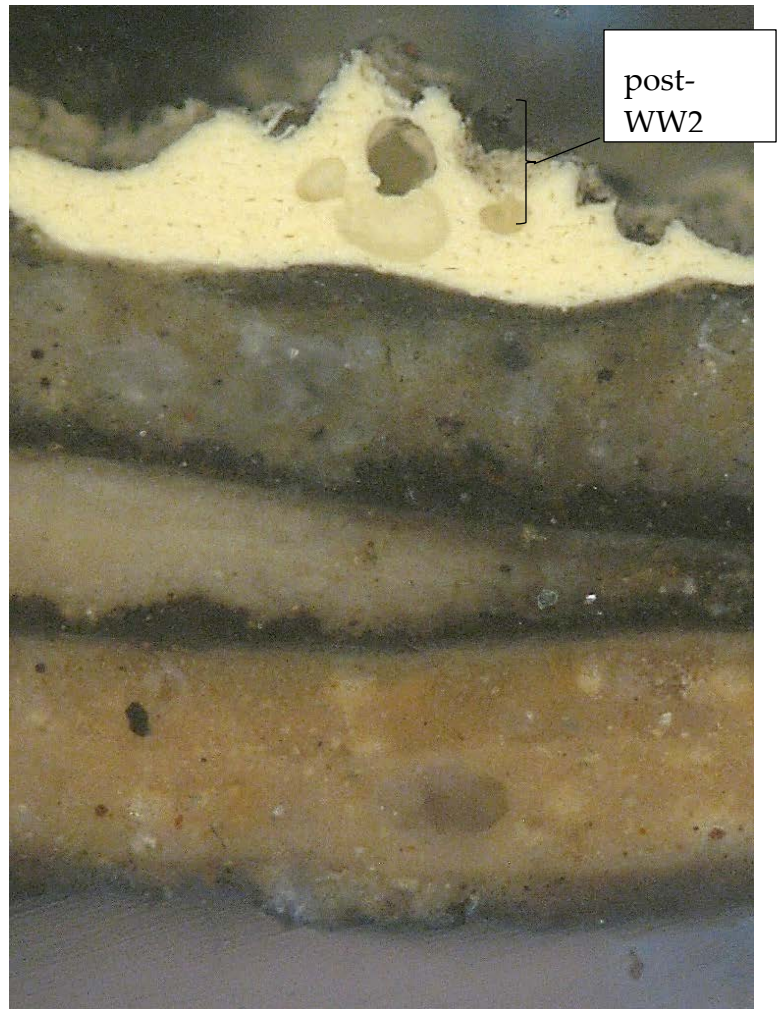
SAMPLE CG3-S11

Statue

Between the limewashes are layers of dirt as well of some of the sealant which worked its way down through the layers.

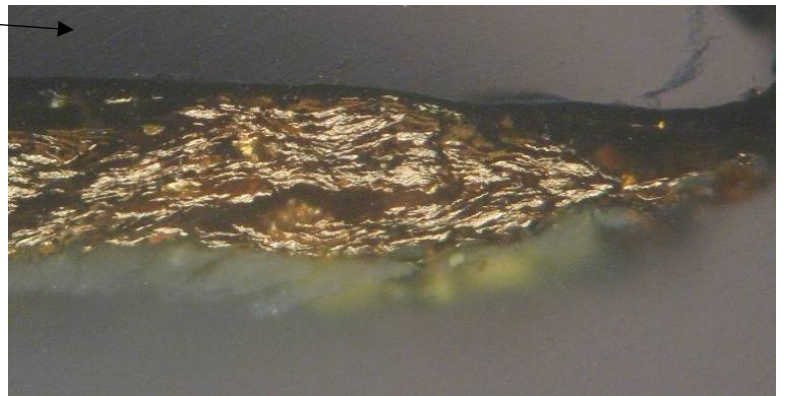
SAMPLE CG2-P9

Letters E & A on plinth

'gold' paint based on
brass filings

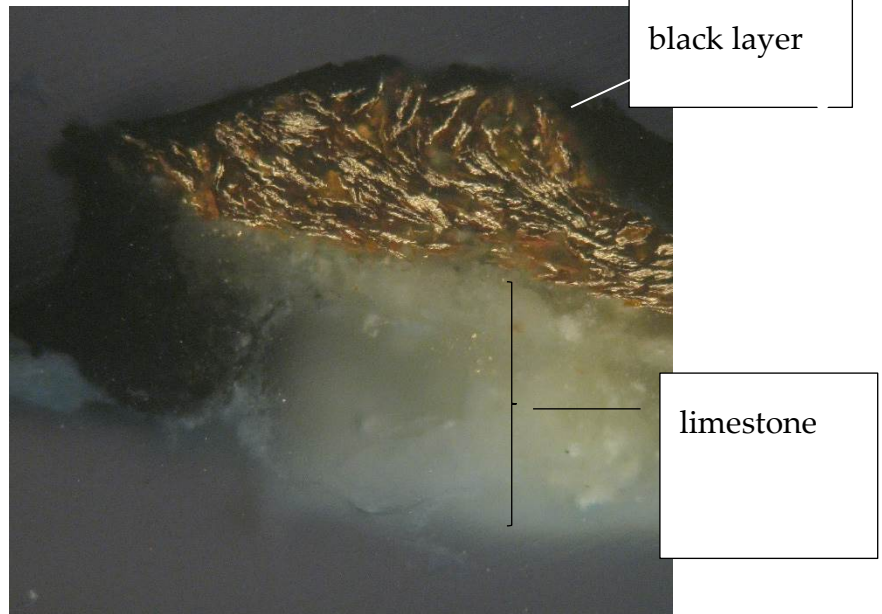
SAMPLE CG3.P12

Letter C on plinth

Showing black paint over
earlier 'gold' paint

The samples taken from the letters of the inscriptions show 'gold' paint based on brass filings in a shellac medium. This paint was later covered over with solid black paint.

'Gold' paint of this type was not in use in the 1880s, and the coating is likely to have been applied in the twentieth-century, probably after the Second World War when the statues were coated with alkyd paints.

The black could have been applied when the groups were painted for the last time.

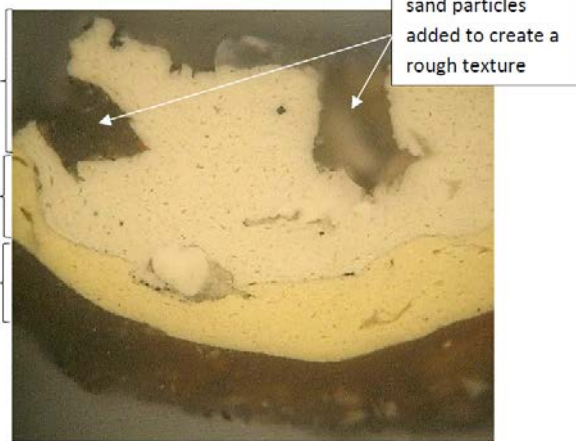
SAMPLE S2

CG1 - Drapery, by foot

off-white alkyd paint
post-WW2
buff-coloured alkyd paint
sealant

The cleaned terracotta surface of the statues was then coated with an organic layer presumably applied as a sealant. In the cross-sections, that layer appears brown [Sample S2, p.4], but this may be partly due to dirt. The sealant worked its way down between the remains of early layers [see Sample S11, p.5]

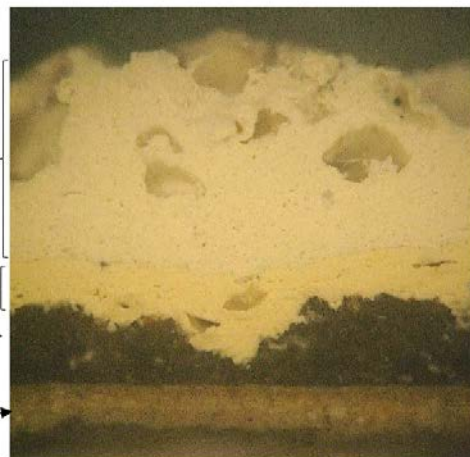
SAMPLE S3

CG2 - Drapery over right leg

final paint scheme
post-WW2 buff alkyd paint
dirt and sealant
stone-coloured
limewash layer

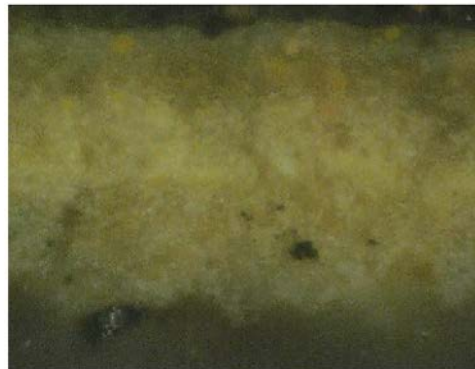
Detail of the limewash

Applied in more than one layer, it is mostly calcium carbonate but contains ochre and carbon black

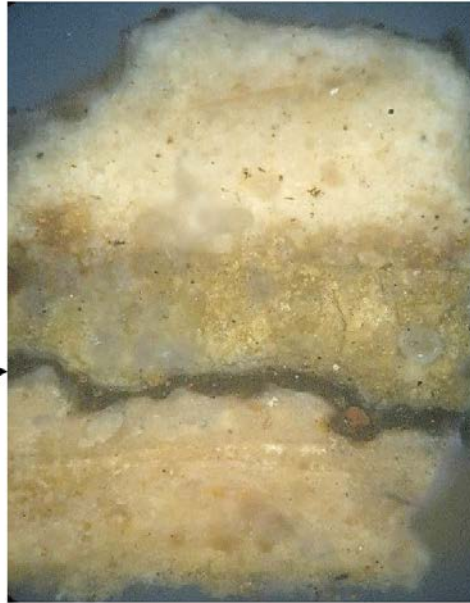
SAMPLE S7

CG2 - Figure 2 - paint over sulphated underlayers

Showing four, possibly five, layers of stone-coloured limewash

Sealant applied after
WW2 has soaked down
between the layers

The red was not repeated, and the statues may now have been coated with a stone-coloured limewash. The figures went on to be painted a further three, possibly four times using similar coloured limewashes, and so the practice must have started quite early [see Sample S.7, p.5].

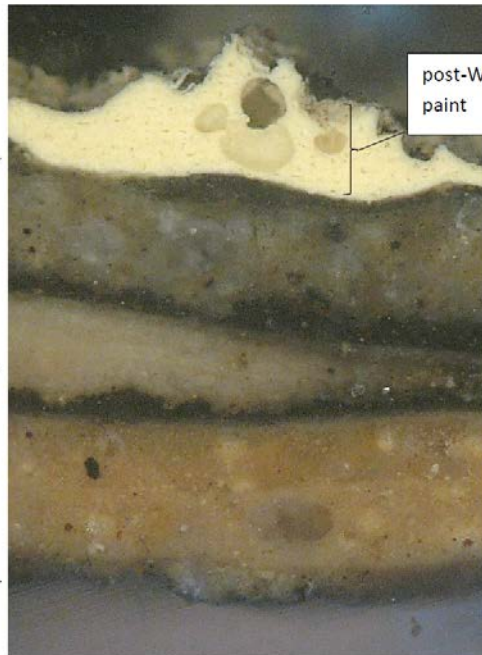
SAMPLE S11

CG3 - Statue

Between the limewashes are layers of dirt as well of some of the sealant which worked its way down through the layers.

stone-coloured limewashes

post-WW2
paint

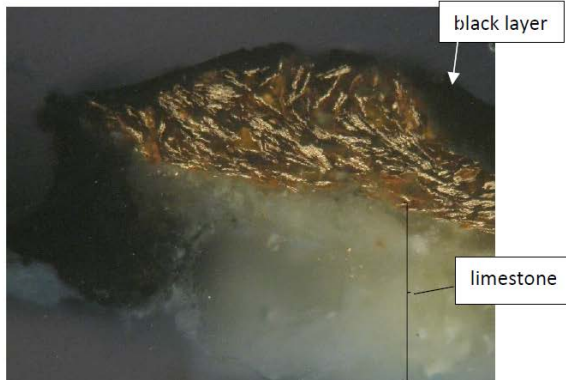
SAMPLE P12

Letter C on plinth

Showing black paint over
earlier 'gold' paint

black layer

limestone

This may have been the moment when 'gold' paint based on brass filings was used to fill in the letters on the plinths [see Sample P12, p.6].

The earlier 'gold' paint on the lettering was now covered over with a layer of solid back paint.

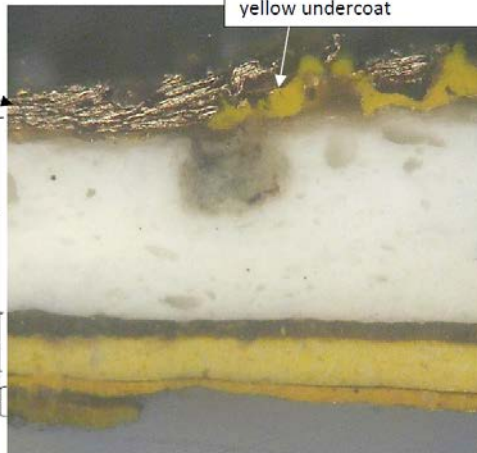
SAMPLE B1
MP1- letter 'B'

late C20th 'gold' paint

Showing 4 lots of gilding
applied before WW2

4th gilding
over white paint
based on lead white

3rd gilding
yellow for 2nd gilding

1st gilding

gold leaf of 4th decoration on
yellow undercoat

The letters on the limestone plinths were gilded. A dull yellow undercoat based on ochre was applied first, followed by oil gilding over a clear oil size [see Sample B1, p.7].

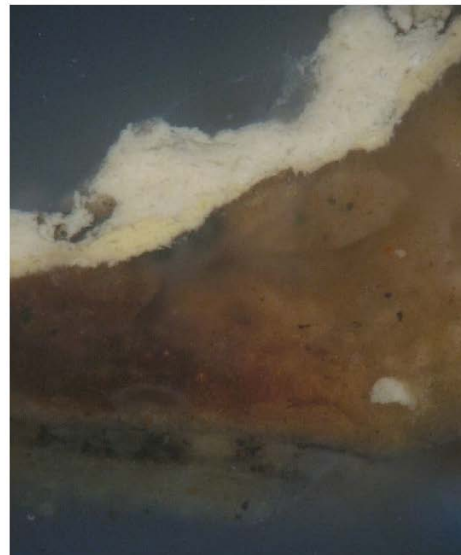
Fragment (i)

SAMPLE B5

MS4.1 – left drapery, under ivy

Showing layers of limewash
under the later C20th alkyd paints

The reddish colour of some of
them is probably due to the
brown sealant which has
soaked down into them.

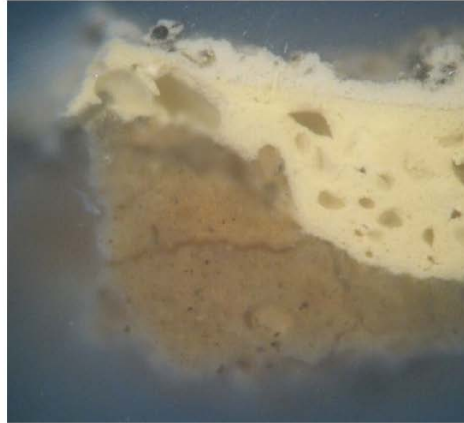
Fragment (ii)

No sealant in this piece

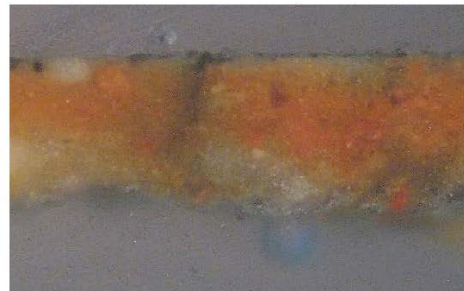
SAMPLE B6

MS4.1 – red on ivy, left leg

A deep red limewash layer
tinted with red iron oxides

The statues were given a coat of reddish limewash, tinted with a red iron oxide pigment. Traces of this were found on the terracotta surface in a couple of samples [see B7, p.8], but the full layer can be seen in Sample B6, p.7.

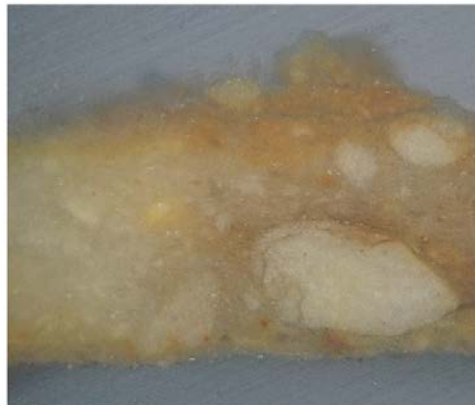
SAMPLE B7

MS2.2 – scrapings of original red

Showing surface of a terracotta
fragment with reddish layer on
top
