Remediation Verification Report

At: Antrim Grove
Allotments, Antrim Grove,
Belsize Park, London, NW3
4XR

For: London Borough of
Camden

Report Reference: LP2248/Verification

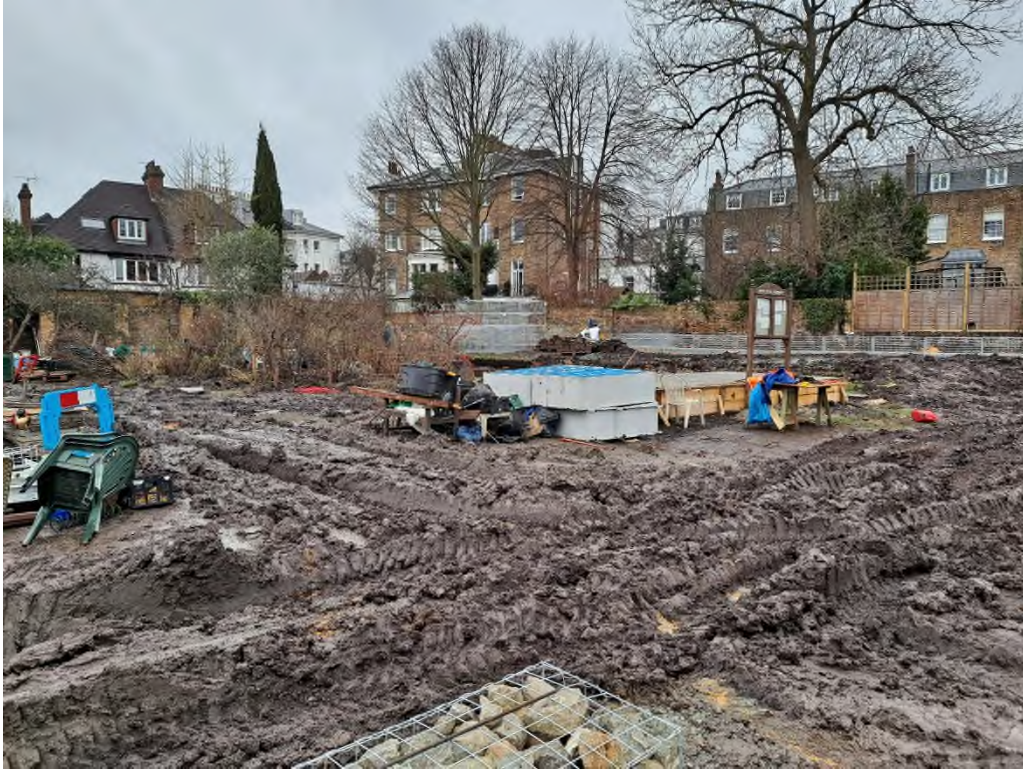
Plate 1: VISIT 15/02/22 – View of site looking west. Site cleared apart from a nursery bed. Central region of the photograph was the location of the communal shed

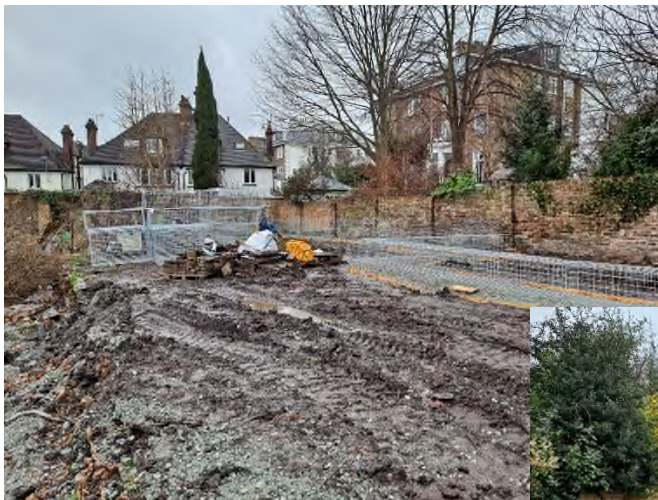
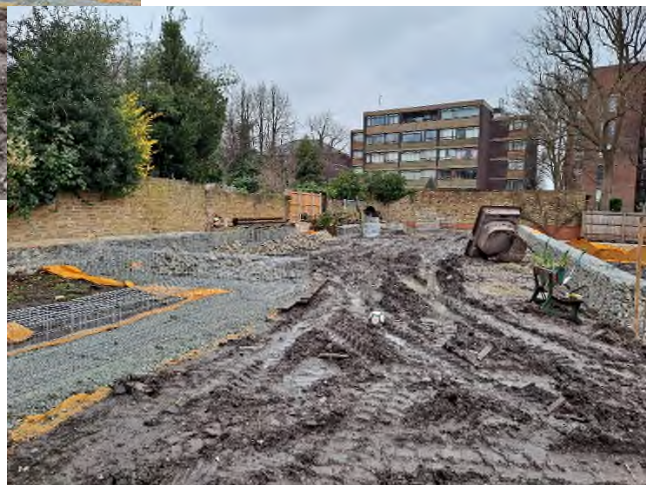
Plate 2: VISIT 15/02/22 – Gabions under construction in the northern regions of the site

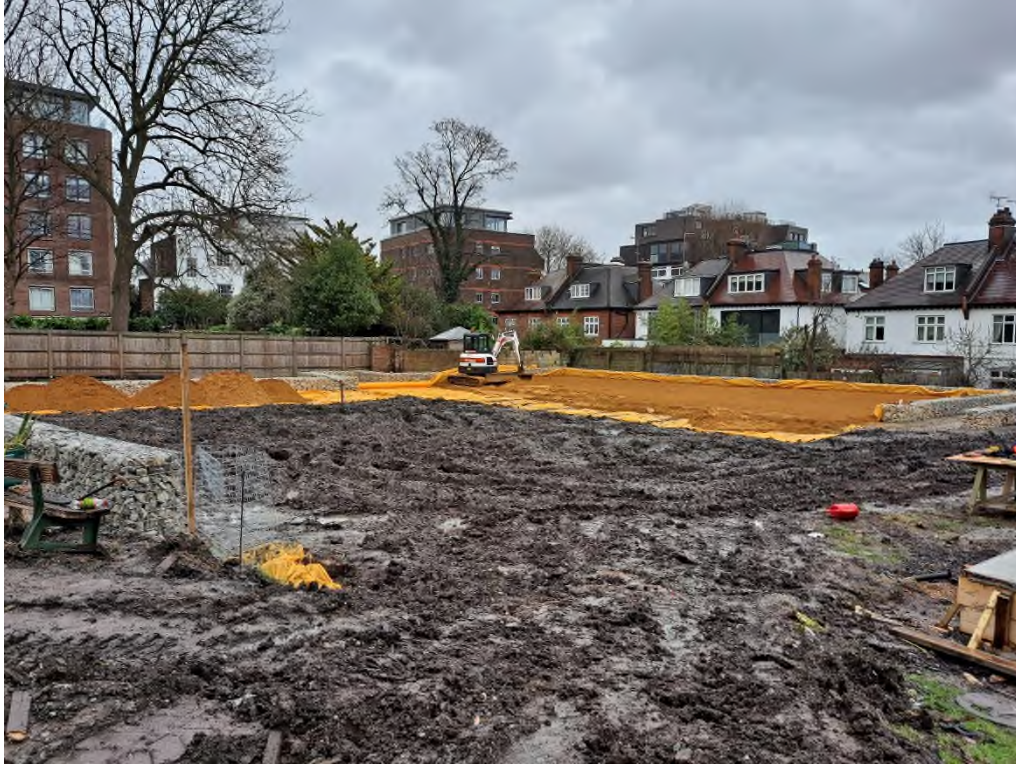
Plate 3: VISIT 15/02/22 – View looking east showing subsoil application over membrane in the southeast of the site

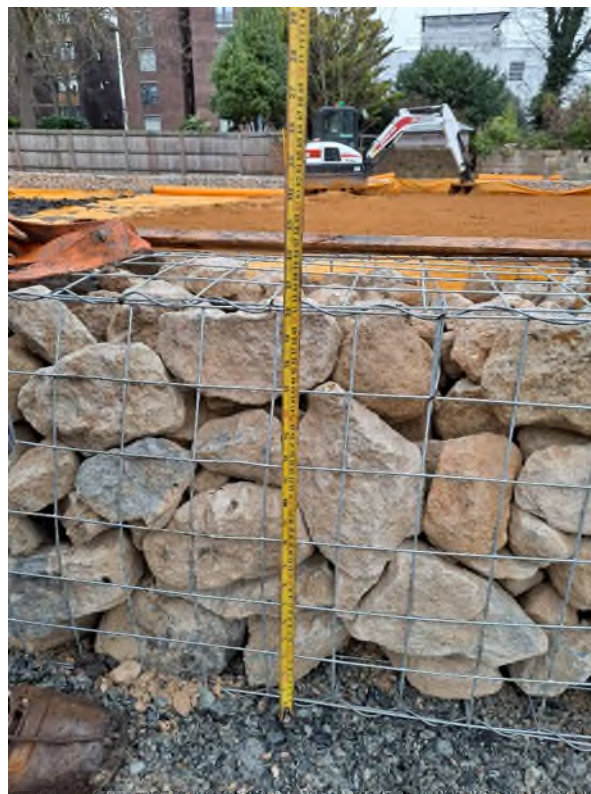
Plate 4: VISIT 15/02/22 – Confirmation of Gabion height – 500mm

At the time of the visit the site had been cleared and 500mm high Gabions had been constructed around the majority of the perimeter area of the site. A 1,000mm high Gabion wall had been constructed in place of the former retaining wall towards the rear of the site. The deter to dig membrane had been placed in the south eastern regions of the site. The membrane comprised Polyfelt produced by Tencate (a non-woven geotextile coloured yellow - similar to Terram). Subsoil had been applied to a depth of c. 250mm but had not yet been gently compacted. No topsoil was present on site. Four samples of subsoil were collected (two from insitu locations in the southeast of the site (confirming the thickness as c. 250mm) and two from material stockpiled on Polyfelt in the east of the site). Photographs are included as Appendix C.

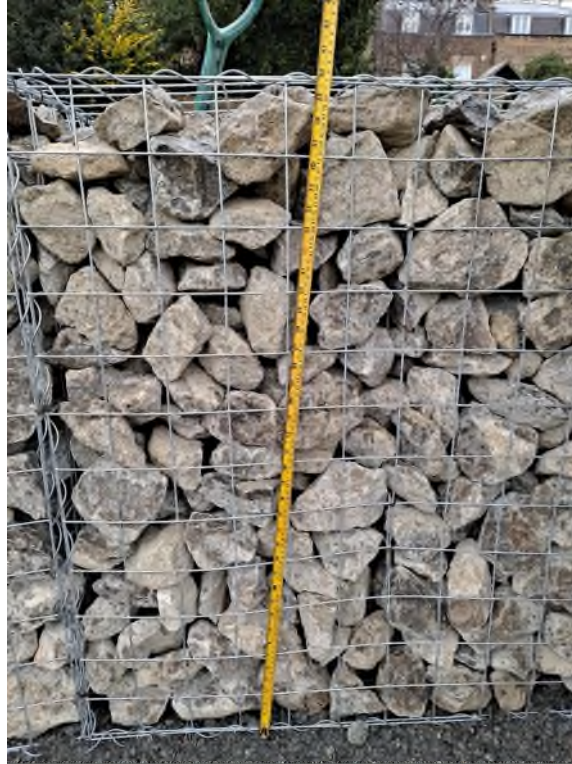
Plate 5: VISIT 15/02/22 – Confirmation of Gabion height in location of former retaining wall – 1,000mm

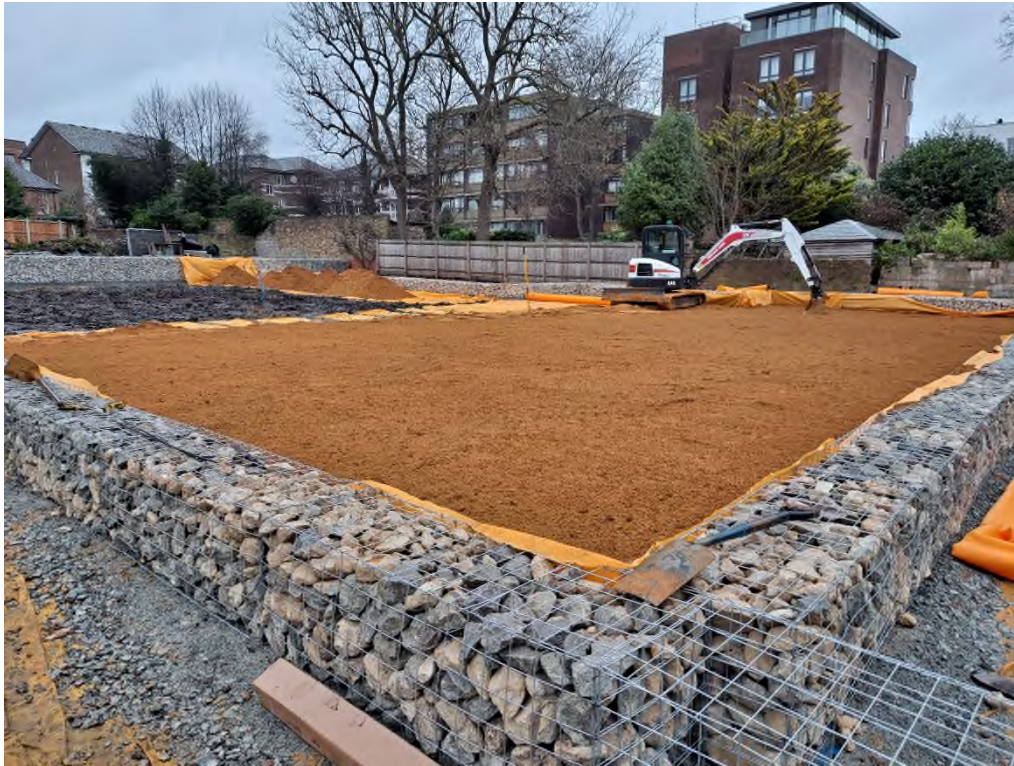
Plate 7: VISIT 15/02/22 – Subsoil being applied over membrane in the southeast of the site. Verification samples taken from this area (#2) and from the stockpile in the background (#2)

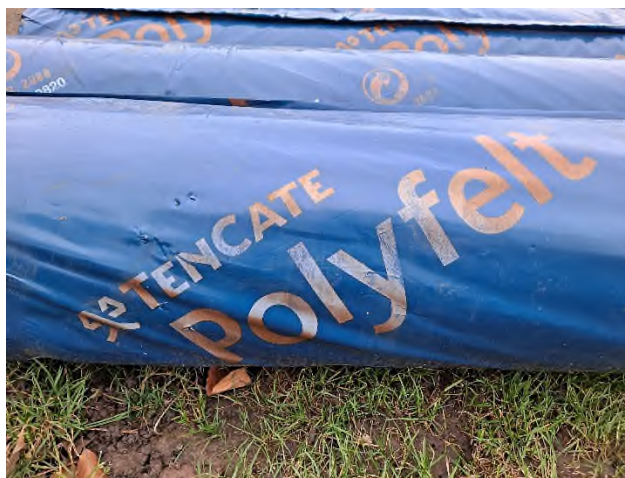
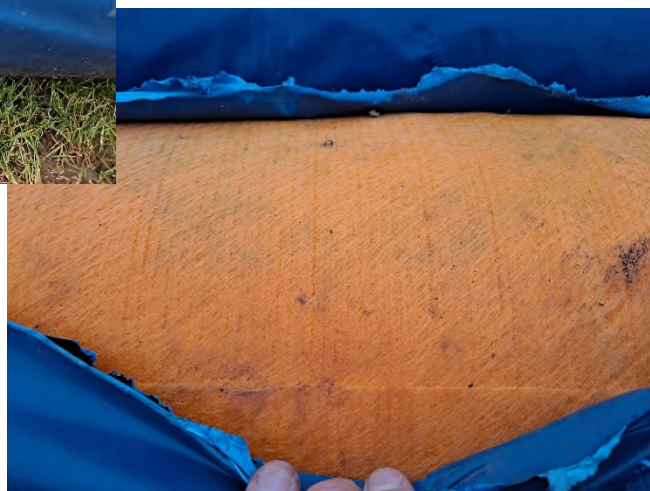
Plate 8: VISIT 15/02/22 – Membrane specification

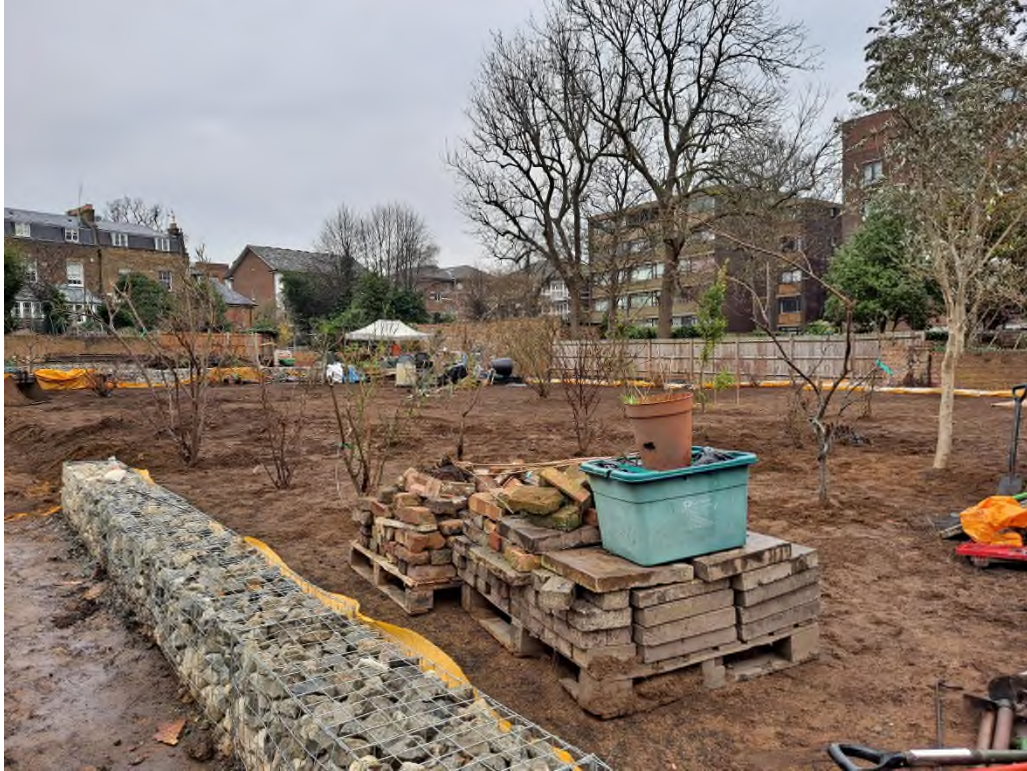
Plate 9: VISIT 16/03/22 – Plots to the right of the site entrance (east of the site) with clean cover applied and selected trees and shrubs re-planted

The area to the right-hand side of the site entrance was filled with subsoil and topsoil as far back as the retaining wall. A smaller area to the left-hand side of the site entrance was also complete from a clean cover infill standpoint. Gabions were being completed at the rear of the site and the communal 'shed' had been re-erected. The completed regions of the site also had some small trees and larger shrubs re-planted. Photographs are included as Appendix B. Six samples of topsoil were taken: five from in-situ locations all at just below surface level (0.0-0.1m bgl). Four samples were taken to the right of the site entrance and one was taken to the left of the site entrance. The sixth sample was taken from a small stockpile of topsoil present on the edge of the completed area to the left of the site entrance.

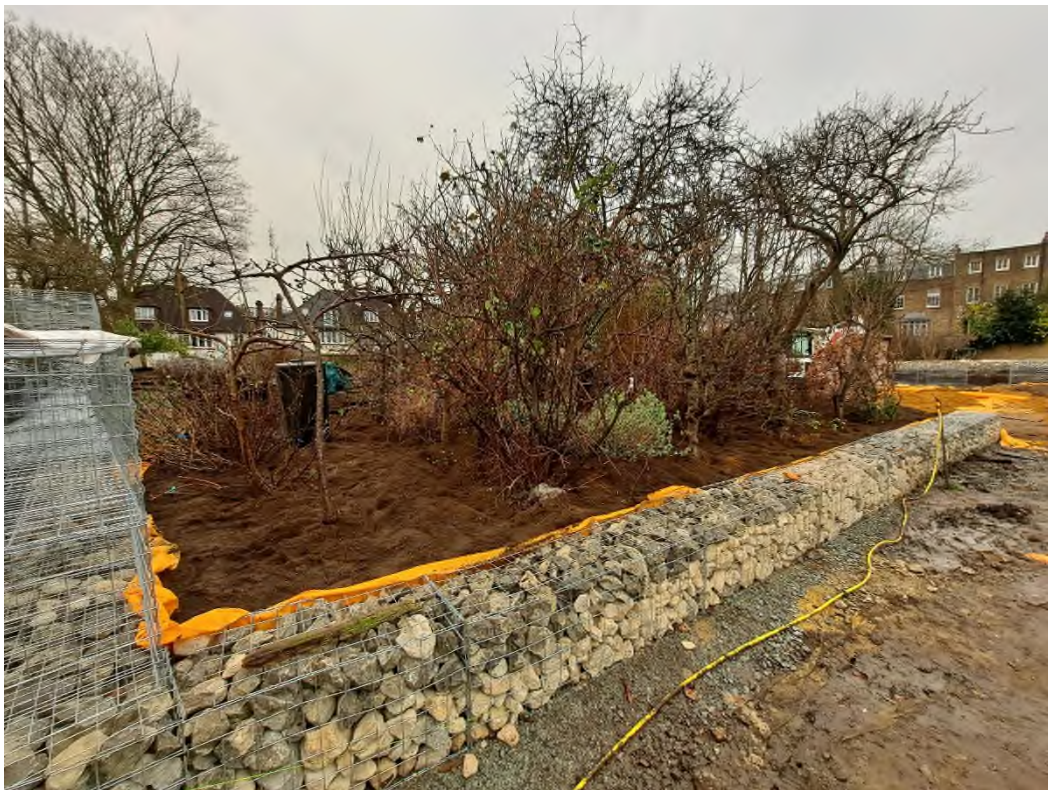
Plate 10: VISIT 16/03/22 – Plots to the left of the site entrance with clean cover applied and selected trees and shrubs temporarily re-planted as a nursery bed

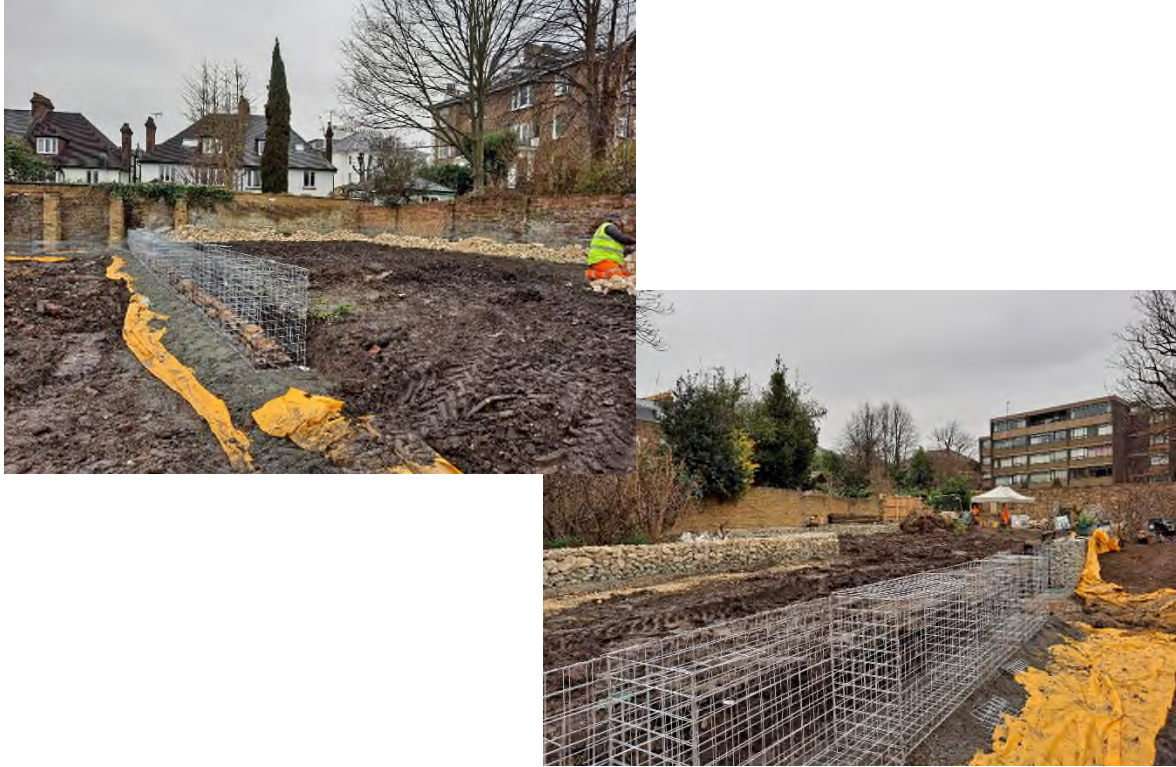
Plate 11: VISIT 16/03/22 – Gabion wall construction at the rear of the site

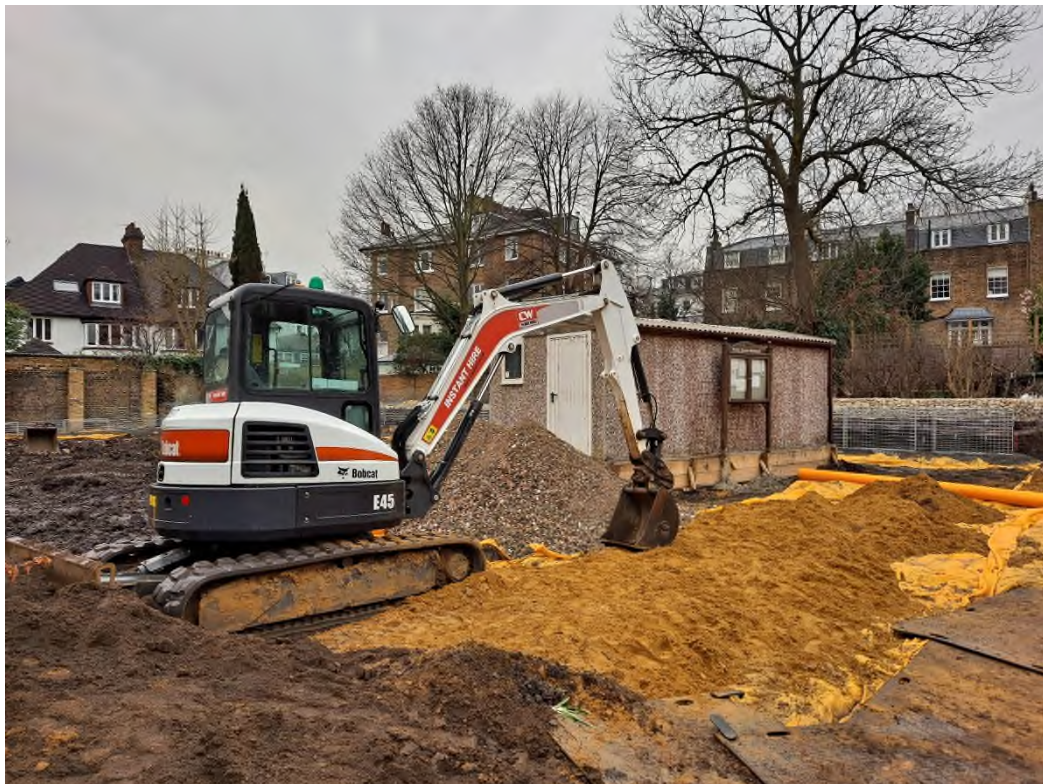
Plate 12: VISIT 16/03/22 – Communal shed re-constructed in the central region of the site

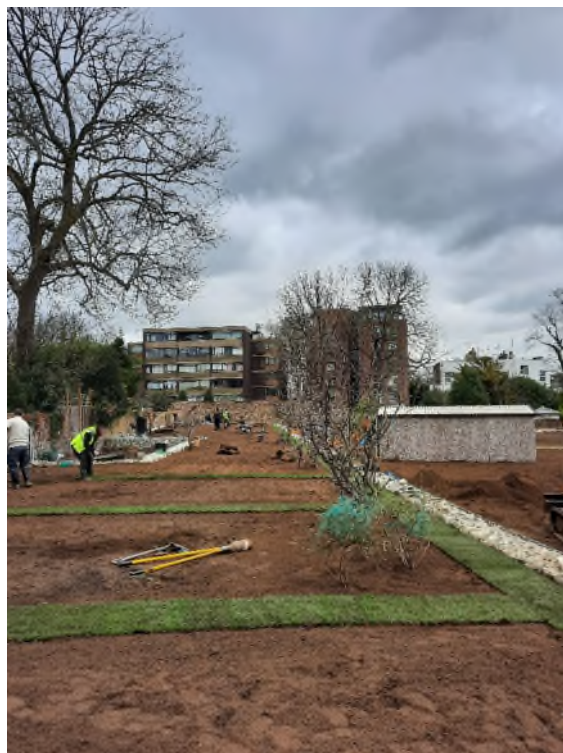
Plate 13: VISIT 05/04/22 – Plots to the north of the site with topsoil and turf boundaries placed.

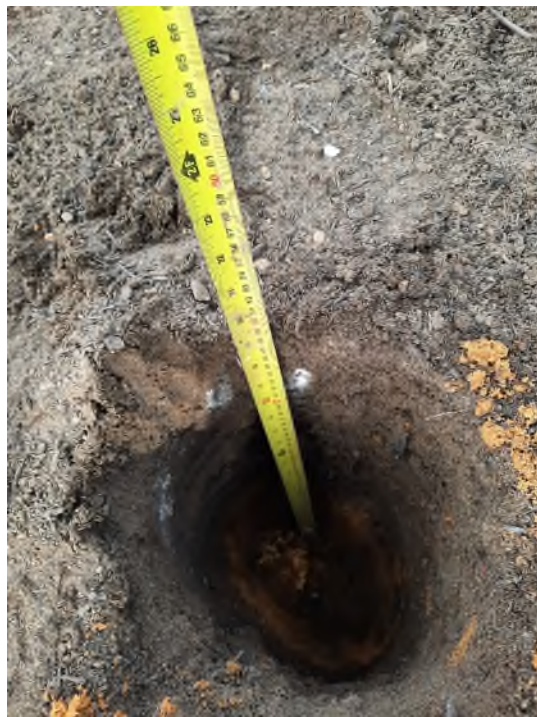
Plate 15: VISIT 05/04/22 – example inspection pit (Plot 1) showing 500mm cover

Verification of clean cover thickness was undertaken on 5th April. Subsoil had been placed across the entire site. Topsoil had been placed across everywhere except a small area near the site entrance. Works were underway to place topsoil in this final area. Trial holes were dug across the site with at least 1 pit excavated per plot. Table 1 lists the findings of the inspection pits. Photographs of example inspection pits are included in Appendix C. The RMS stated that a thickness of topsoil >300mm and subsoil >200mm was required across the site.

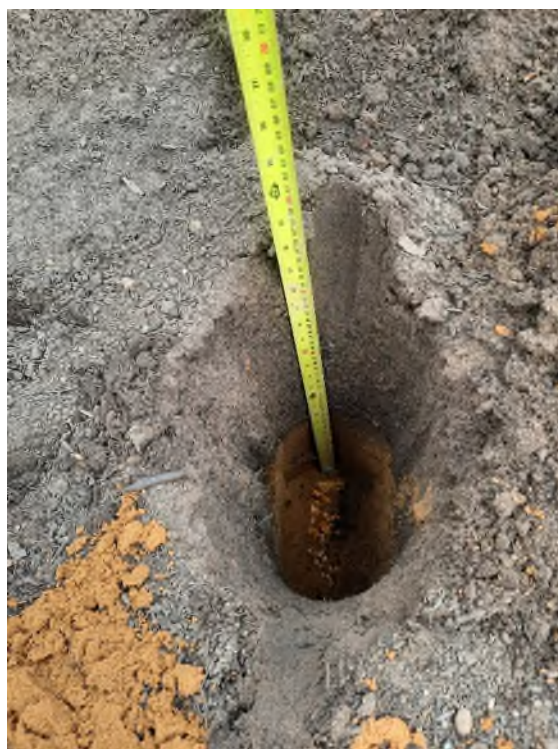
Plate 16: VISIT 05/04/22 – example inspection pit (plot 16a) showing 500mm cover

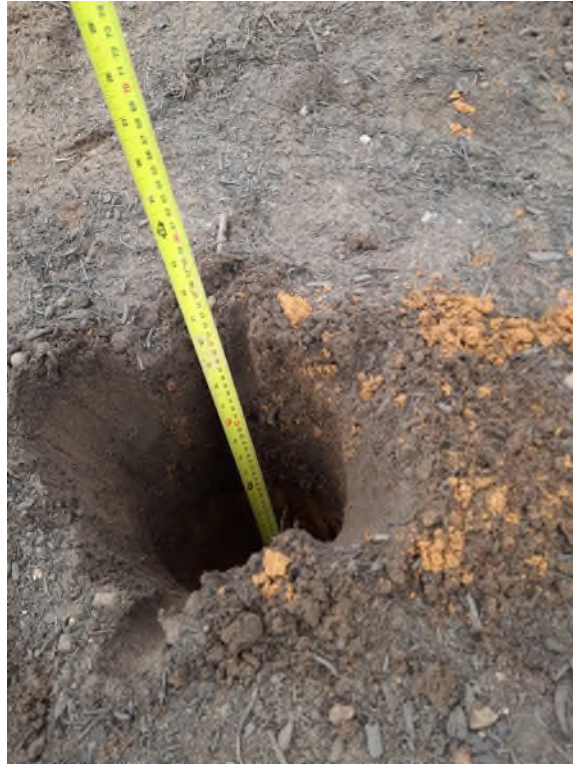
Plate 17: VISIT 05/04/22 – example inspection pit (plot 15b) showing 500mm cover

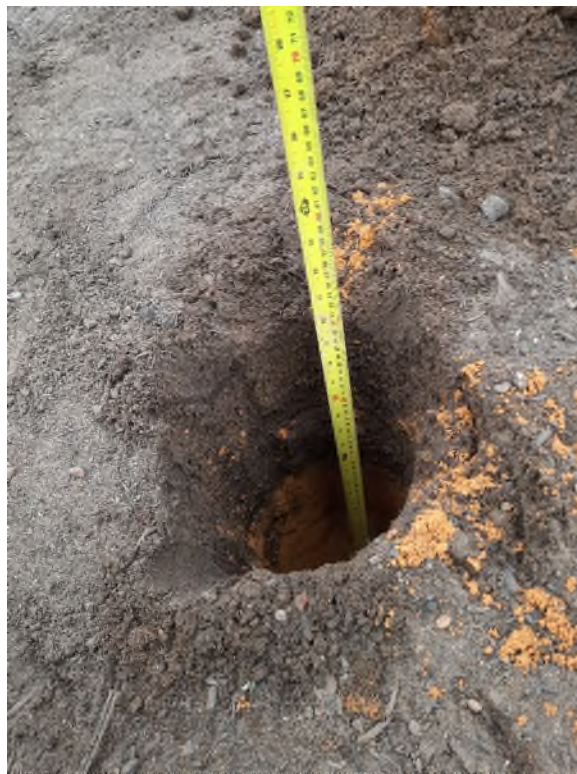
Plate 18: VISIT 05/04/22 – example inspection pit (plot 11a) showing 500mm cover

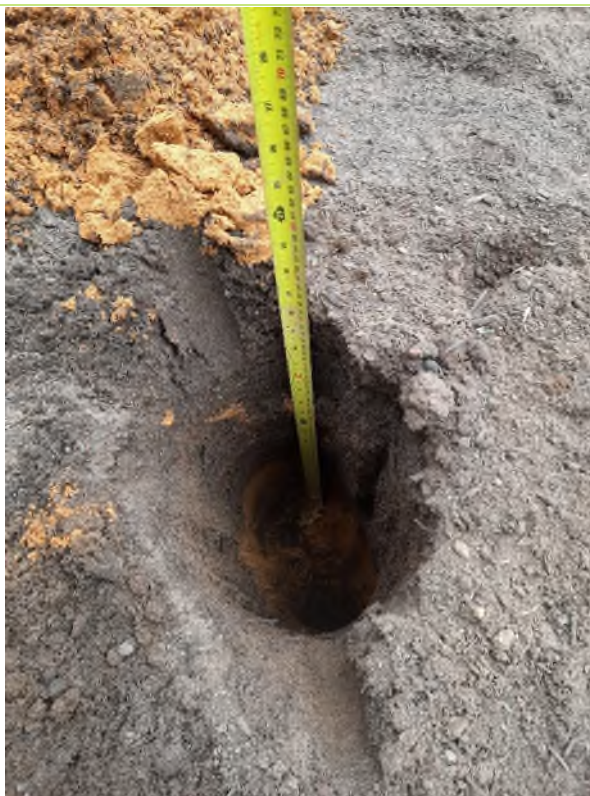
Plate 19: VISIT 05/04/22 – example inspection pit (plot 8b) showing 500mm cover

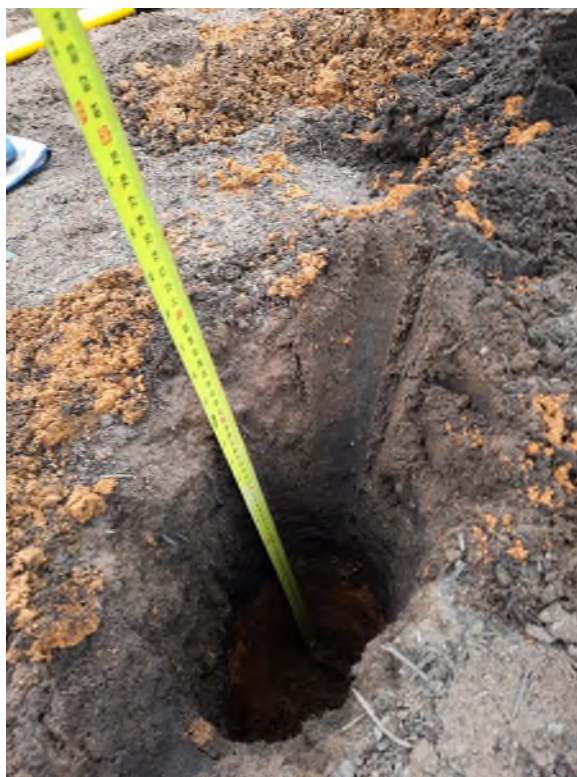
Plate 20: VISIT 05/04/22 – example inspection pit (plot 17b) showing 500mm cover

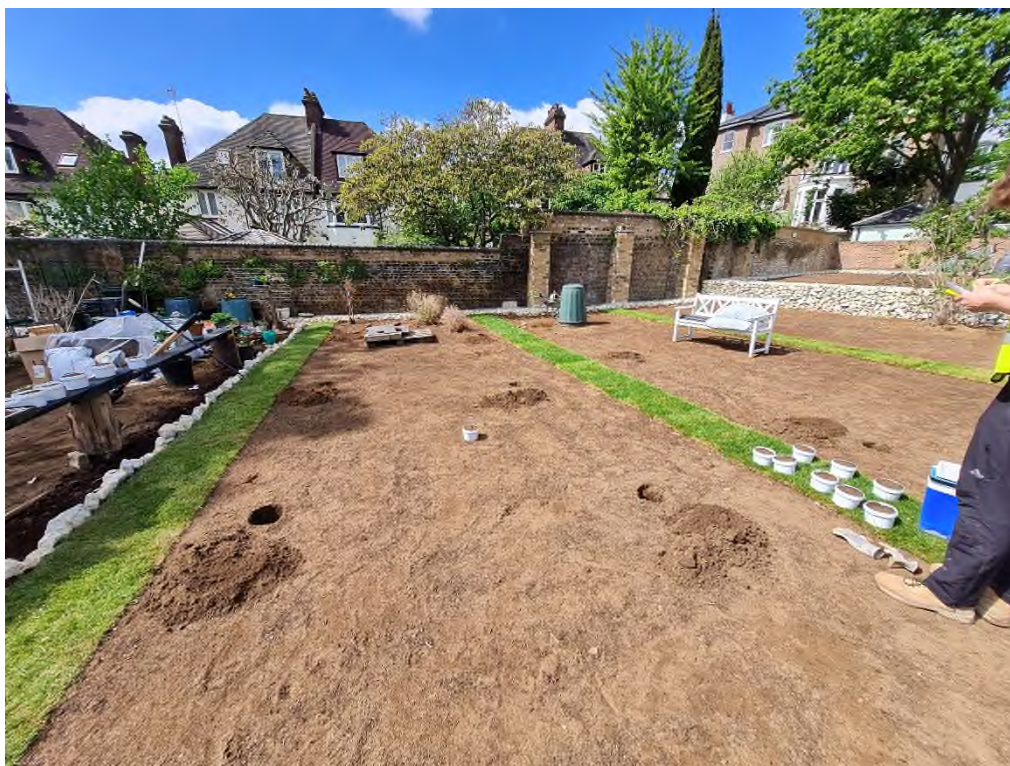
Plate 22: VISIT 05/05/22 – additional sampling locations plot 19.

Of the 12 No. initial samples of Topsoil which were tested a single sample taken on 5th April (plot 19b) was found to just exceed the specified criteria for Arsenic (44.1mg/kg against an import criteria of 37mg/kg). The remainder of the samples met all the criteria.

The geochemical quality of the imported clean cover soils complies with the requirements set out in the RMS apart from a small area located at the southwestern corner of plot 19b/southeastern corner of plot 19a. In this area a minor exceedance of the specified import criteria for arsenic has been identified. Whilst the average concentrations in both the individual plots and across the locale are well below the import criteria it is recommended that the topsoil in an area of approximately 7mx3m at this location is excavated, removed from site and replaced with fresh clean material in order to demonstrate that the remediation across the site has been completed fully in accordance with requirements.
