Roof Maintenance

HNCP

2023-RCK-RP-A-S5101

Roof Maintenance Access

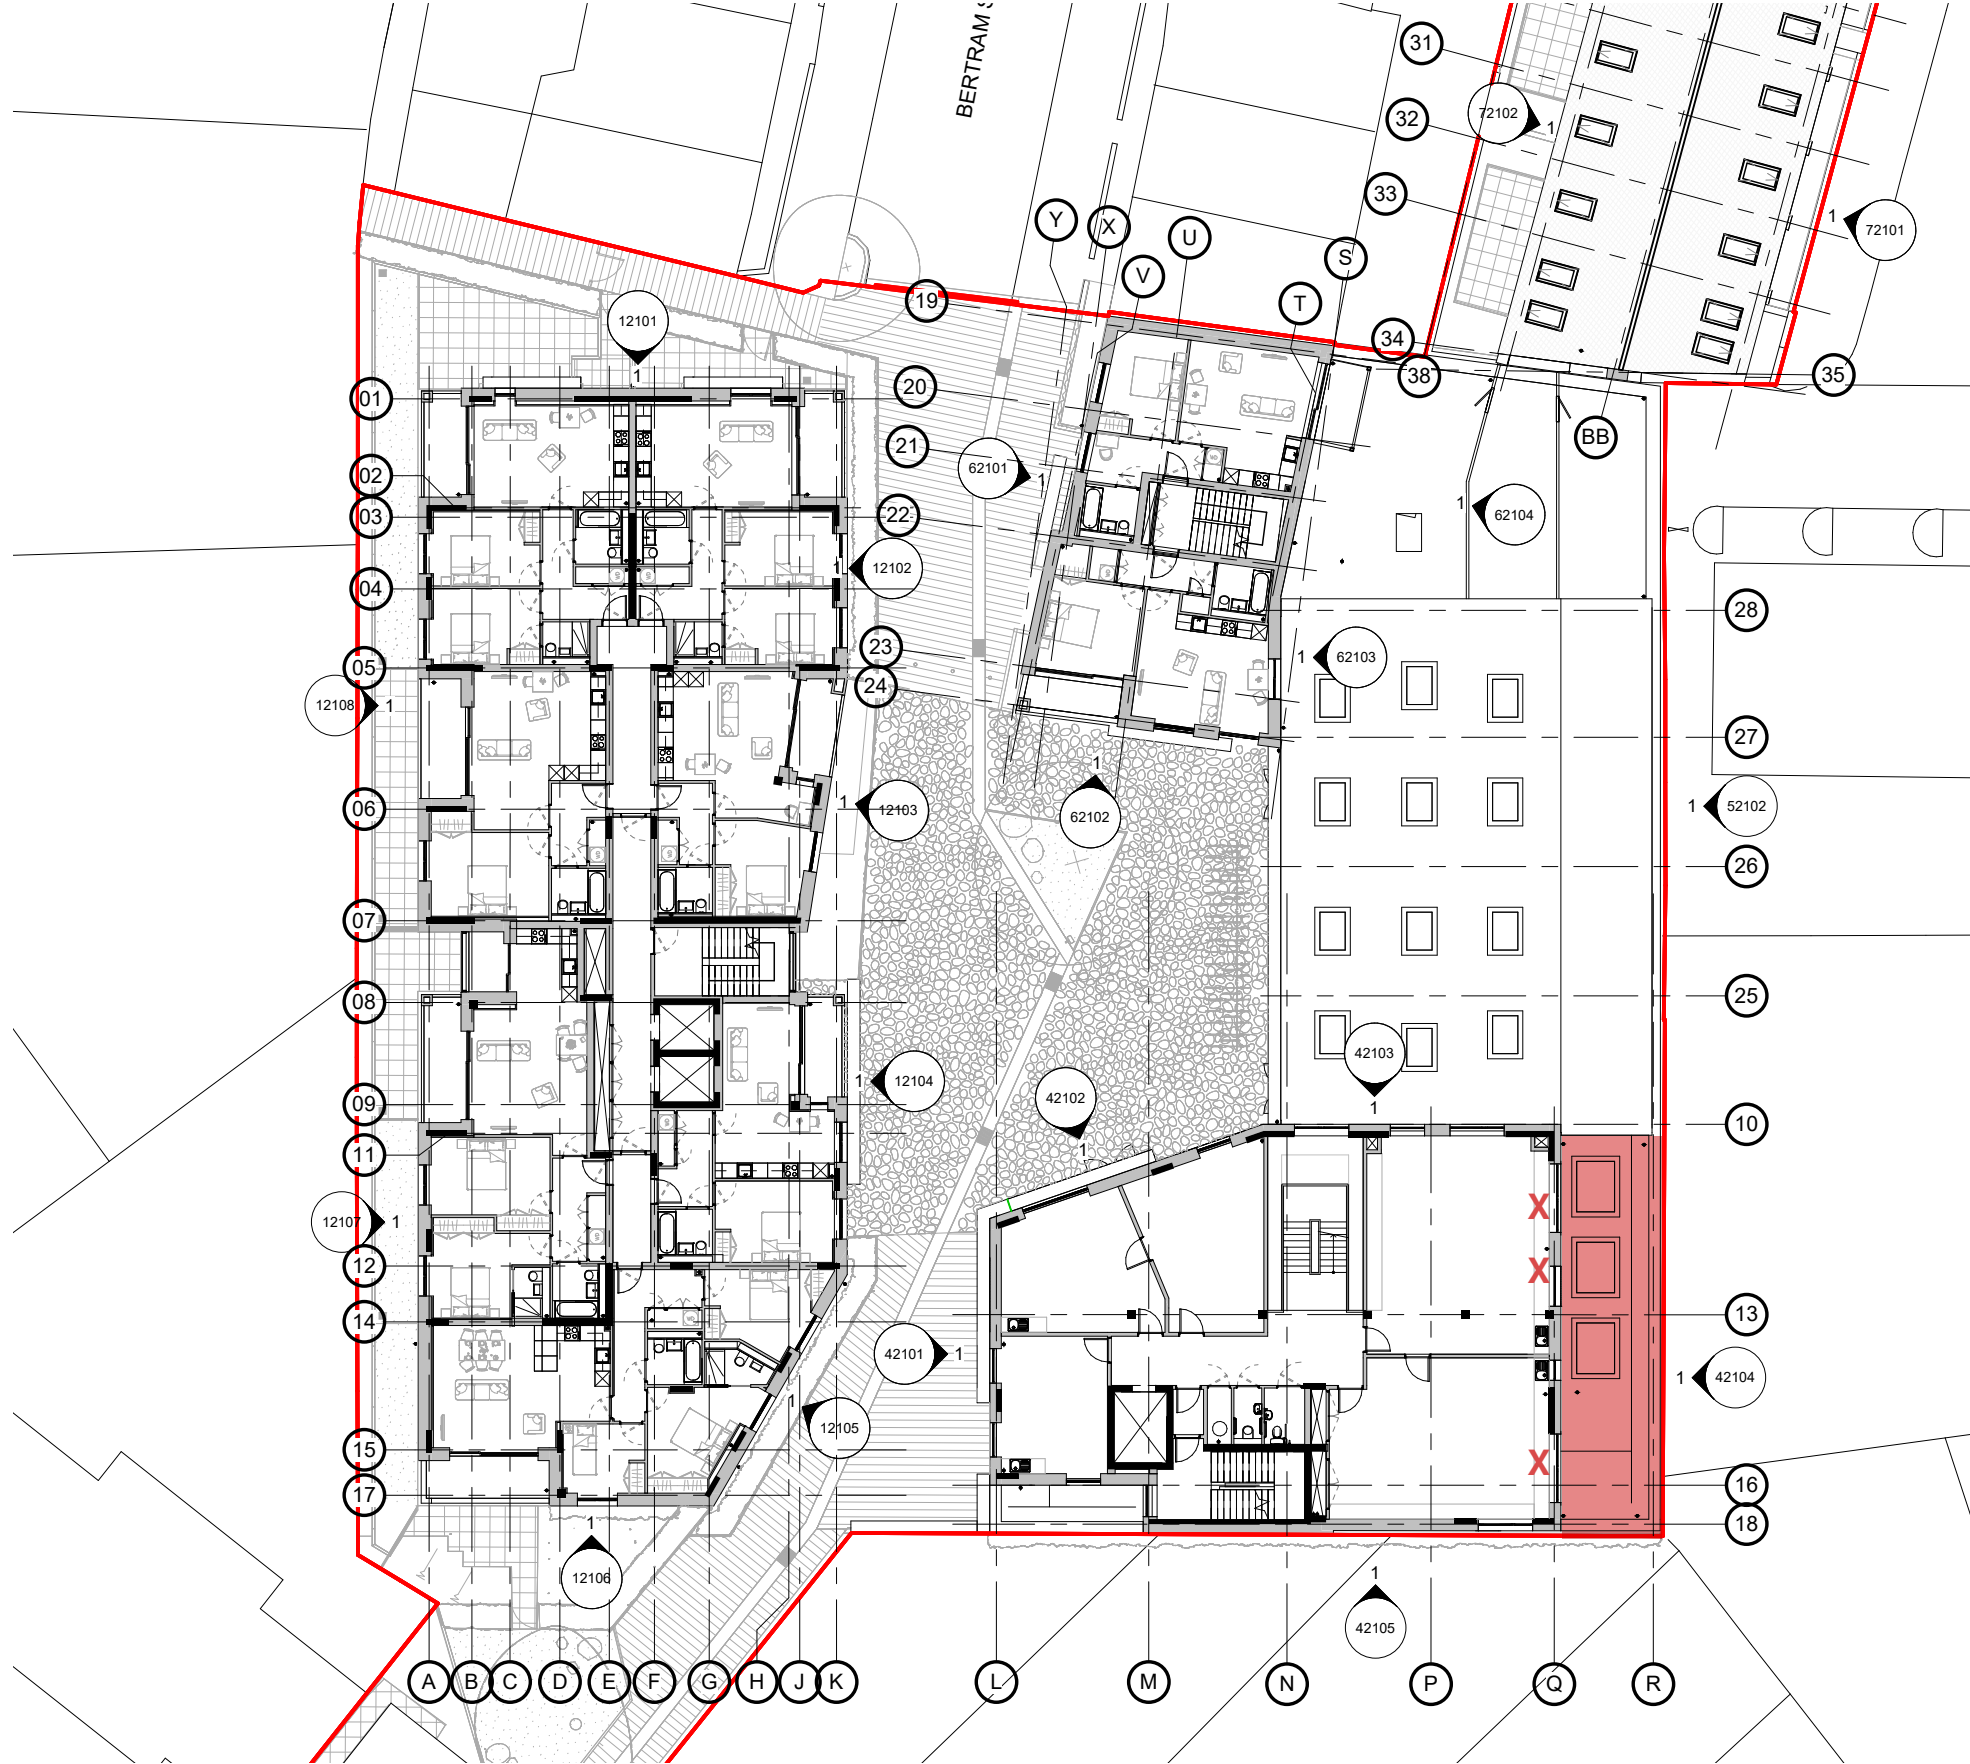
The roof to the east of block B was only accessible by climbing out a top hung window with only 80% openable area. As shown in red on the drawing opposite.

This health & safety risk to maintenance workers could be mitigated by providing a secured access/maintenance only door with level threshold. Necessary to maintain the rooflights, roofing material, gutters/downpipes and facade.

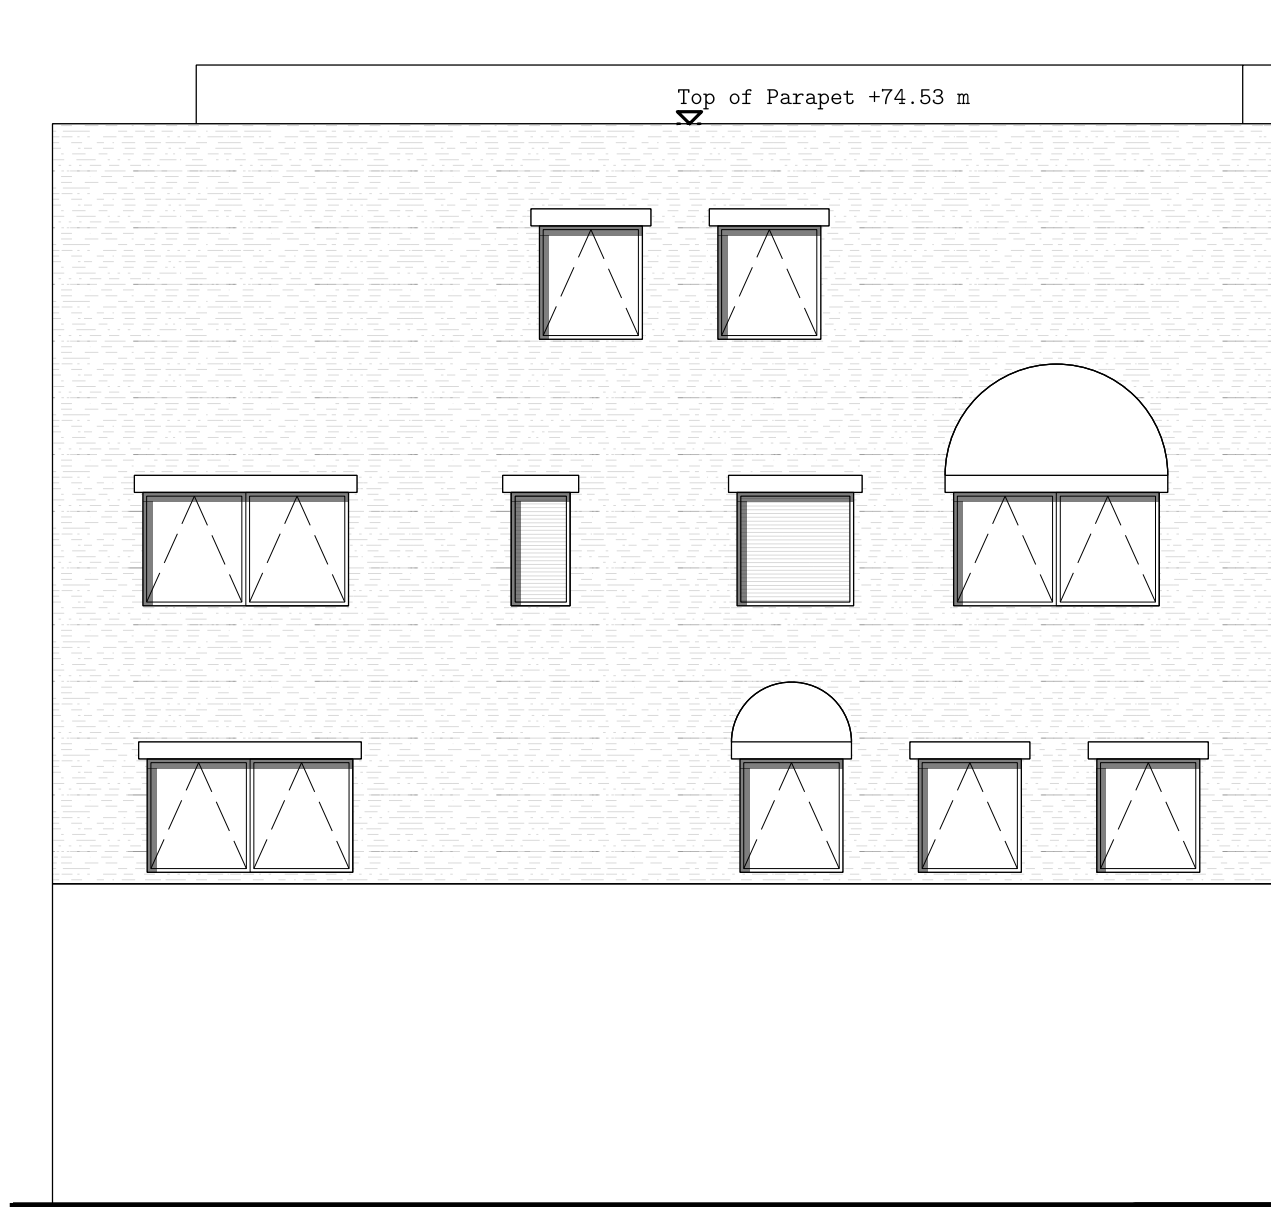
Consented Drawing Above

Block B Eastern elevation, showing the array of top hung windows set back behind the parapet
