ROOF PLAN DETAIL

NO:	REVISION:	DATE:
CLIENT/PROJECT:		
75 FLASK WALK LONDON, NW3 1ET		
SHEET TITLE:		
ROOF PLAN DETAIL		
SCALE:	1:50 (A3)	Do not scale. Contractor to verify all dimensions on site and report errors and omissions to designers before commencing work.
DATE:	08/08/2022	
DRAWING SERIES NO:		
75FW - ROOF 1002

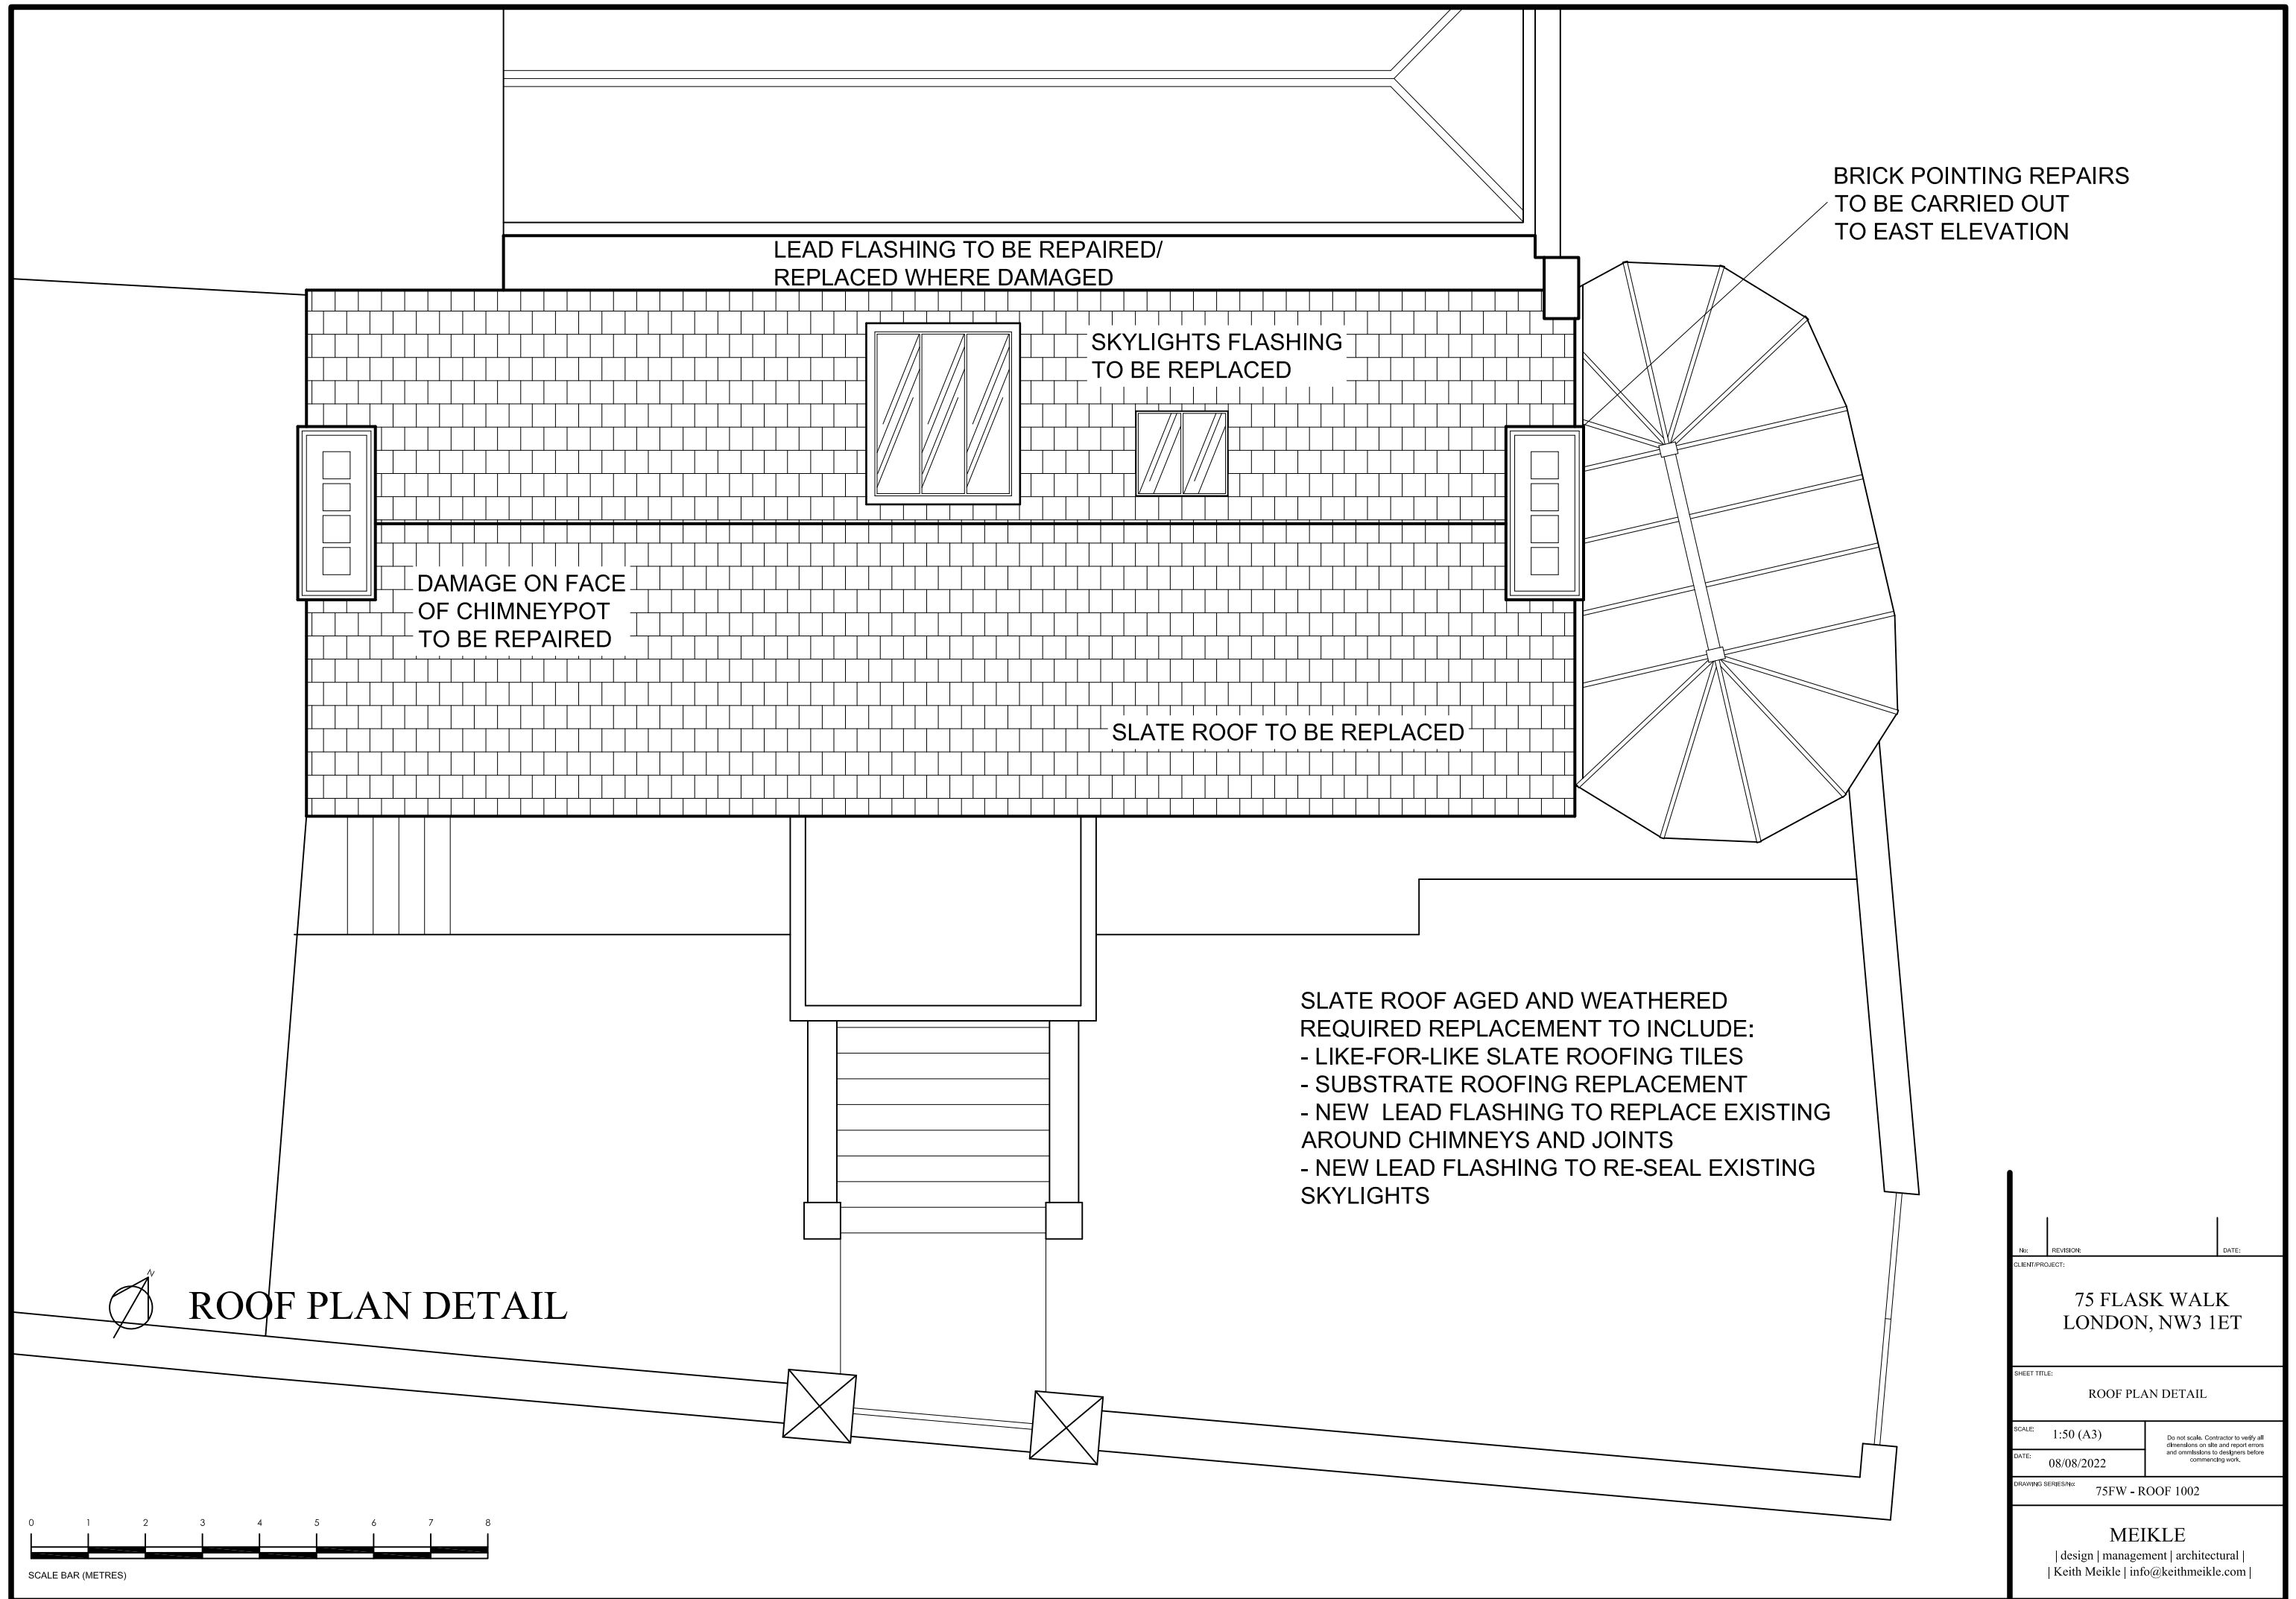
DAMAGE ON FACE  
OF CHIMNEYPOT  
TO BE REPAIRED

SLATE ROOF AGED AND WEATHERED  
REQUIRED REPLACEMENT TO INCLUDE:  
- LIKE-FOR-LIKE SLATE ROOFING TILES  
- SUBSTRATE ROOFING REPLACEMENT  
- NEW LEAD FLASHING TO REPLACE EXISTING  
AROUND CHIMNEYS AND JOINTS  
- NEW LEAD FLASHING TO RE-SEAL EXISTING  
SKYLIGHTS

LEAD FLASHING TO BE REPAIRED/  
REPLACED WHERE DAMAGED

BRICK POINTING REPAIRS  
TO BE CARRIED OUT  
TO EAST ELEVATION

SKYLIGHTS FLASHING  
TO BE REPLACED

SLATE ROOF TO BE REPLACED
