O2 Finchley Road

Geotechnical Interpretative Report

<b>Report Ref.</b>	<b>104878-PEF-XX-XX-RP-C-200008</b>					
<b>File Path</b>	<a href="https://pelf.sharepoint.com/:f:/r/sites/104878/Shared%20Documents/General/01%20-%20WIP/Documents/GG%20Geoenv%20+%20geotech/01%20Reports/Geotechnical%20Interpretative%20Report?csf=1&amp;web=1&amp;e=WGCcMh">https://pelf.sharepoint.com/:f:/r/sites/104878/Shared%20Documents/General/01%20-%20WIP/Documents/GG%20Geoenv%20+%20geotech/01%20Reports/Geotechnical%20Interpretative%20Report?csf=1&amp;web=1&amp;e=WGCcMh</a>					
<b>Rev</b>	<b>Suit</b>	<b>Description</b>	<b>Date</b>	<b>Originator</b>	<b>Checker</b>	<b>Approver</b>
P01	S2	First Issue	July 2022	JB	KS	KS

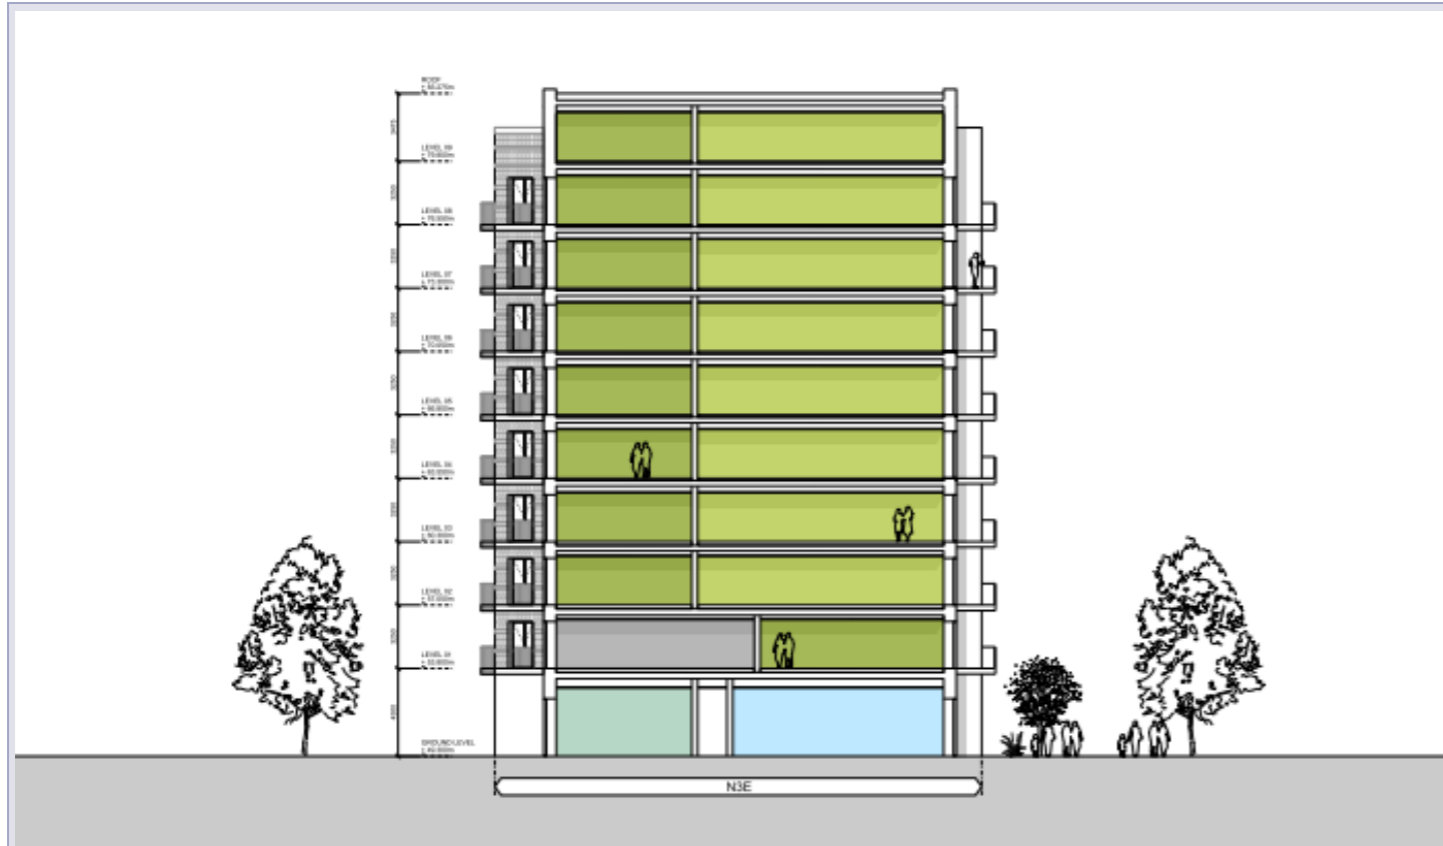
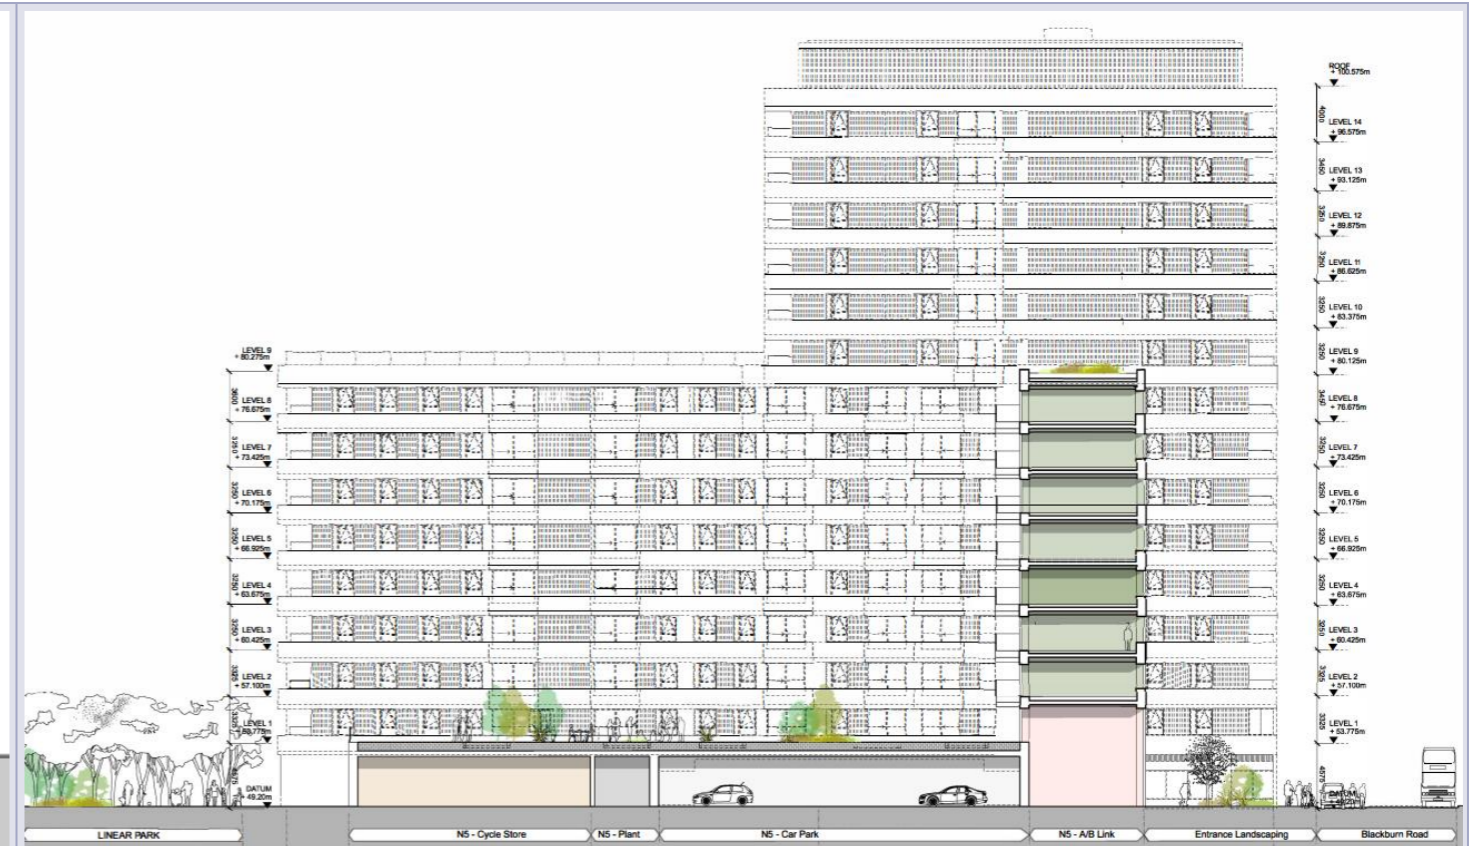
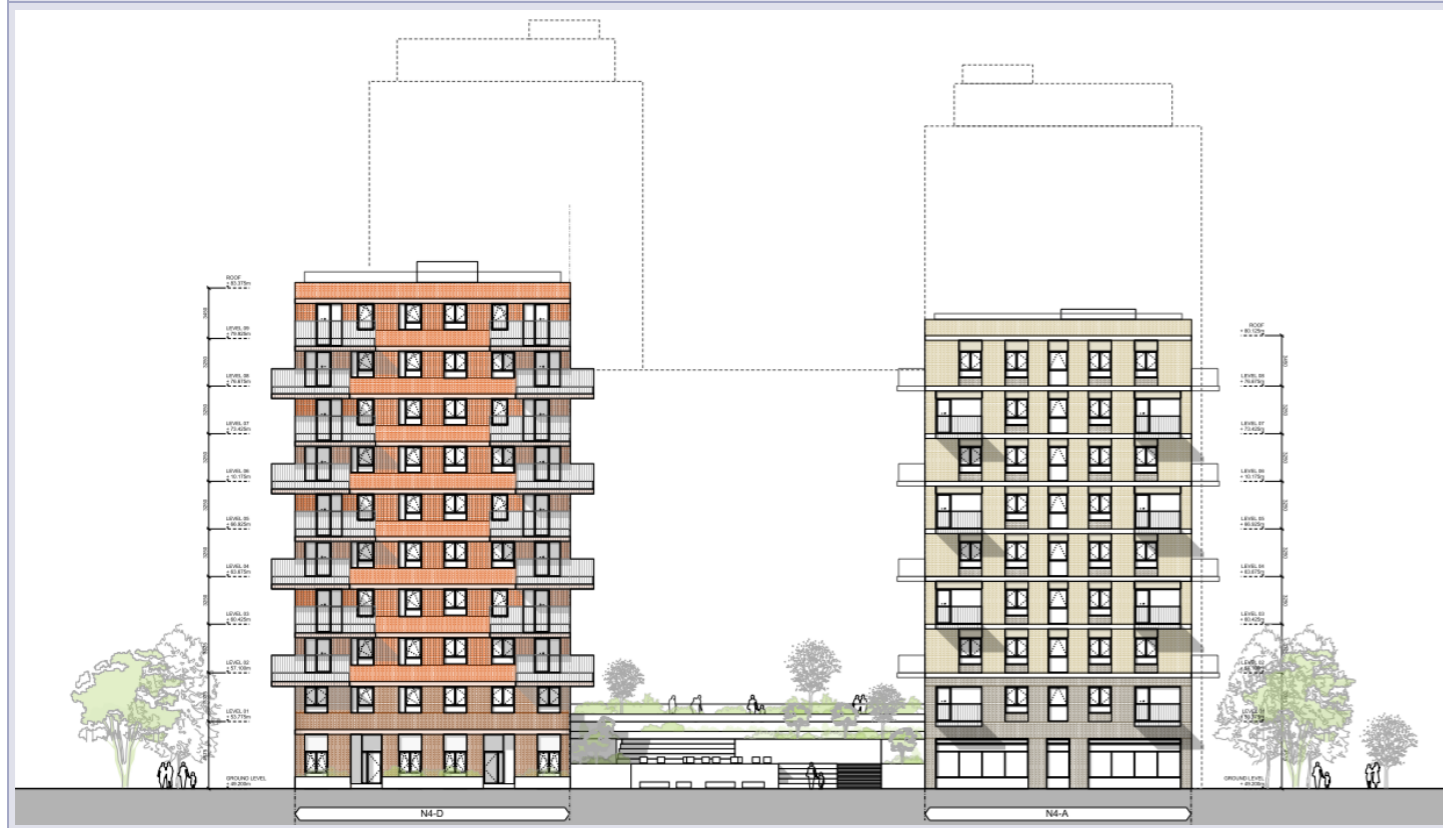
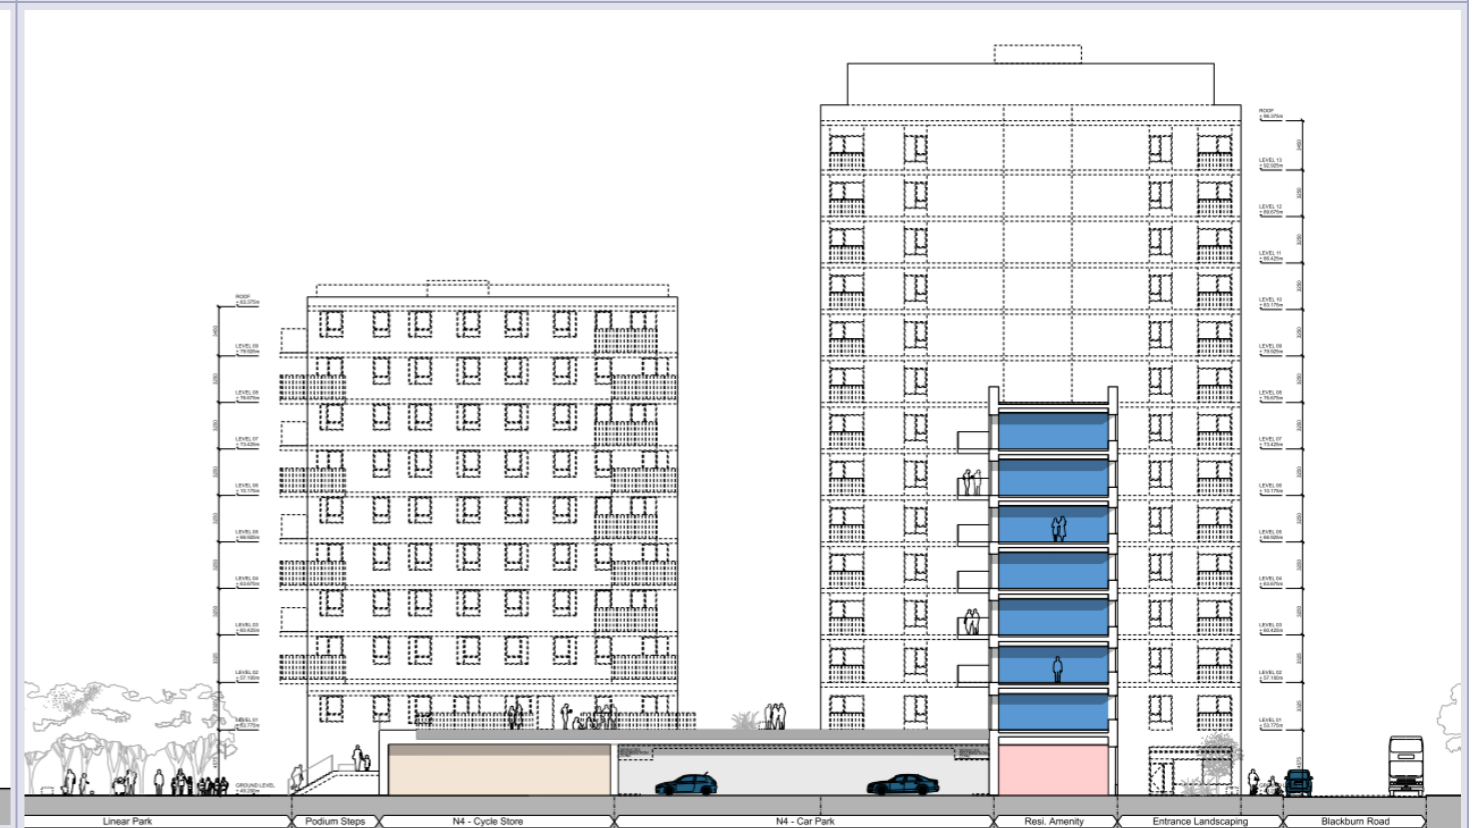
Figure 2: Proposed Development

Cross section from east to west across N3, showing ground floor commercial / community space and bike & refuse stores, with residential units on floors 1-9.

Cross section from north to south across N5, showing ground floor parking / bike storage, commercial / community space and refuse stores, with residential units on floors 0-14 and a raised podium garden on floor 1.

View of southern face of N4 development showing central raised podium gardens, with 8 & 9 story blocks in front and the outline of the 13 & 14 story blocks in the back.

Cross section from east to north to south across N5, showing ground floor parking / bike storage, commercial / community space and refuse stores, with residential units on floors 0-14 and a raised podium garden on floor 1.

The proposed development comprises a mixed use residential and commercial buildings set within areas of landscaped public open space. The evolving masterplan replaces the existing retail premises, showrooms and car parking with a vibrant mixed-use community. Part of the Development will be residential led with mixed tenures. A minimum of 35% affordable housing by floorspace (GIA) and habitable room will be included across the Development. The outline proposals will provide retail area, cinema, indoor sport and recreation space, day care centre/ nursery, commercial space, health centre, public open space, play space and private amenity. The masterplan consists of 1,856 homes within modern, low carbon and energy efficient apartment blocks, ranging from six to fifteen storeys. The masterplan seeks to create a locally integrated and highly sustainable new community in the London Borough of Camden, refer to Figure 5.

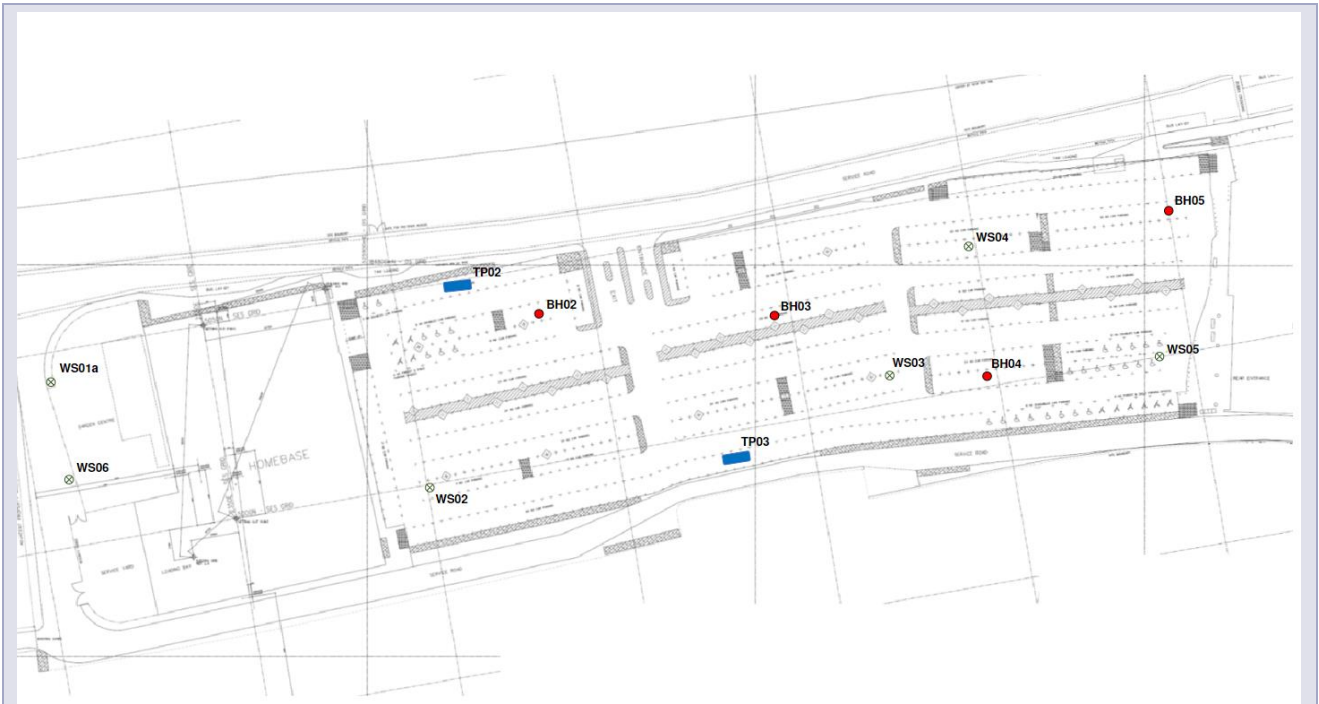
Figure 4: RSK 2021 Geotechnical Investigation Locations

Details of the exploratory hole locations are summarised below and shown on the investigation location plan presented in Figure 4.

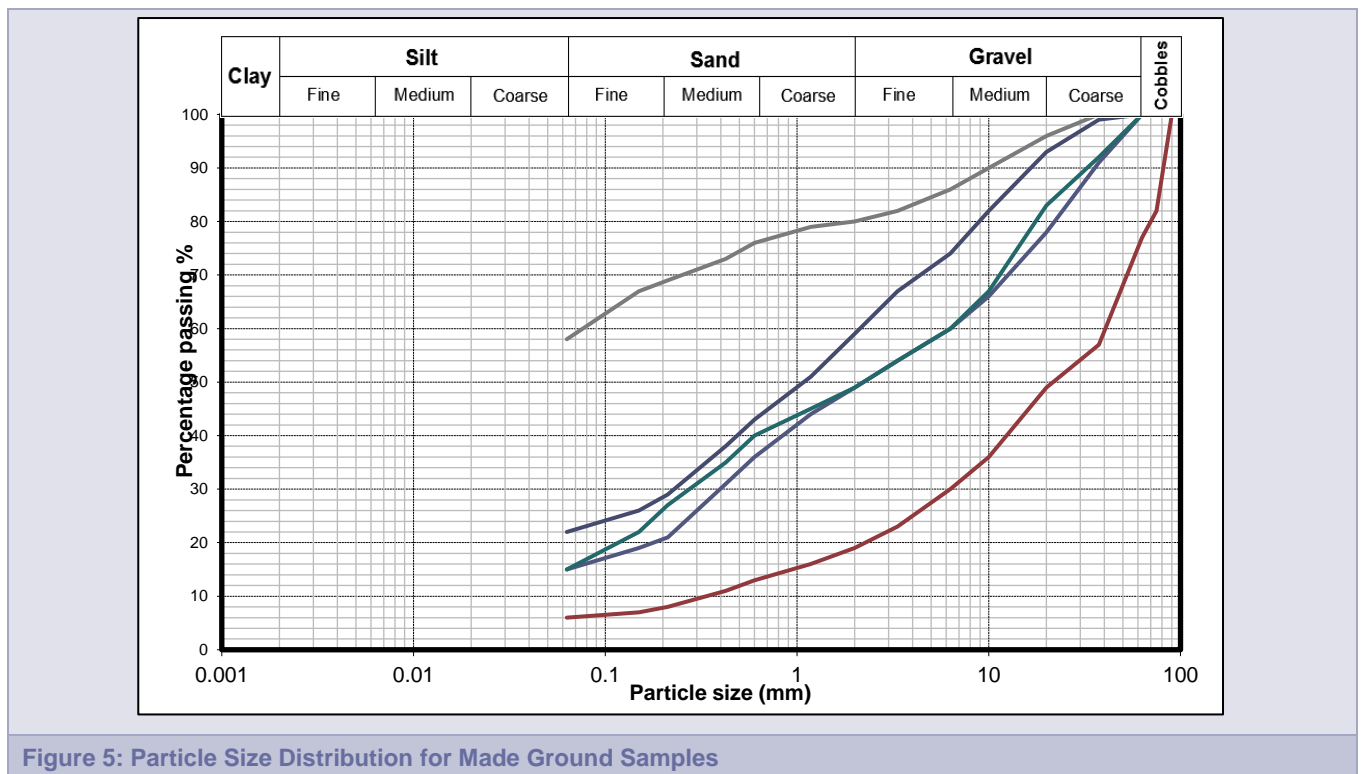
Made Ground was encountered directly under a surface cover of hardstanding (macadam or concrete slab) within all exploratory locations. The composition was typically described as silty sandy GRAVEL or gravelly SAND. Made Ground was encountered to greater thicknesses within the central portion of the carpark, becoming clayey from a depth of approximately 1.0m bgl with this deeper material described as reworked London Clay, typically comprising silty gravelly CLAY with frequent black relict rootlets, the gravel typically consisted of rounded flints, but occasionally included anthropogenic materials including brick and concrete fragments. Figure 5 shows the range of particle gradings recorded for the Made Ground encountered at the site.

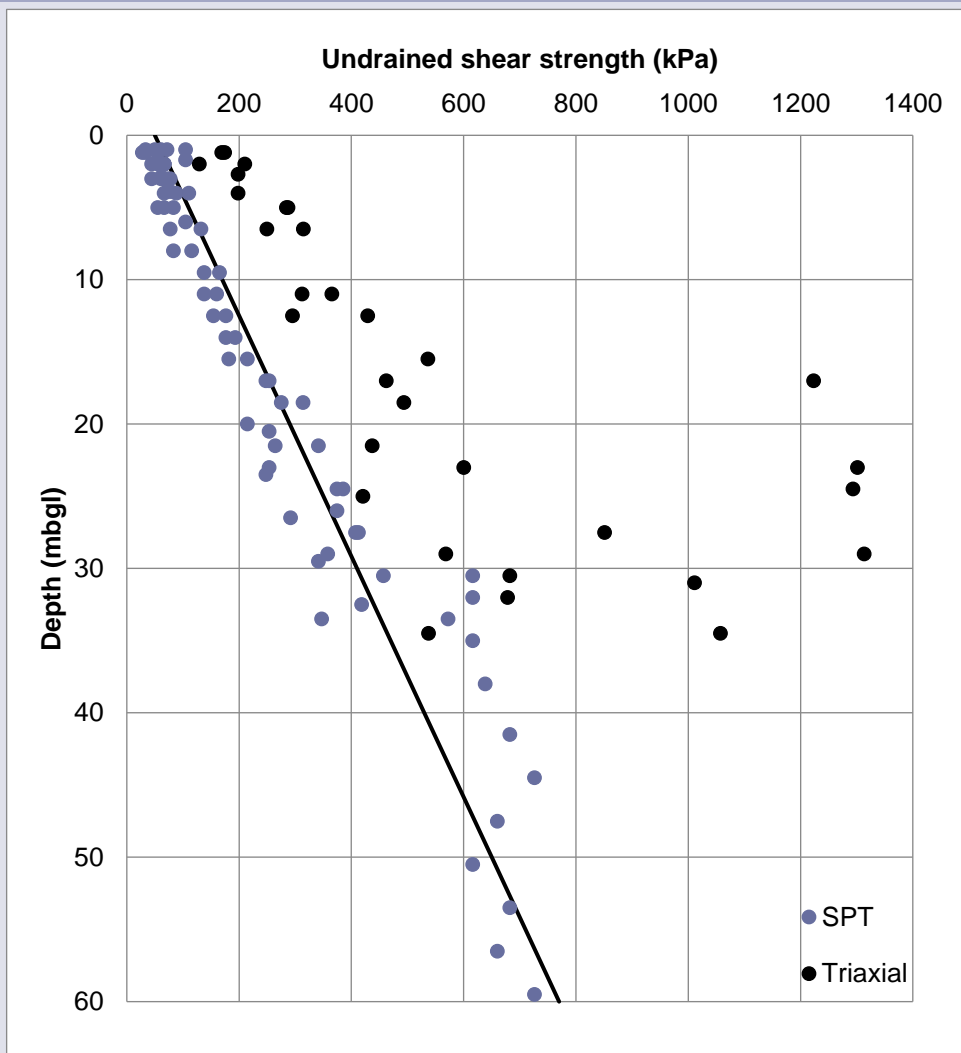
Figure 6: London Clay Undrained Shear Strength Results

31 undrained shear strength triaxial compression tests were undertaken on shallow samples of cohesive material.

When compared to the undrained shear strength predicted by the SPT results, the triaxial test results returned higher values which is conventionally attributed to the size effect of the triaxial specimens and the characteristic undrained strength has been based on the SPT data shown in Figure 6. The design value for the London clay is taken as follows:

77 No. SPT tests were carried out with "N" values ranging from 6 to 50+ with a mean of 46. These results can be correlated to an equivalent undrained shear strength using the relationship of Stroud and Butler (1975) based on a representative Plasticity Index (PI) for the London Clay. Atterberg Limits tests have been undertaken on 33 samples, the average PI of the clay is 45%. Based on the PI obtained, the following relationship between undrained strength and depth is as given below:
