**Method Statement of Repair**

PROJECT TITLE  
**42 BEDFORD SQUARE**

DRAWING TITLE  
0.05 DINING ROOM CHIMNEY PIECE REPRODUCTION

DRAWING NO.  
(33)AD001\_MH

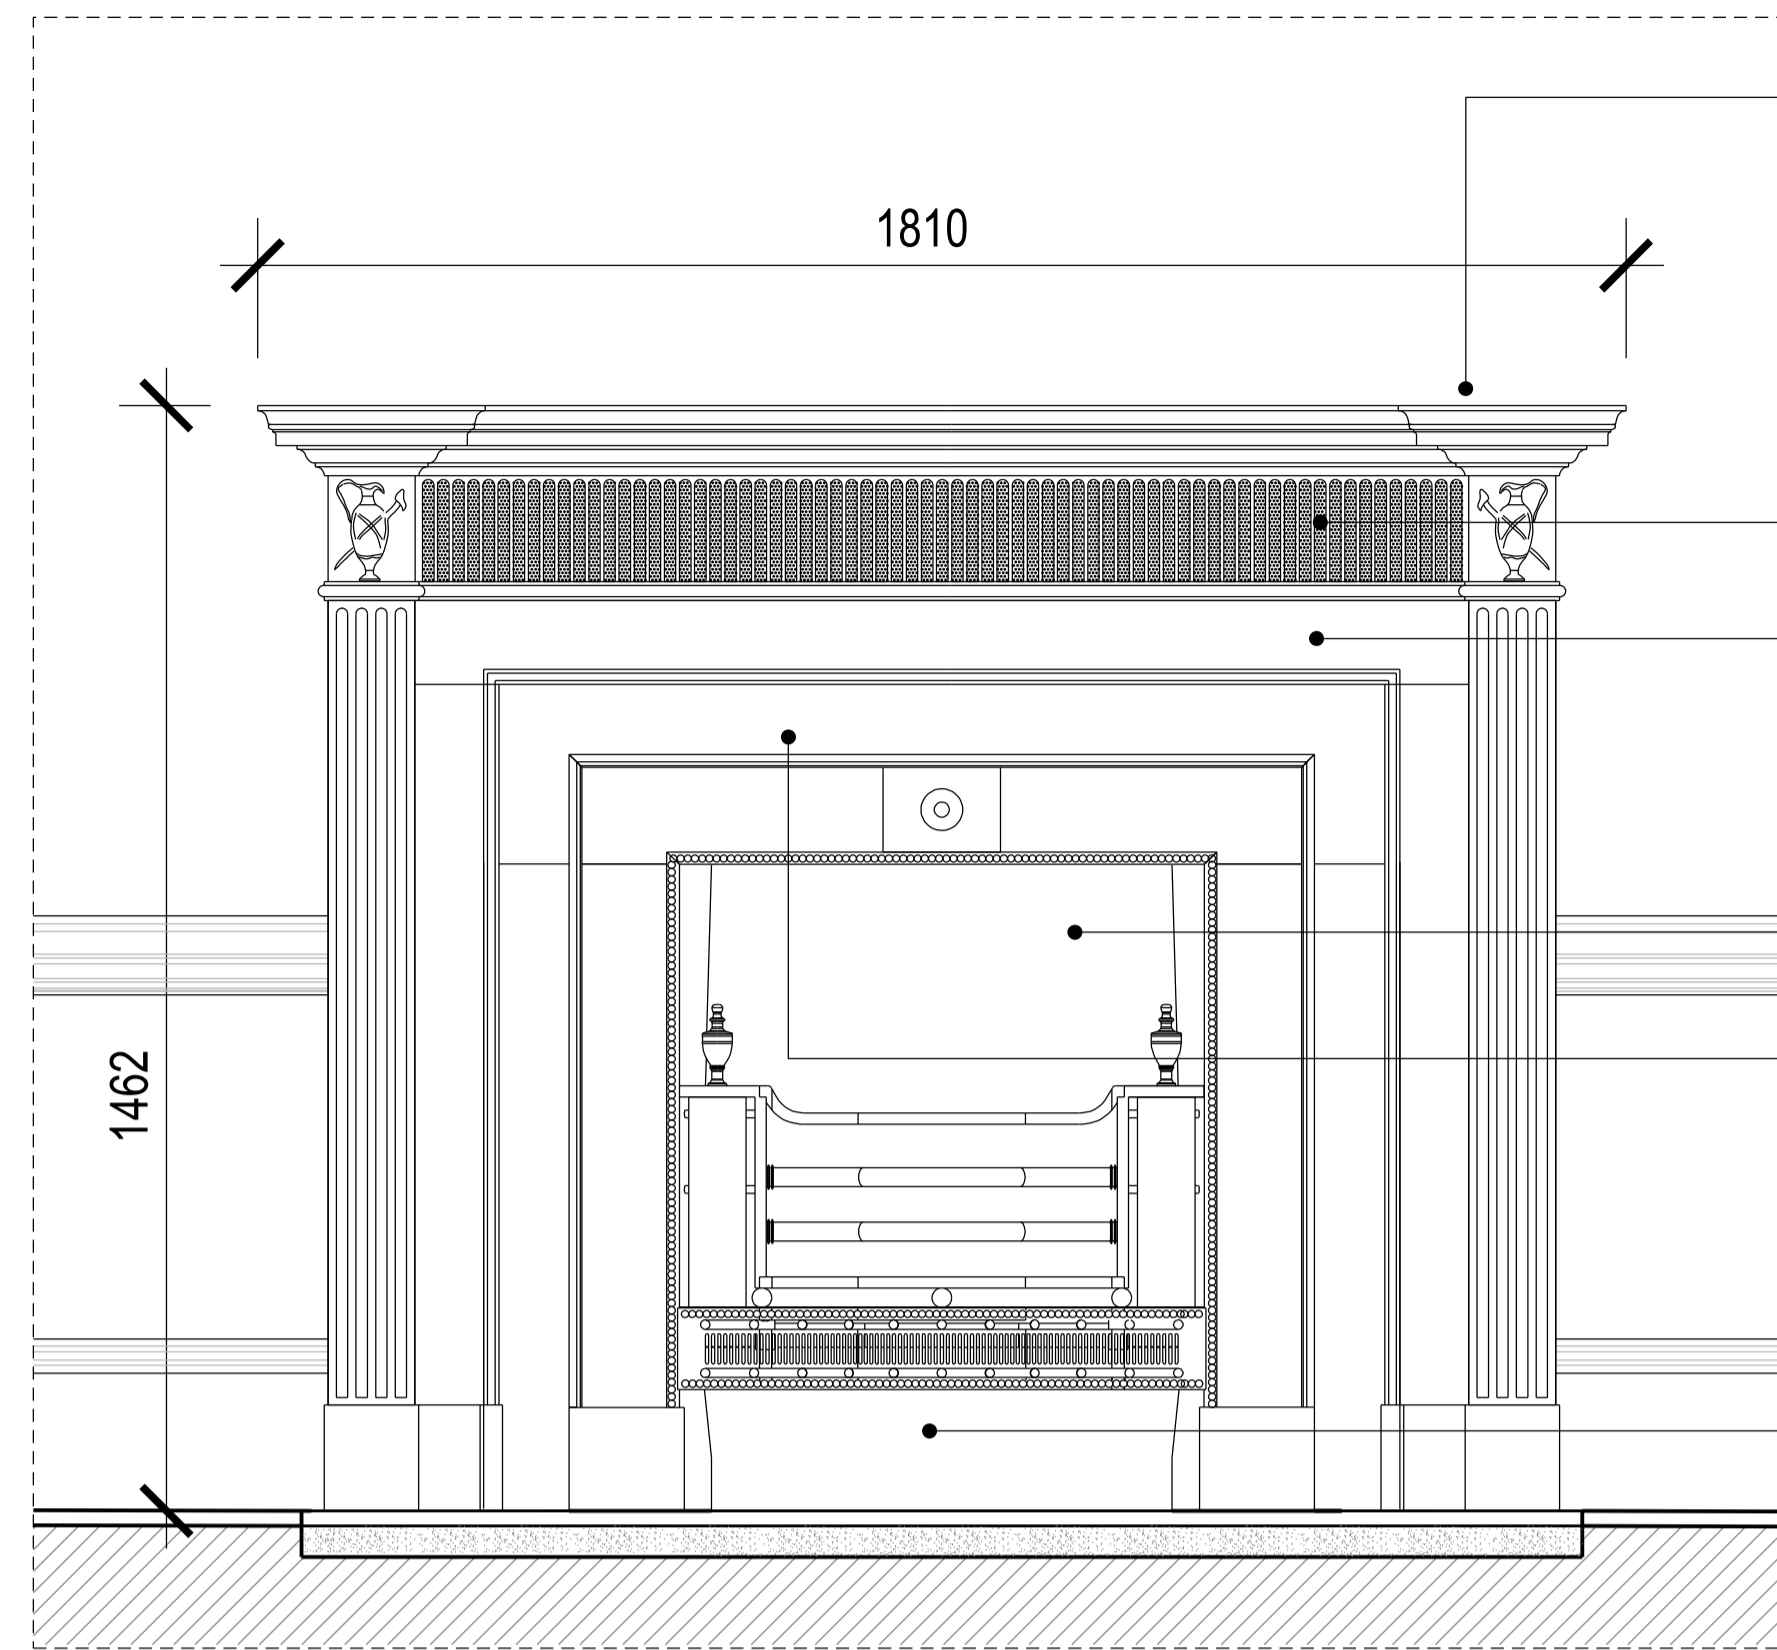
01 CHIMNEY PIECE ELEVATION scale 1:10

Reproduction of original chimney piece to be reinstated as recorded in image 01, by specialist.

Sienna marble inset

Carrara marble slips required to cover the gap between the register grate and marble front piece. This is to be carefully measured on site and match the hearth stone.

Tile & step insert to be removed.

Metal slips required to cover the gap between the register grate and marble front piece. This is to be carefully measured on site and match the material of the installed grate.

Asthall register grate by Jamb. All dimensions to be checked on site in relation to the reinstated chimney piece, the register grate to be aligned with the back side of front marble pieces.

Clean, repair and carefully reinstate original pieces to their original location. Add new pieces in a like for like basis, when missing or not able to be repaired.

Clean and repair existing firebox and integrate new marble hearth to match the existing from the photos and the chimney piece as closely as possible.

Tiles to be removed, register grate to be inserted in a 18th century style appropriate to age + style of building.  
To be discussed with local planning authority prior to submitting to discharge of conditions.

Redecorate painted elements, using same colour and type of paint, as existing.

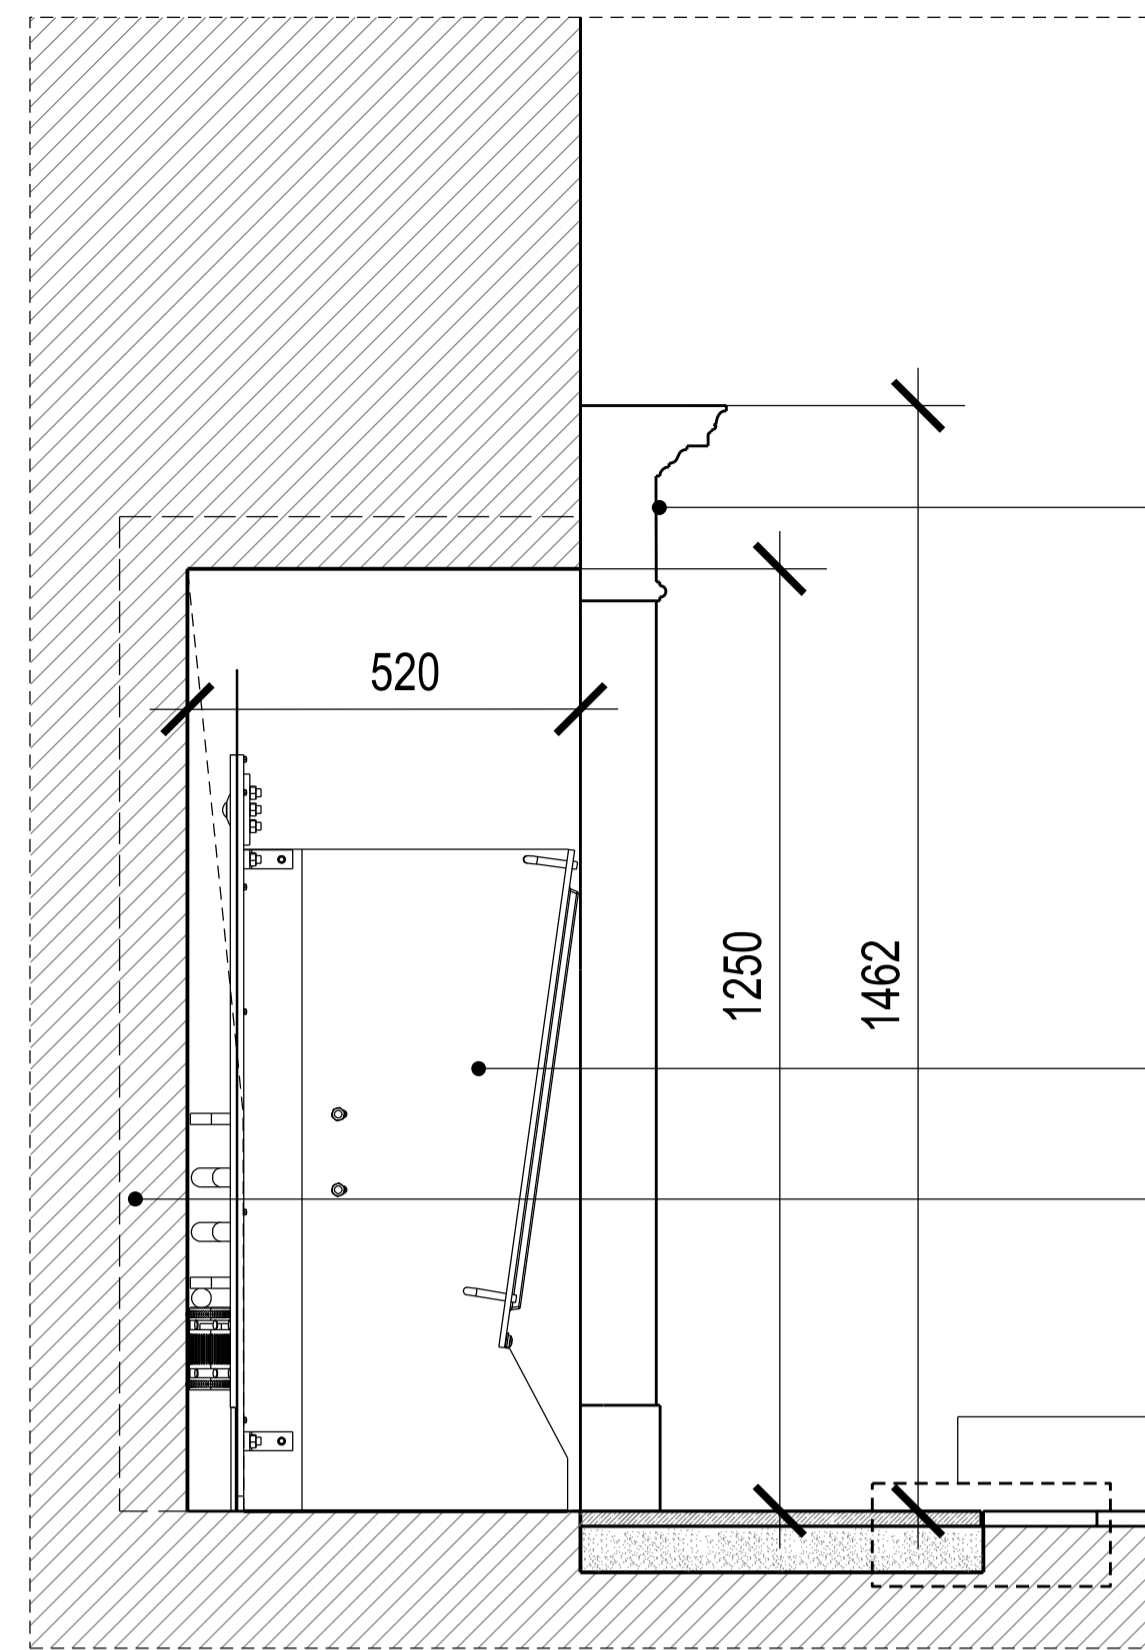
02 CHIMNEY PIECE SECTION scale 1:10

Sienna marble inset

Asthall register grate by Jamb.

Dashed line indicates brick surround

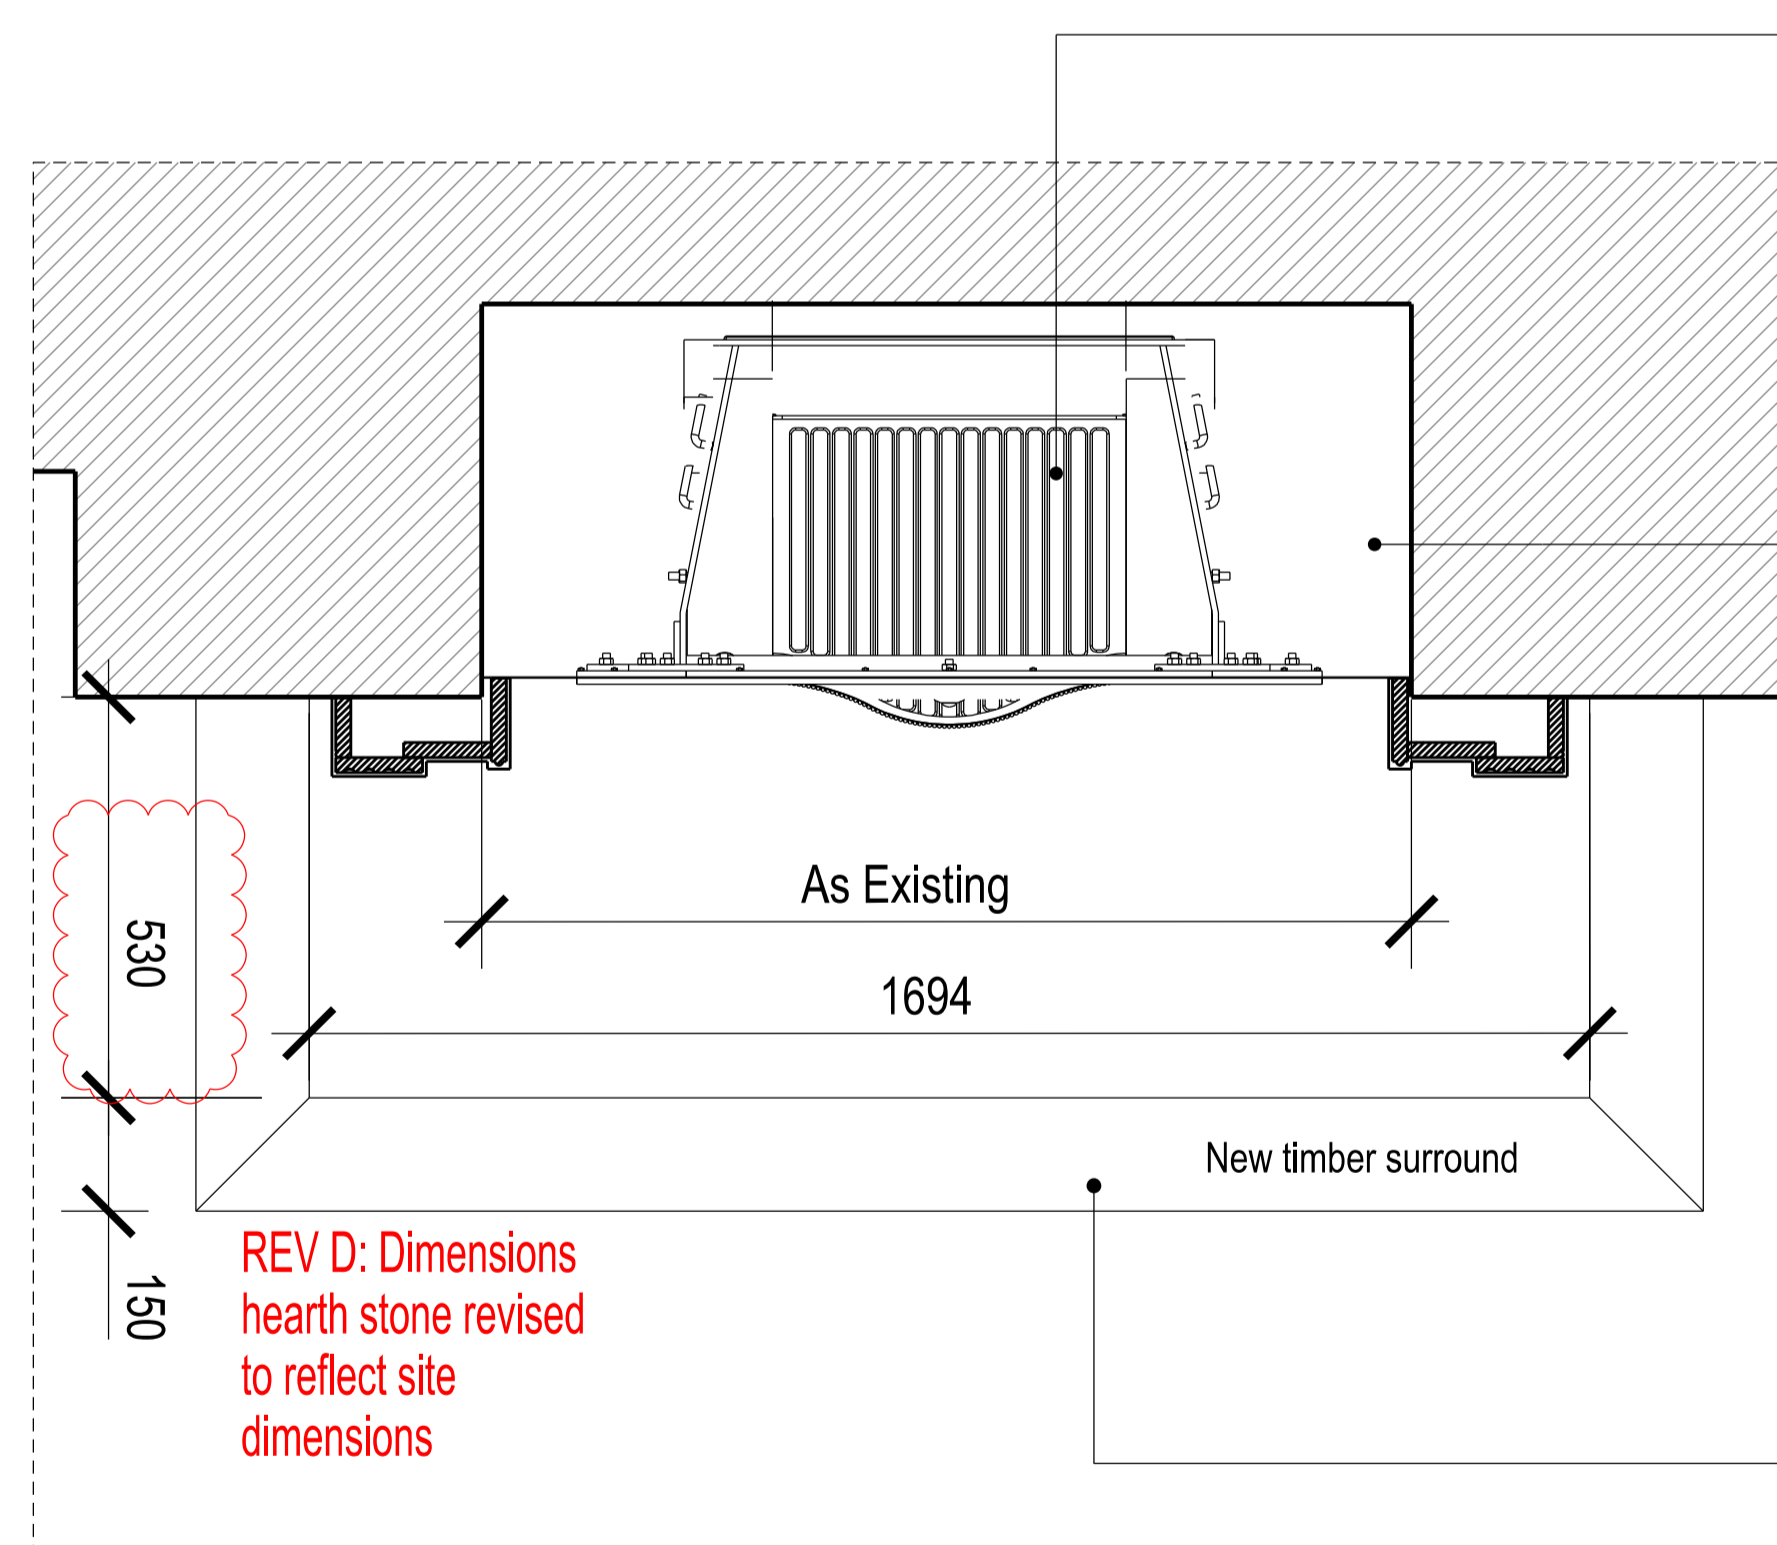
04 CHIMNEY PIECE AND HEARTH PLAN VIEW scale 1:10

Asthall register grate by Jamb aligned with the back side of the front marble pieces (approx 20mm). Tiles and concrete bases to be carefully removed.

Tile & step insert to be removed.

As Existing

REV D: Dimensions hearth stone revised to reflect site dimensions

New timber surround

No hearth stone found upon removal of flooring. A new hearth stone in carrara marble to be installed to match the original one found in the reception room with new timber hearth surround.

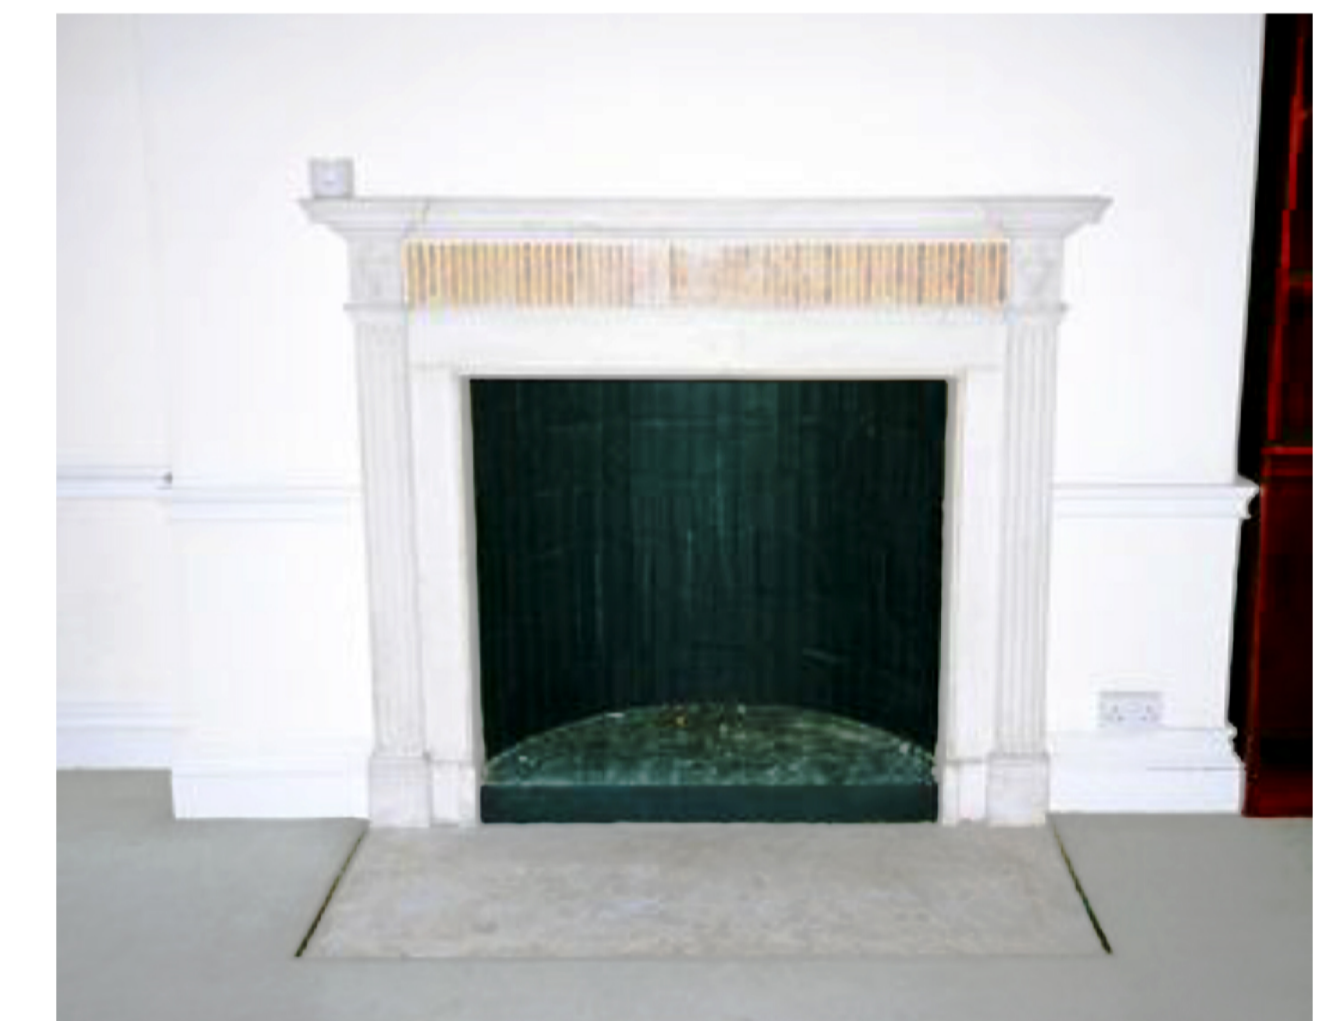
CHIMNEY PIECE - HISTORIC IMAGE SHOWING THE ORIGINAL CHIMNEY PIECE  
Original chimney piece to be matched in design and material as closely as possible.
