Method Statement of Repair

PROJECT TITLE
42 BEDFORD SQUARE

DRAWING TITLE
**1.03 LIBRARY CHIMNEY PIECE
FIRST FLOOR
REPRODUCTION**

DRAWING NO.
(33)AD003_MH

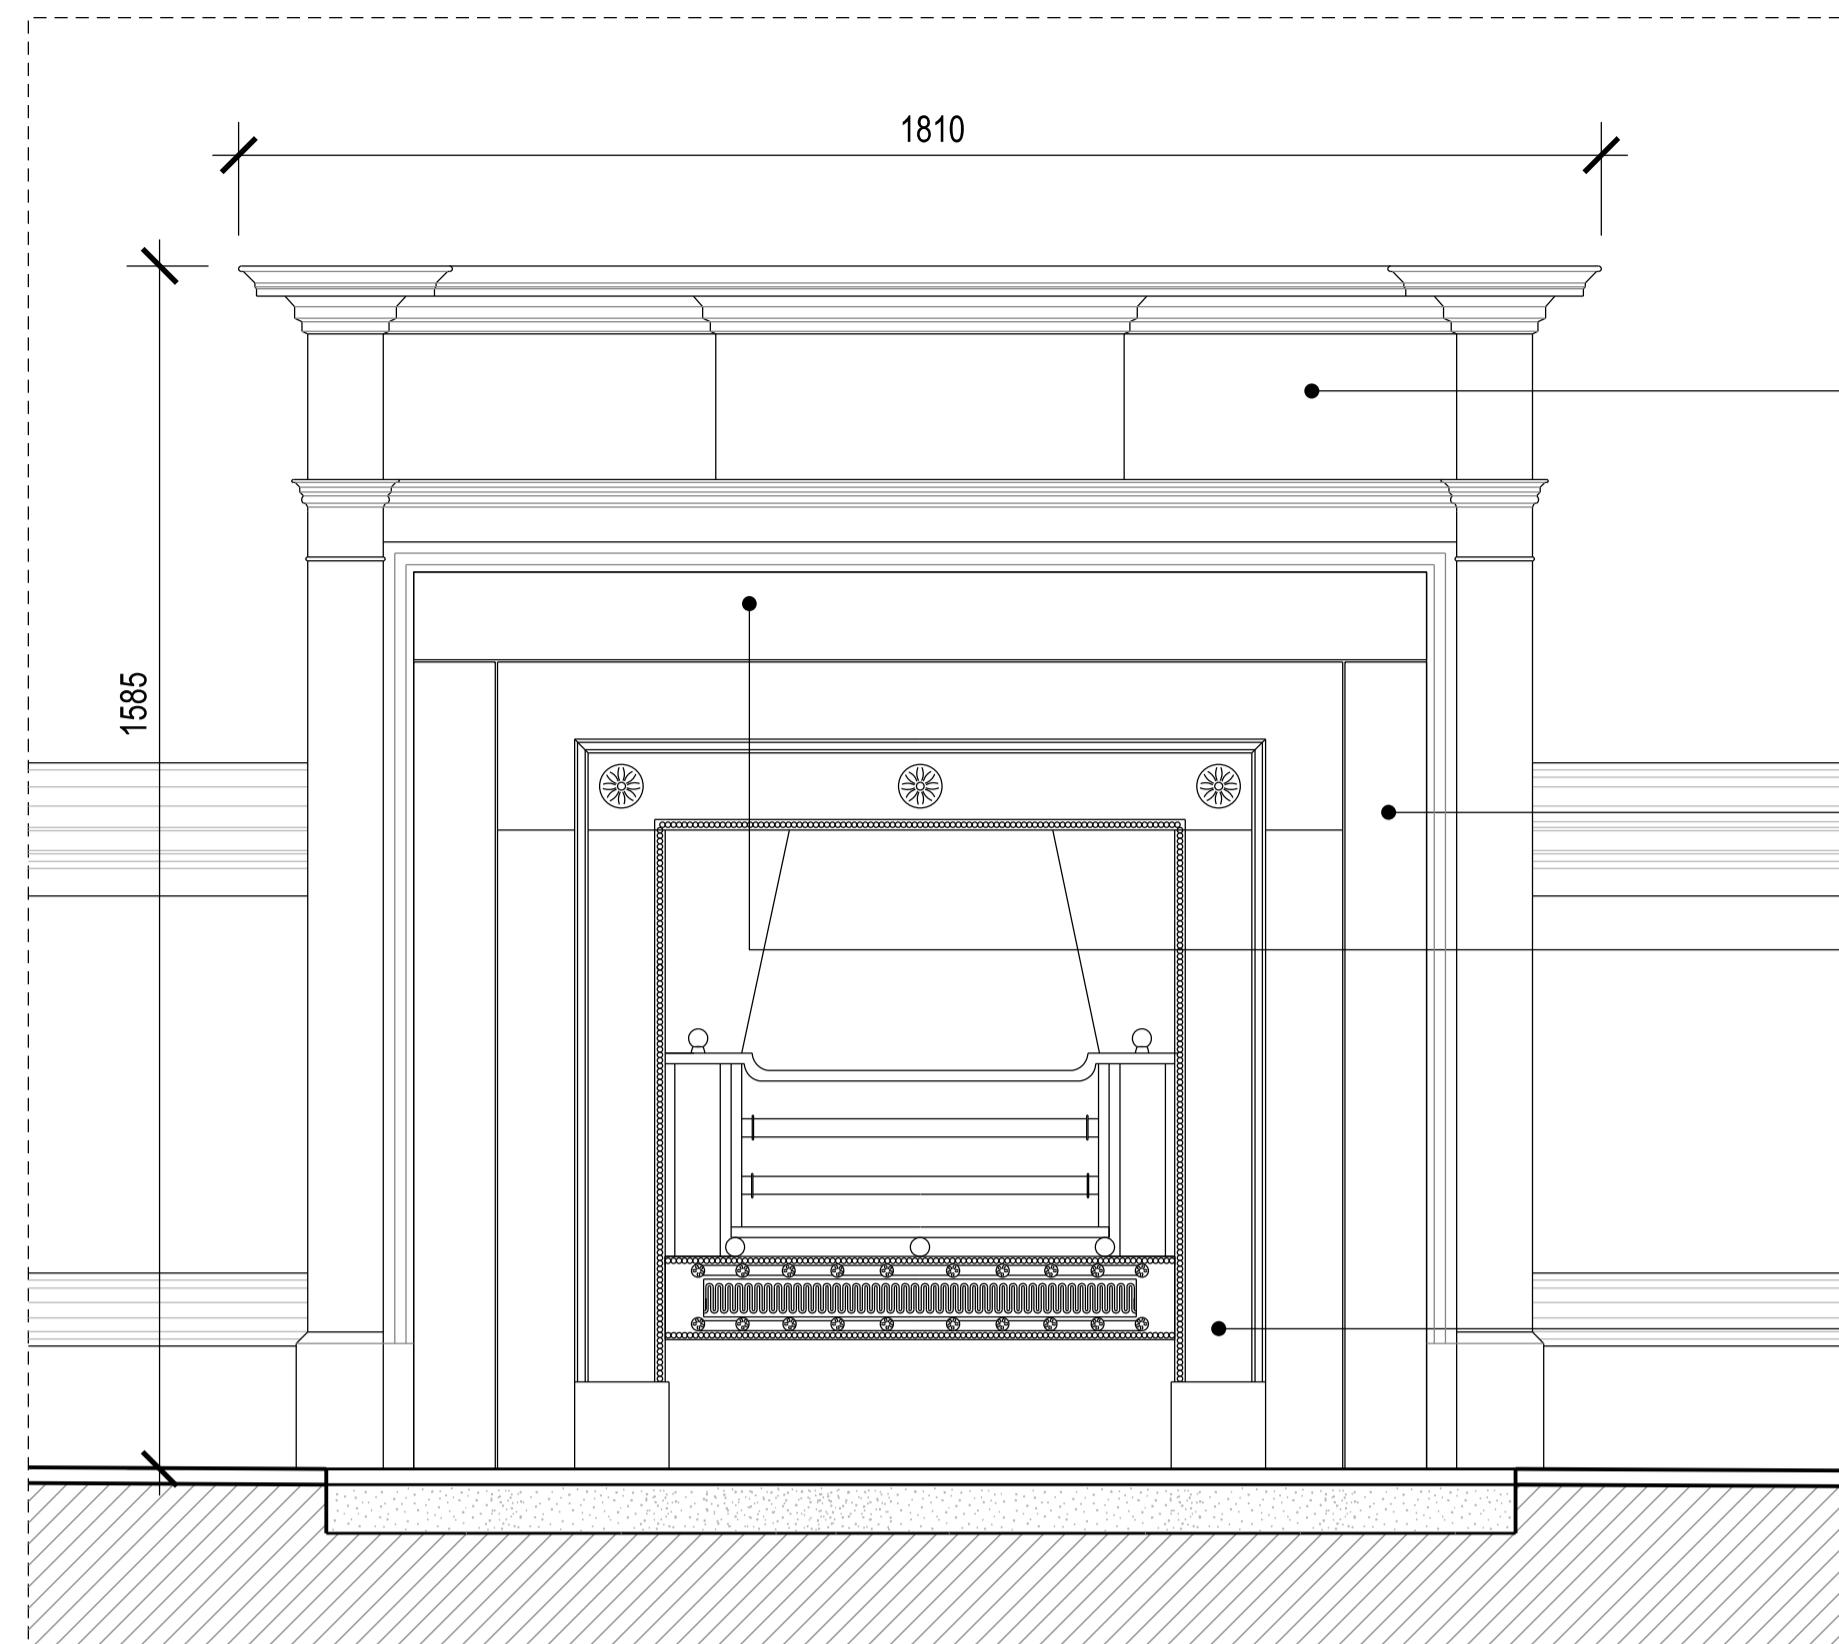
01 CHIMNEY PIECE ELEVATION
scale 1:10

Lassco Reclamation chimney piece, Pine & Plaster in the style of Robert Adam.

Tile and brick insert to be removed.

New Carrara marble slips to match new hearth to be cut to size to match the register grate.

Grove register grate by Jamb. All dimensions to be checked on site in relation to the reinstated fireplace, the register grate to be aligned with the back side of front marble pieces.

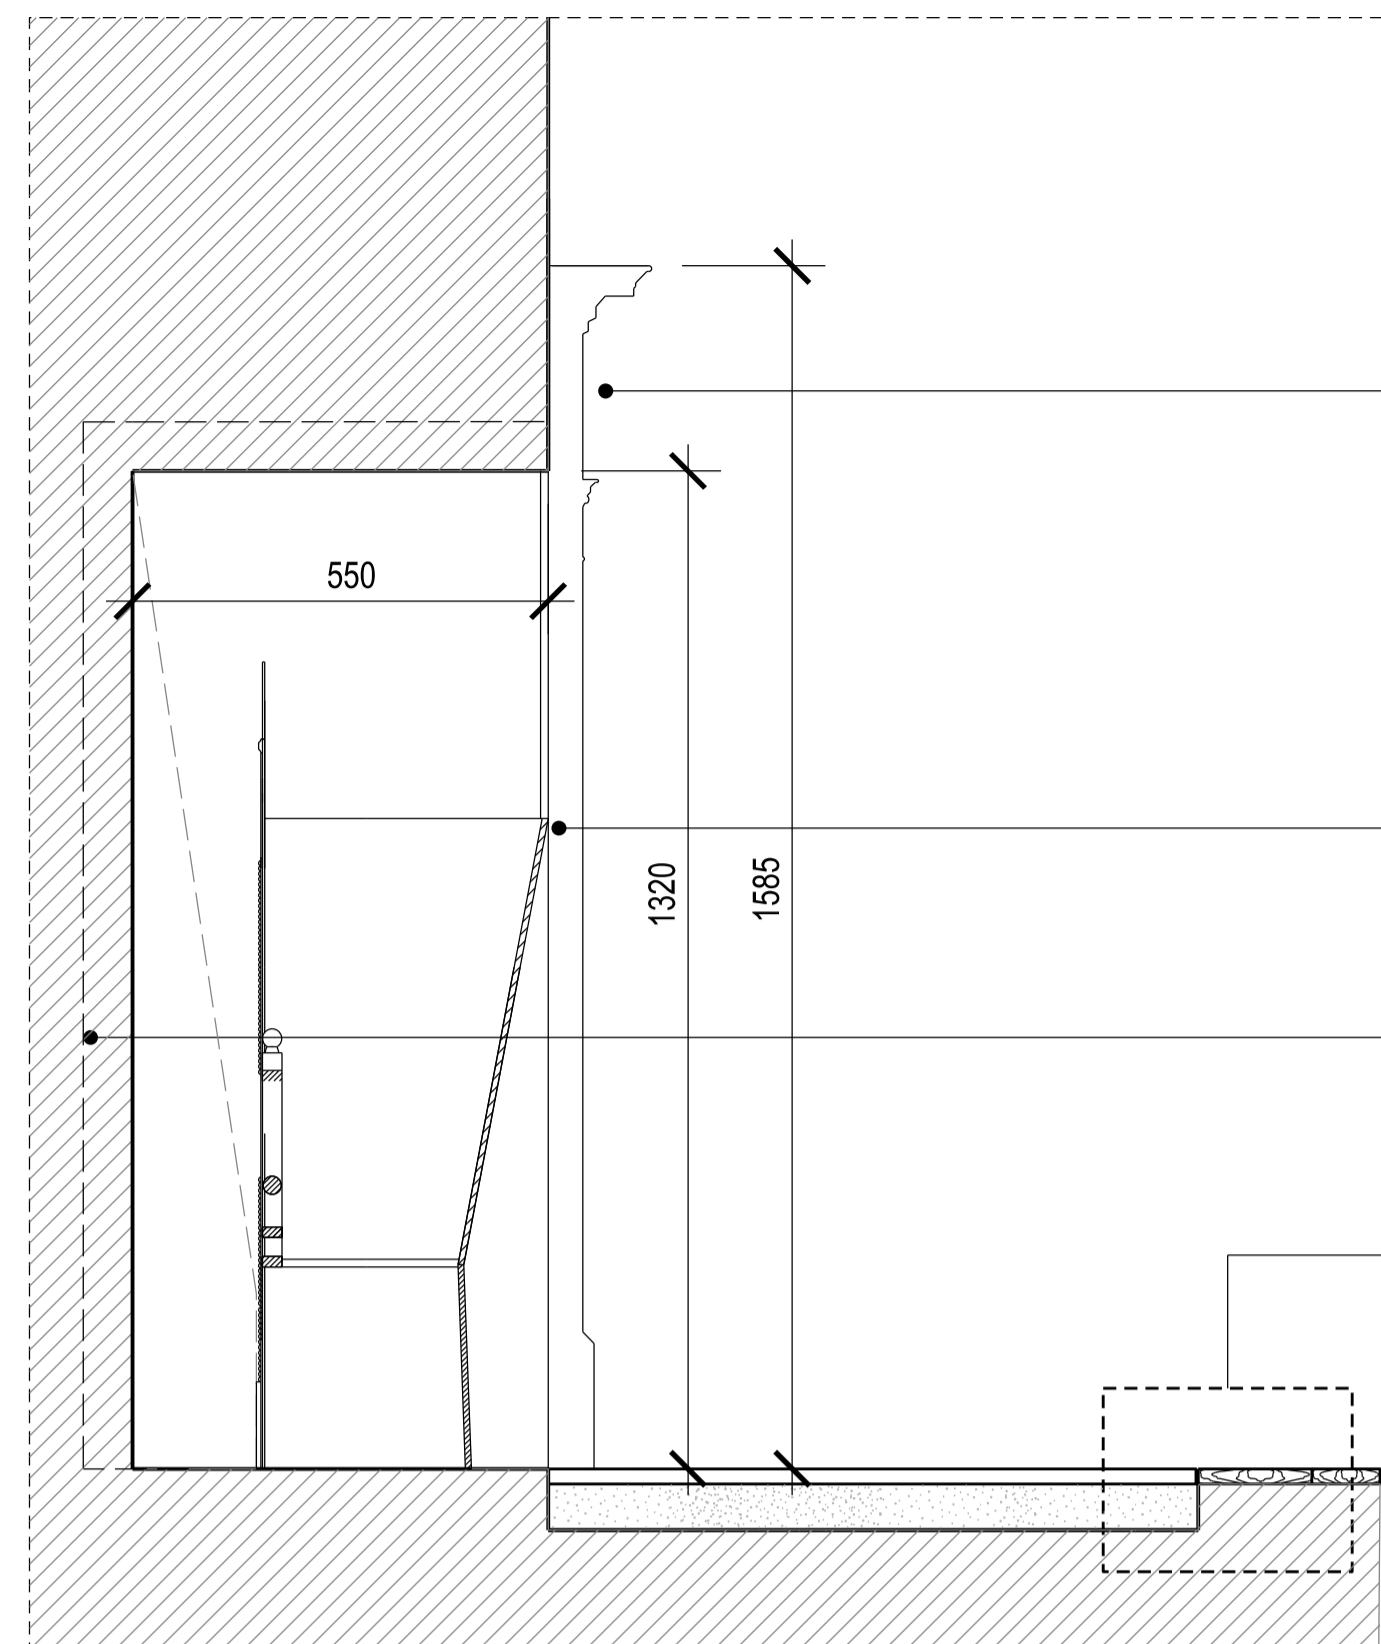
02 CHIMNEY PIECE SECTION
scale 1:10

Lasco reclamation chimney piece, pine & plaster in the style of Robert Adam.

Grove register grate by Jamb.

Dashed line indicates brick surround

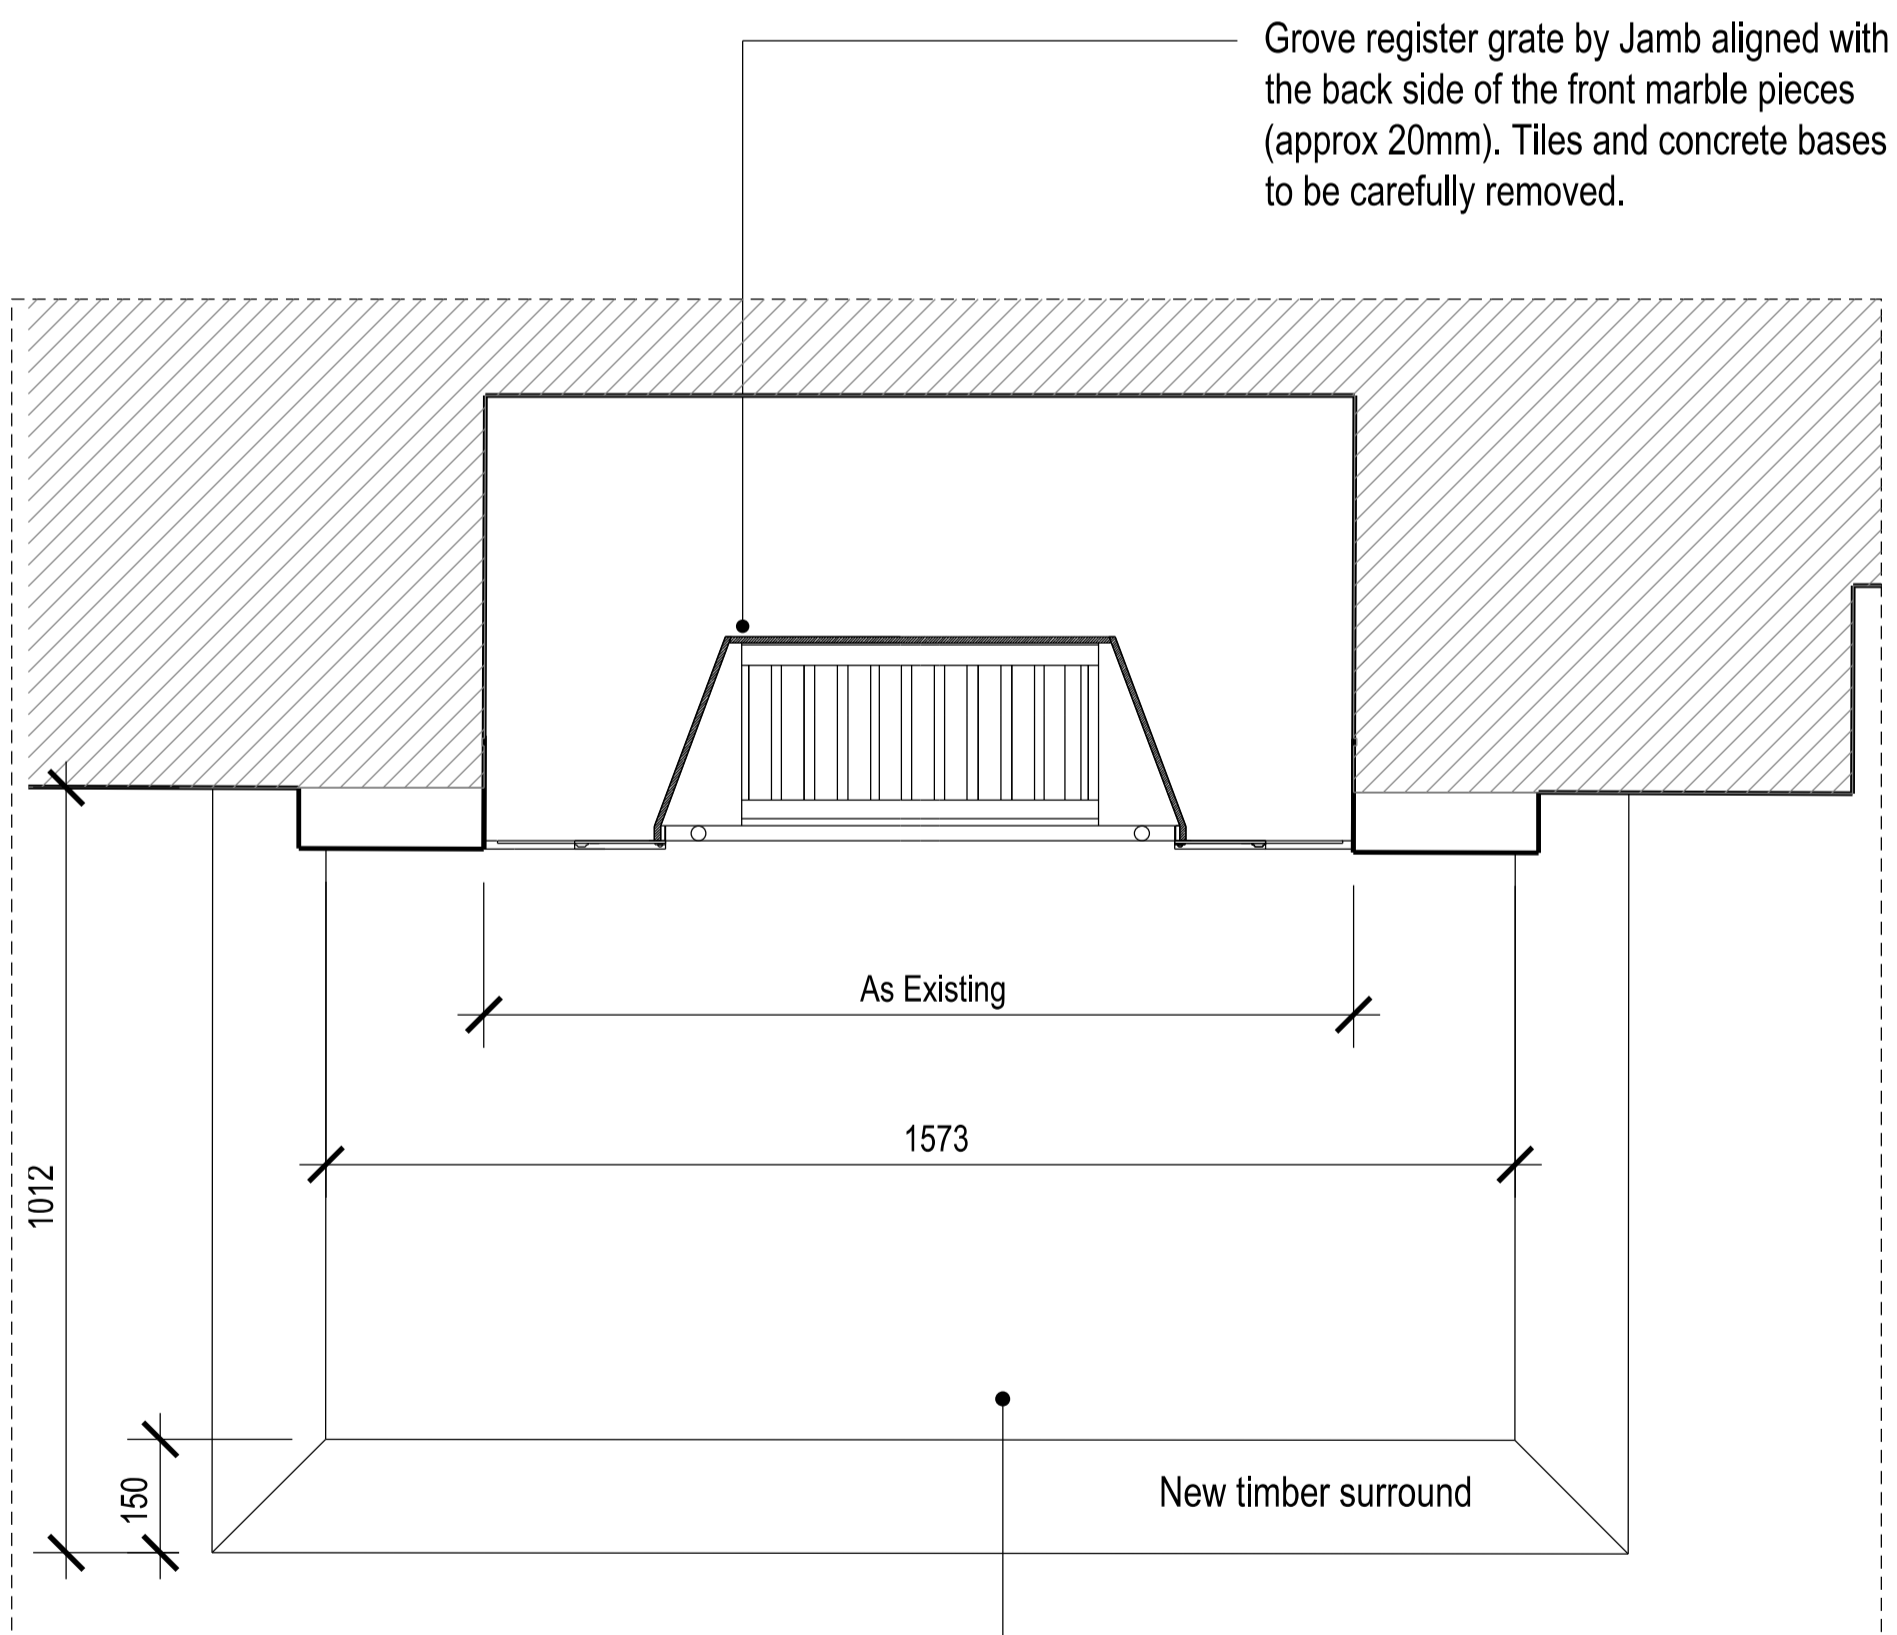
04 CHIMNEY PIECE AND HEARTH PLAN VIEW
scale 1:10

Grove register grate by Jamb aligned with the back side of the front marble pieces (approx 20mm). Tiles and concrete bases to be carefully removed.

As Existing

New timber surround

New marble hearth stone to match others in the house. Original hearth stone found to be lost.

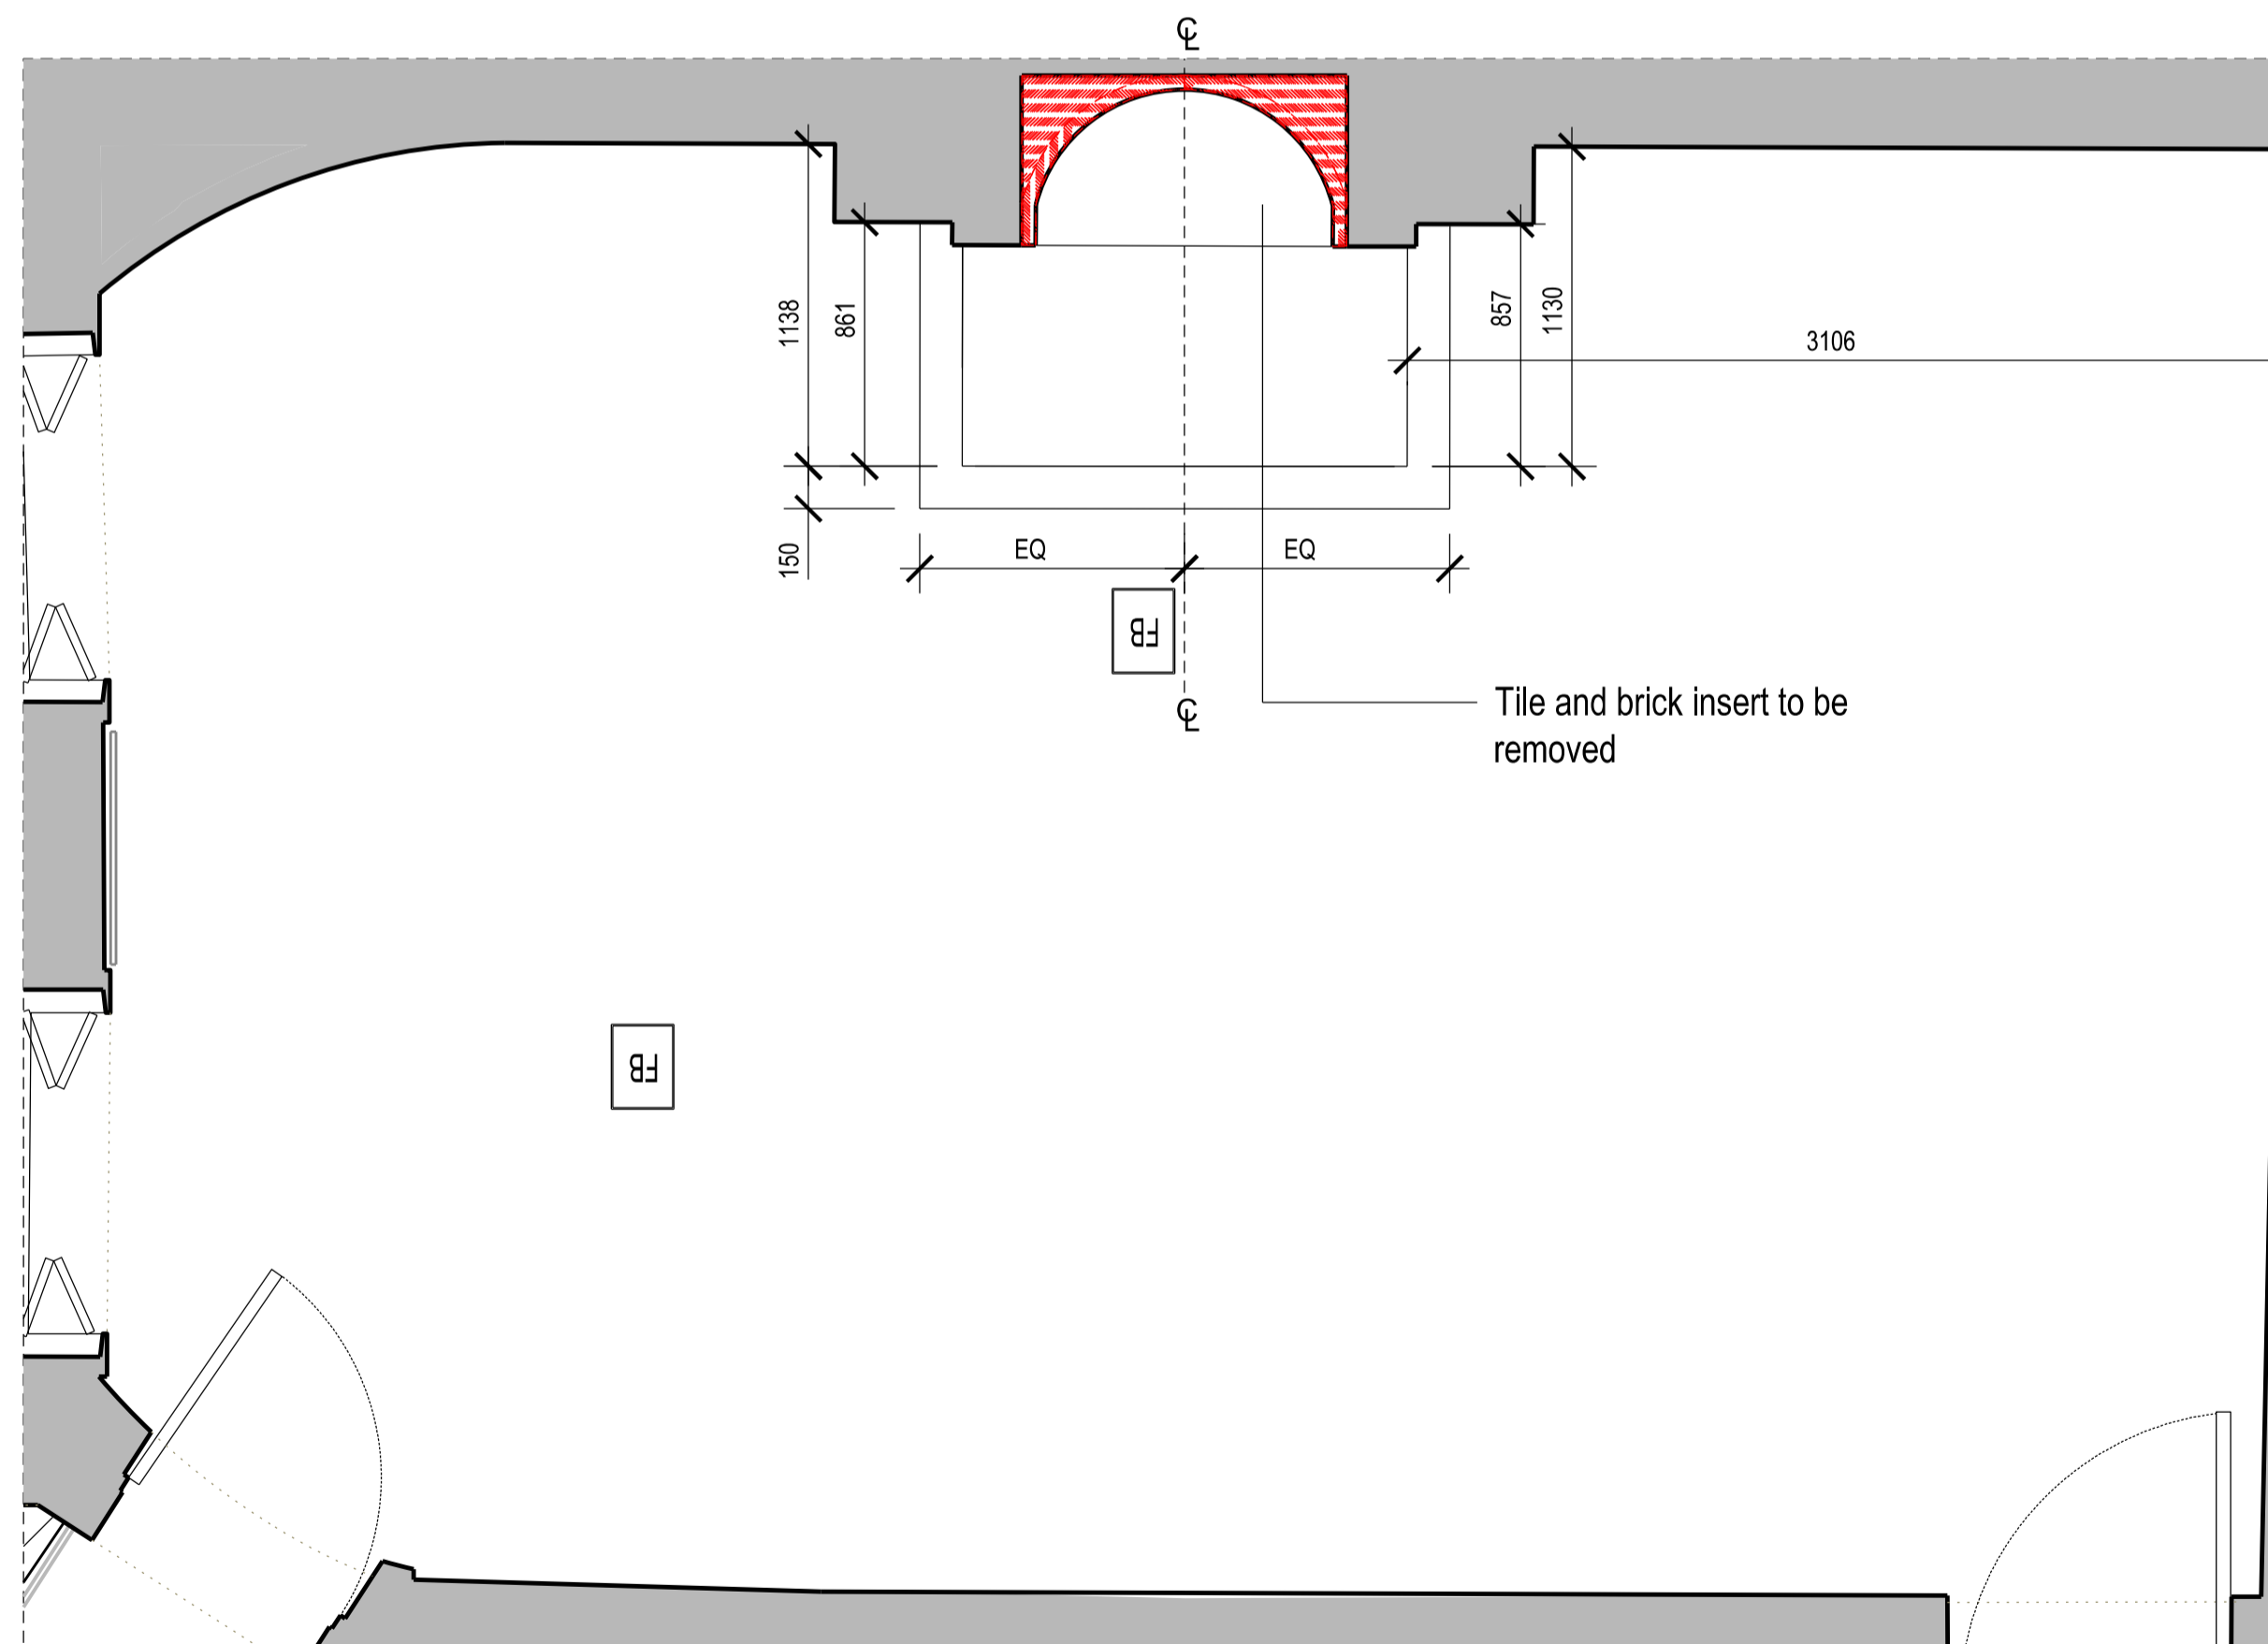
05 KEY PLAN
ROOM 1.03 LIBRARY
scale 1:25

Tile and brick insert to be removed

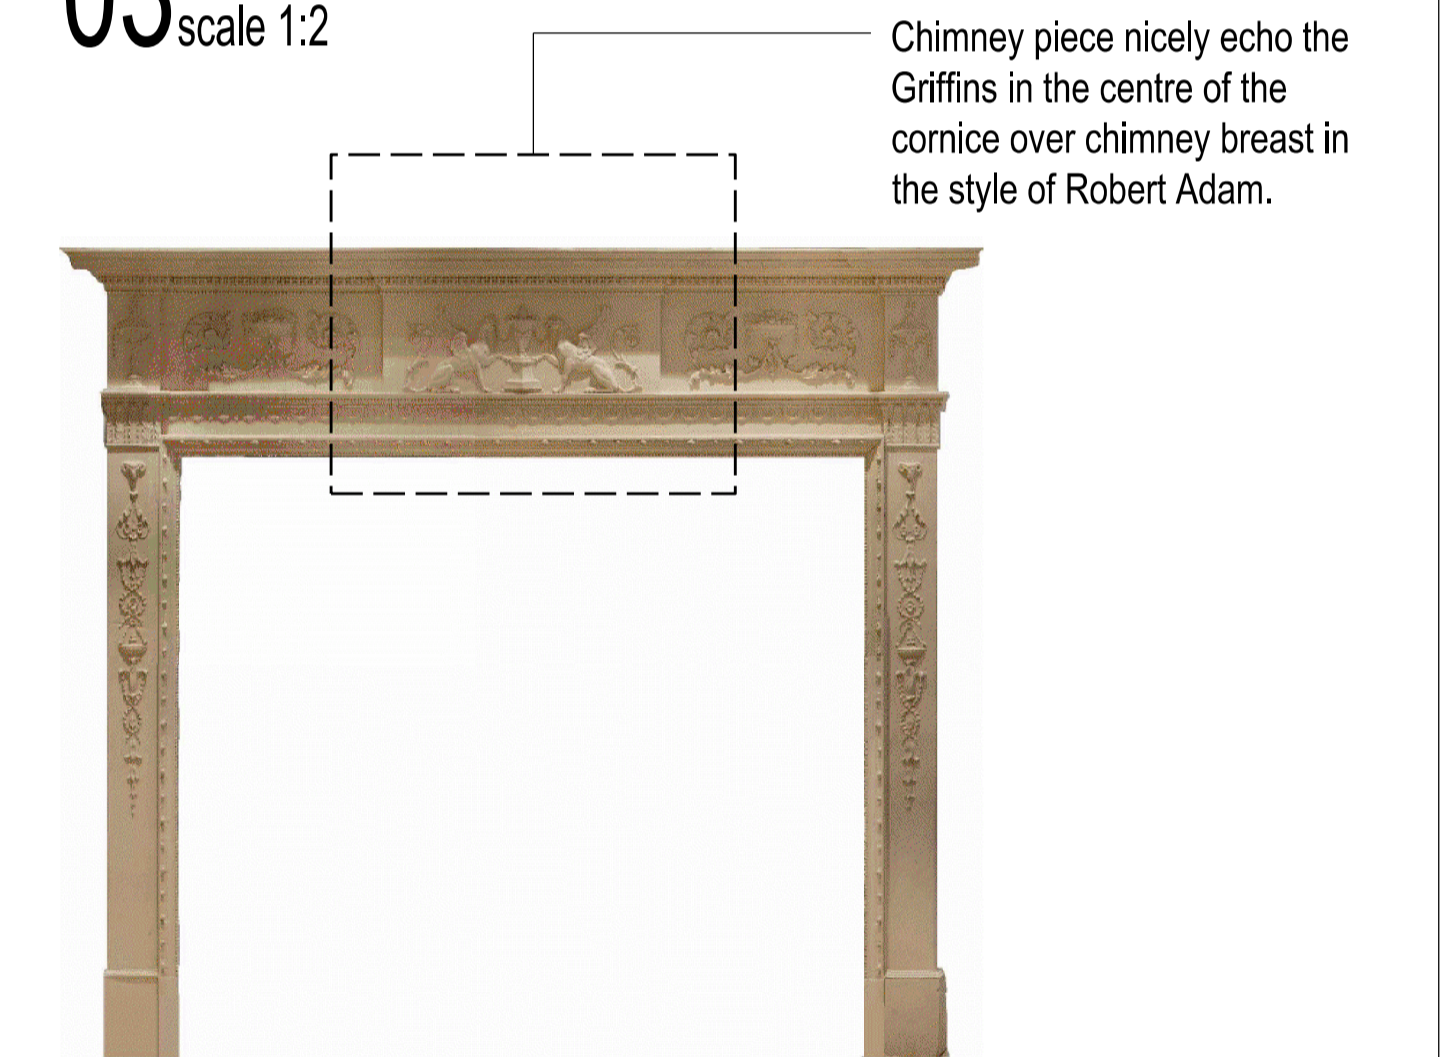
Chimney piece nicely echo the Griffins in the centre of the cornice over chimney breast in the style of Robert Adam.

CHIMNEY PIECE IMAGE
18th Century Pine & Plaster chimney piece purchased from Lassco Reclamation in London.

See (33)AD003_B elevation drawings for comparison of scale between the original chimney piece and this reclaimed chimney piece. The original chimney piece was lost prior to current owner purchasing the building. Our consent allowed for the reproduction chimney piece however through discussions with the Conservation Officer it was agreed that this reclaimed chimney piece would make an adequate substitute.
