Project
76 Lawn Road
NW3 2XB

Title
Typical Side Hung Casement Window

Status
PLANNING

Revision	Drawn By	Approved By	Drawing Number
A	CM	ED	31_600

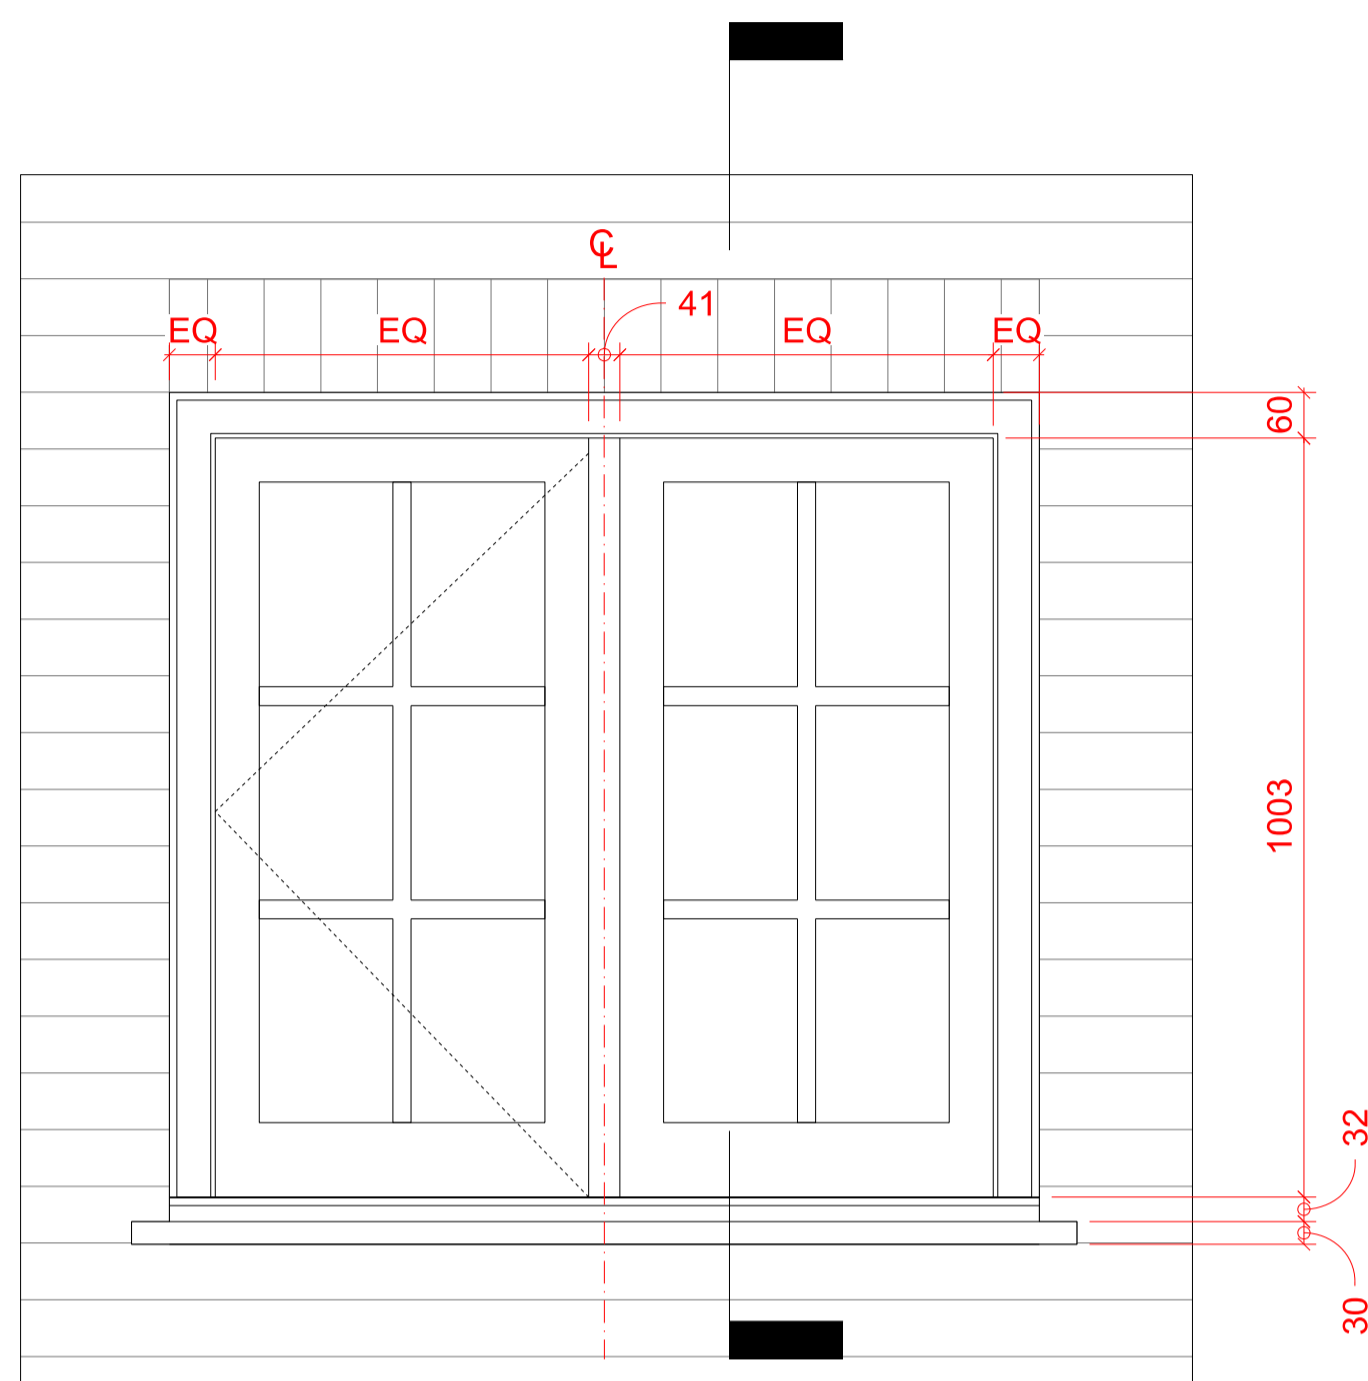
02 - Typical Side Hung Casement Window Elevation
 1:10

New white painted timber frame double glazed casement windows with windows bar detailing to match local context.

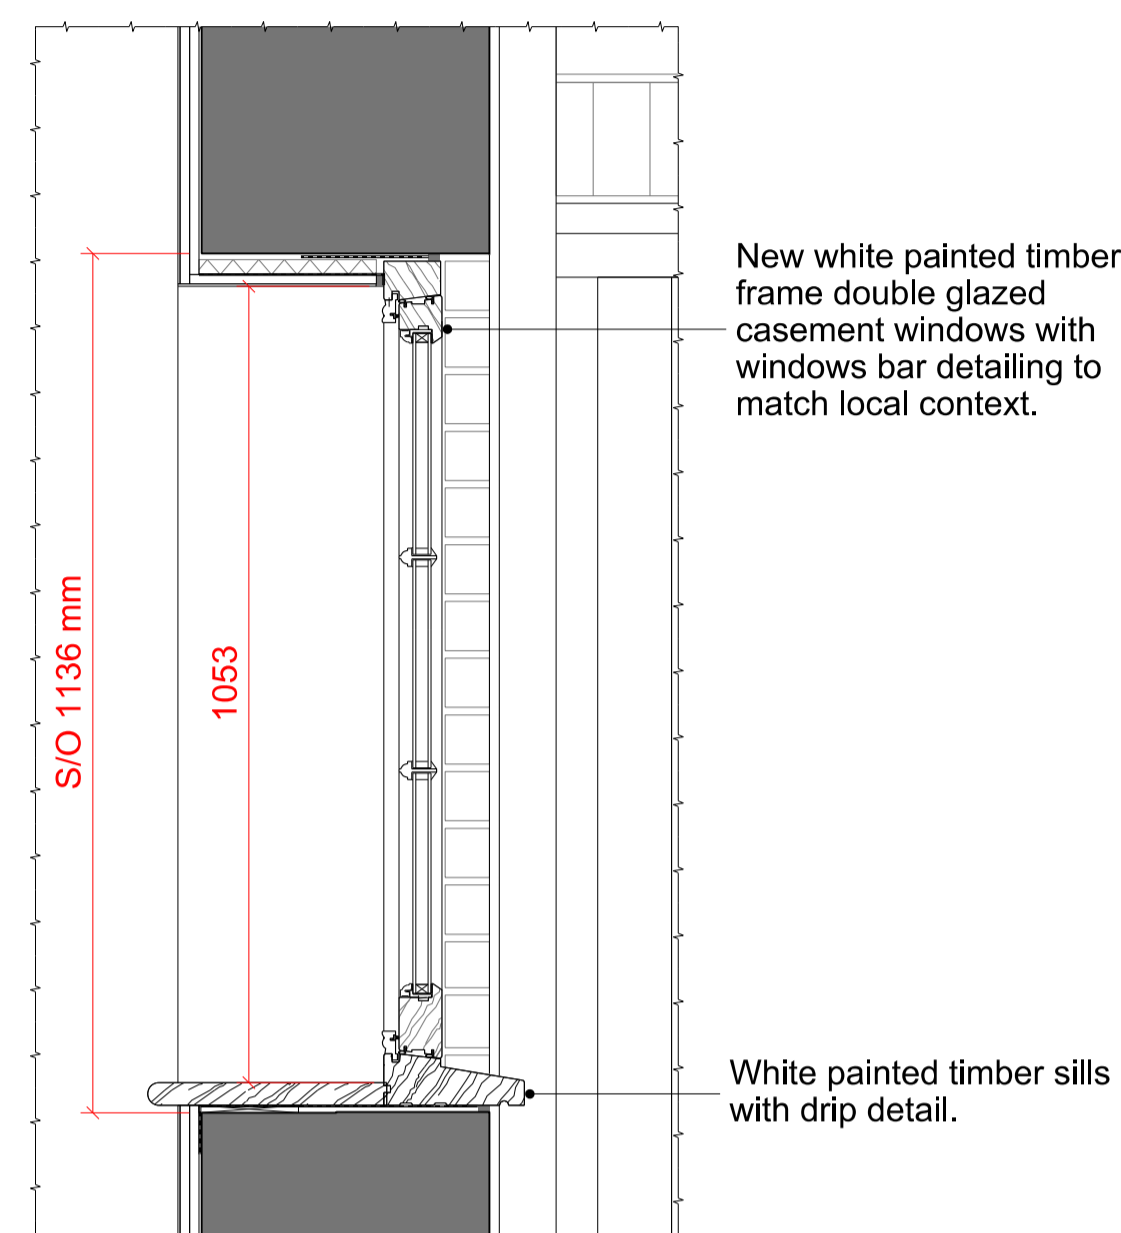
03 - Typical Side Hung Casement Window Section
 1:10

White painted timber sills with drip detail.
