## ***Phase I DESK TOP STUDY REPORT***

**Bird In The Hand PH  
West End Lane  
London  
NW6 4NX**

**January 2022  
Report No. 17185**

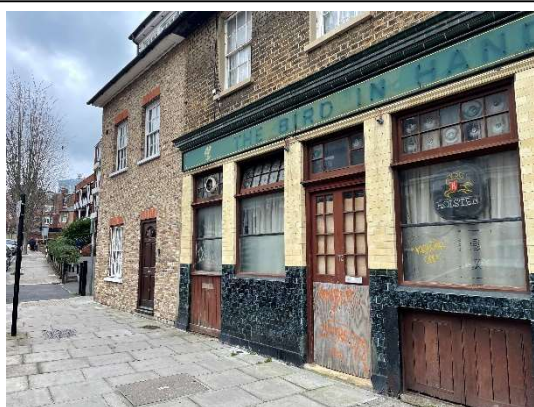
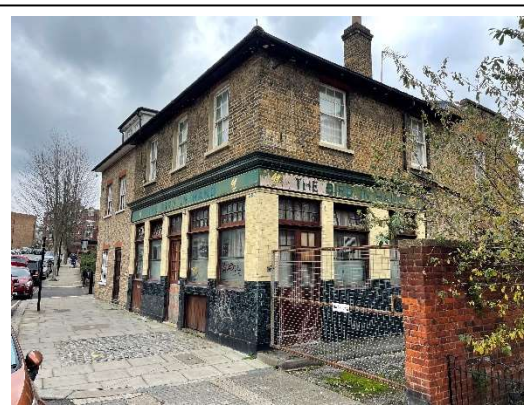
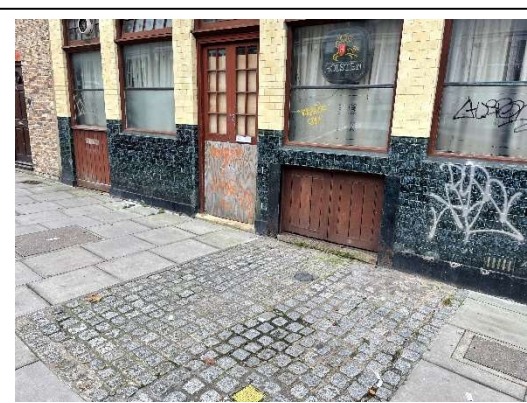
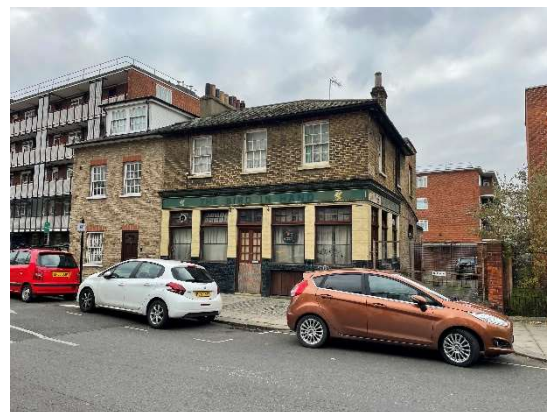
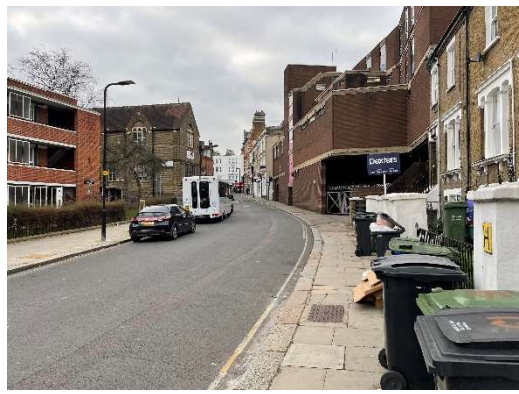
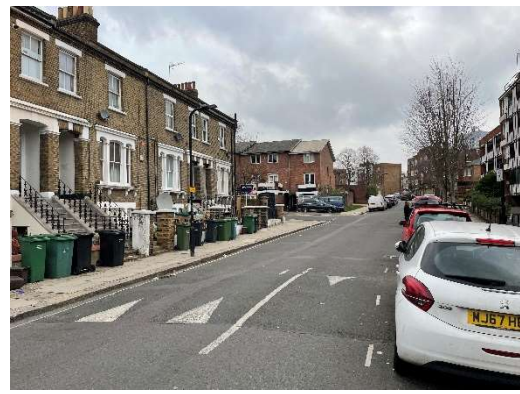
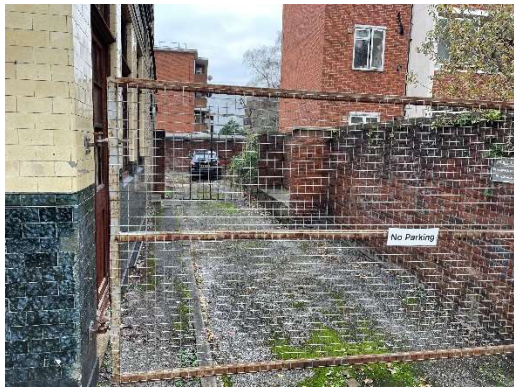
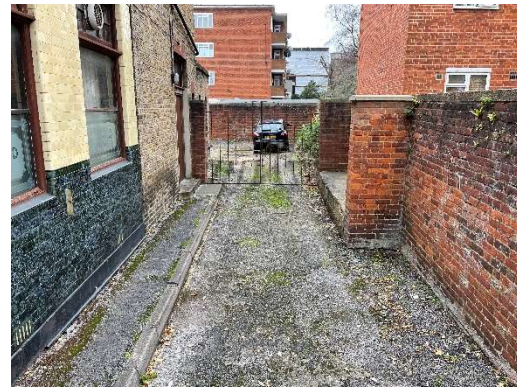
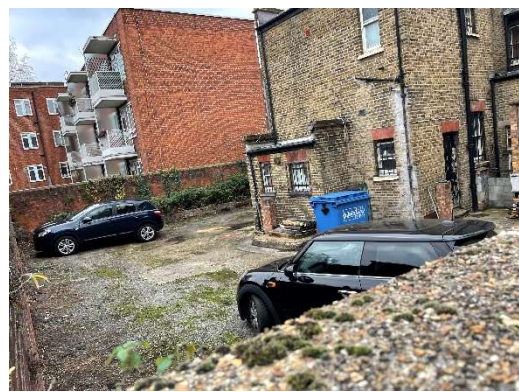
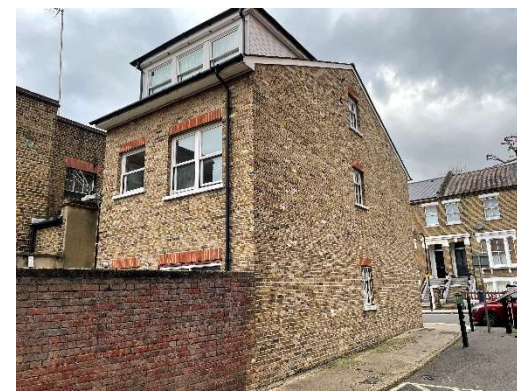
### **2.5 Site Reconnaissance – Photos**

The site is accessed off West End Lane and forms an existing two storey commercial public house with associated land. The access into the site is limited, although, this is mainly a product of the small size of the site. The main entrance into the site is via a steel gate which leads round the side of the existing public house and to the rear of the site where parking is in place. Pedestrian access through the public house is available via the front door.

The site is a rectangular parcel of land which has a public house main building fronting directly onto the pavement at the front of the site and across the front boundary. This extends up to the side access area where approximately 2.00-2.50 metres of vehicle access is available into the site. This provide vehicle access to the rear section of the site which is for vehicle parking for patrons of the former public house.

The main public house is of brick construction and appears to have a dray entrance on the western section of the building which may be indicative of a semi basement or basement.

The rear section of the site is laid to a combination of concrete and tarmac, some of which is loose. The rear car park is bounded on all sides by a brick wall approximately 2 metres tall. An extension is present into the rear garden from the main building.

No plants and vegetation were identified in the site as the site is laid entirely to hard landscaping.

By examination of the site, no above ground tanks are in place, no feature are present to suggest that any below ground fuel tanks would be in place within the site area. No staining was seen in place.
