**9 WOBURN WALK
LONDON**

HISTORICAL REPORT

OCTOBER 2006

9 Woburn Walk - Introduction

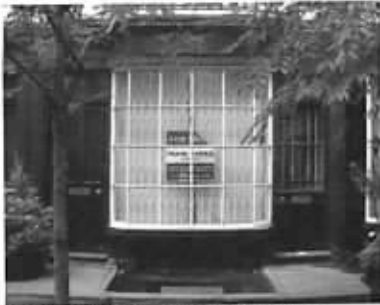
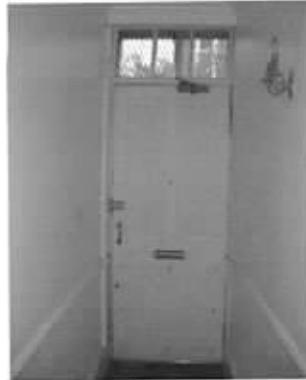
- Main entrance door to be retained and redecorated. Lower panels have been covered and boarded up externally these panels will be removed to expose the original door behind. (Photographs G 1 and G 2)
- Hallway to retain the existing skirting, dado rail and cornice.
- Original staircase to first floor to have dado rail and skirting reinstated, along with new windows at half landing. (Photograph G 3)

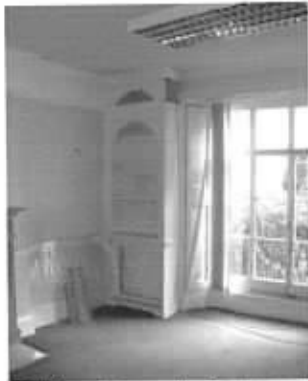
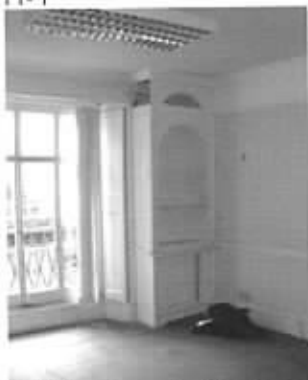
- Existing bookcases above radiators to either side of window to be removed (photographs F1-1 and F1-4) - later addition.
- Reinstall skirtings, dado, picture rail where bookcases removed to match existing.
- Existing casement window to balcony and shutters to be retained and overhauled (photographs F1-7 and F1-6).
- Timber fireplace surround to be removed (photograph F1-3).
- Ceilings and walls to be redecorated.
- Door DF/01 to be retained and redecorated.
- Stud walls to store area (photograph F1-2) to be removed. This has been added at a later date as there is evidence of the original skirting within the cupboard. (photograph F-8)

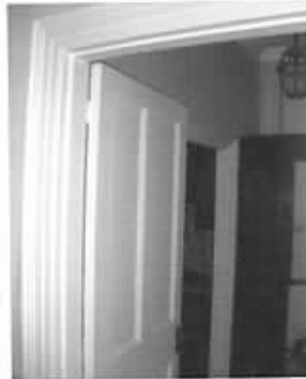
First Floor Room 1 – Photograph F2-2

- Existing alcove unit (photograph F2-3) to be removed (later addition).
- DF/02 (photograph F2-2) to be retained and refurbished.
- DF/04 into conservatory (F6) is not original (photograph F2-4) and is to be replaced with sash windows similar to WS/03 (see example photograph).
- Original staircase, handrail and square balustrade (photograph F2-4) to be retained and redecorated.
- Stair handrail and balustrade to second floor to be retained and made good.

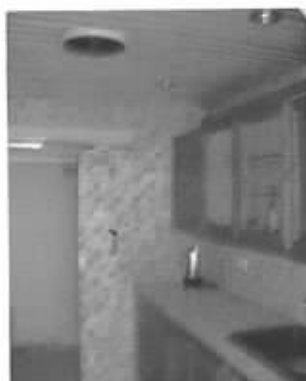
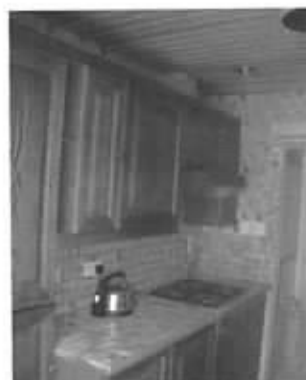
- All kitchen units to be removed (photographs F4-1 and F4-2), together with false ceilings. Original ceiling to be investigated as to its condition and any features which may be missing are to be reinstated.

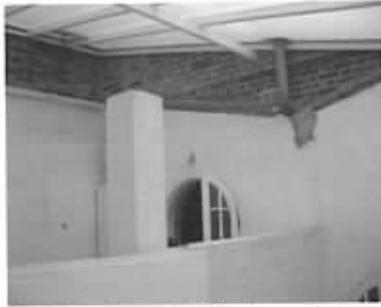
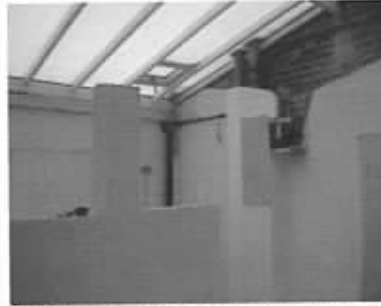
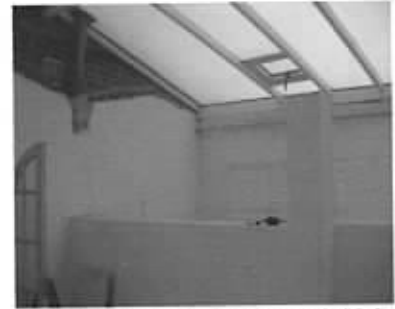
- Conservatory area to have existing central wall (photographs F5-1, F5-2 and F5-3) taken down along with patent glazing roof.

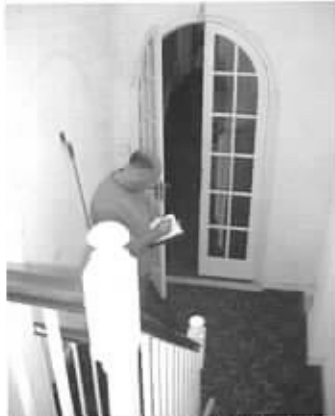
First Floor Room 6 – Photograph F6-1

- Existing staircase and balustrade (photograph F6-2) to be removed (later addition)
- Door DF/04 to be removed (photograph F6 1) and replaced with a sash window of a style in keeping with WS/03 as shown.

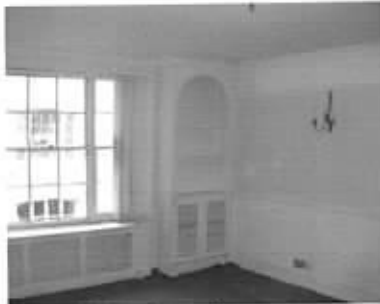
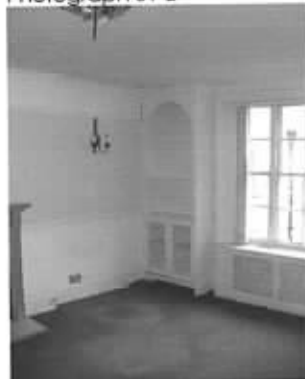
- Existing bookcases to either side of window (photographs S1-1 and S1-5) to be removed.
- Where bookcases removed skirting, dado, picture rail and cornice to be reinstated to match existing. Walls to be made good.
- Existing window to be retained and overhauled. Radiator casing under to be removed and skirting to be added if non-existent.
- Timber fireplace to be removed (photograph S1-4)
- Door DS/01 (photograph S1-2) to be retained and redecorated.
- Existing mirror-faced wardrobes (photographs S1-2 and S1-3) to be removed. Existing skirting continues through to wall.

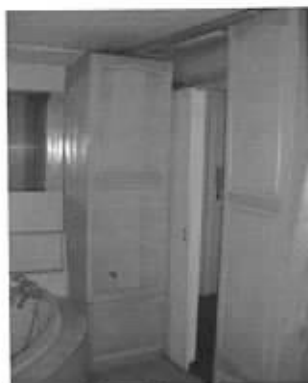
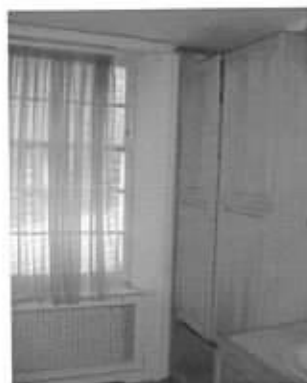
- All bathroom fittings and boxing to be removed (photograph S3-1 and S3-2).
- Windows to be retained and made good. Casing under windows to be removed.

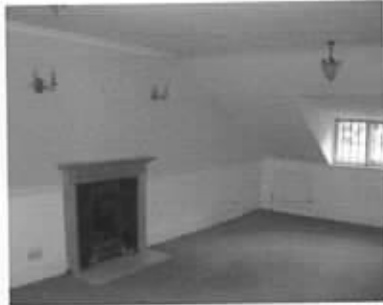
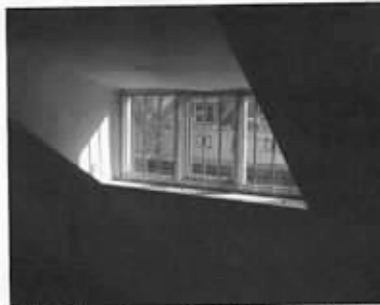
- Existing dormer window WT/01 to be removed (later addition) and new window to be made to original design (photograph T1-1 and T1-1a).
- Existing alcove unit to be retained.
- Existing wall cupboards (photographs T1-3 and T1-4) to either side of windows WT/02 and WT/03 to be removed. Cornice, dado rail and square edge skirting to be continued through to rear wall - to match existing.
- Existing handrail and balustrade, although not original to be retained (photograph T1-4)
- Existing rear windows (photographs T1-3 and T1-4) to be retained and repainted.
- Ceiling and walls to be redecorated.
