Appendix 3 Desk Study References

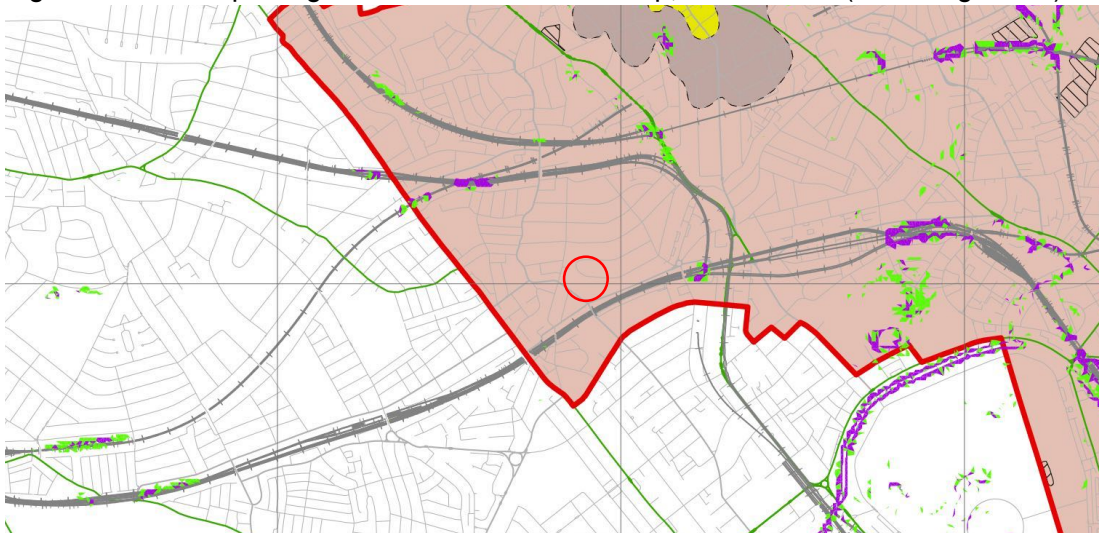
Figure 10 Slope Angle and Worked Ground Map, LB Camden (GHHS figure 16)

Slopes in green, 7 – 10 degrees; Slopes in purple, >10 degrees.

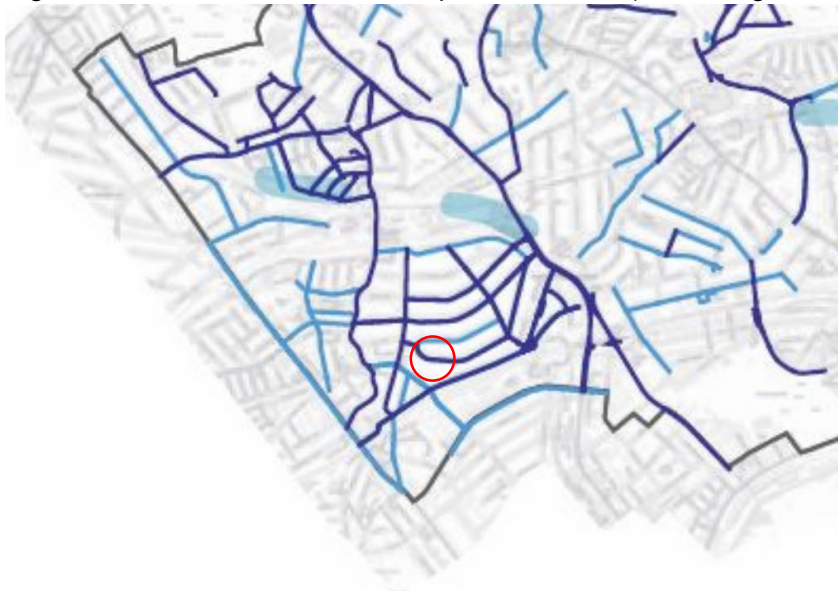
Figure 12 Flooded Streets Map, LB Camden (GHHS Figure 15)

The highlighted streets are known to have flooded in 1975 (light blue) and 2002 (dark blue).

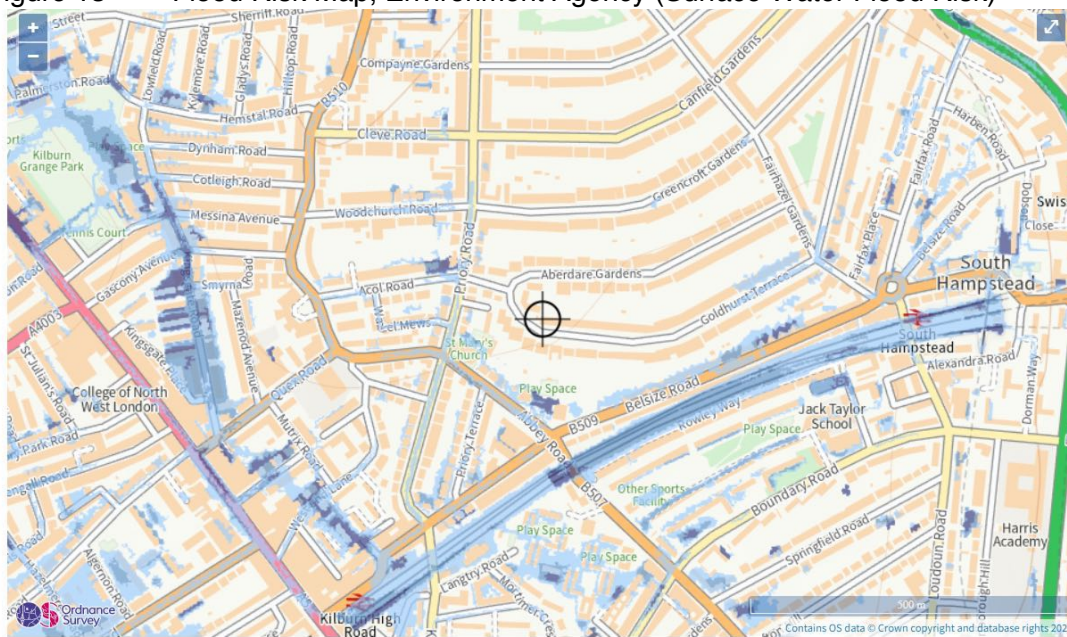
Figure 13 Flood Risk Map, Environment Agency (Surface Water Flood Risk)

Extent of flooding from surface water
