Camden Lock Market

West Yard, East Vaults & Dead Dog Basin

Archaeological Desk Based Assessment August 2022

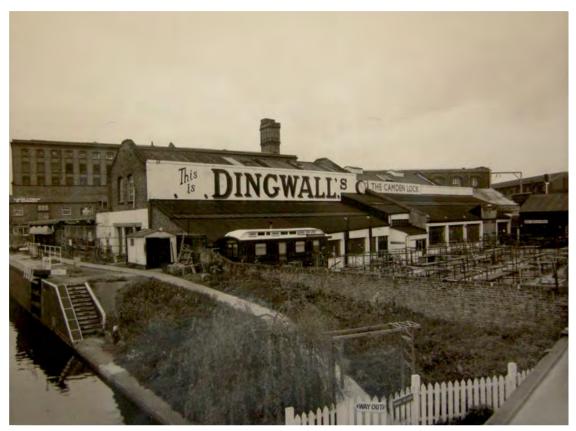
Fig 13 The site looking north-west 1975 (LMA ref: SC/PHL/02/Box1313/22). The market stalls in East Yard are on the right of the photo. The Interchange warehouse is in the background on the left of the photo

- 4.2.34 By the end of the 1960s there was a decline in industrial activities in the area. T E Dingwall closed in 1971 and the site was leased to Northside Developments for 10 years, on the basis that it would be used for arts and crafts. A market opened in East Yard in 1973, occupied by cabinet makers, furniture repairers and folk artists (Stephen Levrant Heritage Architecture, July 2015, 22). However, this made little impact to the plan of the buildings on the site; the Ordnance Survey 1:1,250 scale map of 1975 (Stephen Levrant Heritage Architecture, July 2015, 33; not reproduced) shows only minor changes. Fig 13, taken in 1975, shows the new market on the East Yard. The building with 'Dingwall's' painted on its east side is a reminder of the former use of the area; this building is still there, as can clearly by seen in Fig 16. A comparison of Fig 13 and Fig 16 also shows how the ground level has been raised along the south-eastern edge of the site. The stalls in the East Yard in Fig 13 also appear to be below the current ground level, suggesting that the reduced level area currently underneath the building in the south-east corner of the site may not in fact be much below the former ground level in this area.

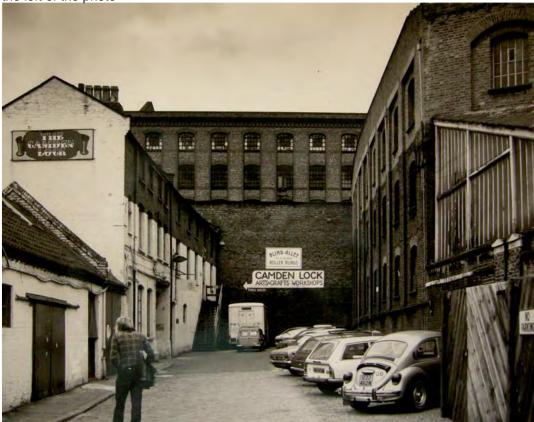
Fig 14 The west end of Camden Lock Place looking west in 1980 (LMA ref: SC/PHL/02/0919/25)

Borough of Camden ref: 2005/3089/C). Fig 14 shows the west end of Camden Lock Place in 1980 before the new building on the corner of Middle Yard and Camden Place was built. Instead a one storey building is shown in this location. The photograph also shows the wall which formerly divided Camden Lock Place from the interchange complex. This was knocked through sometime between 1989 and 1991 when the Interchange Building was refurbished. The buildings on the right hand side of the photograph (on the north side of Camden Lock Place and outside the site) have since been demolished and the existing buildings built in their place. Fig 15 shows what the west end of Camden Lock Place looks like today.

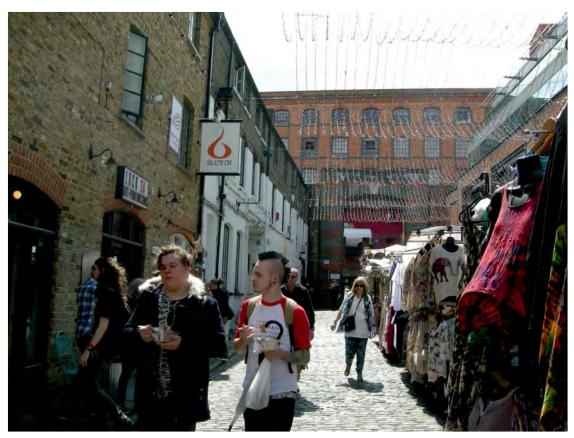
Fig 15 The west end of Camden Lock Place looking west in 2015 (MOLA photo 23.06.2015)

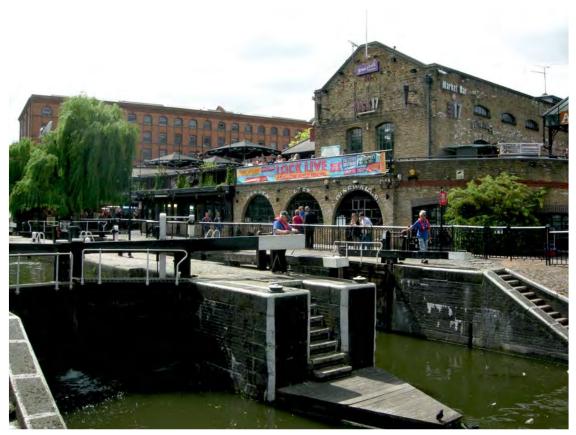
Fig 16 The site looking north-west in 2015 (MOLA photo 23.06.2015). The Dingwall's building shown in Fig 15 is still there on the right side of the photo. The Interchange Building is on the left

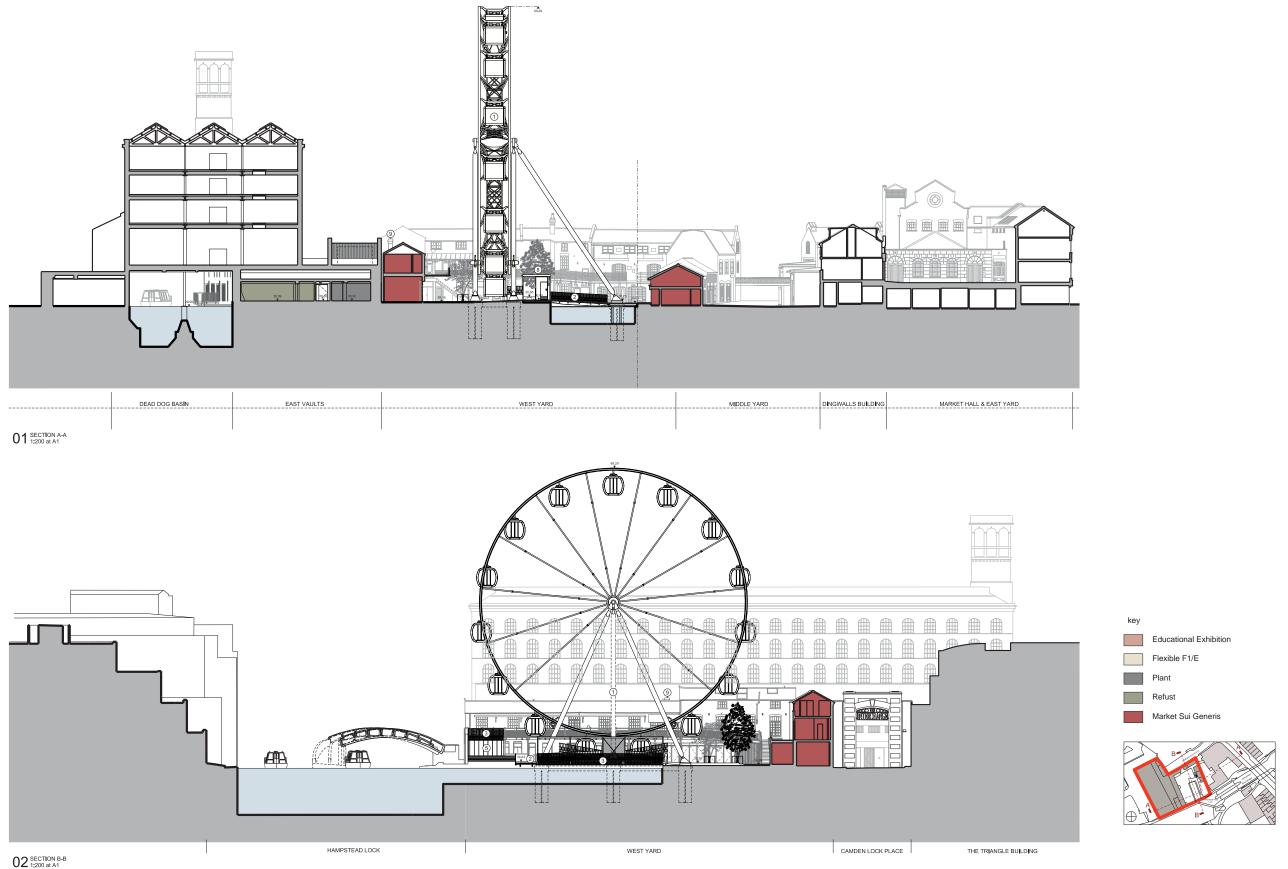
Fig 20 Proposed site sections AA and BB (Piercy & Company, dwg ref 13663 A LZZ P04 200, rev B, dated 10.08.2022)

- 6.2.4 The Observation Wheel is to be located to the west of the canal inlet (Fig 20) and is to have a single piled central raking prop and four raking piled support columns for the wheel, the locations are shown in Figs 21–23. Foundations for the Observation Wheel will be required at the base of each of the five raking props. At this stage it is anticipated that the foundations will comprise bored CFA (Continuous flight auger) piles (Walsh, 2021, p21). This pile type would minimise the impact upon possible archaeological remains, however it will remove any archaeological remains within its footprint, which will comprise 19th century masonry foundations.

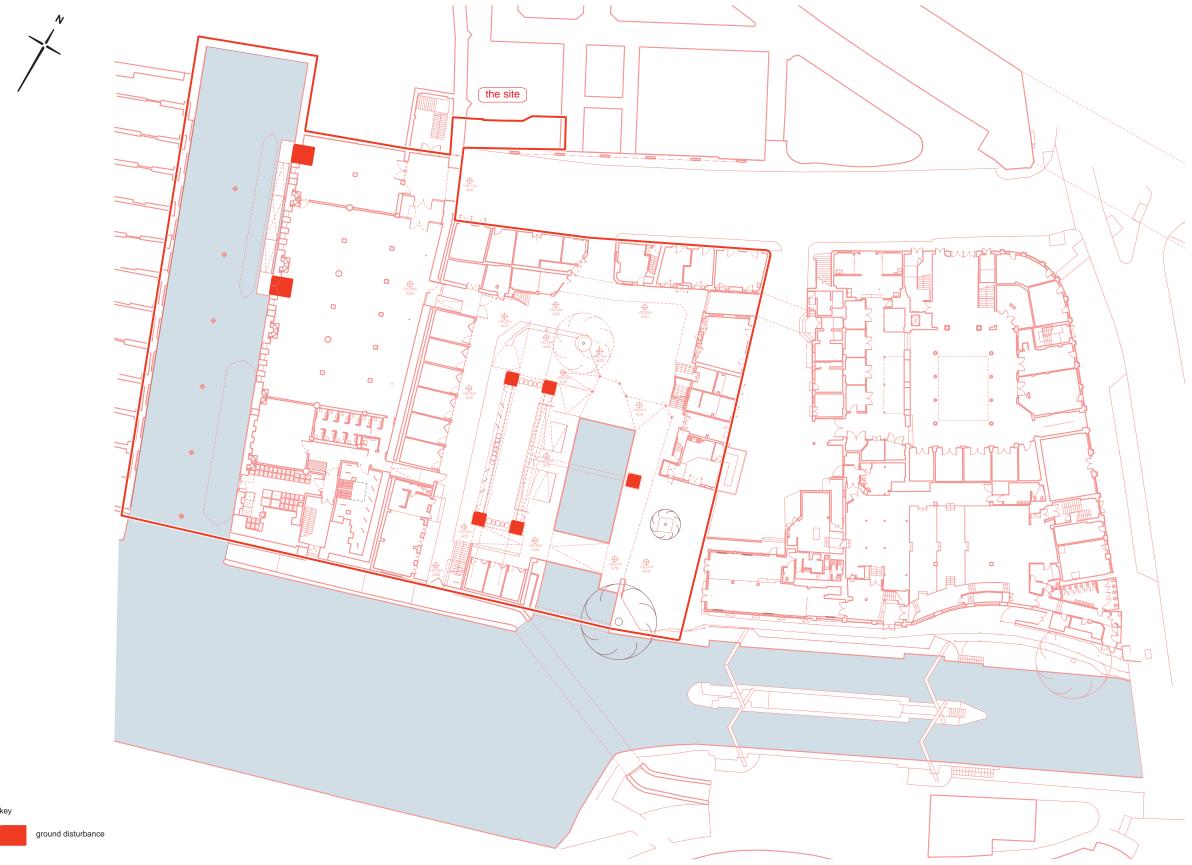
Fig 21 Areas of proposed ground floor disturbance (Piercy & Company, dwg ref: 13663 A L00 P03 SK01, dated 09.05.2022)

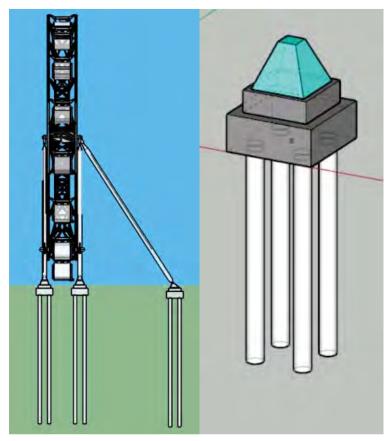
Fig 24 Section looking north, illustrating possible Observation Wheel heigh and foundation arrangement and typical schematic pile cap arrangement (Walsh 2021, 22)

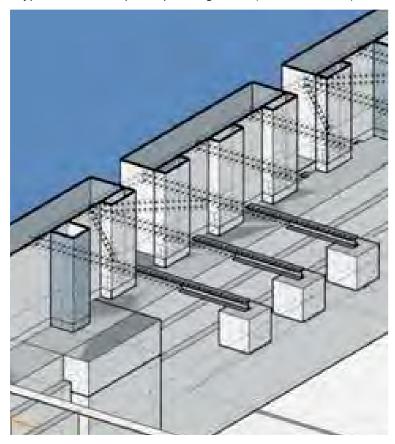
Fig 25 Engineering illustration of the foundations for the jetty

- 6.2.9 The ends of the jetty structure will be steel framed and will cantilever from the adjacent basin wall (Fig 25). The cantilevered jetty will sit on six small concrete piers and its central portion will be a floating pontoon. The pier foundations for the jetty structure will remove any archaeological remains within their footprint to their maximum depth, which is currently unknown and might comprise 19th century masonry foundations
