- 1NO EXISTING EXTERNAL MACHINES REMOVED FROM SITE
- 1NO NEW EXTERNAL MACHINE INSTALLED THROUGH EXISTING APERTURE WITH SOME REMODELLING REQUIRED
- ALL FINISHES TO BE MADE GOOD INTERNALLY AND EXTERNALLY AND TO MATCH EXISTING
- NEW EXTERNAL BUTTON SIGNAGE ABOVE NEW MACHINE
- NEW CCTV CAMERA INSTALLED

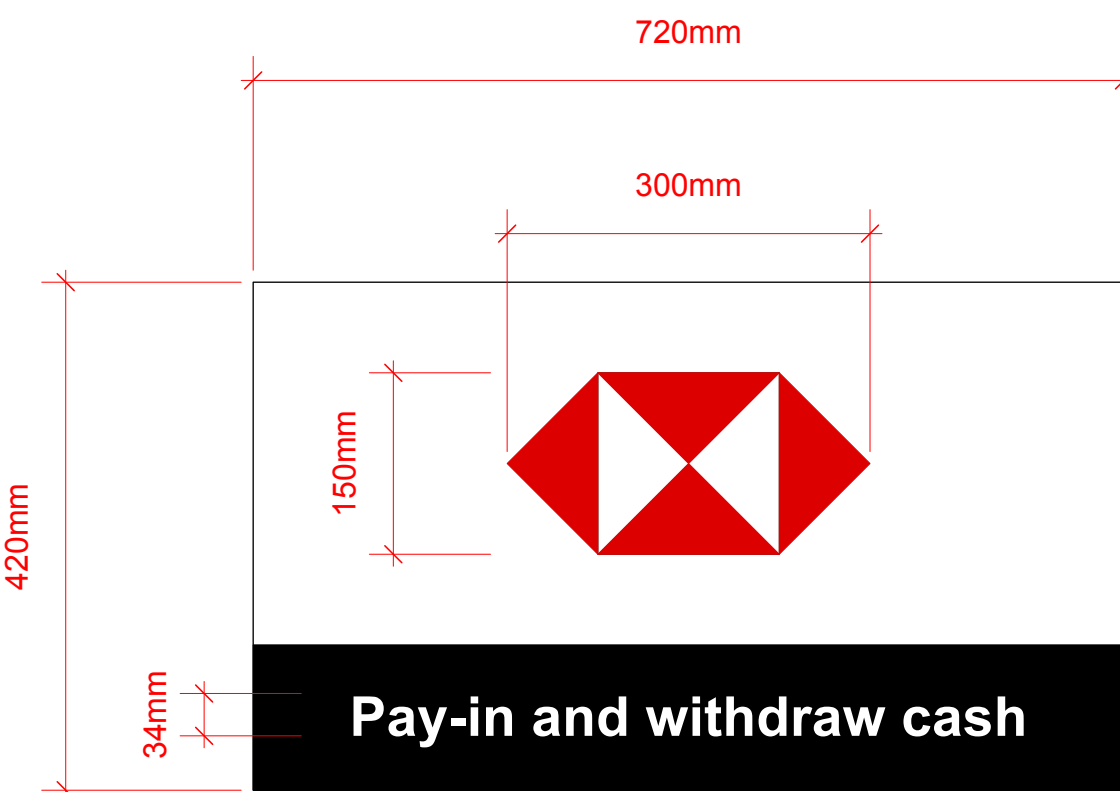
SIGNAGE DETAILS  
External Standard Button Sign
