Architecture for London

Photographic Study
3 Gainsborough Gardens, London, NW3 1BJ

August 2022

1.0 Introduction

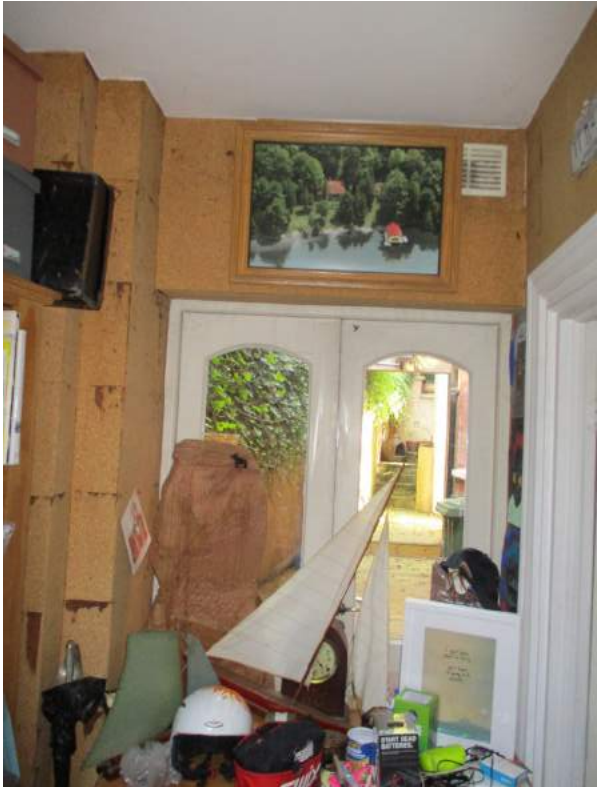
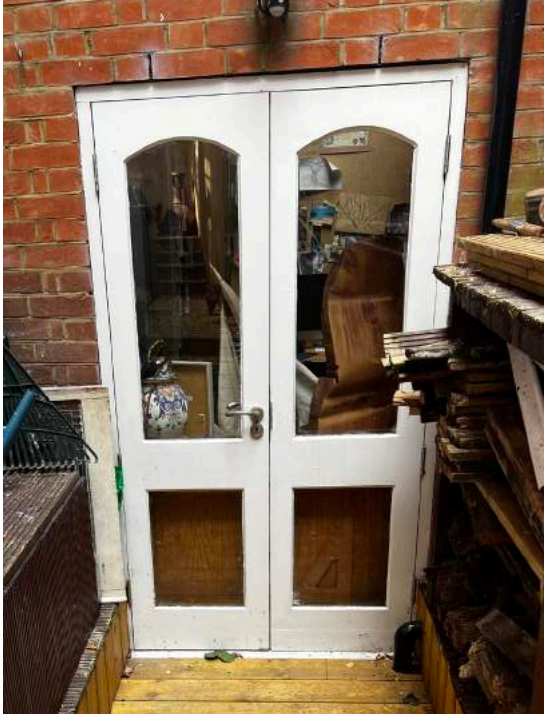
1. Study & Study doors.

Study doors to garden to be retained. Room to be redecorated.
Existing cork lining is to be replaced with more sympathetic renovation.

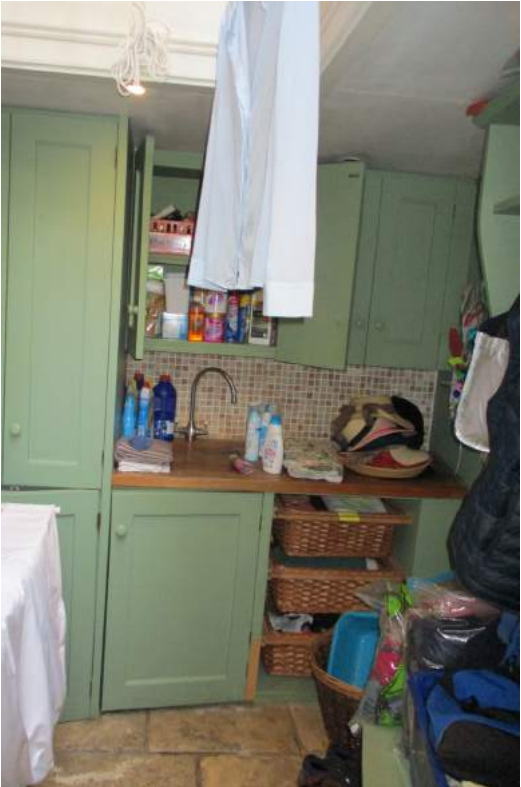
2. Utility Room.

The contemporary fit out is to be stripped out to allow for new cabinets and a new utility room layout.
Where the internal layout is to be rearranged all the original architectural mouldings are to be faithfully replicated.

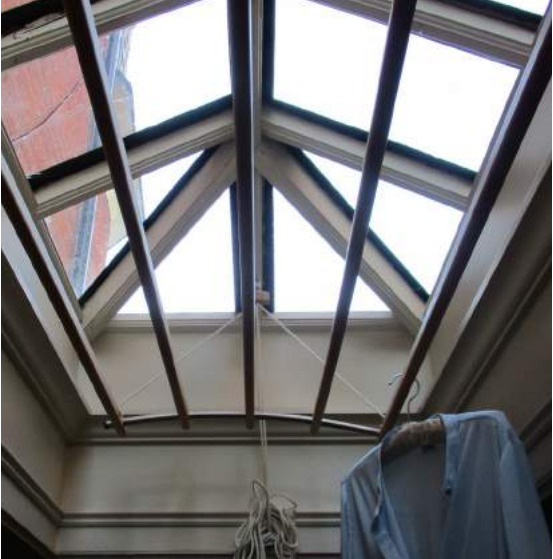
3. Utility Room Roof lantern.

Existing roof lanterns to be refurbished and retained.

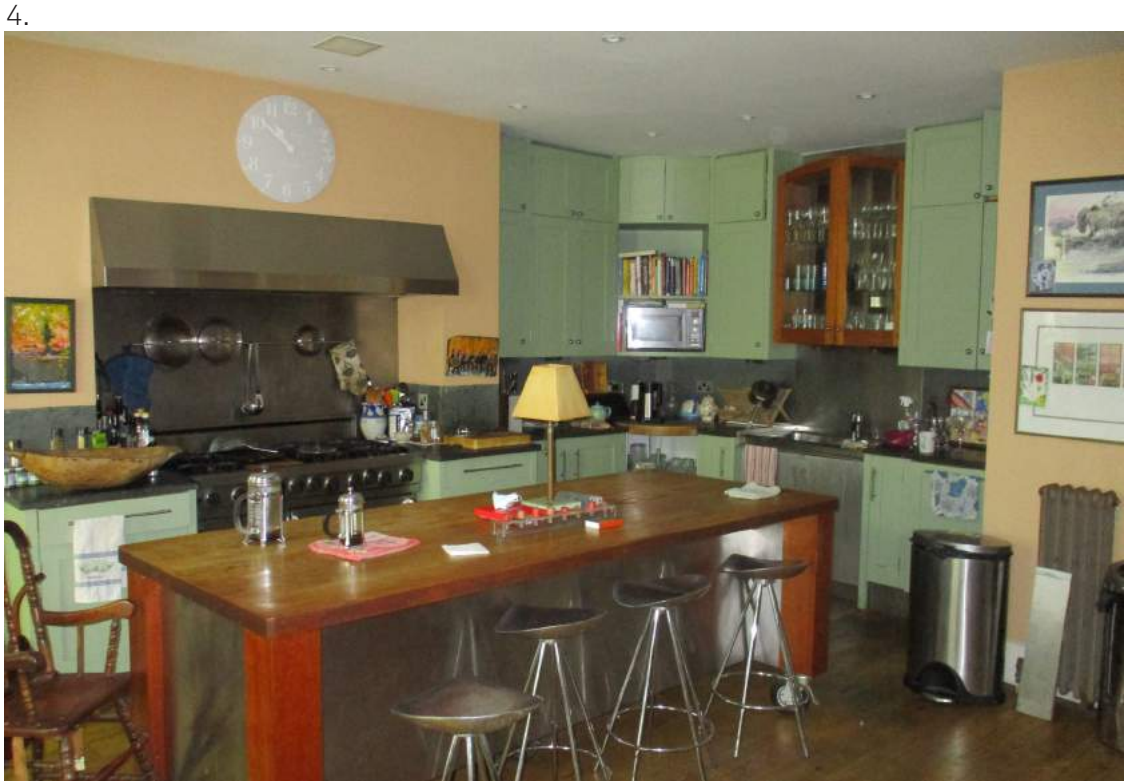
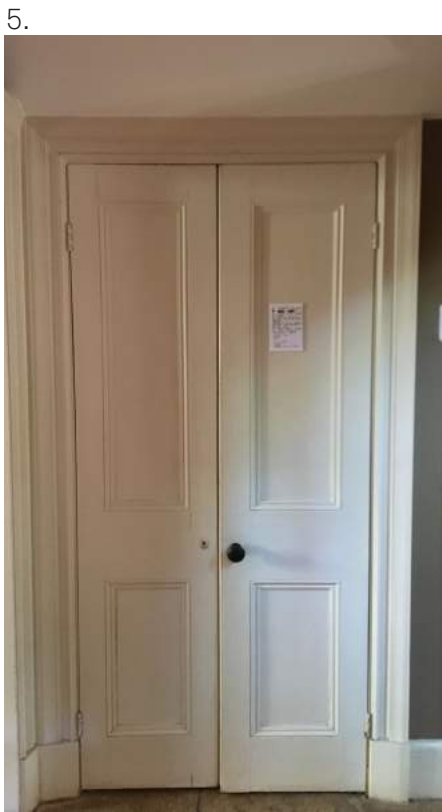
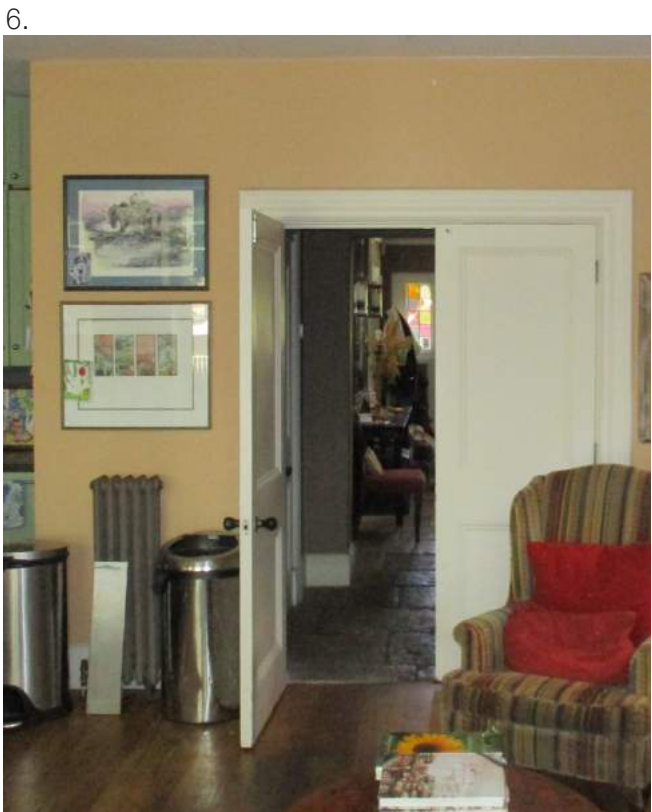
4. Existing kitchen fit out
Contemporary kitchen to be stripped out to make way for new fit out.
5. Existing hall cupboard doors.
Doors and section of internal wall to be removed and retained for reuse to allow for the new kitchen.
- Where the internal layout is to be rearranged all original architectural mouldings are to be faithfully replicated.
6. Existing double doors between kitchen and hall.
Section of partition wall to be demolished to allow for new kitchen.
Architectural mouldings are none original throughout kitchen and dining area due to the renovation and extension in the 90s.

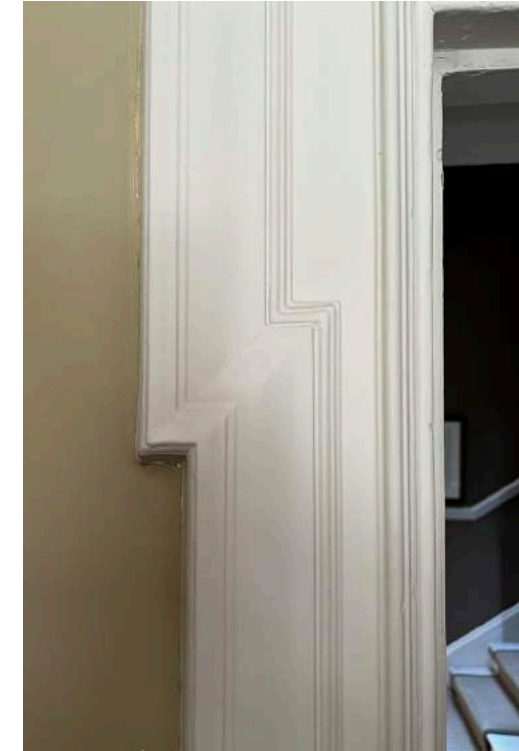
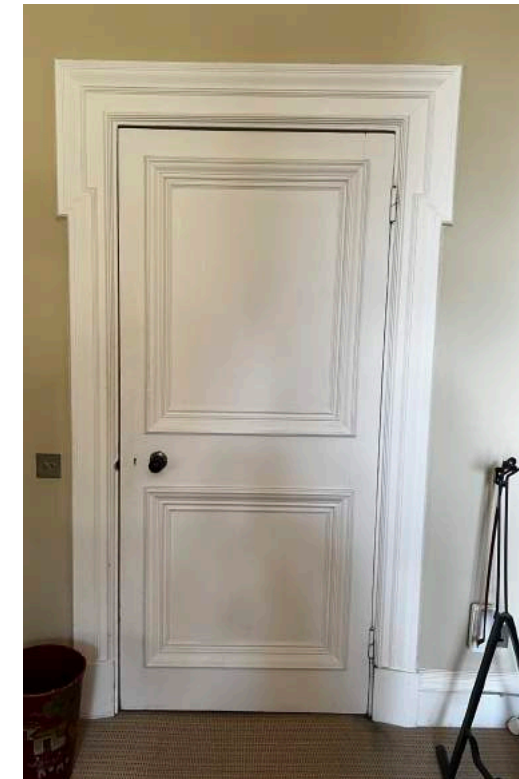
6. Existing architrave and living room doors.
Architraves and solid doors look to be the original design.
Existing opening to be widened to allow for double doors.
The original architraves are to be faithfully replicated and the doors and door furniture are to be reused. New architrave and solid door to match existing like for like.

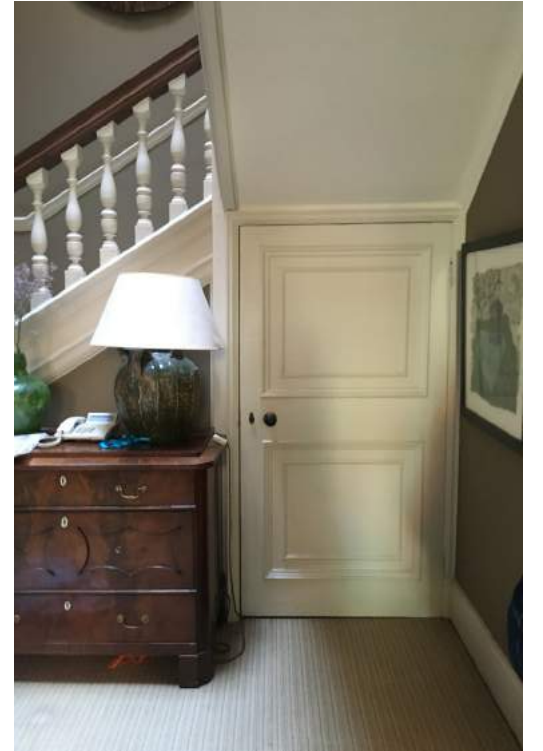
7. Existing WC door.
Carefully rehung in existing frame. Ensuring no damage to existing architectural mouldings or existing door.

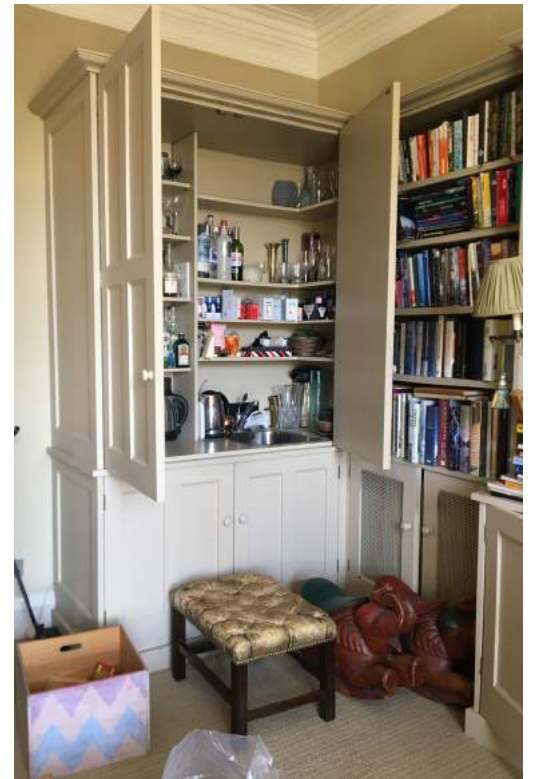
8.

8.Existing living room cabinetry.
Allow for strip out of contemporary fitted cabinets.

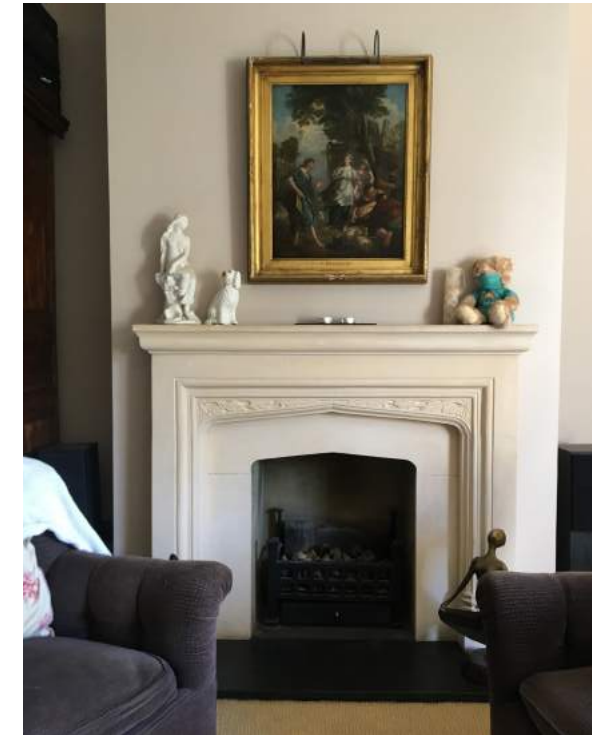
9.

- 9.Fireplace to be protected and retained during restoration.
- 10. Master bedroom doors to remain in existing locations.
- 11.All original radiators to be retained and reused throughout renovation
- 12.All architectural mouldings are to be faithfully replicated. Skirting in this room is thought to be original.

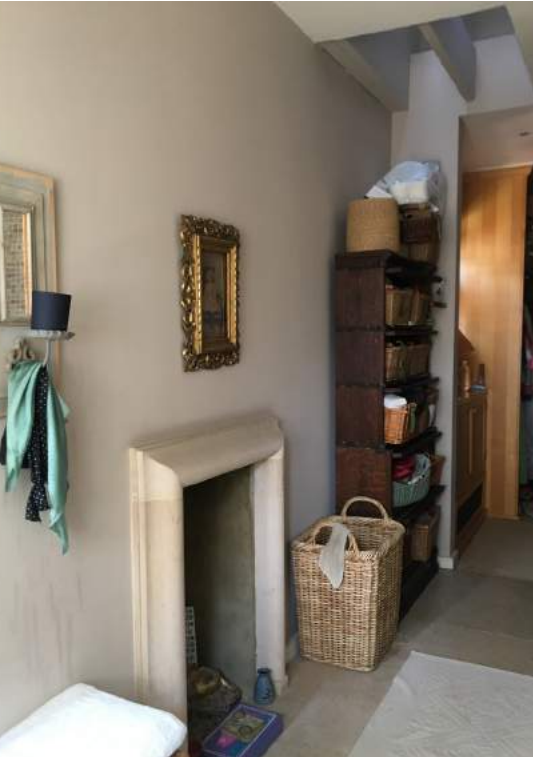
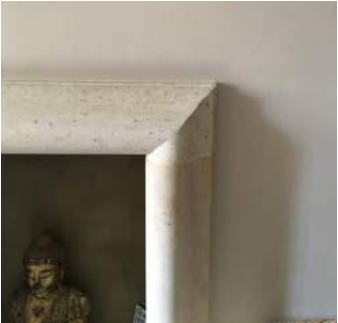
13. Bathroom fire place
Fireplace to be removed and retained for reuse to allow for new layout.

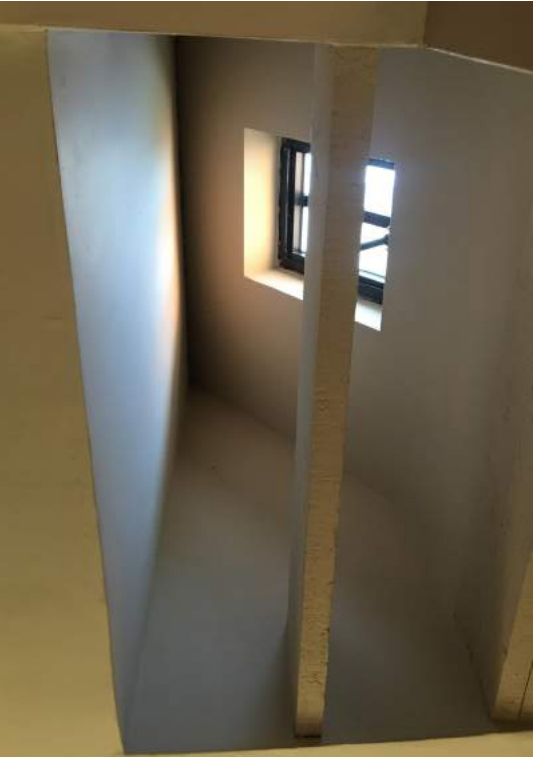
14. Bathroom Roof light.
Small roof light and exposed roof rafters removed to allow for new internal partition.
Roof light in poor condition.

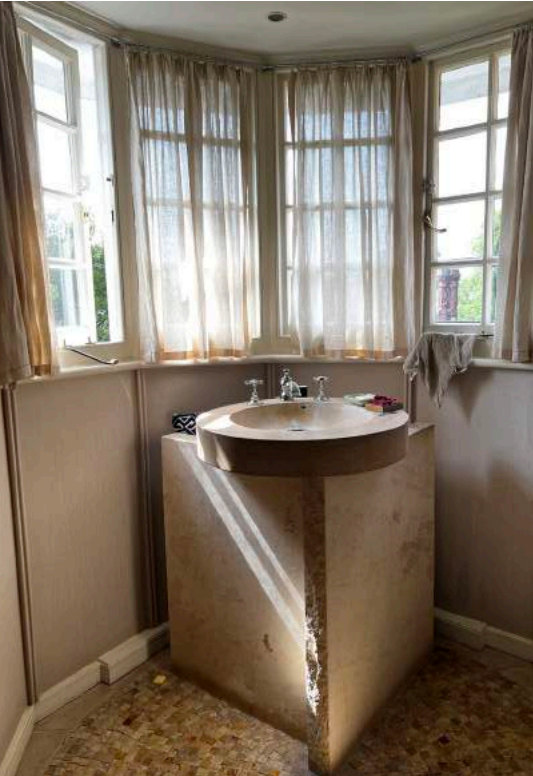
15. Bathroom turret.
Windows to be repaired and refurbished where necessary.
Existing contemporary bathroom fitout to be stripped out.

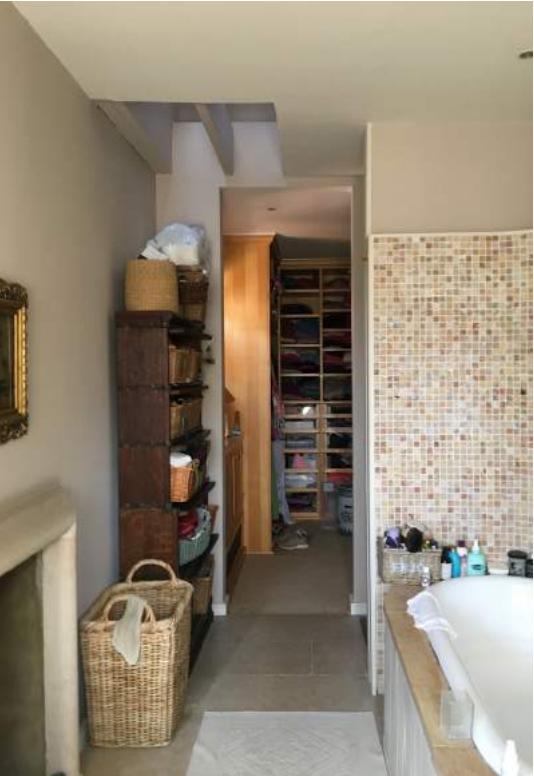
16. Access through to dressing room from en suite.
New internal partition to be introduced between rooms.

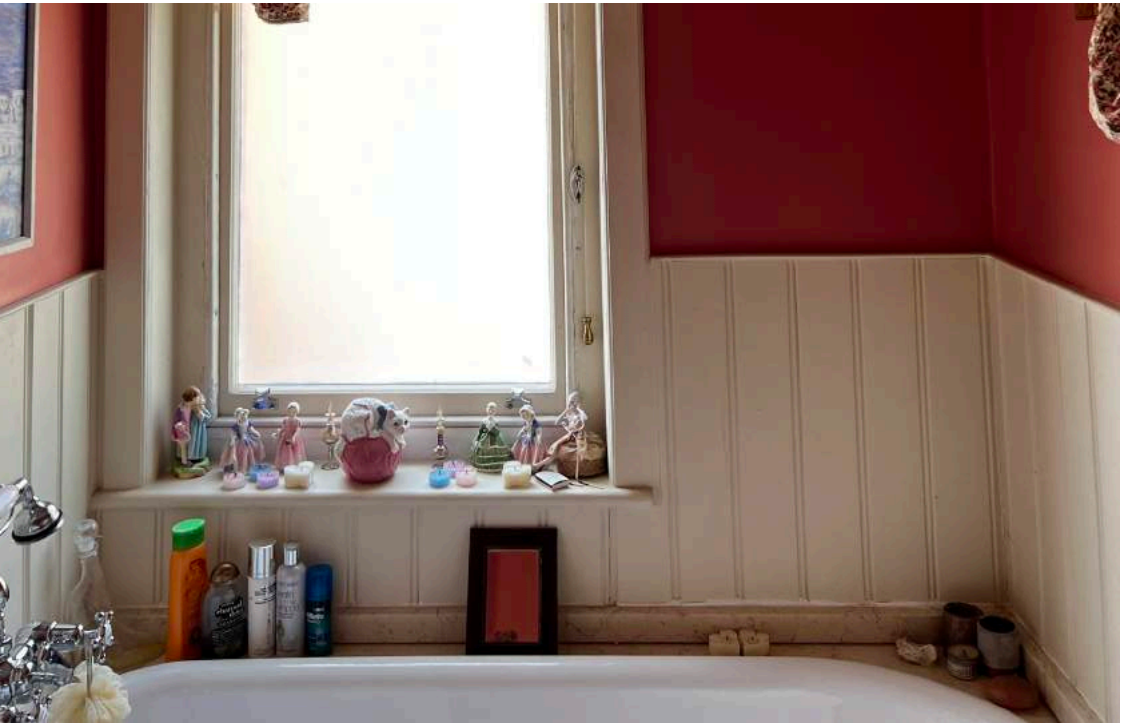
17. 1st floor bathroom
Contemporary bathroom fit out to be stripped out to allow for renovation. Where the internal layout is to be rearranged all the original architectural mouldings and internal doors are to be faithfully replicated.

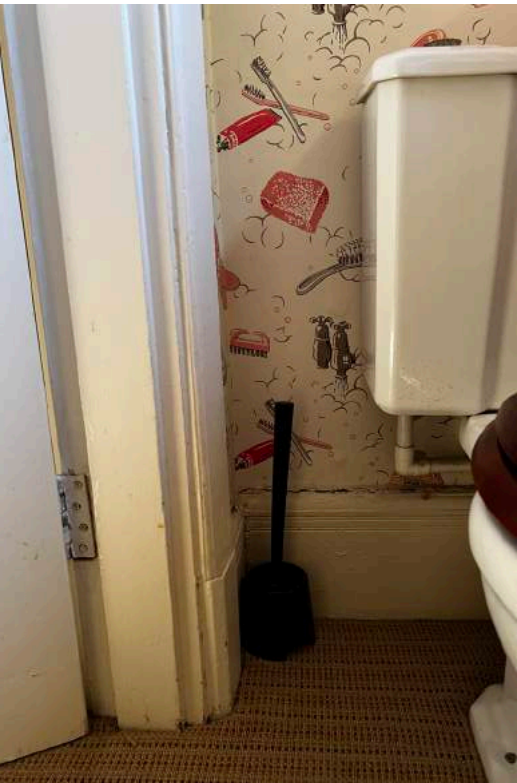
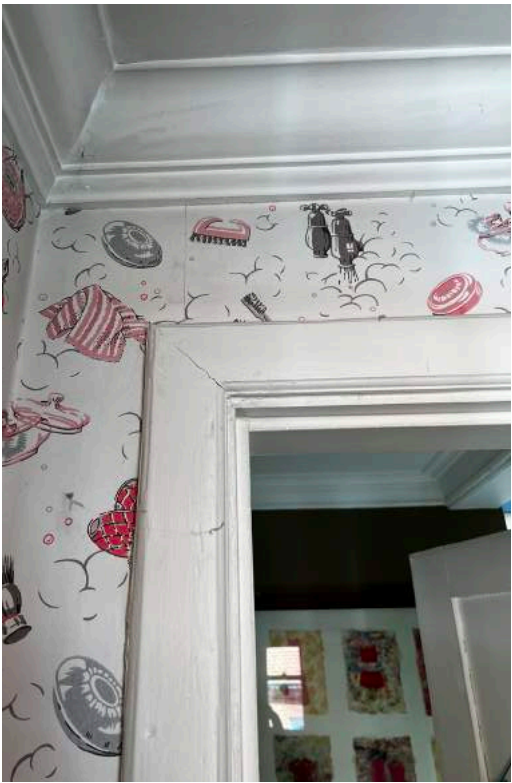
18. WC
Cornicing and architrave is thought to be none original in WC.

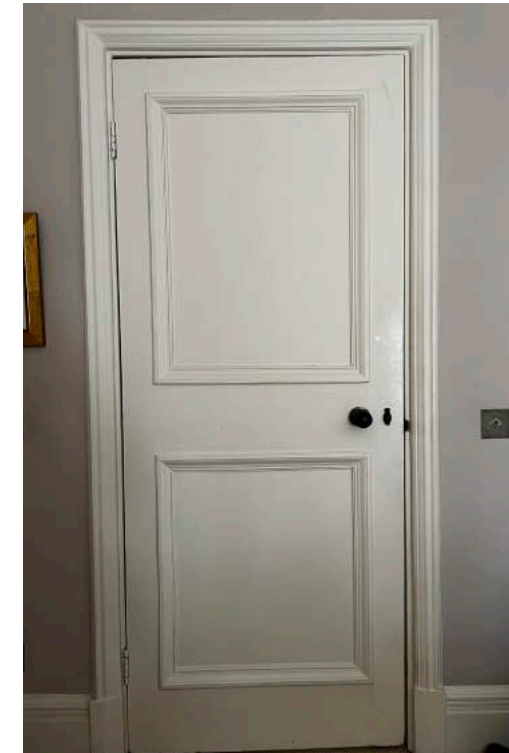
19. Bedroom 2 entrance door

Bedroom door together with door furniture, architrave and frame is relocated to allow for new layout. *

*Where the internal layout is to be rearranged all the original architectural mouldings and internal doors are to be faithfully replicated.

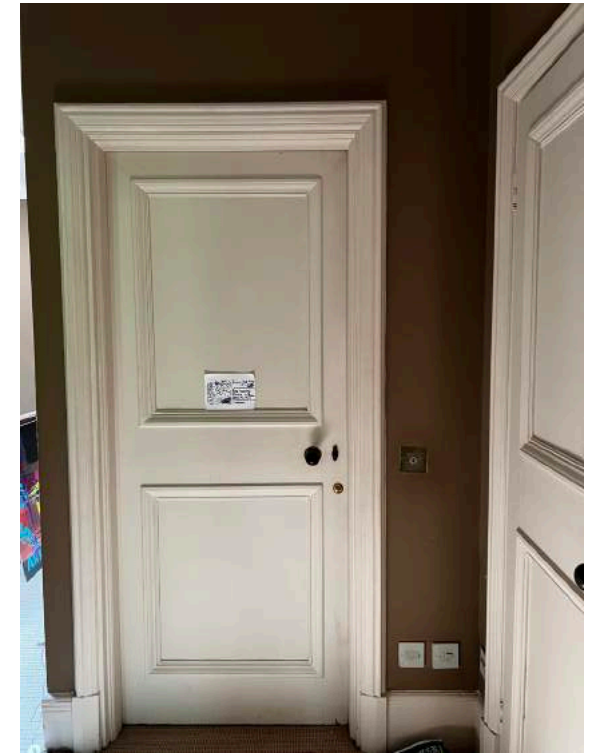
20. Bathroom entrance door

Bathroom door together with door furniture, architrave and frame is relocated to allow for new layout. *

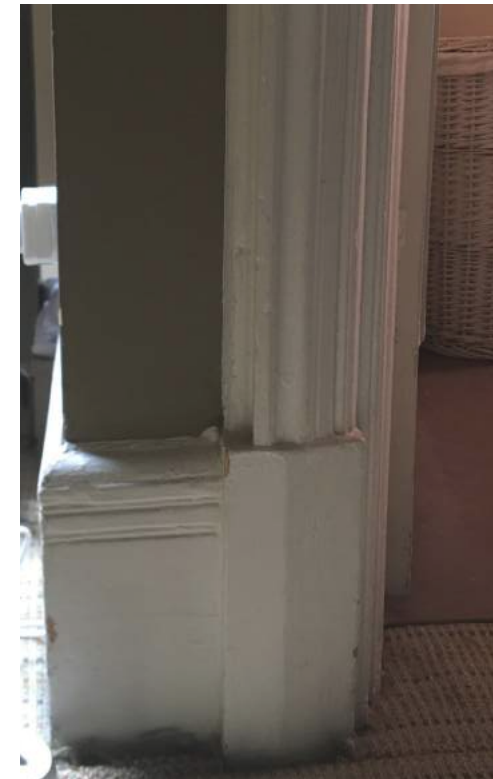
21. Architectural Mouldings

The skirting boards and architraves on the hall doors is thought to be original. *

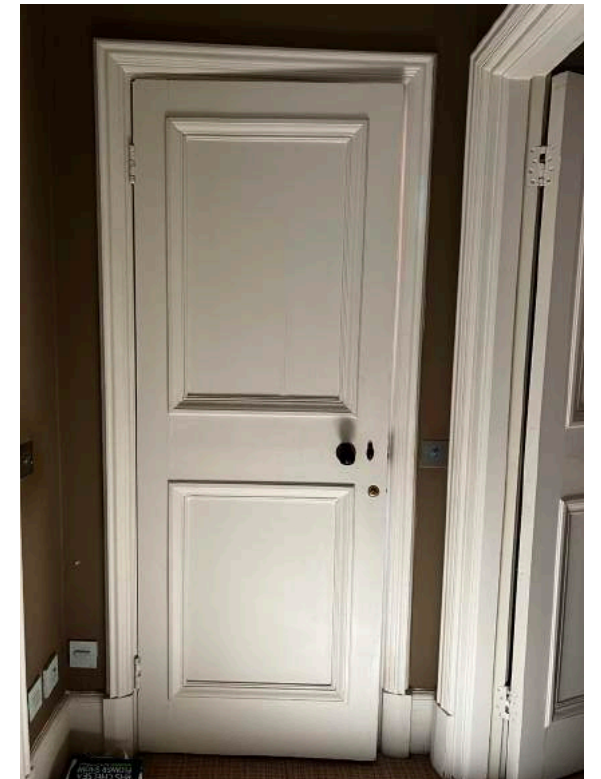
22. WC entrance door

Bathroom door is relocated to allow for new layout. *

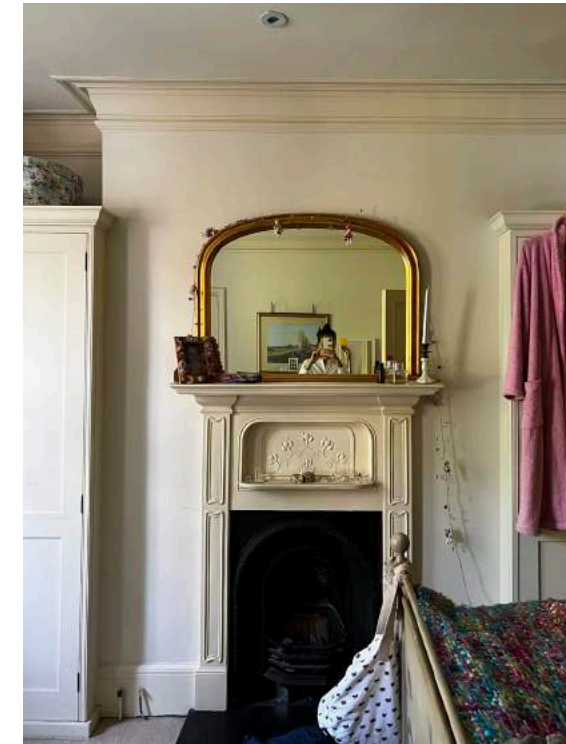
23. Bedroom 2 fireplace

Existing fireplace to be protected and retained during restoration.

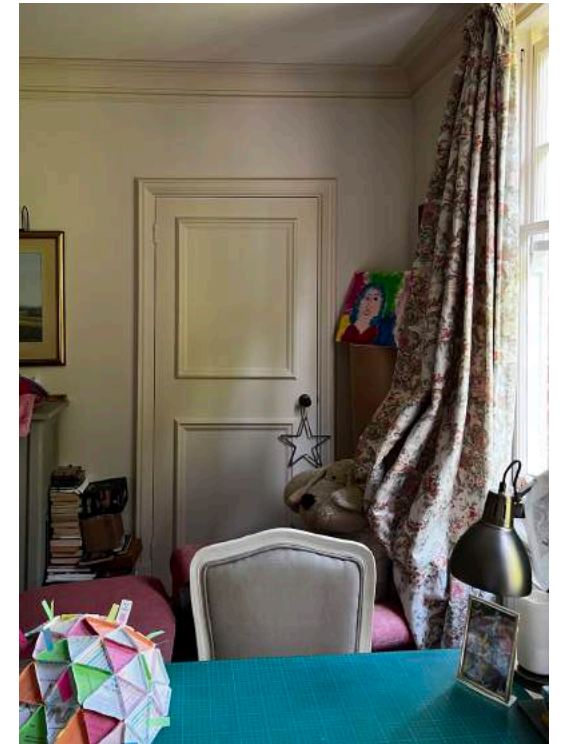
24. Door between bedrooms

Door between bedrooms is to be infilled.*

* Where the internal layout is to be rearranged all the original architectural mouldings and internal doors are to be faithfully replicated.

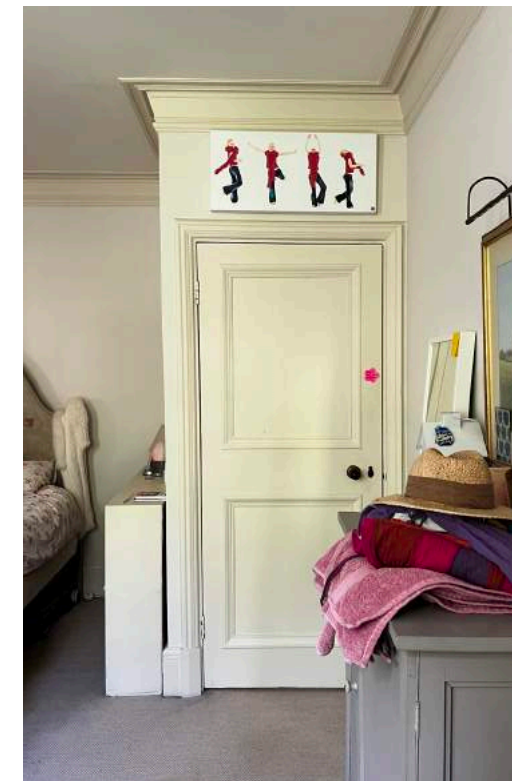
25. Bedroom 2 entrance door

Existing door together with door frame, architrave and door furniture are relocated.*

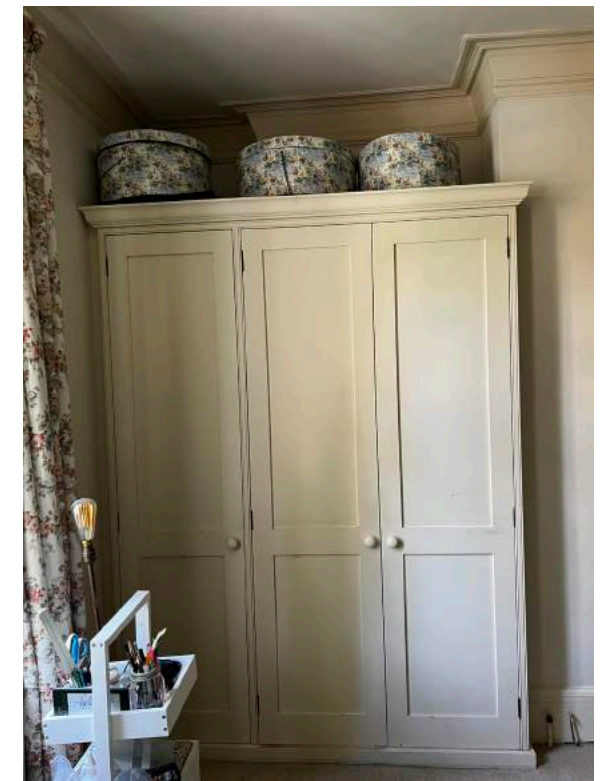
26. Fitted wardrobes

Fitted wardrobes to be protected and retained during restoration.

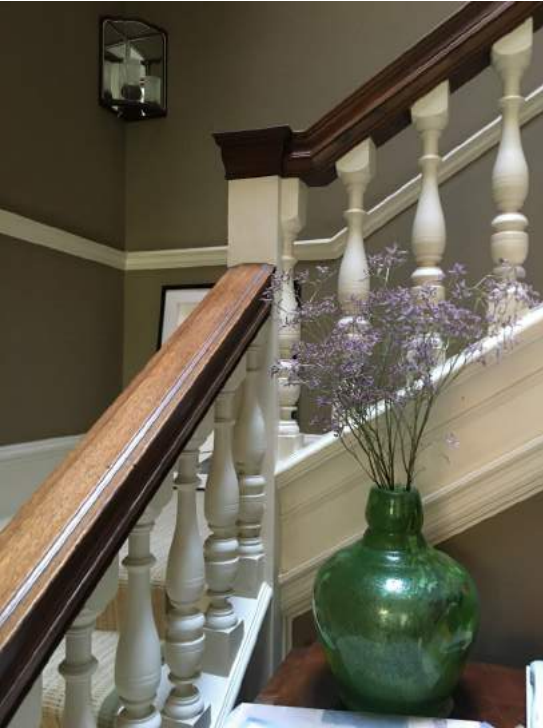
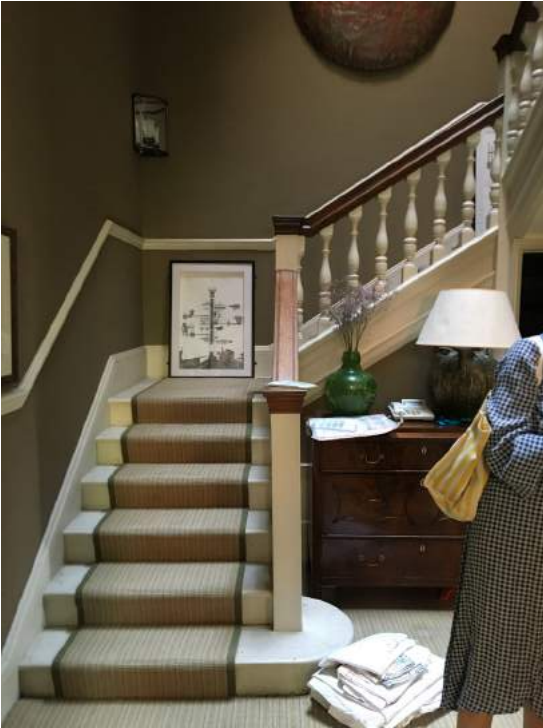
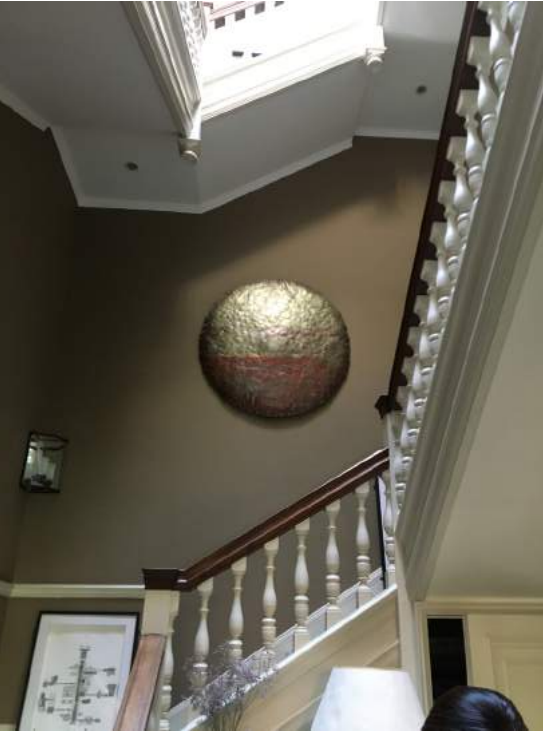
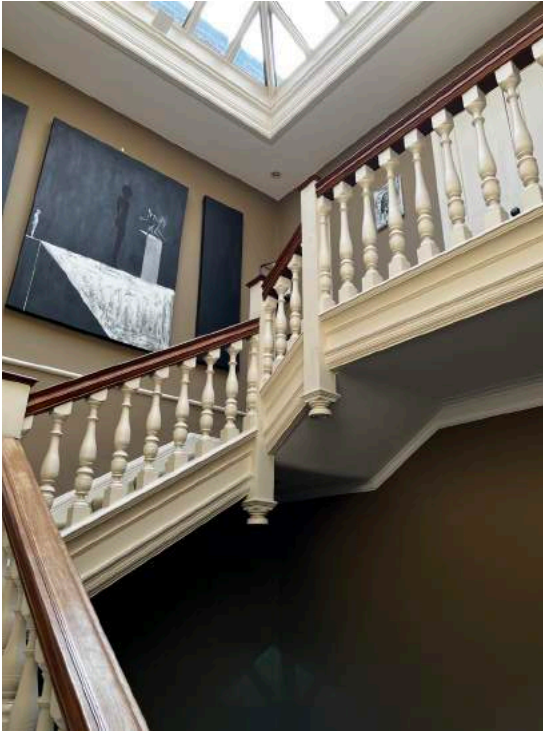
27/30. Hall Stair
Staircase to be protected and retained during restoration.
Stair to be repaired where damaged and to take new stair carpet runner.

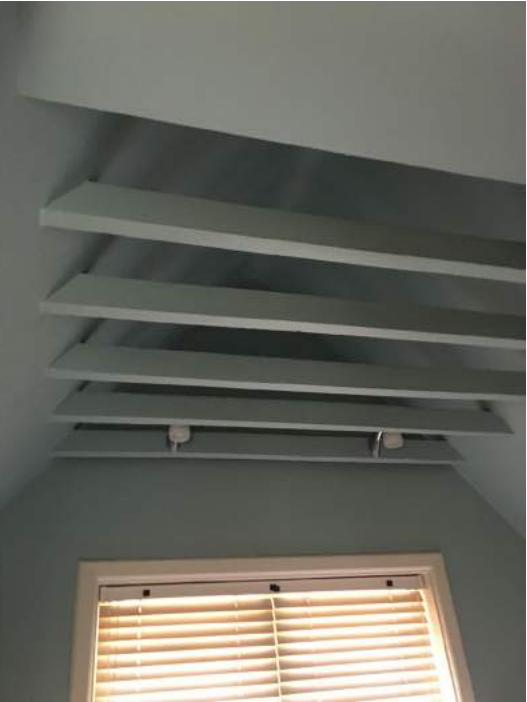
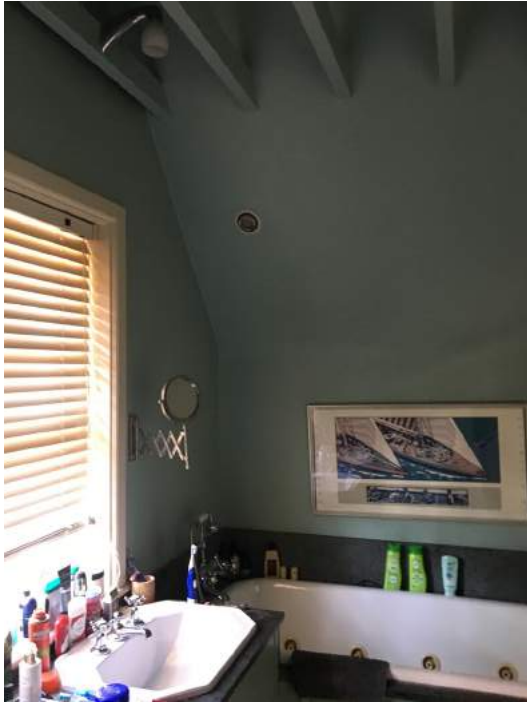
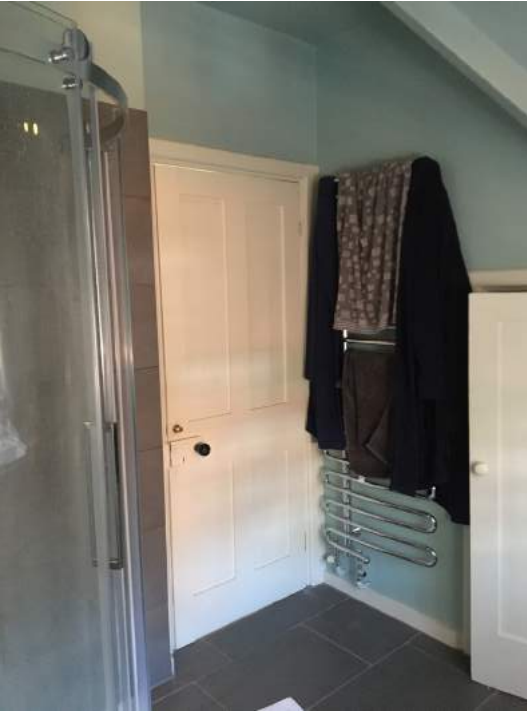
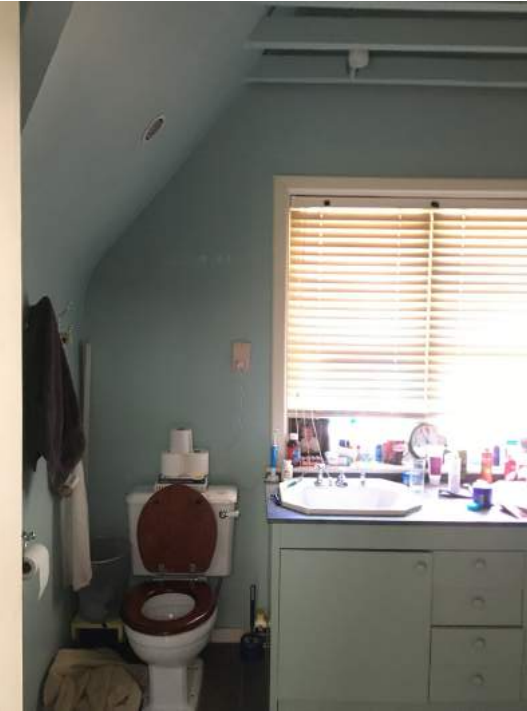
31/34. Existing Bathroom fit out
Contemporary bathroom to be stripped out to make way for new fit out.

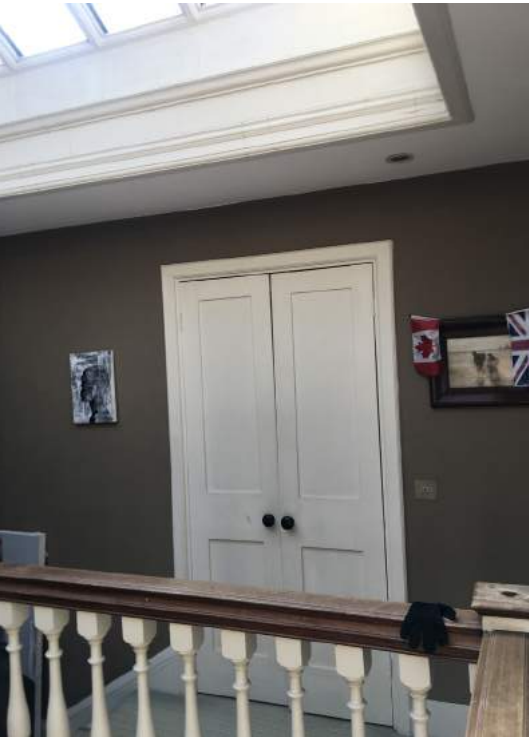
35. Hall Cupboard doors.
Hall cupboard to be removed to allow for more space to Bedroom 4

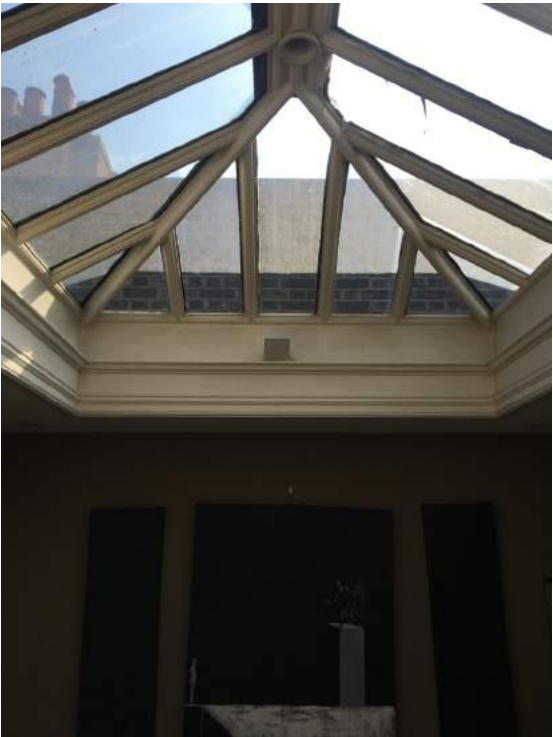
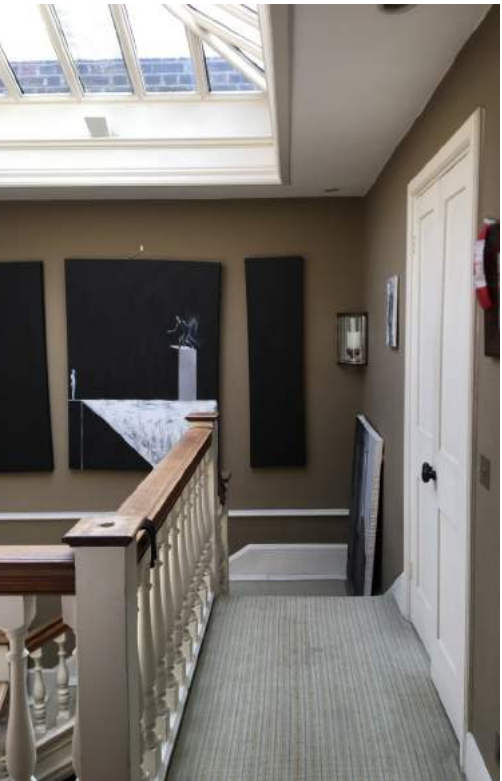
36/37. Hall Roof Lantern
Hall roof lantern is in poor condition and leaks. Allow for like for like replacement subject to further investigation and conservation approval.
New lantern to be high spec. and thermally broken.

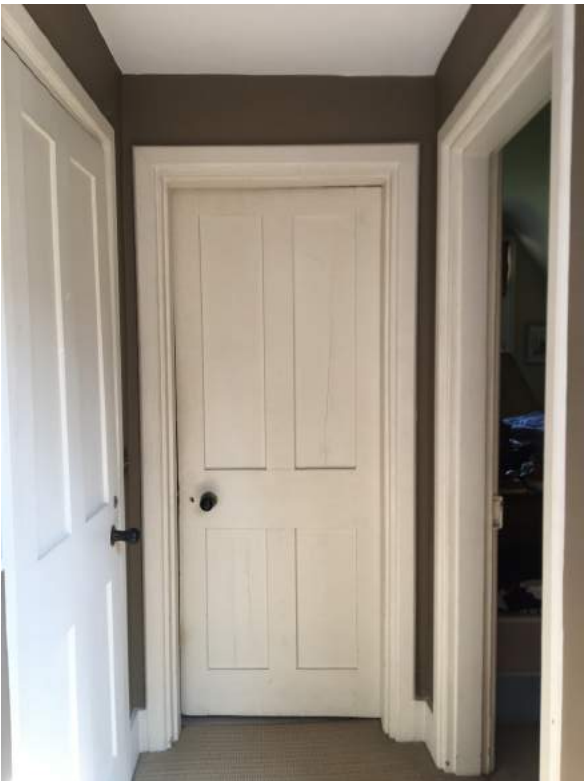
38. Shower room, Bedroom 5 and Bedroom 6 entrance doors.
Internal doors together with door furniture, architrave and frame is relocated to allow for new layout. *.

*Where the internal layout is to be rearranged all original architectural mouldings and internal doors are to be faithfully replicated.
