Historic Building Assessment No. 36 Percy Street, London, W1T 2DH

September 2022

## 1 Introduction

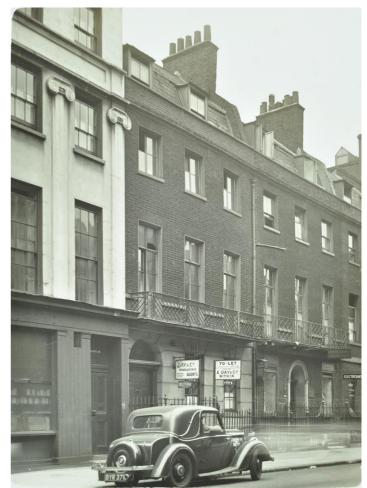
Figure 2: No. 36 Percy Street, 1940s.

2.3 During the 19th century, the first floor windows at nos. 36 and 37 were dropped and replaced with doors that lead onto an iron balcony (figure 2). Casements had been introduced at mansard level and 2x2 sashes were used at second floor level. Figure 2 also indicates that there were originally shutter at first floor level – these no longer exist.

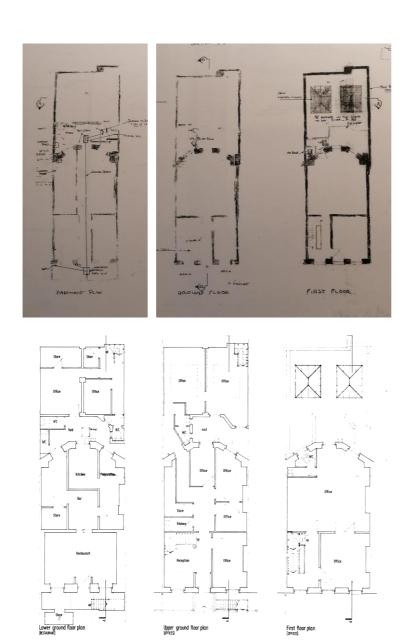
Figure 7: 1950 plans (above) and 1980s plans (below). At basement level, partitions have been removed to the front room and added to the rear room. The ground floor rear room was very heavily partitioned by the 1980s and a small area of partitioning was added at first floor level to the rear room. The plans show that the staircase between ground and lower ground was removed during the post-war period.

2.8 The works of the 1950s made fairly fundamental changes to the building and wider site. In the period from the 1950s until listing in 1987, various other alterations were made to the building. Comparing drainage plans of 1950 for the lower floors with existing plans from

1988 (figure 7) the level of change and intensification of use is evident.

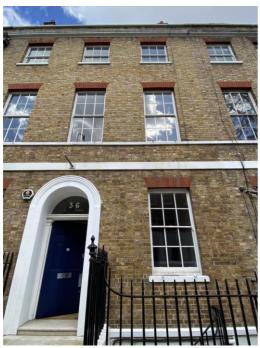
Figure 8: Front elevation.

3.2 The principal elevation is three storeys high above the basement and three bays wide with a central doorcase. The main entrance door is modern, as are the windows which are all timber sashes. The building is constructed in stock brick with rubbed red brick arches (figure 8).

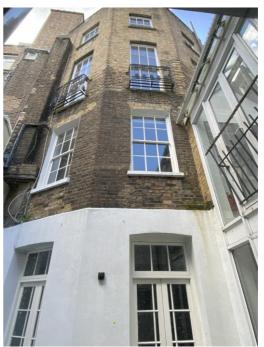
Figure 9: Rear elevation

3.3 The elevation comprises a full height and full width canted bay (figure 9). The upper levels appear to have been rebuilt or heavily repaired with the window arches to the lower floors replaced. The windows to the rear elevation are not original but match the fenestration pattern seen on the front elevation. As noted above, the link block and rear extension within the courtyard are modern.

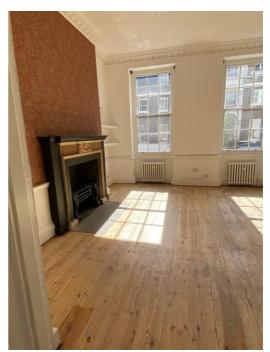
Figure 13: First floor front room.

3.11 The first floor retains the original front and rear room layout. The only fireplace in the building is located in the first floor front room although we know from the list description that this has been relocated from the rear room (figure 13). The rear room is a substantial size but has modern plaster finishes throughout.

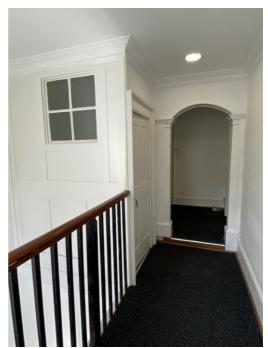
Figure 14: Second floor WC and arch through to the secondary staircase.

3.12 At second floor level the main staircase terminates. There is a small later WC enclosure over the stair and an arched opening to the secondary staircase (figure 14). There are modern partitions to the rear and the dividing walls between front and rear rooms and the front room and stair compartment are in modern stud work and plasterboard (figure 15).

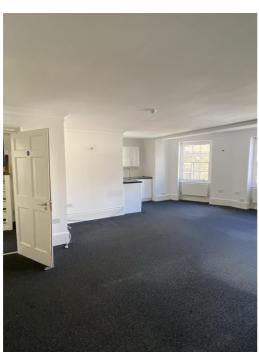
Figure 15: Second floor rear room.

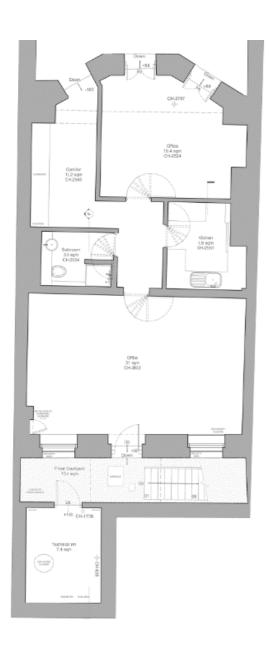
Figure 17: Existing lower ground floor plan

- 4.4 At present the front room presents its self as a single volume (figure 17). However, Figure 16 shows evidence of the former historic layout of the front room which contains two partitions creating a corridor from the front door leading from the front lightwell.
- 4.5 Corridors forming dedicated access routes from the front lightwell were fairly typical for houses of the period. However these were often set to one side of the property aligned with the entrance door. Here the entrance door and door to the front lightwell is in the centre of the building, this has created a central corridor arrangement.
- 4.6 The proposed intension (figure 18) would be reinstate, as far as possible, the historic corridor. The only difference being that one side of the corridor is scalloped to take account of the door opening to the rear room.

4.9 At present the rear room is divided with modern partitions forming a bathroom; kitchen; corridor and office (Drawing A1.11 figure 17).

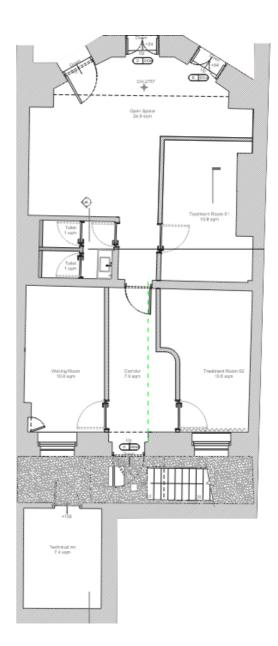
Figure 18: Proposed lower ground floor plan

4.10 The proposal layout would rationalise the layout. The layout of the rear room has been amended following the May 2022 refused scheme. The existing toilets remain. The laundry room has been removed. The existing kitchen and office partition walls would be removed. By doing so the corridor would be omitted creating a larger single volume to the majority of the space.
