25 John Street, London

External Service Stairs to Lightwell As Existing	Project JSC25.01 Scale (A3) 1:50	No 3600 Status 5C Revision 0
---	---	---

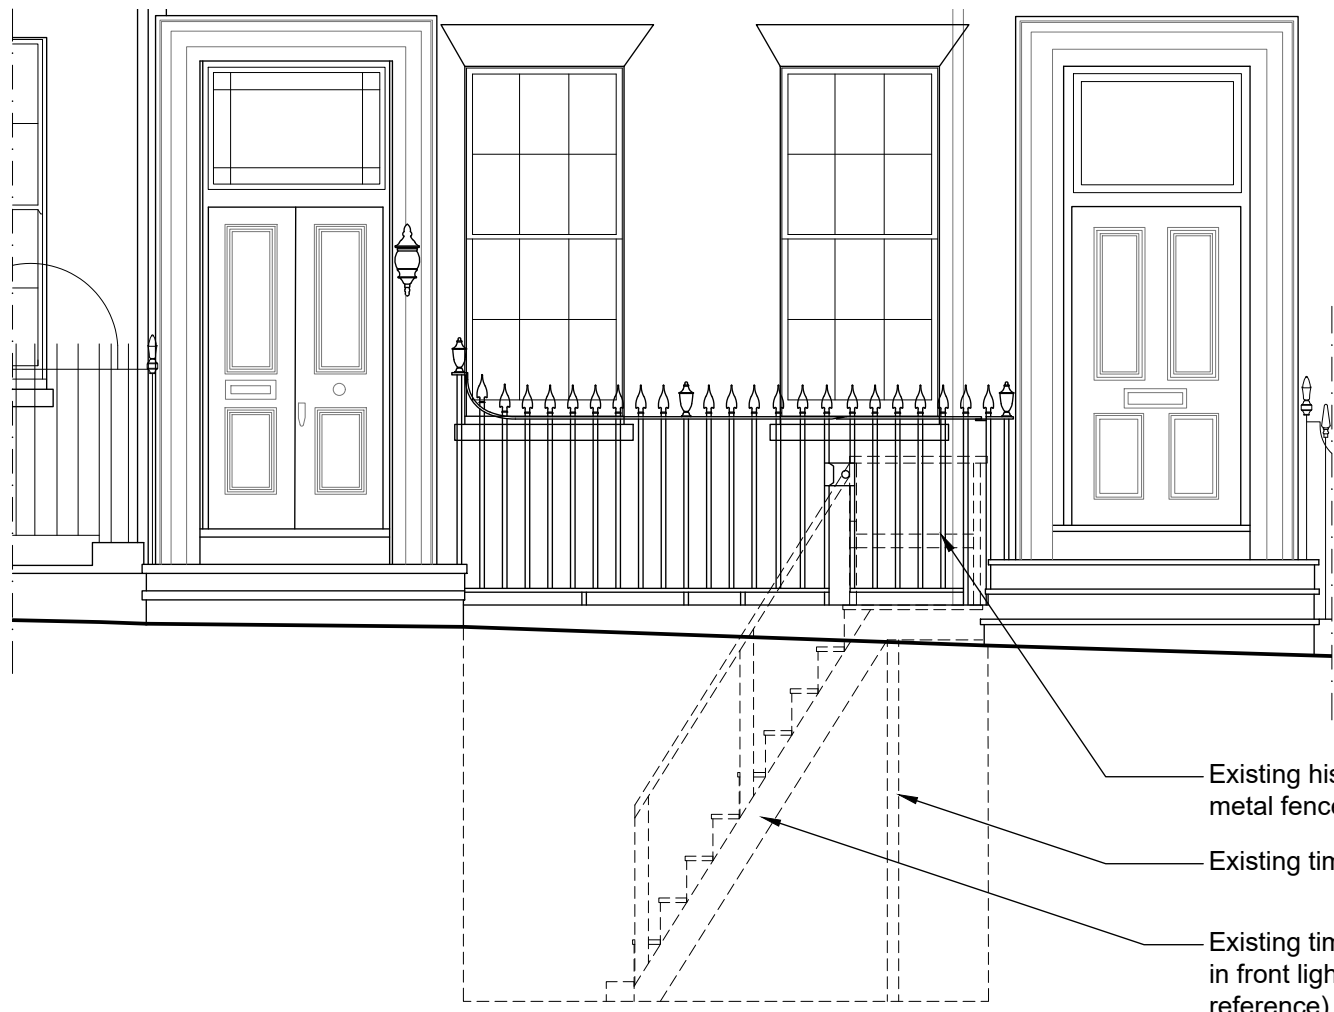
01 Fence Elevation - As Existing
3600 1:50 @ A3

Existing door opening into vault.

Existing historic black painted metal fence and service gate.
Existing timber post.
Existing timber service stairs in front lightwell (dotted for reference), in poor condition.

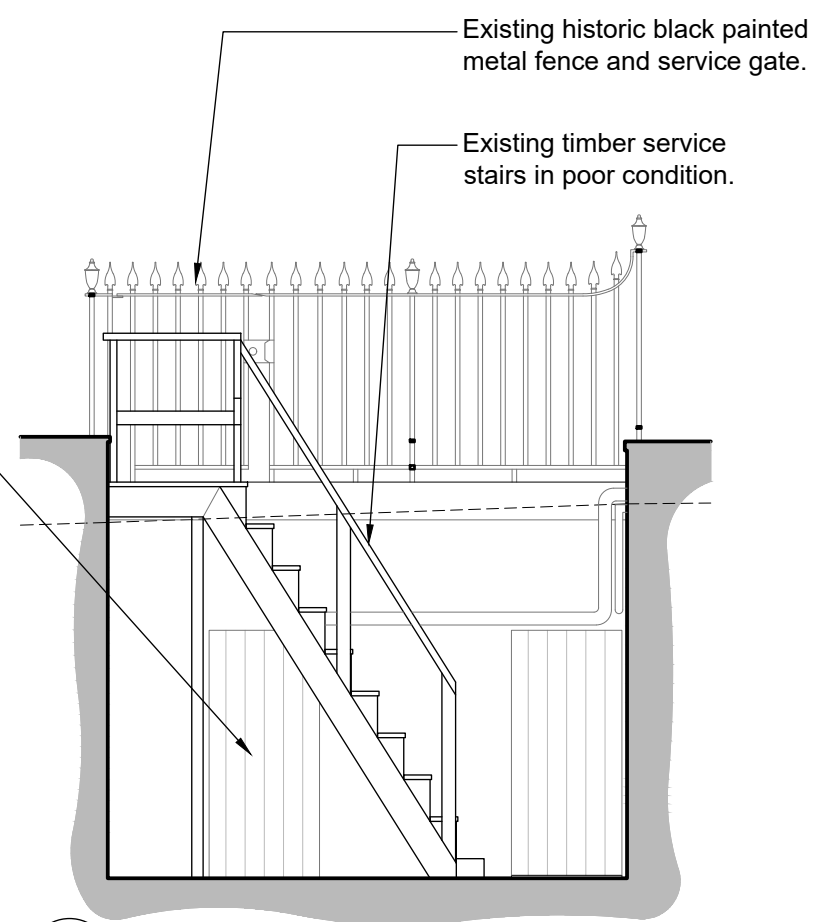
03 Section Through Lightwell - As Existing
3600 1:50 @ A3

Existing historic black painted metal fence and service gate.
Existing timber service stairs in poor condition.

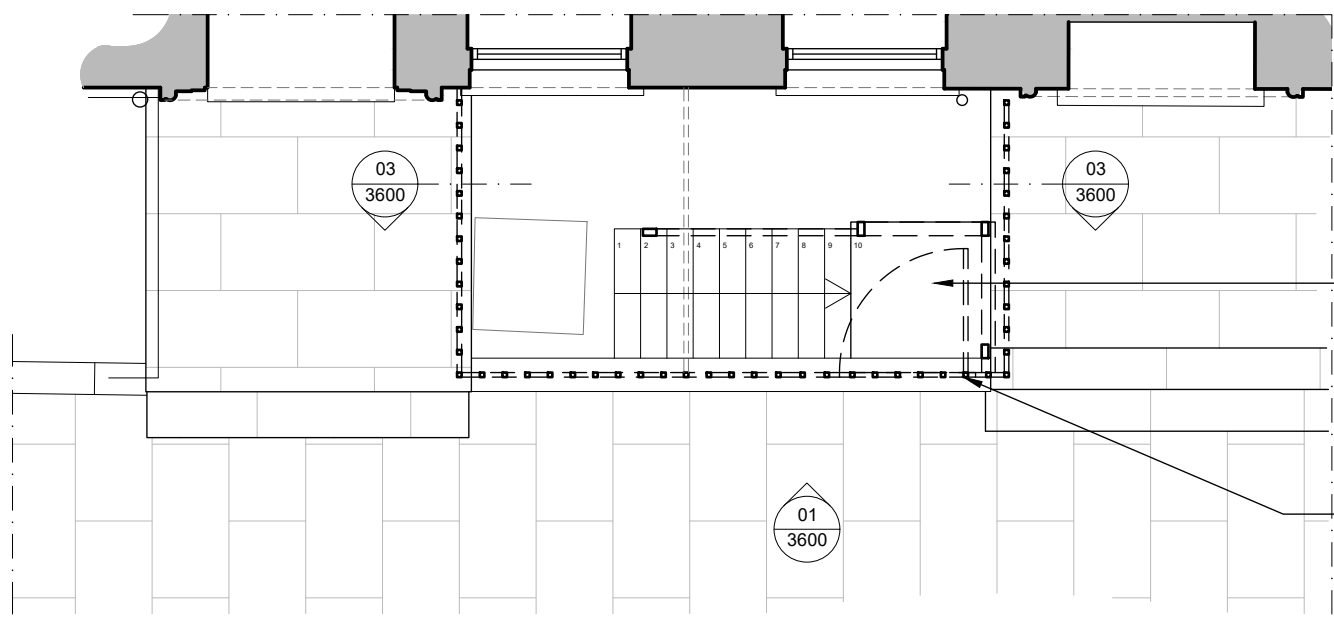
02 Ground Floor Plan - As Existing
3600 1:50 @ A3

Existing timber service stairs in poor condition.
Existing historic black painted metal fence and service gate.
