12 AND 13 PRIMROSE HILL STUDIOS: HERITAGE STATEMENT

This Heritage Statement has been prepared to inform the evolution of a scheme for residential development of numbers 12 and 13 Primrose Hill Studios, London NW1 8TR and to assess the impact of the scheme on the heritage value of the Grade II listed Buildings and the Conservation Area within which they sit.

12 and 13 Primrose Hill Studios are Grade II-listed buildings located in the Primrose Hill Conservation Area in the London Borough of Camden. The statutory list description of the listed building is included in Appendix A, a summary of guidance on the Primrose Hill Conservation Area provided by the local planning authority is in Appendix B.

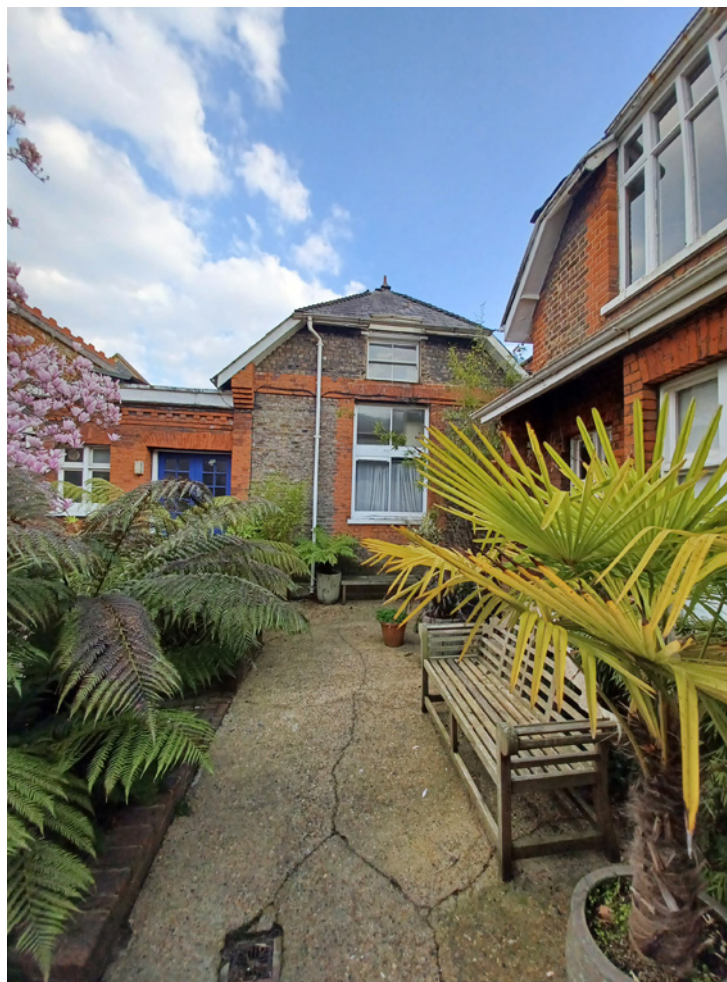
Principal elevation of No.12 Primrose Hill Studios, 2022 looking east. The Lodge is to the right. (Purcell)

The principal elevation of Studio 12 is of stock and red brick, and comprises a gable end bay, with half-hipped roof above, projecting slightly from a flat-roofed entrance block. The entrance block is clad almost entirely in redbrick and has a large recessed double door opening with an adjacent window opening to the north side. Both openings have original flat gauged-brick arches. The double part-glazed timber doors appear to be original, and are repeated in the neighbouring studios. The entrance door includes original brass handles and decorative timber panelling. The entrance is accessed via a stone step, which appears to be a modern addition. The adjacent window opening is now fitted with a modern four-pane fixed window with casement overlights divided by a thick transom and mullion. The entrance block elevation features a brick dentil course beneath a timber parapet. The façade features a number of detracting elements including a modern light fitting and modern drain pipe. The gable bay is predominantly faced in stock brick with redbrick detailing. The bay is flanked by redbrick piers terminating in brick corbels supporting the hipped roof above. There is a central window opening in a plain redbrick surround which has a heavily altered timber sash window. The sash appears to have been fixed shut and altered with a wide transom bar, which roughly corresponds to the position of the internal mezzanine gallery. This suggests that the alterations to the window were undertaken at the same time the mezzanine gallery was installed. The window opening features a flat gauged redbrick arch, but this is lost within a redbrick band extended across the width of the bay from corbel to corbel. Above this redbrick band is a smaller gable window opening, presumably a later addition that also corresponds to the insertion of the mezzanine gallery, which has an early-20th century two-over-two timber sash window which cuts into the oversailing timber eaves of the hipped roof above. The white-painted drainpipe to the north of the window opening appears historic. The guttering fixed to the eaves cornice cuts across the upper level window and detracts from the appearance of the elevation.

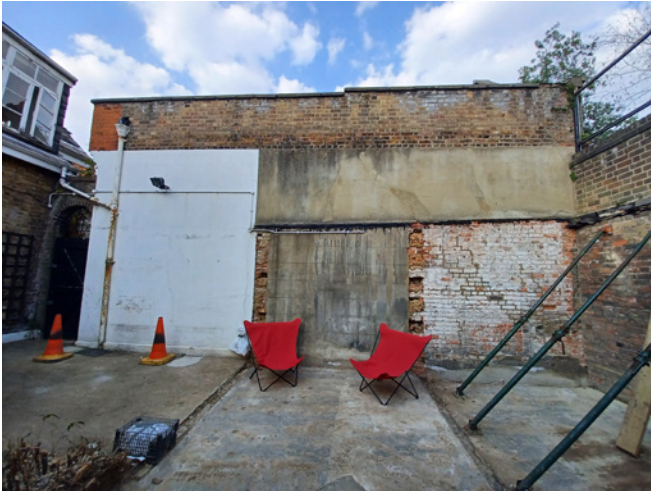
South elevation of No. 12 showing location of removed garages, 2022 (Purcell).

The south return elevation of Studio 12 is blind. The recent removal of the 1950s garages exposed a cement rendered wall to the rear internal wall of the north garage and heavily soiled red brick with localised patch repairs to the rear wall of the former southern most garage. The upper level of the south elevation has a band of yellow stock brickwork likely rebuilt following World War II bomb damage, with contrasting red brickwork to the west end addressing the corner with the north elevation, and is terminated by a plain concrete coping. An original cast iron drainpipe with ornamental hopper has been retained to the east, but is in a poor condition. Additional modern pipework and external lighting has also been fixed to this elevation, which adds visual clutter.

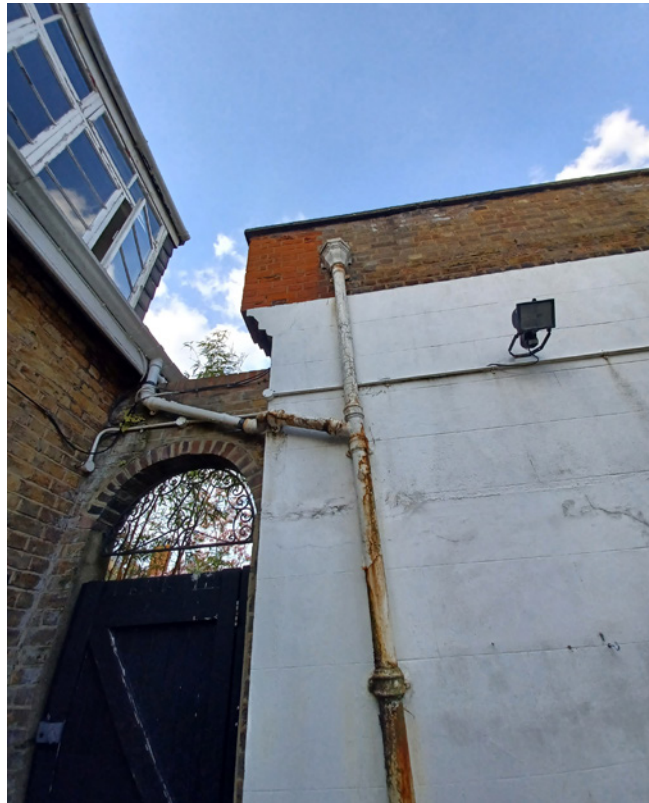
Cement render and brickwork to the south elevation of 12 Primrose Hill Studios, 2022 (Purcell)

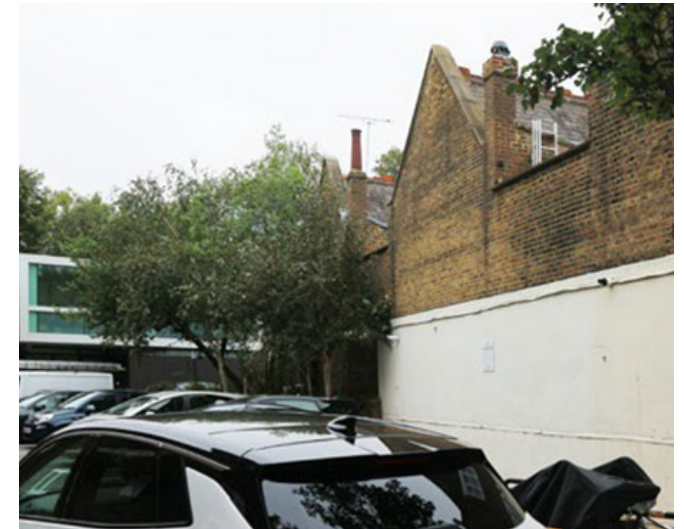
View of the rear elevation of 12 Primrose Hill Studios, 2021 (Insall).

The rear elevation faces onto a modern surface carpark between Kingstown Street and Manley Street. It is entirely blind and faced in stock brick with concrete coping at roof level. Between the rear gable bay and flat-roofed entrance block there is an original square brick chimney stack with a modern clay pot projecting above the parapet. The majority of the rear elevation is also concealed behind mature trees.

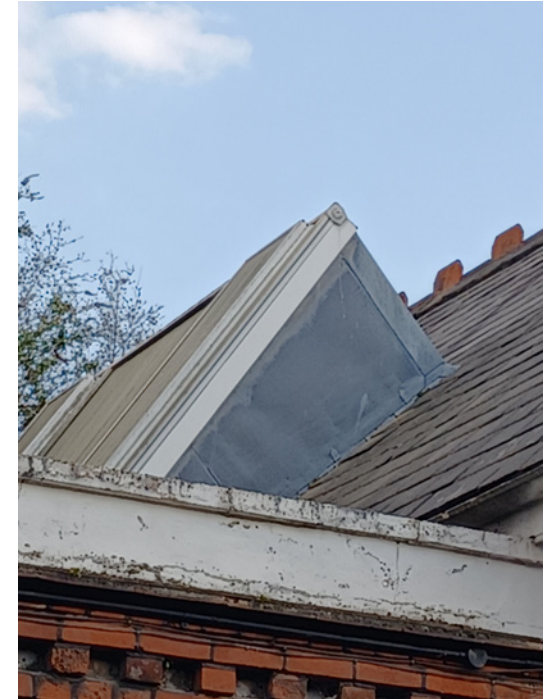
Detail of slate roof and north roof light opening to No.12 with later frame inserted and modern detailing, 2022 (Purcell).

Studio 12 has a variegated roofline comprising a half-hipped roof over the gable bay and a flat roof over the adjoining entrance block. The half-hipped roof is clad in slate with clay ridge tiles, and is in need of repair. There is a seemingly original small skylight opening in the south slope of the hipped roof which features a multi-pane, timber-framed window. This skylight is repeated in Studios 9-10. A larger original skylight opening in the north slope has a later pane window with thinly-profiled iron glazing bars inserted. This skylight is similarly in an original location but the window itself is modern. The adjacent flat roof over the entrance block is clad in asphalt, but this is damaged in parts. There is a rooflight to the rear of the flat roof lighting the windowless rear room, but the rooflight itself is a modern replacement and is in a poor condition. A modern timber-framed lean-to rooflight is located towards the middle of the flat roof.

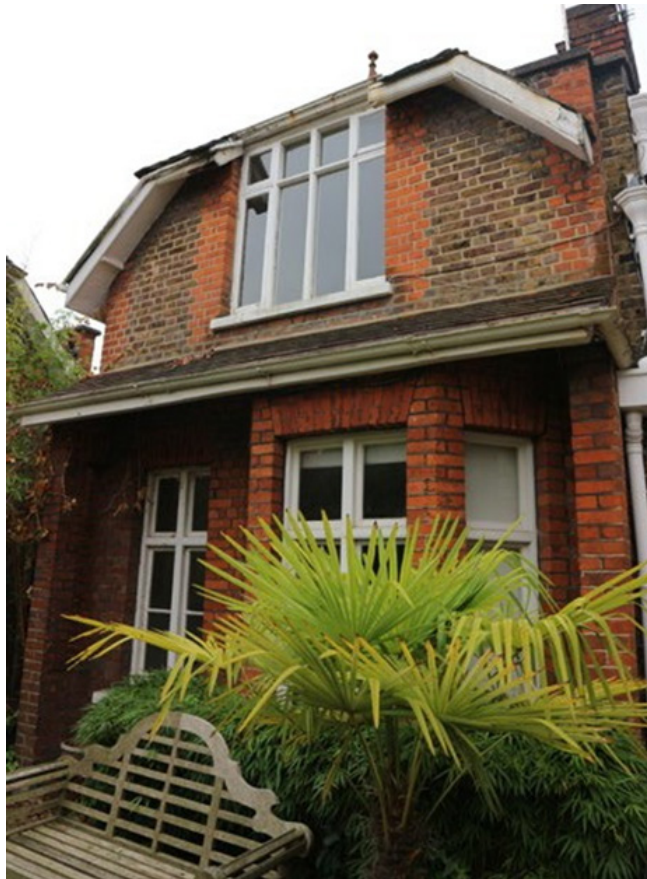
Principal elevation to 13 Primrose Hill Studios, 2021 (Inall).

The front elevation of The Lodge is two storeys and executed in stock brick with redbrick detailing. At ground floor level there is a canted bay window with openings featuring flat gauged-brick arches. The ground floor is protected by a narrow pentice extending the full width of the original elevation, which is clad in clay tiles and supported by two slender redbrick columns. Above the pentice, at first floor, is a large timber-framed, eight-light gable window which cuts into the oversailing timber eaves of the hipped roof above. The first floor level is clad in a mix of red and stock brick. On the east side of the main front elevation is the return of a single-storey stock brick post-war extension, which features a single narrow window opening with a flat gauged brick arch. The thick, uniform profile of the glazing bars on all fenestration indicates that the windows are post-war 20th century replacements.

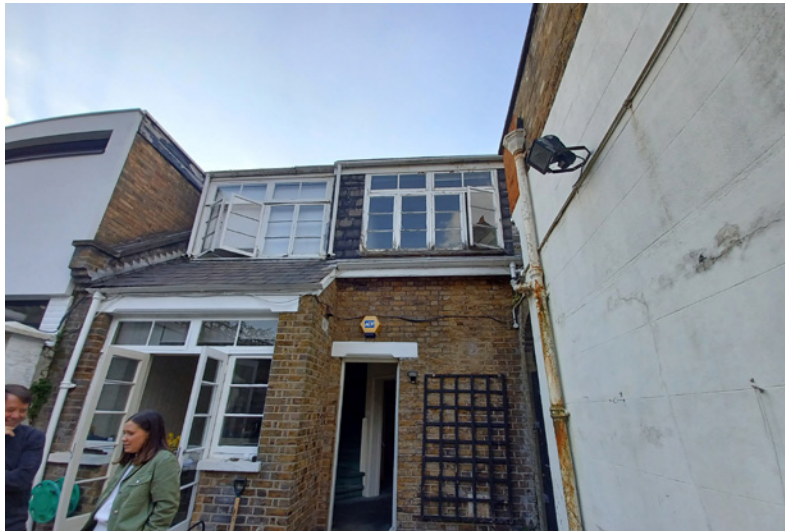
Modern south elevation of lodge from courtyard, 2022 (Purcell).

The east elevation, facing onto the yard, appears to have been predominately rebuilt post-war following significant bomb damage (as detailed in Section 3), this supposition is confirmed by trial pit investigations revealing modern concrete strip foundations rather than the stepped brick footings common to the rest of the buildings. The ground floor is a modern, post war extension that replaced an earlier porch, and is clad in stock brick with a rendered skirting. The canted bay projection has a pair of modern timber French doors, with side and overlights, surmounted by a rendered lintel, which is presumably concrete, and a lean-to slate roof. To the north the rebuilt elevation steps back and there is a modern doorway opening, with a timber panelled part-glazed door, which is also surmounted by a rendered lintel. At second floor level the original brick elevation was replaced with a pair of large 20th century dormers featuring multi-pane, timber-framed windows and flat asphalt roofs. The dormer over the north half of the east elevation also features hung slate cladding and modern pipework. Both dormers are surmounted by modern guttering. Various detracting modern wiring, lighting and security plant has been fixed to this elevation.

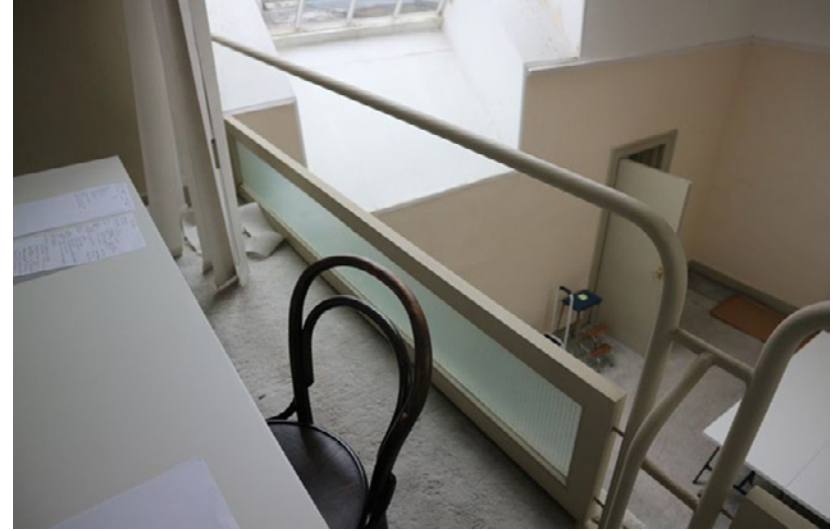
Modern balustrade to mezzanine gallery level of the Painting Room in 12 Primrose Hill Studios, 2021 (Insall).

The mezzanine itself appears to be supported by a series of beams fixed into the west wall. The gallery level has the same modern carpeting and skirting as the rest of the Painting Room. The ceiling cornice also continues along the walls. To the west wall is the continuation of the original large window architrave, which is bisected by the mezzanine leaving two fixed panes of opaque glazing. Above this, separated by the cornice, is a smaller early-20th century two-over-two timber sash window in a moulded architrave, which was presumably inserted when the mezzanine was relocated to this side of the studio. To the south side of the gallery is a modern four-panelled door to the staircase and a modern fitted cupboard with reflective sliding doors. The east side of the gallery is protected by a modern steel-framed balustrade with Georgian wire glazed panels.

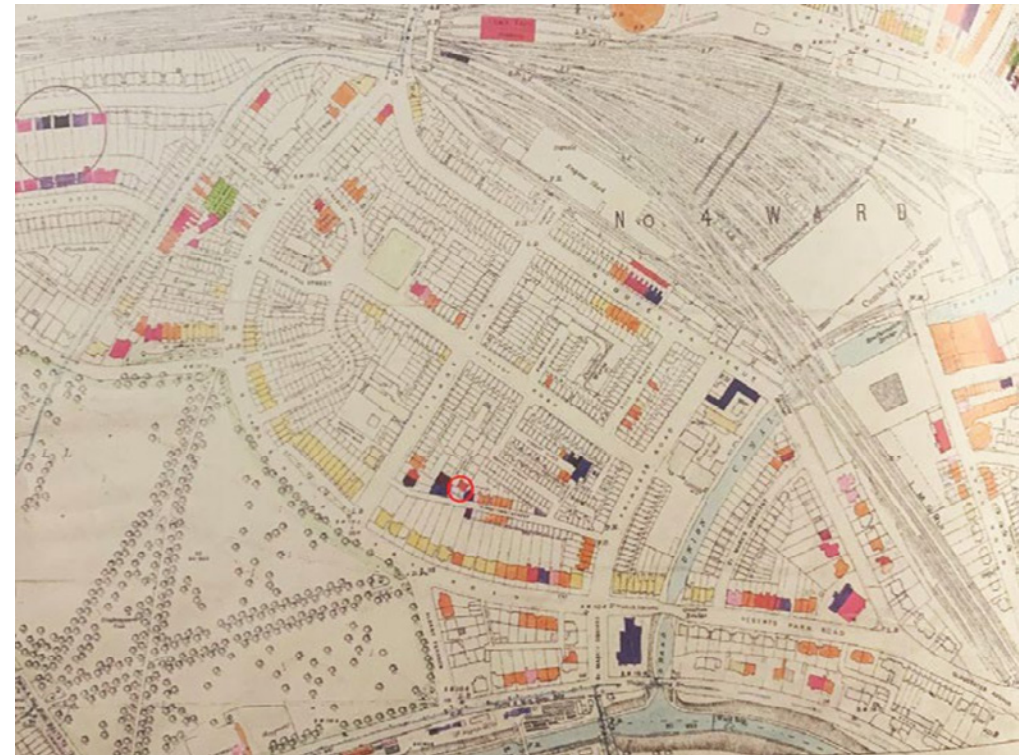
Second World War damage to Primrose Hill depicted in the London County Council Bomb Damage Maps, 1939-45.

According to the London County Council Bomb Damage Map, Studio 12 was 'Seriously Damaged – Doubtful if Repairable', as indicated by the red colour. That said, a photograph from 1983 showing the principal elevation of the studio reveals that it was subsequently repaired. The extent of this rebuild is unsubstantiated but sections of brickwork in the principal elevation (to the communal courtyard) and the secondary elevation to the private courtyard have clearly been replaced. The south half of the building (the studio) was covered by a half-hipped roof which was punctuated on the west side by a high level, four-pane sash window which cut through the eaves. This window is not repeated on Studios 9-11, and its interruption of the original architecture marks it out as a later addition, likely inserted to bring light to the non original mezzanine when inserted. The window itself appears to date to the early 20th century.

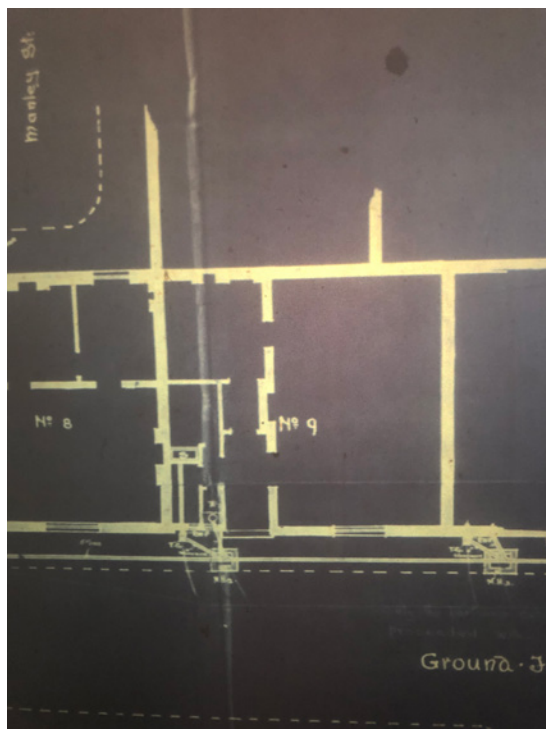
Detail of drainage plan showing interior layout of Studio 9, 1910 (Camden Archives).

No original plans of Studio 12 have been found in the archives and as discussed above, the configuration shown in the 1880 drainage plan does not appear to have been built. However, a 1910 drainage plan shows the layout of No.9 and includes an annotation stating that the internal arrangement of No.9 was repeated across Studios 10-12. According to the plan of Studio 9, the south half of Studio 12 was occupied by the studio or Painting Room, which featured a central fireplace on the north side and a large window on the west side facing the internal courtyard of the complex. This plan makes no indication that the large studio rooms had a mezzanine

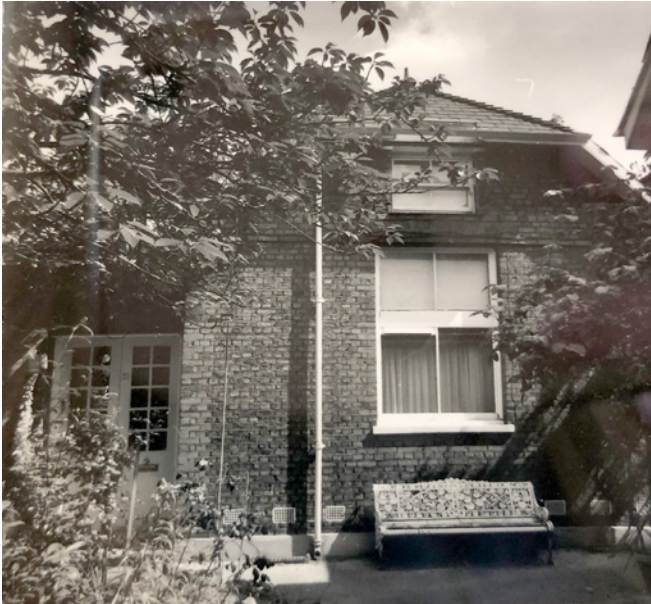
Photograph showing the exterior of Studio 12, 1983 (Camden Archives).

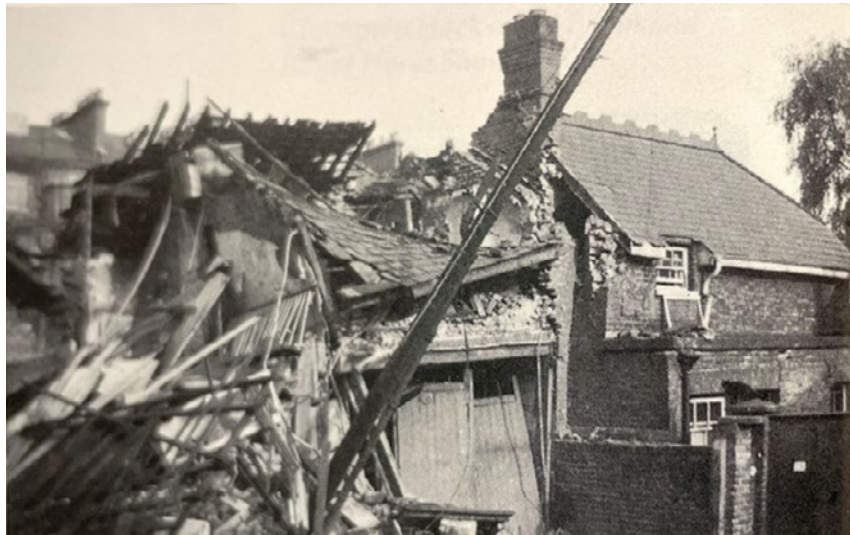
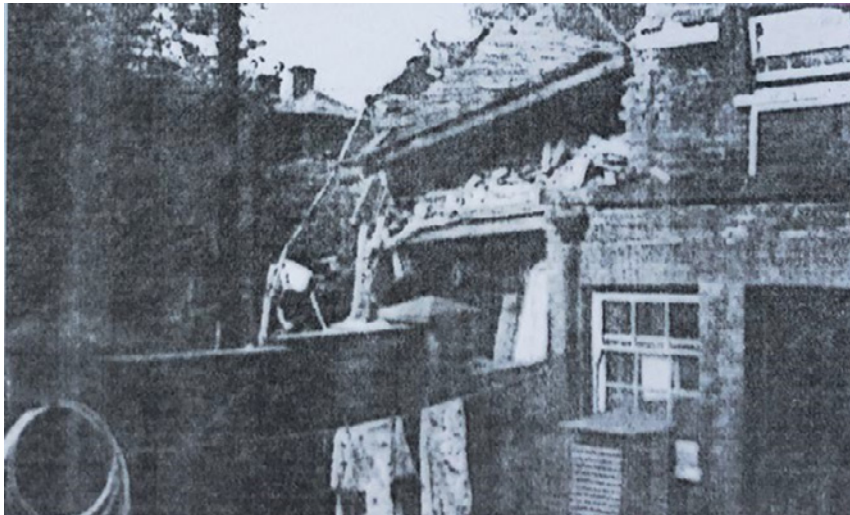
Untitled showing bomb devastation to the adjacent stables and damage to the porters lodge.

Untitled 1 showing bomb devastation to the adjacent stables and damage to the porters lodge.

A pair of photographs printed in Bordass' thesis show the extent of bomb damage to the stable block to the rear of The Lodge on Kingstown Street.¹⁷ These photographs show the damage that was caused to the south party wall of the Lodge, and also show the east elevation of No.13 before the elevation was rebuilt and dormers were inserted at first floor level. At this time, the ground floor porch featured a simple sash window and flat-arched doorway, where the present French doors are, with what appears to have been a narrow window further north. At first floor there was a single small sash window, which cut into the eaves cornice, located towards the south end of the east elevation.
