317 Finchley Road

SPT / Depth Relationship

## Undrained Shear Strength / Depth Relationship

**GROUND INVESTIGATION REPORT  
GEOENVIRONMENTAL INVESTIGATION  
AND INTERPRETATIVE REPORT  
ON LAND AT  
317 FINCHLEY ROAD  
LONDON**

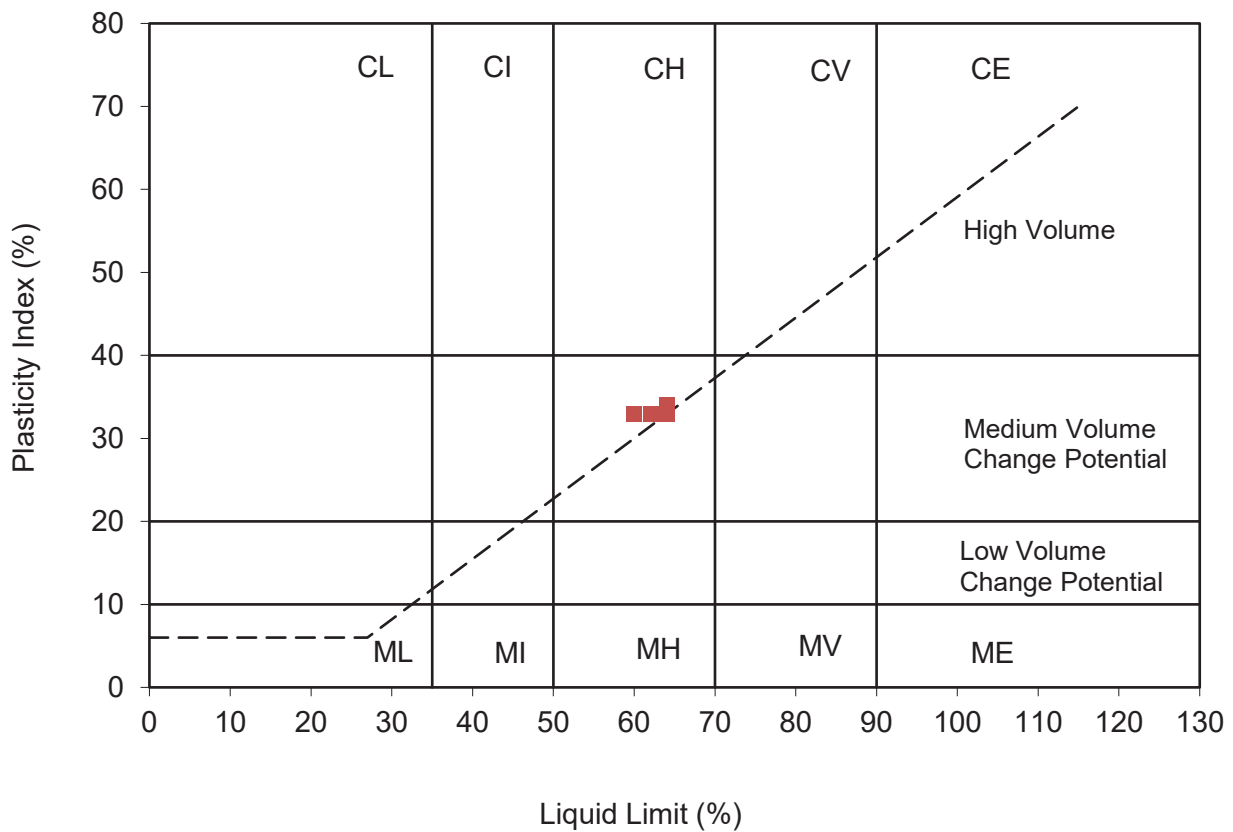
## Figure 4

### Plasticity Index Chart

■ London Clay

--- A Line

Test	Range
Moisture Content (%)	28 – 42
Liquid Limit (%)	63 – 77
Plastic Limit (%)	26 – 37
Plasticity Index (%)	26 – 50
Modified plasticity index (%)	20.28 - 50

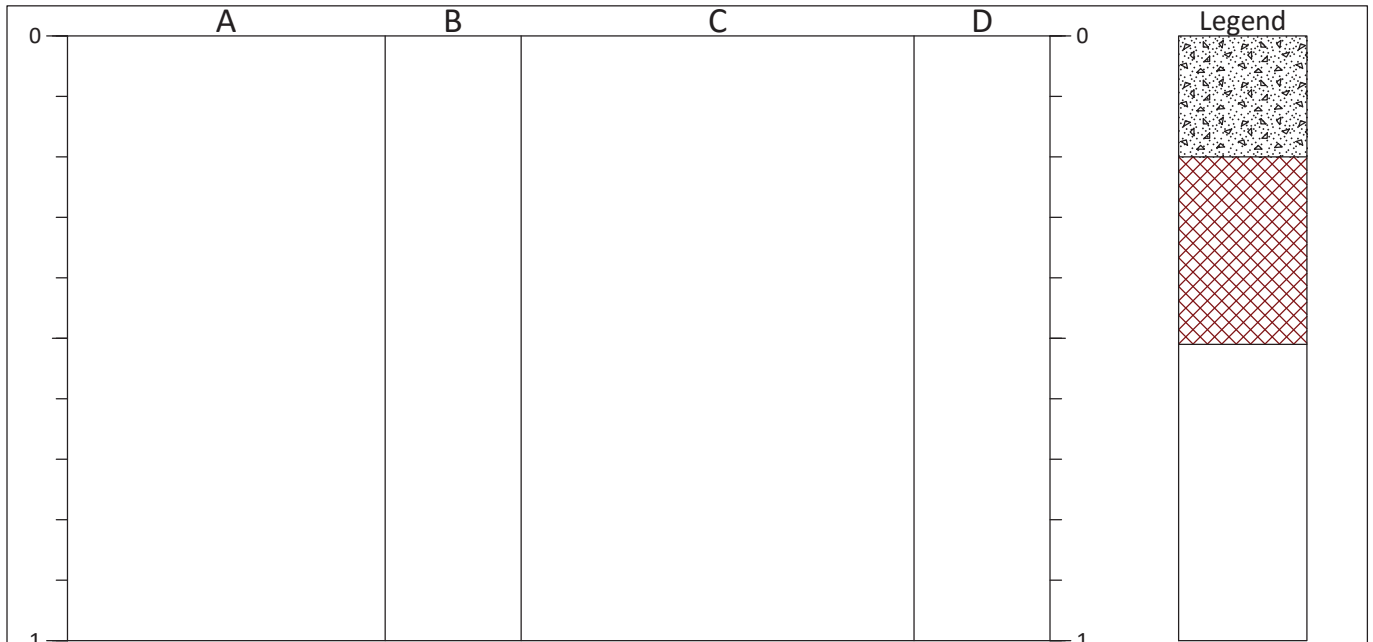
Project Finchley Road, London.				HAND PIT No  <b>HP03</b>
Project ID GSI 0548	Date 29-01-16 29-01-06	Ground Level (m)	Co-Ordinates ( )	
Contractor Aden Build				Sheet 1 of 1

STRATA				SAMPLES & TESTS		
Depth	No	DESCRIPTION	Depth	No	Remarks/Tests	
0.00-0.20		MADE GROUND: Grey CONCRETE.				
0.20-0.51		MADE GROUND: Soft brown slightly sandy CLAY. Occassionally thinly laminated. (POSSIBLE REWORKED MATERIAL)

Shoring/Support: Stability:   	<b>GENERAL REMARKS</b>  Exploratory hole cleared of buried services. No groundwater encountered.
---------------------------------------------------------------------------------------------------------------------------	--------------------------------------------------------------------------------------------------------

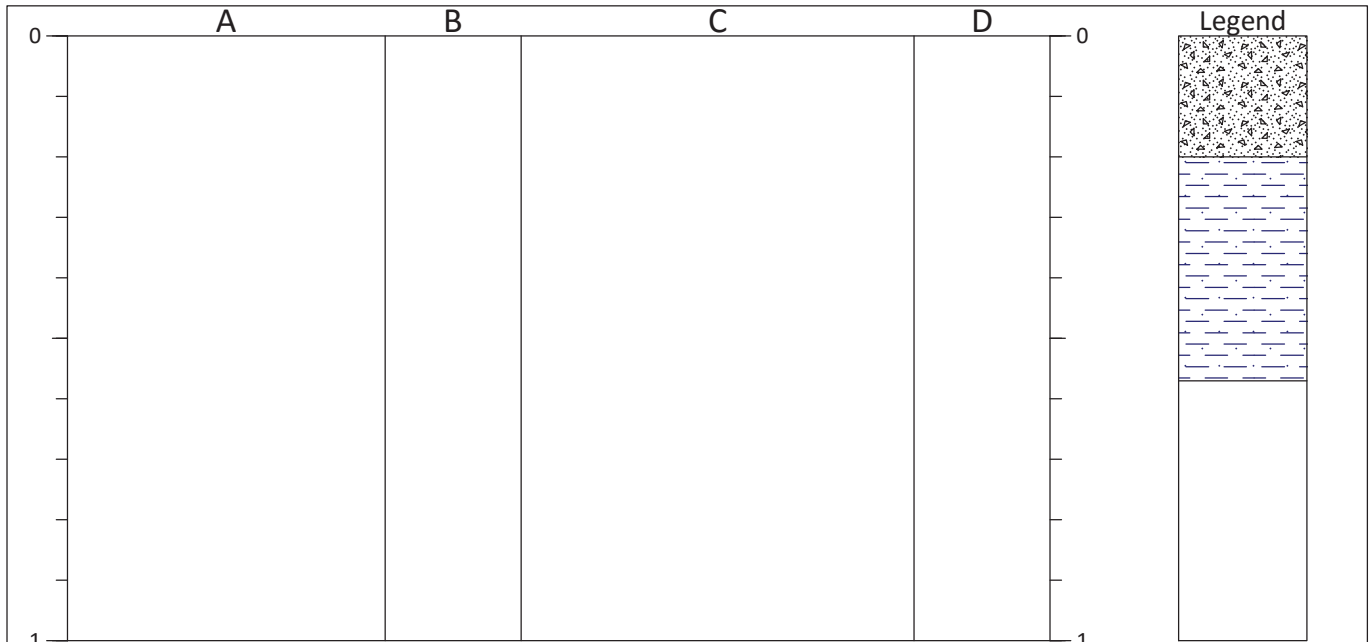
Project Finchley Road, London.				HAND PIT No  <b>HP04</b>
Project ID GSI 0548	Date 01-02-16 03-02-16	Ground Level (m)	Co-Ordinates ( )	
Contractor Aden Build				Sheet 1 of 1

STRATA				SAMPLES & TESTS		
Depth	No	DESCRIPTION	Depth	No	Remarks/Tests	
0.00-0.20		MADE GROUND: Dark grey CONCRETE.				
0.20-0.57		Firm brown laminated CLAY. (WEATHERED LONDON CLAY FORMATION)

Shoring/Support: Stability:   A B C D	GENERAL REMARKS Exploratory hole cleared of buried services. No groundwater encountered.
------------------------------------------------------------	---------------------------------------------------------------------------------------------

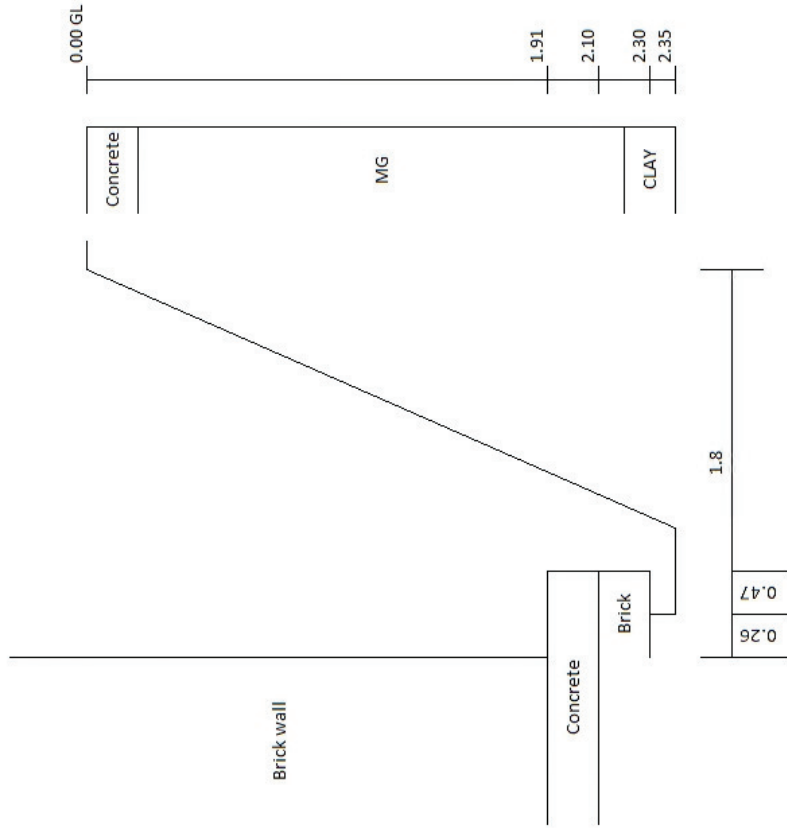
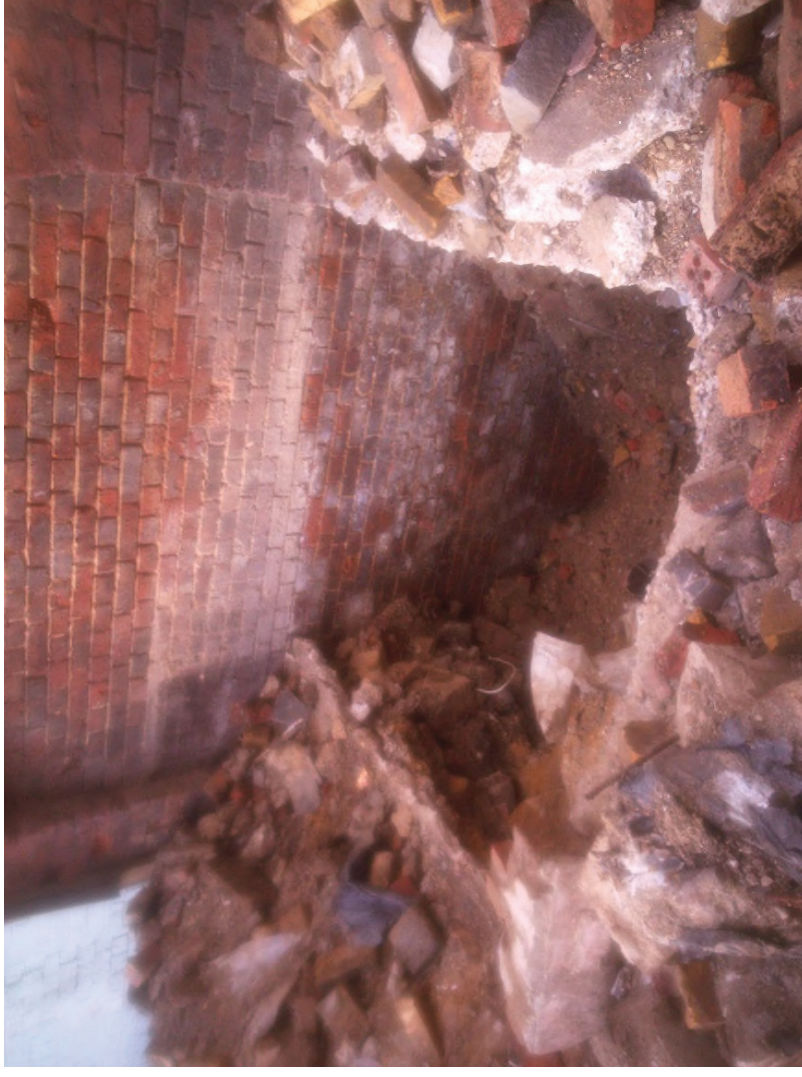
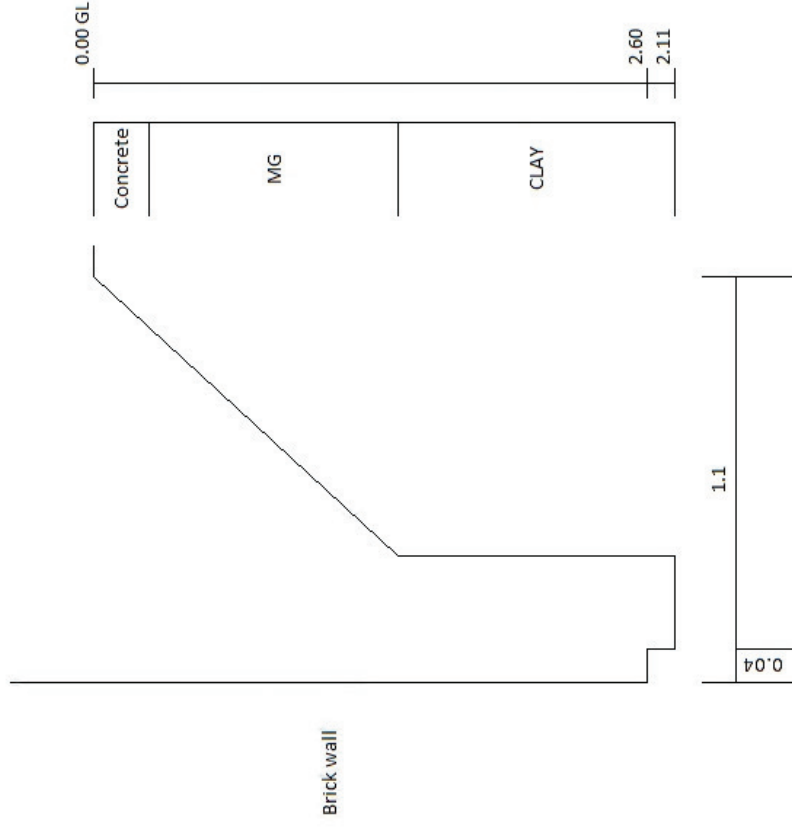
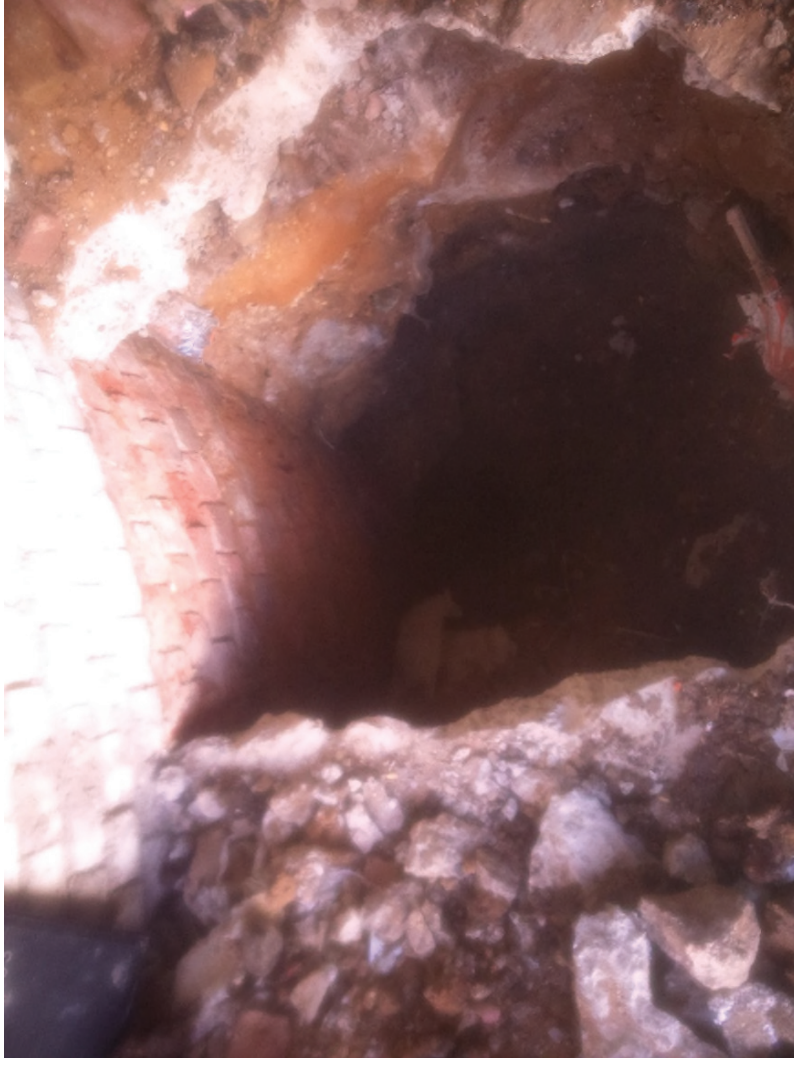
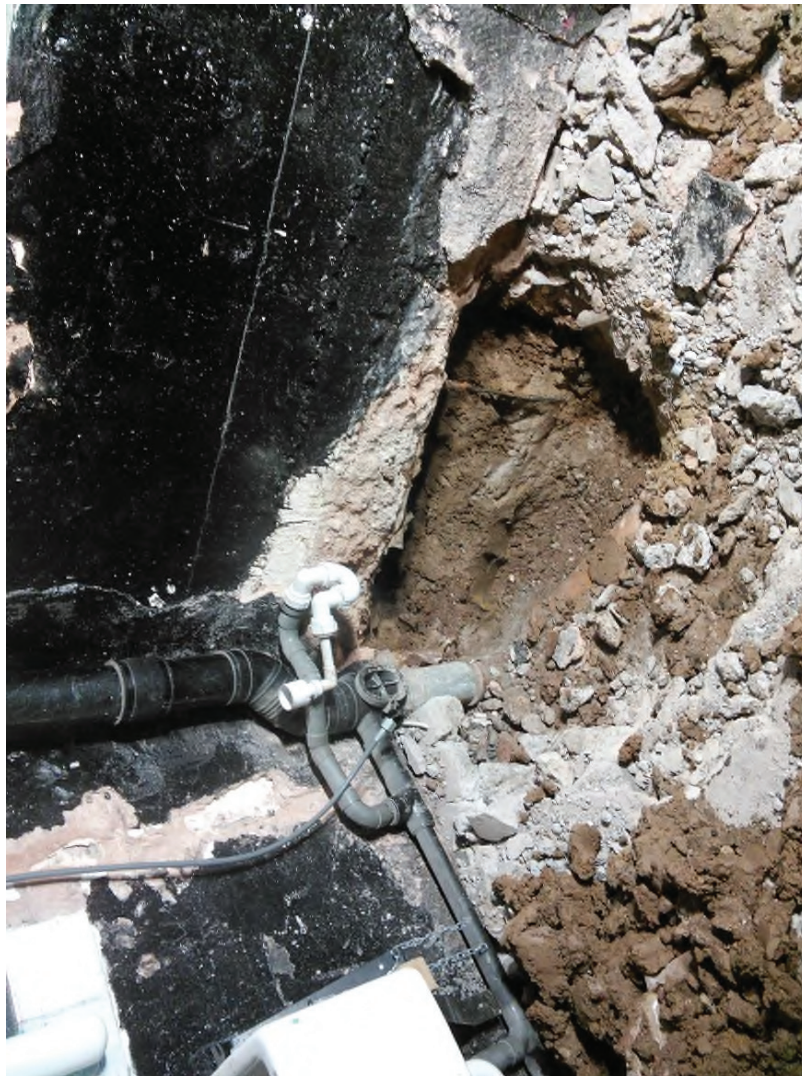
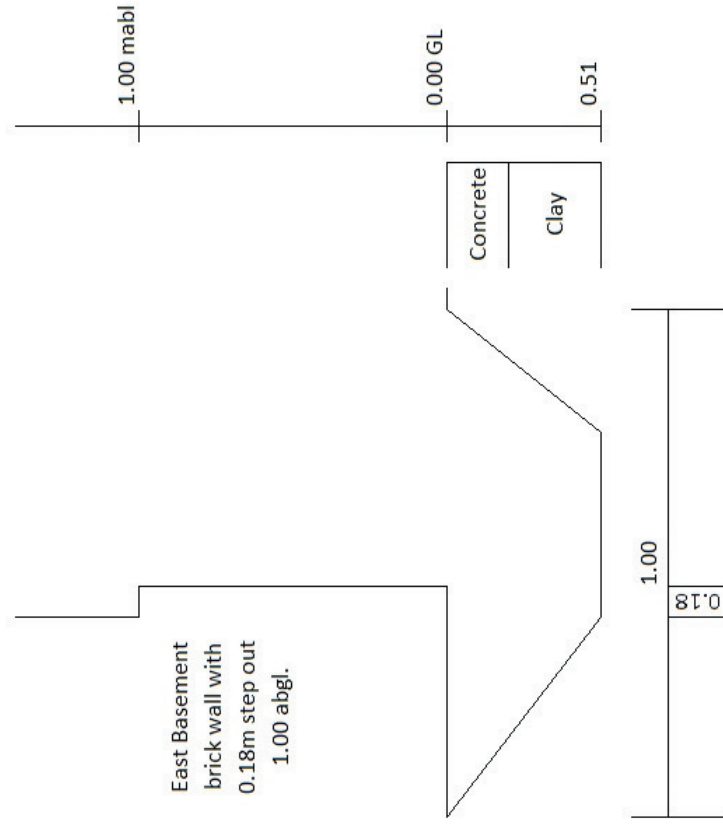
### HAND PIT SKETCHES AND PHOTOGRAPHS

- 3.4.1 Four hand excavated trial pits were excavated at the site in locations specified by the client referenced HP01 through to HP04, in order to expose the existing foundations used at the site.
- 3.4.2 The hand pits were excavated to depths of between 0.51 and 2.40mbgl.
- 3.4.3 All dimension of the exposed foundation were recorded and photographed.
- 3.4.4 Hand pit logs are presented in Appendix D.
- 3.4.5 Hand pit sketches and photographs are presented as drawings GSI0548-04 to GSI0548-07 in Appendix E.
