Project 29 Great James Street

Code QA202

Date 23rd June 2022

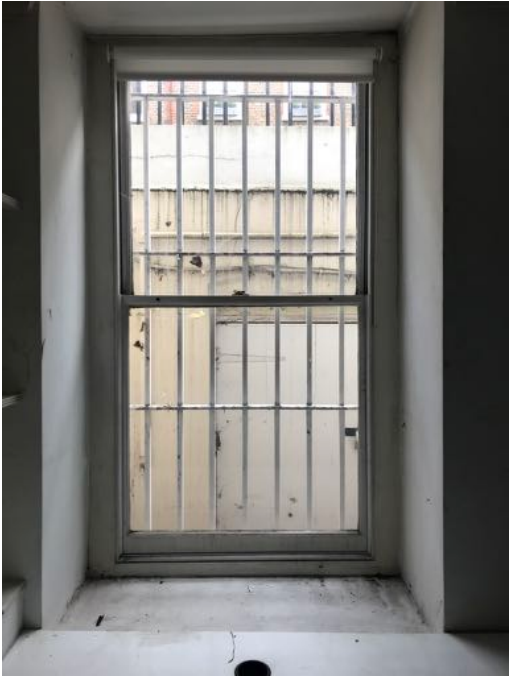
Code	Location	Existing Condition	Photo	Proposed Condition
Basement				
WB.01	Bed (B04)	<ul style="list-style-type: none">Existing non-original 1 over 1 timber sash window with hornsSecurity bars in front of window on exterior face

<ul style="list-style-type: none">New 6 over 6 timber sashes, without horns.Large profiled glazing barsRectangular headed top sashSash box retained and refurbishedSills to be repairedClear glass
WB.02	Bed (B04)	<ul style="list-style-type: none">Existing non-original 1 over 1 timber sash window with hornsSecurity bars in front of window on exterior face

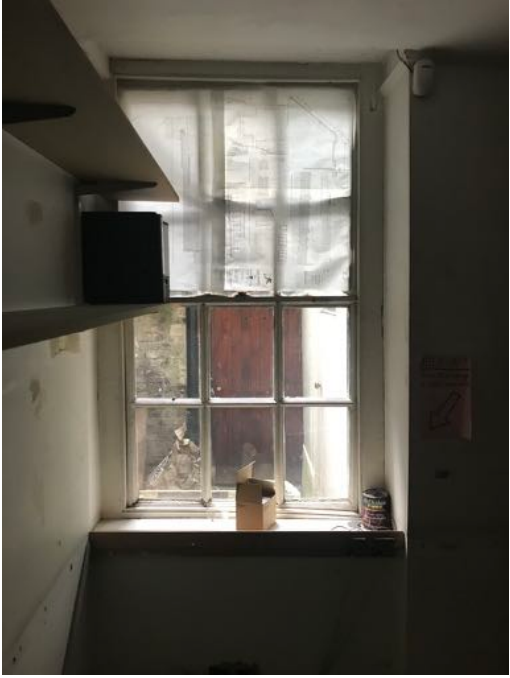
<ul style="list-style-type: none">New 6 over 6 timber sashes, without horns.Large profiled glazing barsRectangular headed top sashSash box retained and refurbishedSills to be repairedClear glass
WB.03	Gym (B09)	<ul style="list-style-type: none">Existing (assumed original) 6 over 6 timber sash window without horns

<ul style="list-style-type: none">Existing 6 over 6 timber sashes refurbishedExisting sash box retained and refurbishedSills to be repairedGlass retained

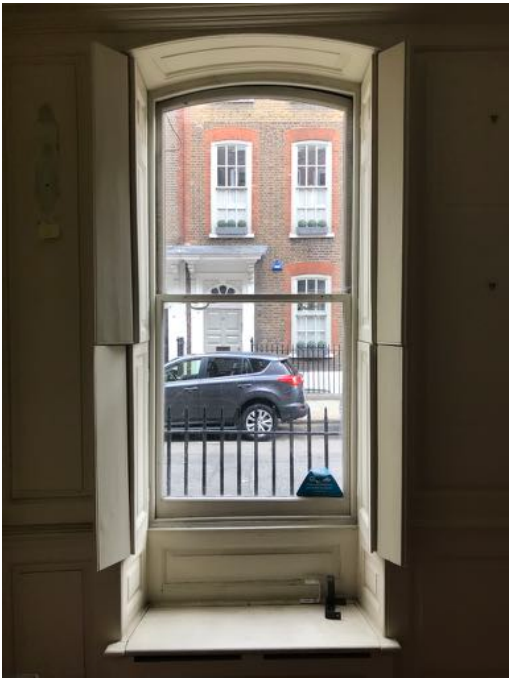
Code	Location	Existing Condition	Photo	Proposed Condition
Ground Floor				
WG.01	Dining (G01)	<ul style="list-style-type: none">Existing non-original 1 over 1 timber sash window with hornsSide hung foldable internal shutters

<ul style="list-style-type: none">New 6 over 6 timber sashes, without horns.Large profiled glazing barsArch headed top sashSash box and architrave retained and refurbishedInternal shutters to be refurbishedSills to be repairedClear glass
WG.02	Dining (G01)	<ul style="list-style-type: none">Existing non-original 1 over 1 timber sash window with hornsSide hung foldable internal shutters

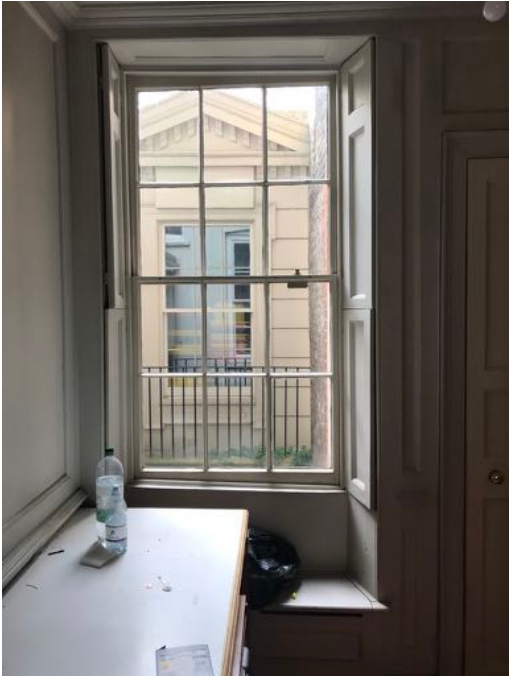
<ul style="list-style-type: none">New 6 over 6 timber sashes, without horns.Large profiled glazing barsArch headed top sashSash box and architrave retained and refurbishedInternal shutters to be refurbishedSills to be repairedClear glass
WG.03	Reception (G12)	<ul style="list-style-type: none">Existing non-original 6 over 6 timber sash window with hornsSide hung internal shutters

<ul style="list-style-type: none">New 6 over 6 timber sashes, without horns.Large profiled glazing barsRectangular headed top sashSash box retained and refurbishedInternal shutters to be refurbishedSills to be repairedClear glass

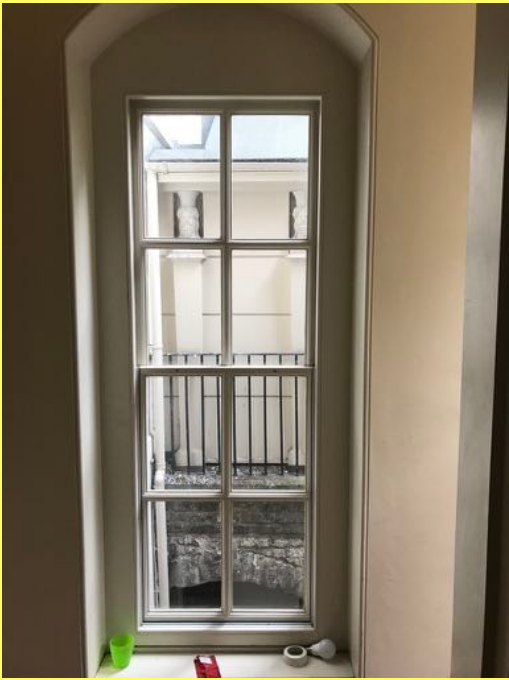
Code	Location	Existing Condition	Photo	Proposed Condition
WG.04	Hall (G10)	<ul style="list-style-type: none">Existing non-original 4 over 4 timber sash window with horns

<ul style="list-style-type: none">Window to be stripped out New 4 over 4 timber sashes, without horns.Large profiled glazing barsRectangular headed top sashSash box retained and refurbishedInternal shutters to be refurbishedSills to be repairedClear glass
WG.05	Store (G05)	<ul style="list-style-type: none">Existing non-original 6 over 6 timber sash window without horns

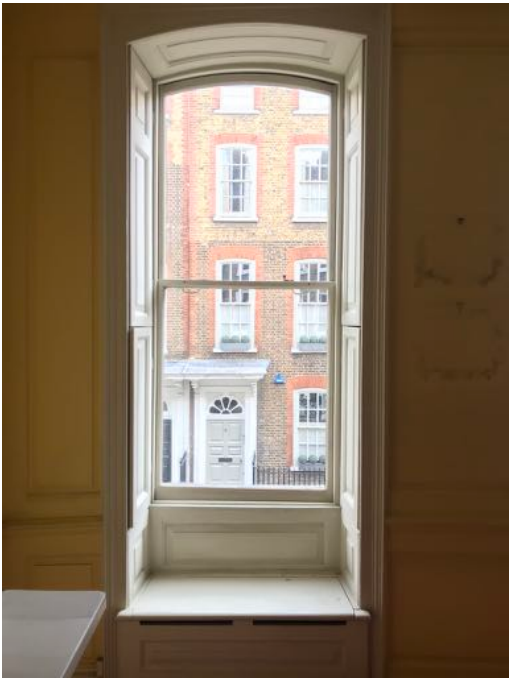
Code	Location	Existing Condition	Photo	Proposed Condition
First Floor				
W01.01	Living Room (101)	<ul style="list-style-type: none">Existing non-original 1over 1 timber sash window with hornsSide hung internal shutters

<ul style="list-style-type: none">New 9 over 6 timber sashes, without horns.Large profiled glazing barsArch headed top sashSash box retained and refurbishedInternal shutters to be refurbishedSills to be repairedClear glass
W01.02	Living Room (101)	<ul style="list-style-type: none">Existing non-original 1over 1 timber sash window with hornsSide hung internal shutters	 	<ul style="list-style-type: none">New 9 over 6 timber sashes, without horns.Large profiled glazing barsArch headed top sashSash box retained and refurbishedInternal shutters to be refurbishedSills to be repairedClear glass
W01.03	Living Room (101)	<ul style="list-style-type: none">Existing non-original 1over 1 timber sash window with hornsSide hung internal shutters	 	<ul style="list-style-type: none">New 9 over 6 timber sashes, without horns.Large profiled glazing barsArch headed top sashSash box retained and refurbishedInternal shutters to be refurbishedSills to be repairedClear glass

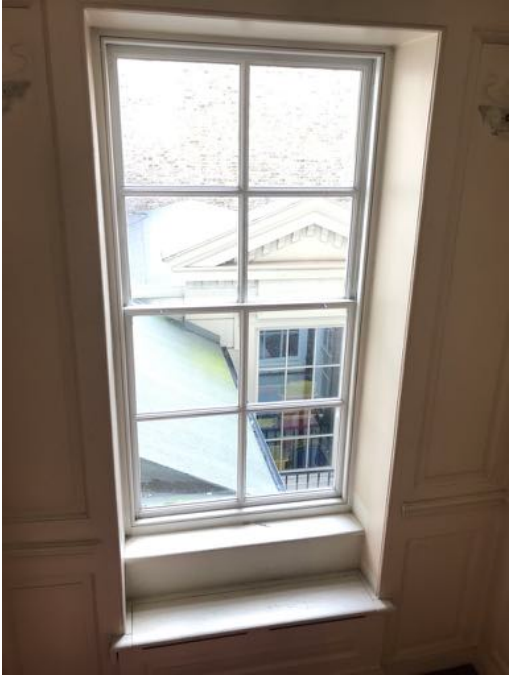
Code	Location	Existing Condition	Photo	Proposed Condition
W01.04	Stair (102)	<ul style="list-style-type: none">Existing non-original 4 over 4 timber sash window without horns

<ul style="list-style-type: none">New 6 over 6 timber sashes, without horns.Large profiled glazing barsRectangular headed top sashSash box retained and refurbishedSills to be repairedClear glass
W01.05	Office (103)	<ul style="list-style-type: none">Existing non-original 2 over 2 timber sash window without hornsSide hung internal shutters fixed shut

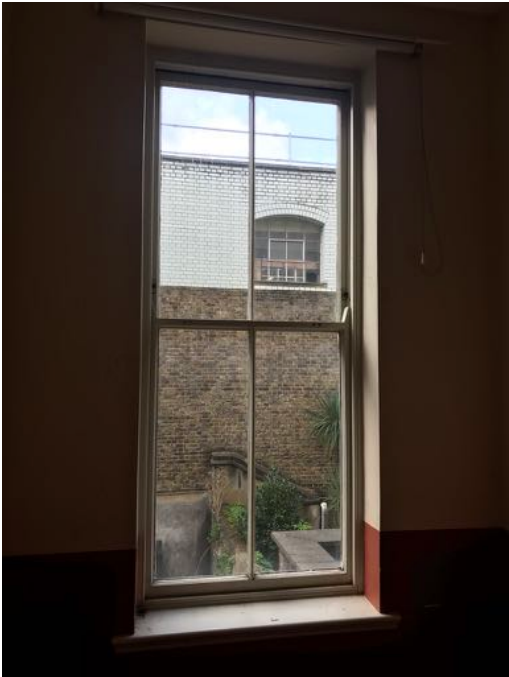
<ul style="list-style-type: none">New 4 over 4 timber sashes, without horns.Large profiled glazing barsRectangular headed top sashSash box retained and refurbishedSills to be repairedGlass to be clearShutters refurbished and made operableClear glass
W01.06	Bar (104)	<ul style="list-style-type: none">Existing non-original 2 over 2 timber sash window with horns

<ul style="list-style-type: none">Non non-original window to be stripped out and replaced with door D01.07

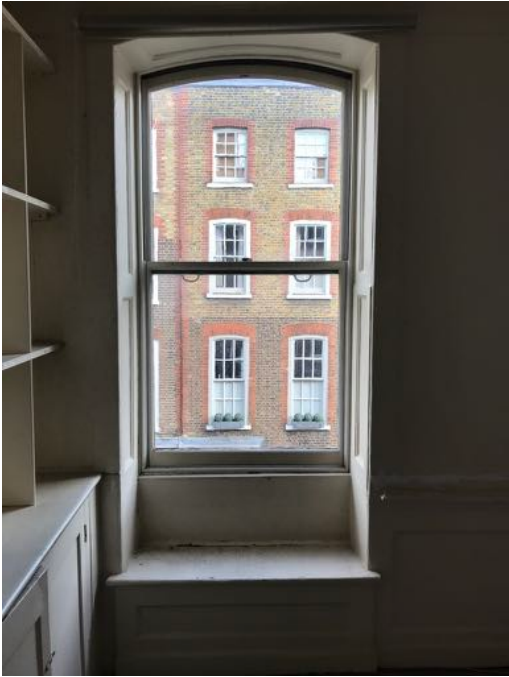
Code	Location	Existing Condition	Photo	Proposed Condition
Second Floor				
W02.01	Master Bed (201)	<ul style="list-style-type: none">Existing non-original 1 over 1 timber sash window without hornsSide hung internal shutters fixed shut

<ul style="list-style-type: none">New 6 over 6 timber sashes, without horns.Large profiled glazing barsArch headed top sashSash box retained and refurbishedSills to be repairedClear glassShutters to be refurbished and made operable
W02.02	Master Bed (201)	<ul style="list-style-type: none">Existing non-original 1 over 1 timber sash window without hornsSide hung internal shutters fixed shut

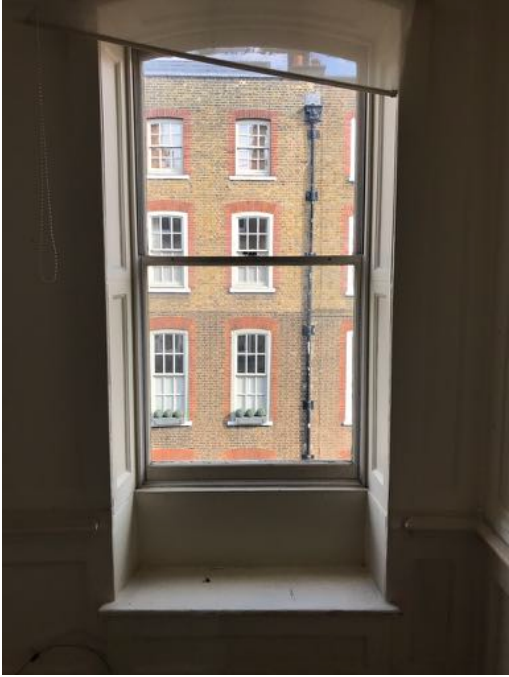
<ul style="list-style-type: none">New 6 over 6 timber sashes, without horns.Large profiled glazing barsArch headed top sashSash box retained and refurbishedSills to be repairedClear glassShutters to be refurbished and made operable
W02.03	Master Bed (201)	<ul style="list-style-type: none">Existing non-original 1 over 1 timber sash window without hornsSide hung internal shutters fixed shut

<ul style="list-style-type: none">New 6 over 6 timber sashes, without horns.Large profiled glazing barsArch headed top sashSash box retained and refurbishedSills to be repairedClear glassShutters to be refurbished and made operable

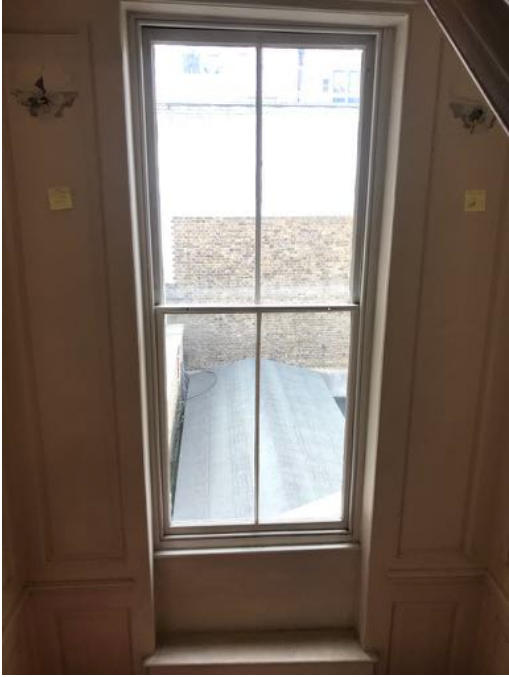
Code	Location	Existing Condition	Photo	Proposed Condition
W02.04	Stair (202)	<ul style="list-style-type: none">Existing non-original 2 over 2 timber sash window without horns

<ul style="list-style-type: none">New 6 over 6 timber sashes, without horns.Large profiled glazing barsRectangular headed top sashSash box retained and refurbishedSills to be repairedClear glass
W02.05	Bathroom (205)	<ul style="list-style-type: none">Existing non-original 2 over 2 timber sash window without horns

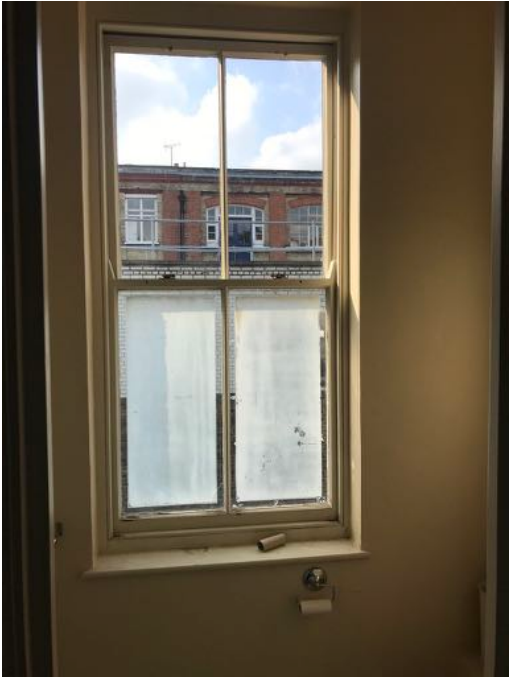
<ul style="list-style-type: none">New 6 over 6 timber sashes, without horns.Large profiled glazing barsRectangular headed top sashSash box retained and refurbishedSills to be repairedClear glass
W02.06	Dressing (206)	<ul style="list-style-type: none">Existing non-original 2 over 2 timber sash window with horns

<ul style="list-style-type: none">New 6 over 6 timber sashes, without horns.Large profiled glazing barsRectangular headed top sashSash box retained and refurbishedSills to be repairedClear glass

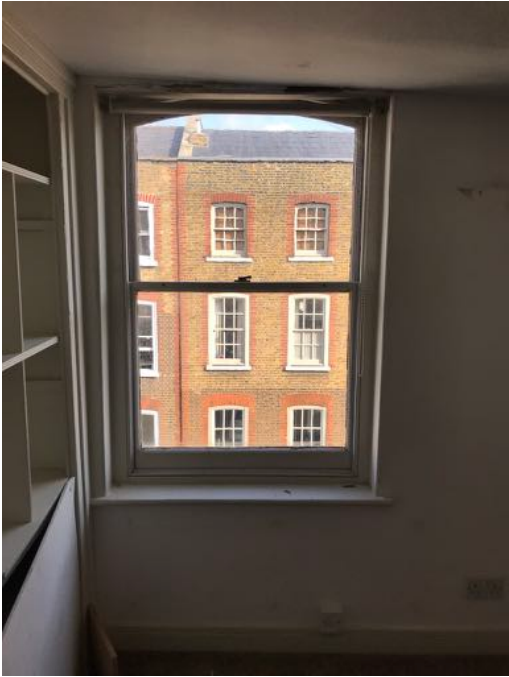
Code	Location	Existing Condition	Photo	Proposed Condition
Third Floor				
W03.01	Ensuite (309)	<ul style="list-style-type: none">Existing non-original 1 over 1 timber sash window with horns

<ul style="list-style-type: none">New 6 over 6 timber sashes, without horns.Large profiled glazing barsArch headed top sashSash box retained and refurbishedSills to be repairedClear glass
W03.02	Bedroom 3 (302)	<ul style="list-style-type: none">Existing non-original 1 over 1 timber sash window with horns

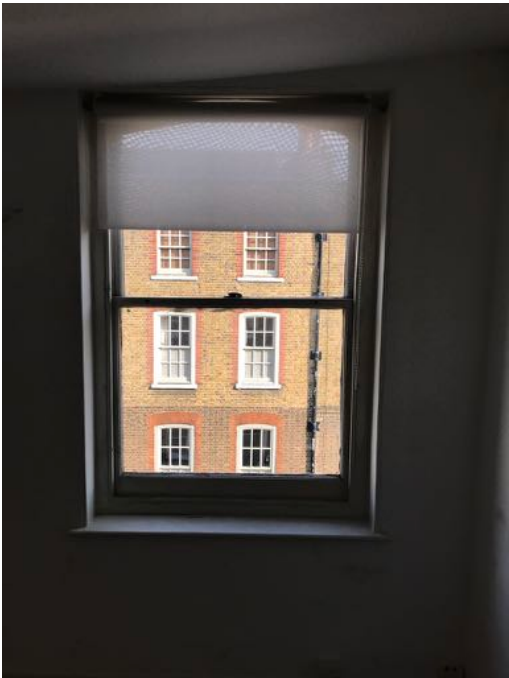
<ul style="list-style-type: none">New 6 over 6 timber sashes, without horns.Large profiled glazing barsArch headed top sashSash box retained and refurbishedSills to be repairedClear glass
W03.03	Bedroom 3 (302)	<ul style="list-style-type: none">Existing original 2 over 2 timber sash window without horns

<ul style="list-style-type: none">New 6 over 6 timber sashes, without horns.Large profiled glazing barsArch headed top sashSash box retained and refurbishedSills to be repairedClear glass

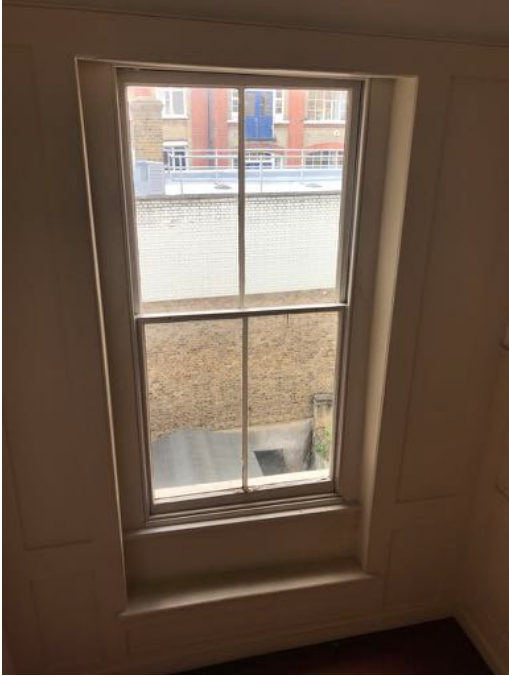
Code	Location	Existing Condition	Photo	Proposed Condition
W03.04	Stair (302)	<ul style="list-style-type: none">Existing non-original 2 over 2 timber sash window without horns

<ul style="list-style-type: none">New 6 over 6 timber sashes, without horns.Large profiled glazing barsRectangular headed top sashSash box retained and refurbishedSills to be repairedClear glass
W03.05	Dressing (305)	<ul style="list-style-type: none">Existing non-original 2 over 2 timber sash window without horns

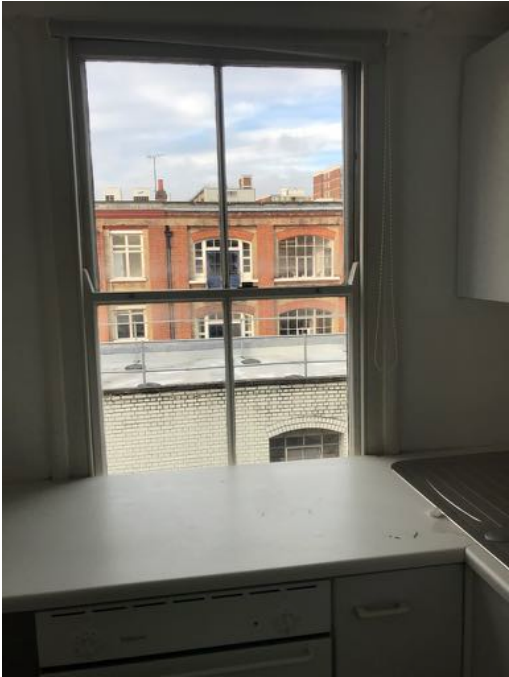
<ul style="list-style-type: none">New 6 over 6 timber sashes, without horns.Large profiled glazing barsRectangular headed top sashSash box retained and refurbishedSills to be repairedClear glass
W03.06	Ensuite (306)	<ul style="list-style-type: none">Existing non-original 2 over 2 timber sash window without horns

<ul style="list-style-type: none">New 6 over 6 timber sashes, without horns.Large profiled glazing barsRectangular headed top sashSash box retained and refurbishedSills to be repairedClear glass
